## VEHICLE INSPECTION REPORT

SV66LOH

### Fiat Fullback 2.4 180hp LX Double Cab Pick Up Auto

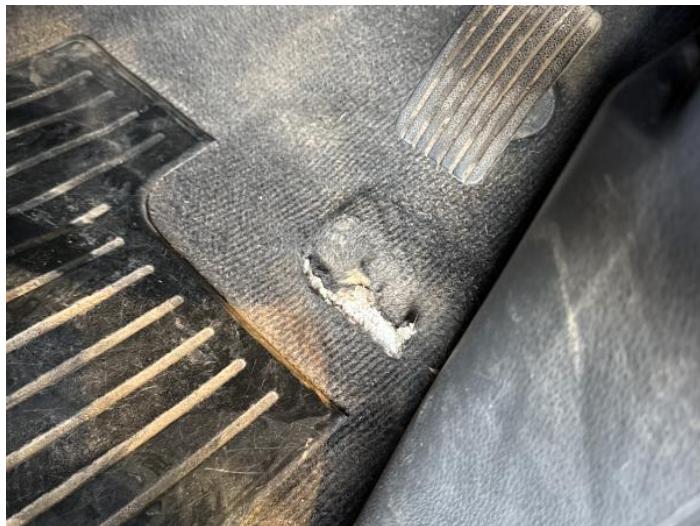
1: Carpets Front  
Torn  
Over 10mm

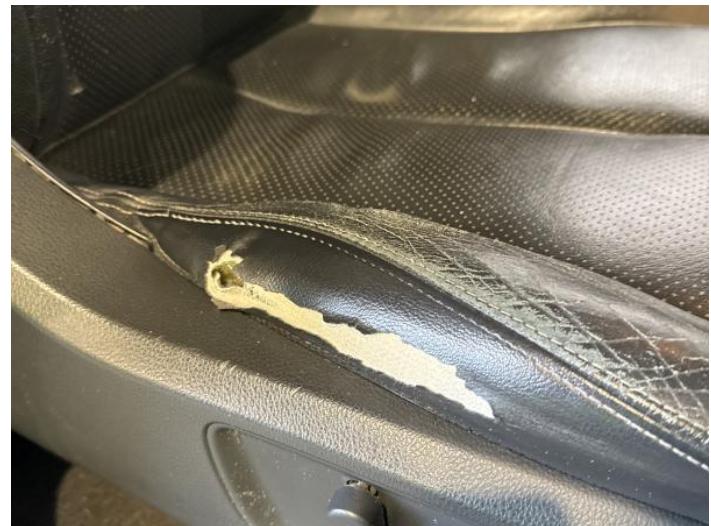
2: Seat Base Cover osf  
Holed  
Over 3mm

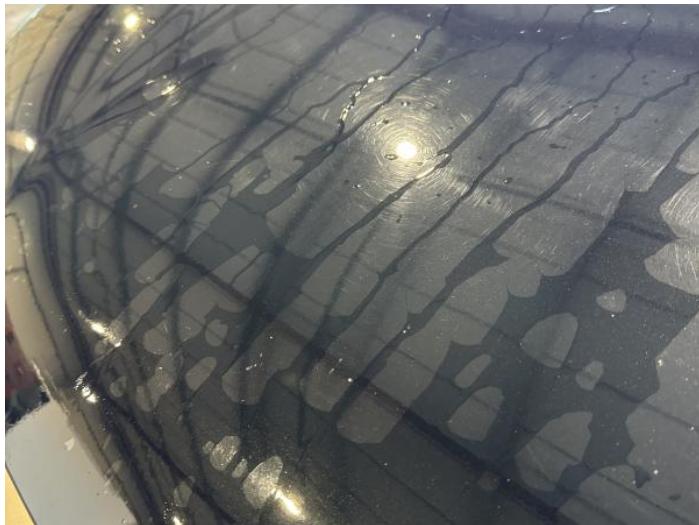
3: Bonnet  
Chipped  
Multiple Chips

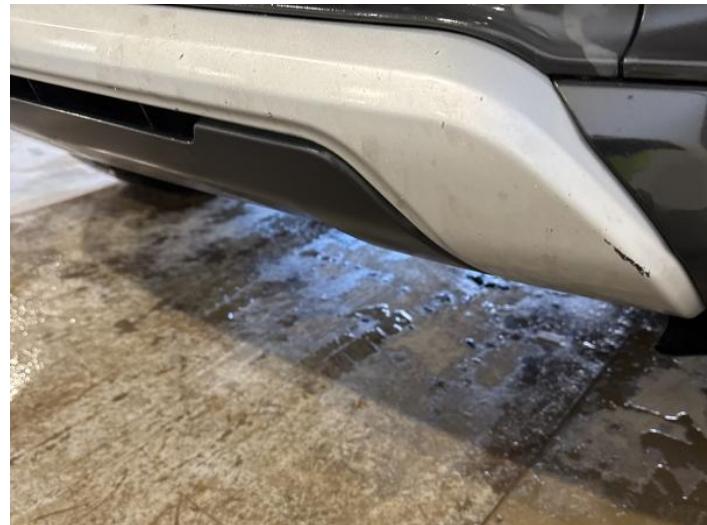
4: Bumper Front Moulding  
Scratched (Painted)  
Over 25mm Thru Paint

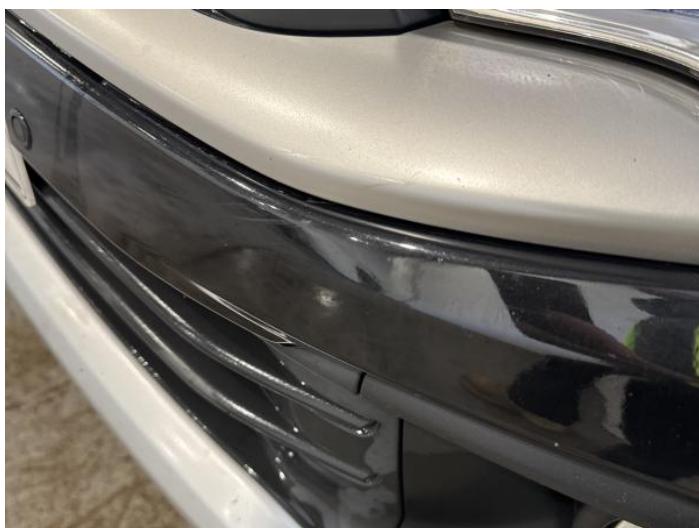
5: Bumper Front  
Chipped  
Multiple Chips

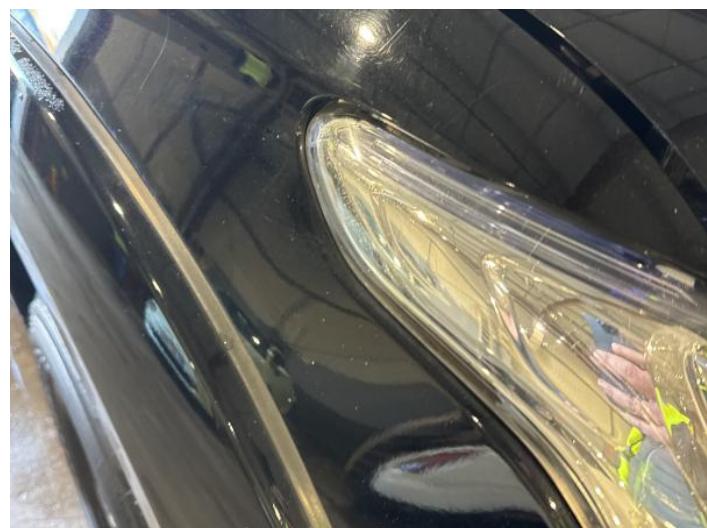
6: Wing osf  
Chipped  
Multiple Chips

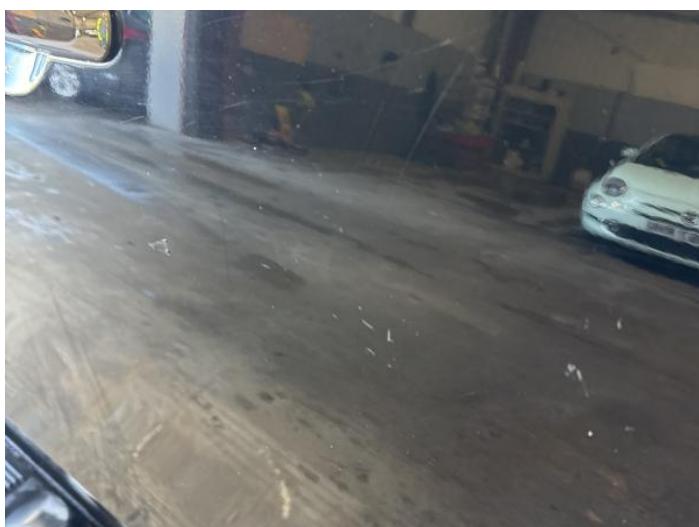
7: Door osf  
Scratched  
Over 25mm Thru Paint

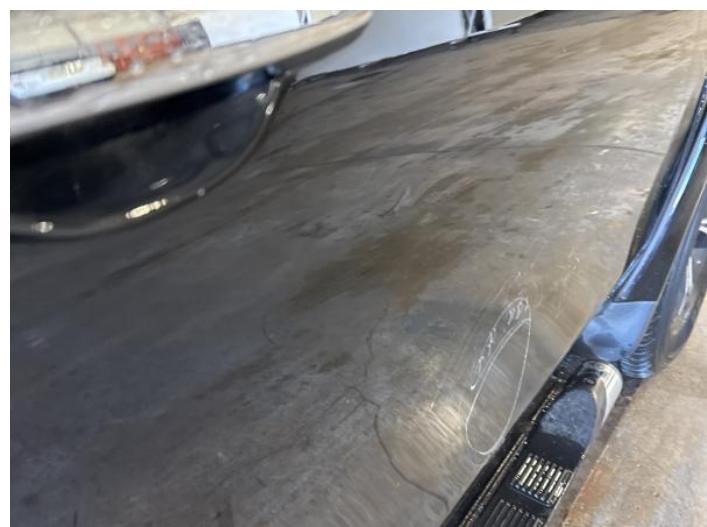
8: Door osf  
Dented  
Between 10mm + 30mm

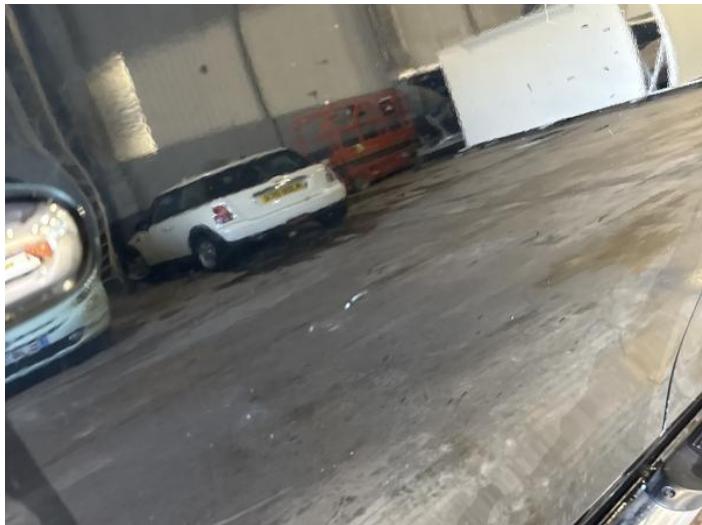
9: Door osr  
Scratched  
Over 25mm Thru Paint

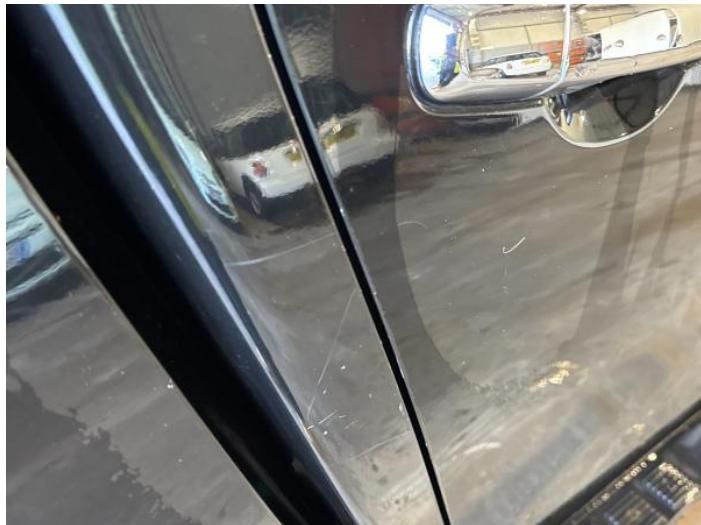
10: C Post osr  
Scratched  
Over 25mm Thru Paint

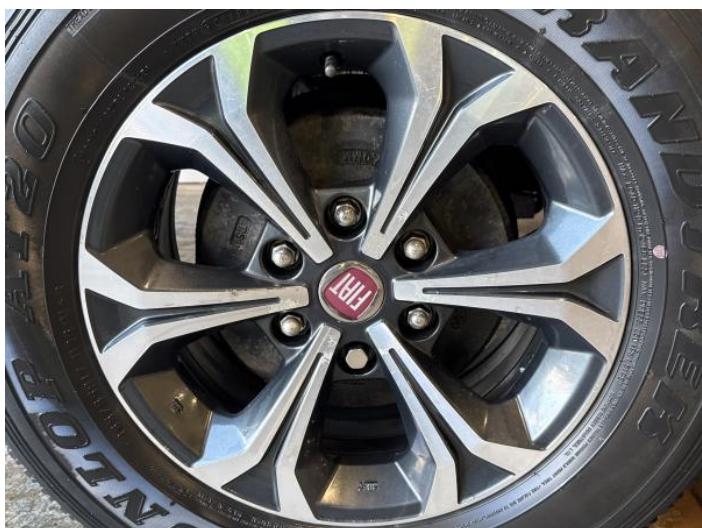
11: Wheel osr  
Corroded  
Light

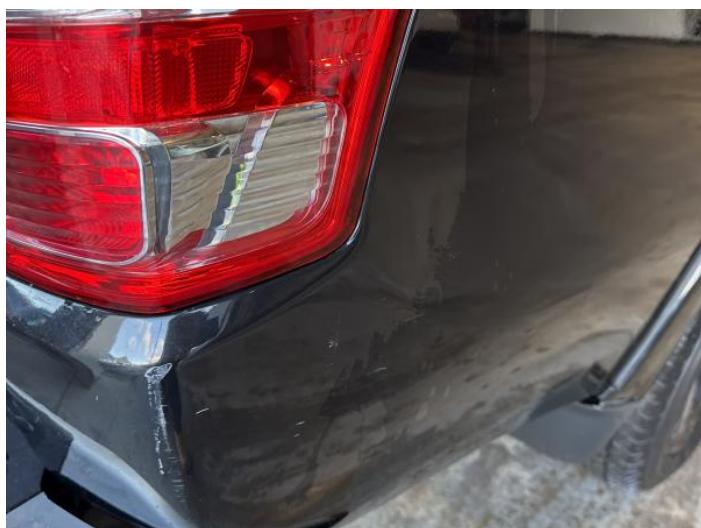
12: Qtr Panel osr  
Scratched  
Over 25mm Thru Paint

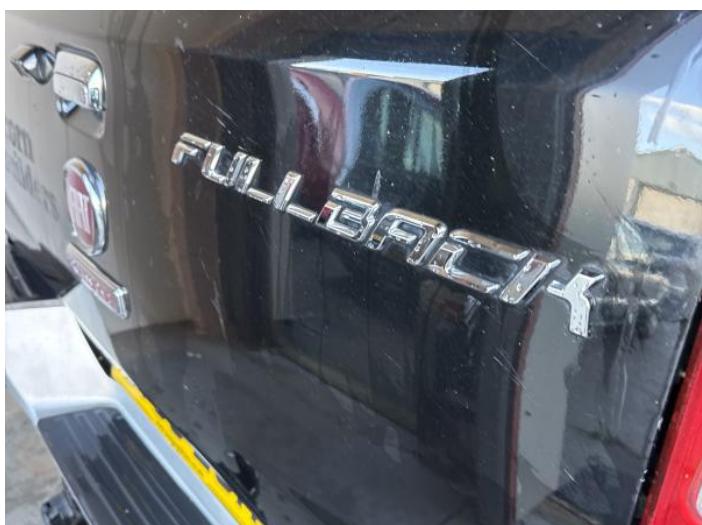
13: Tailgate  
Scratched  
Over 25mm Thru Paint

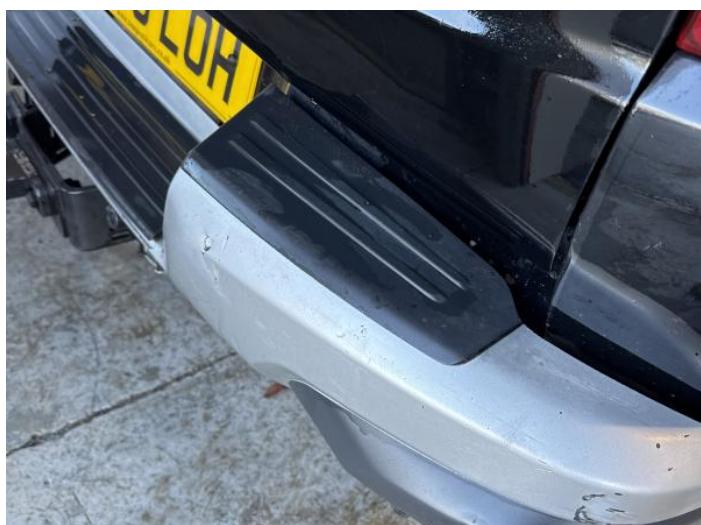
14: Bumper Rear  
Dented  
With Paint Damage

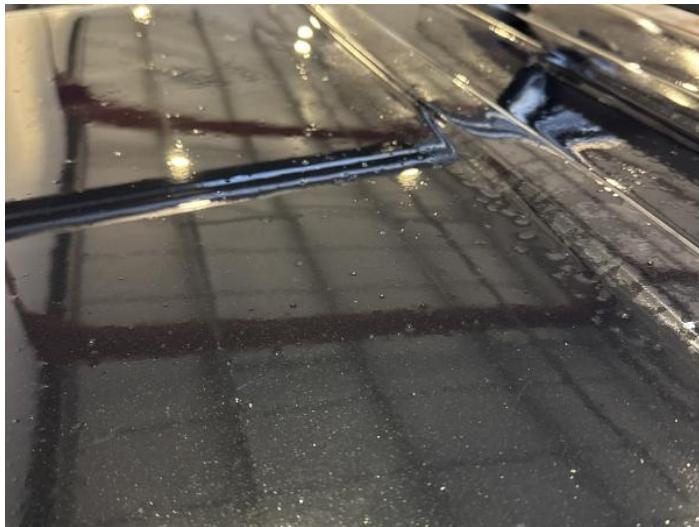
15: Roof  
Dented  
Over 30mm

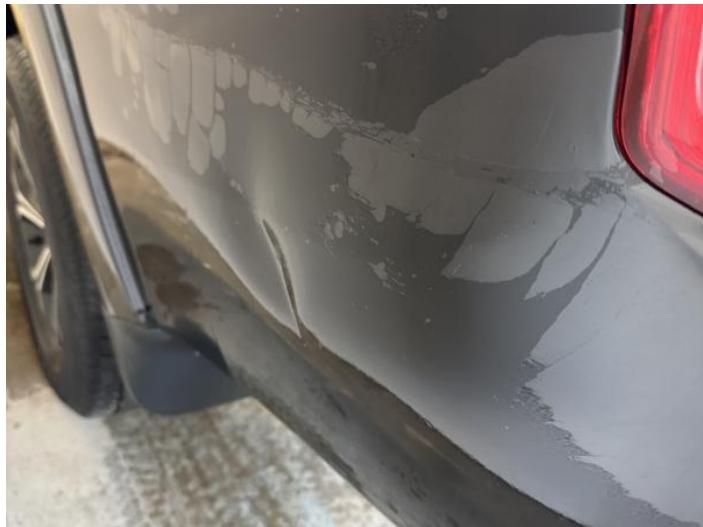
16: Qtr Panel nsr  
Dented  
Over 30mm

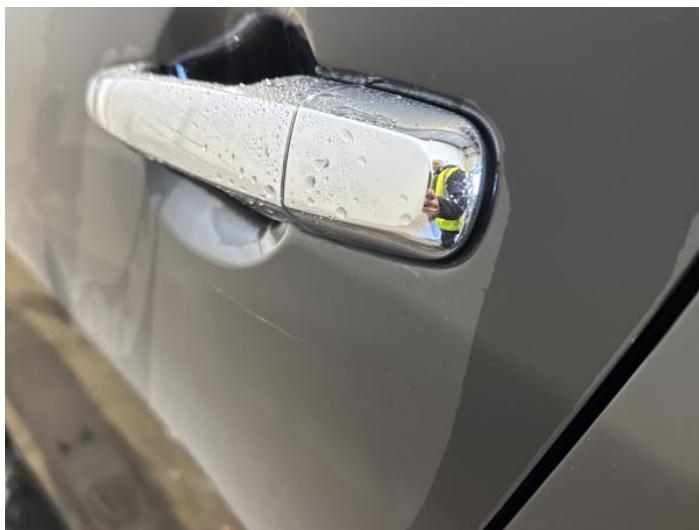
17: Door nsr  
Scratched  
Over 25mm Thru Paint

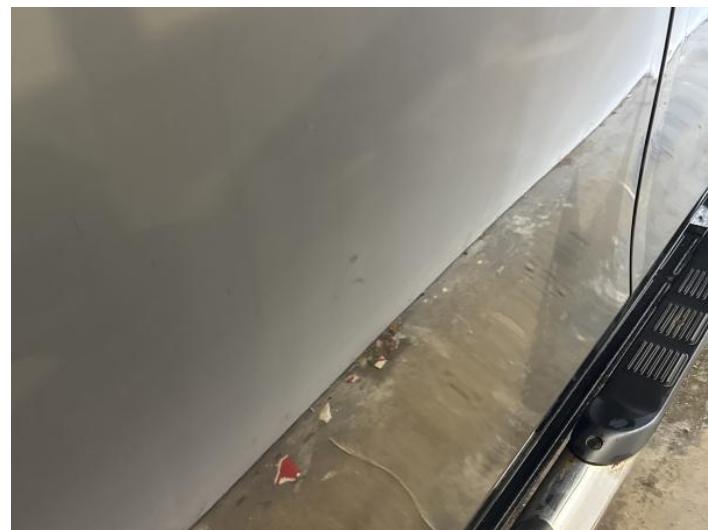
18: Door nsf  
Scratched  
UpTo 25mm Thru Paint

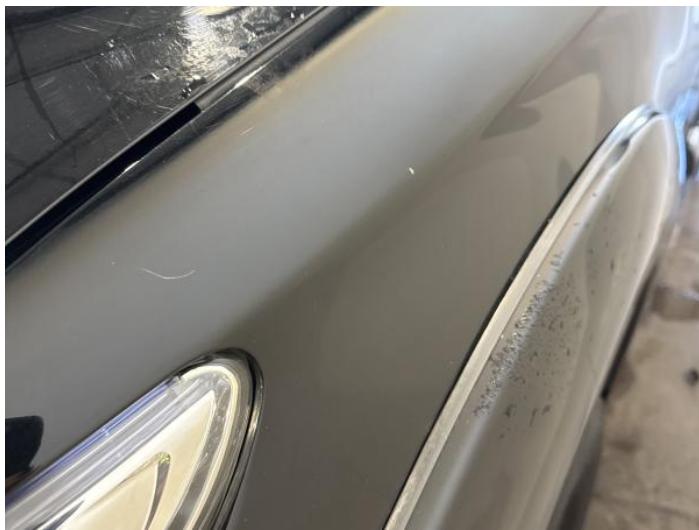
19: Wing nsf  
Chipped  
1 To 5
