VEHICLE INSPECTION REPORT

HV63TKY

Mini Countryman 1.6 Cooper 5dr

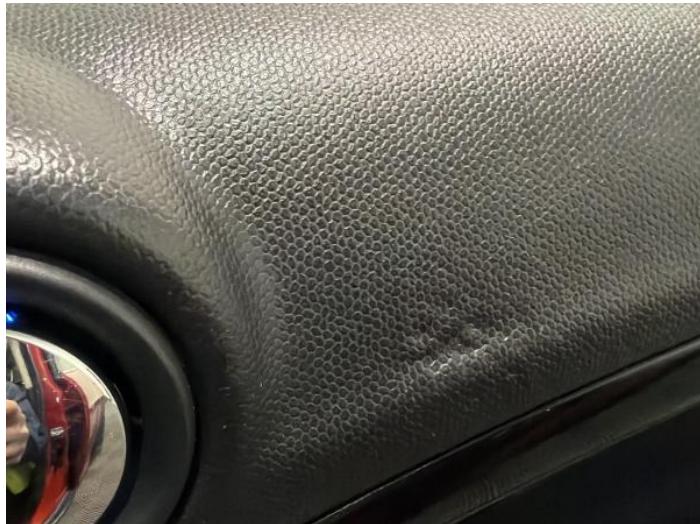
1: Door Pad osf
Scuffed
UpTo 25mm

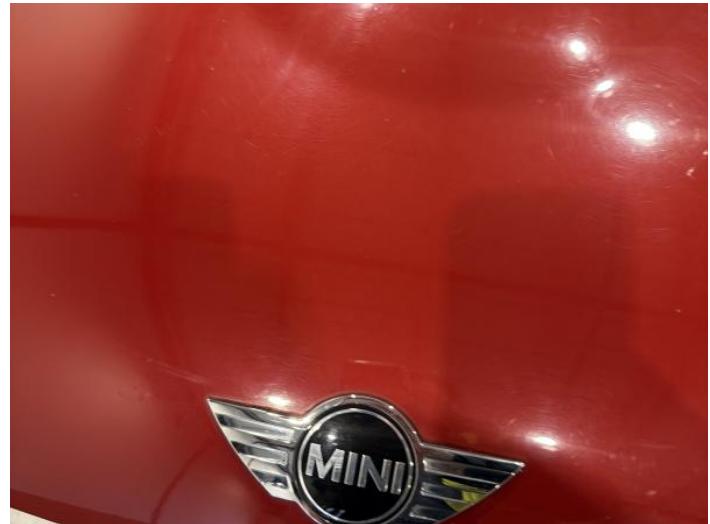
2: Bonnet
Chipped
Multiple Chips

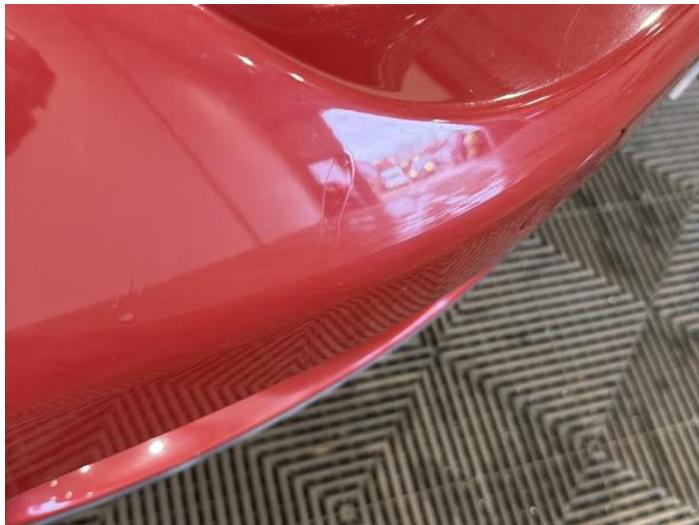
3: Bumper Front
Poor Previous Repair
Poor Paint

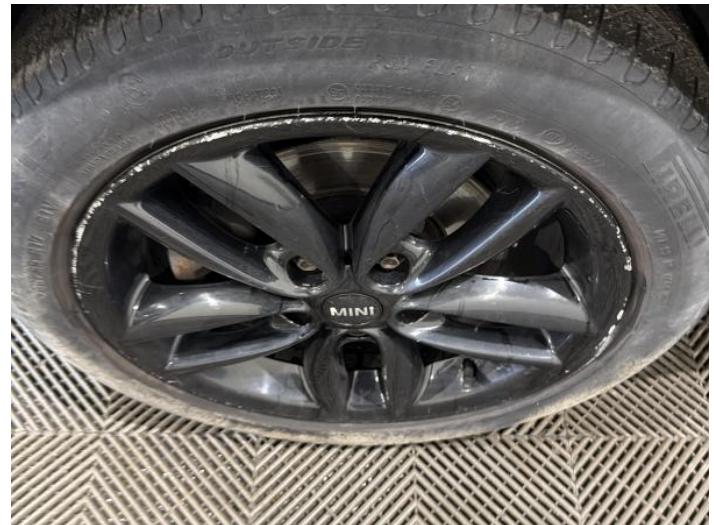
4: Wheel nsf
Scratched
Over 50mm

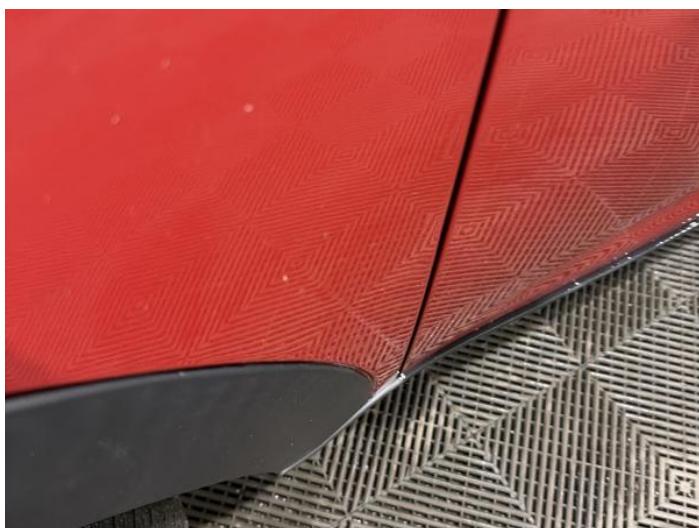
5: Wing nsf
Chipped
1 To 5

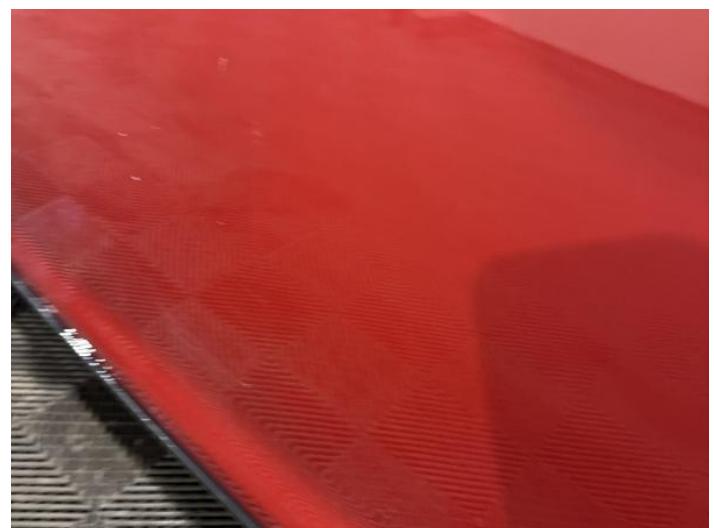
6: Door nsf
Chipped
Multiple Chips

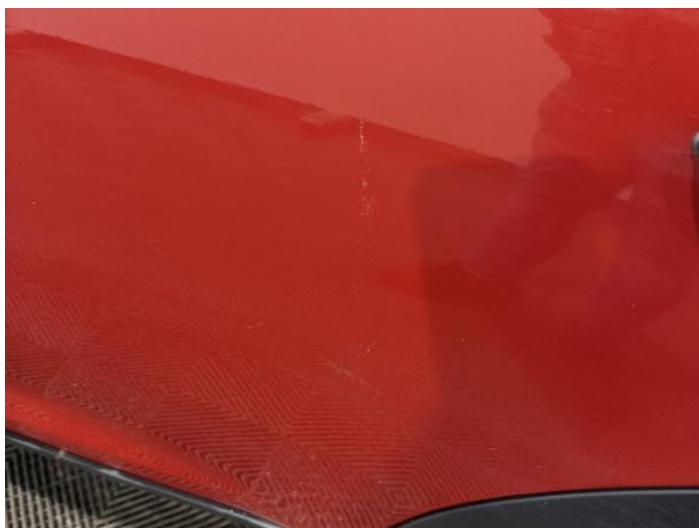
7: Door nsr
Dented
With Paint Damage

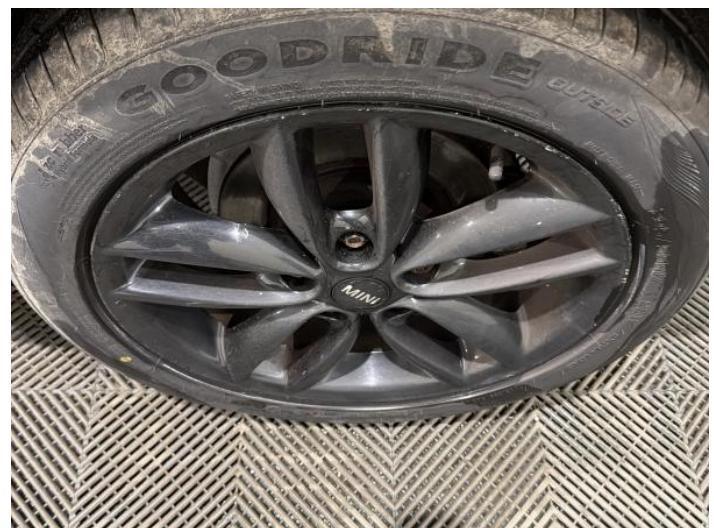
8: Wheel nsr
Scratched
Over 50mm

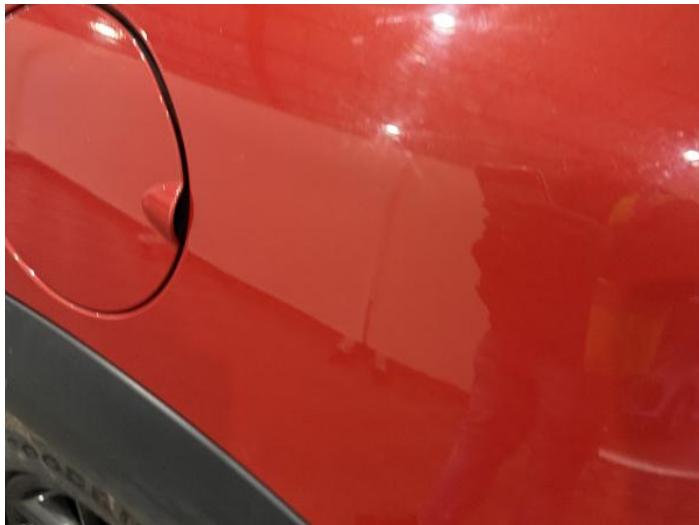
9: Qtr Panel nsr
Dented
2 Or Less UpTo 10mm

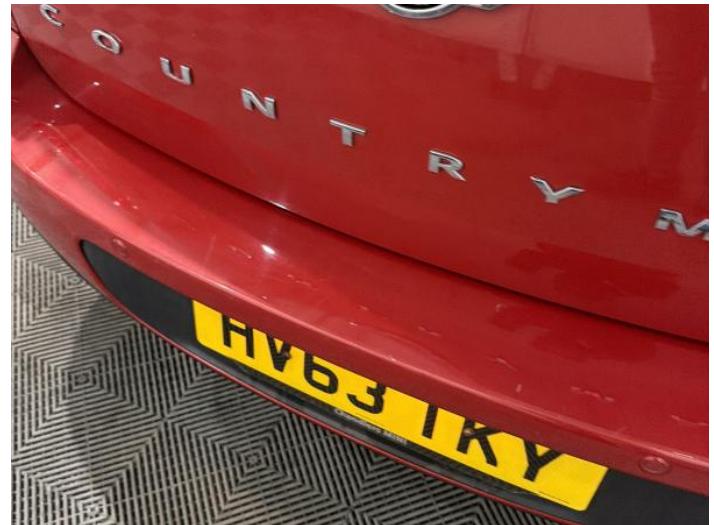
10: Bumper Rear
Scratched
Over 100mm Thru Paint

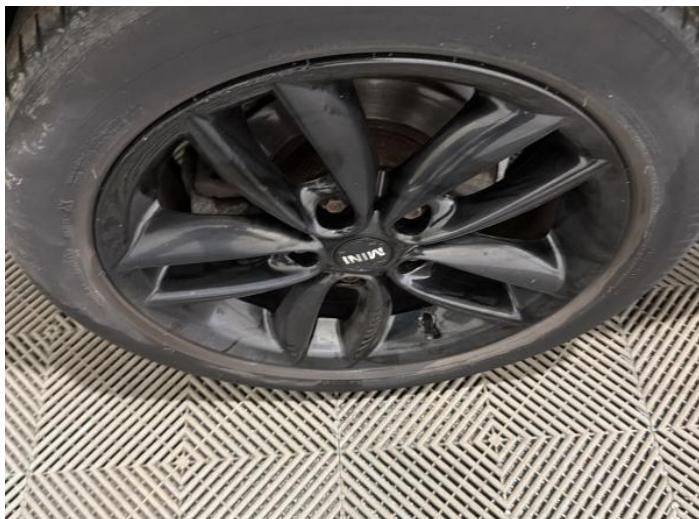
13: Wheel osr
Scratched
Up To 50mm

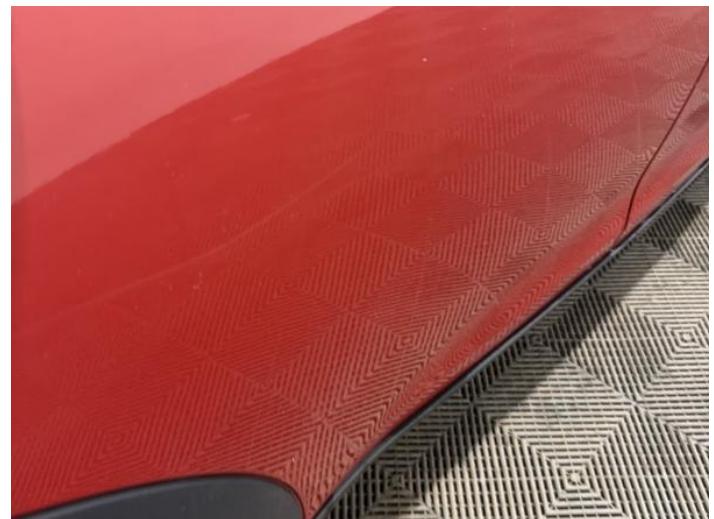
14: Door osr
Dented
With Paint Damage

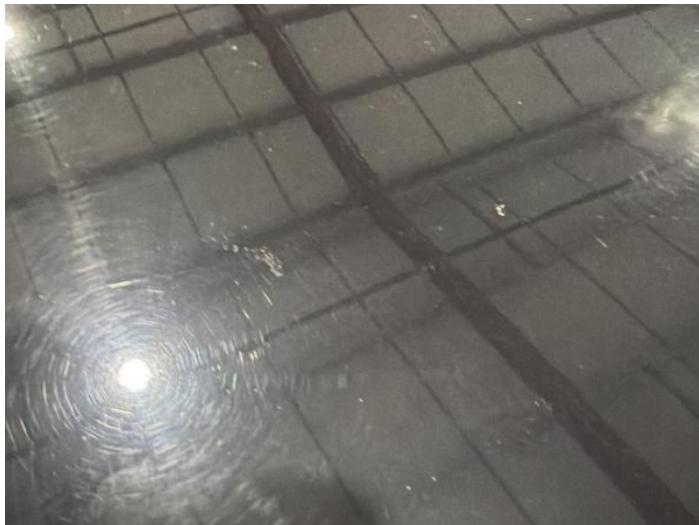
15: Roof
Dented
Hail - Moderate

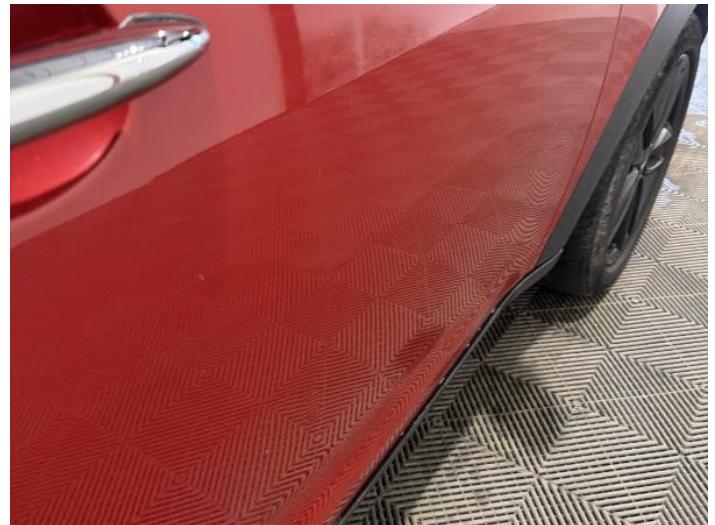
16: Door osf
Chipped
1 To 5

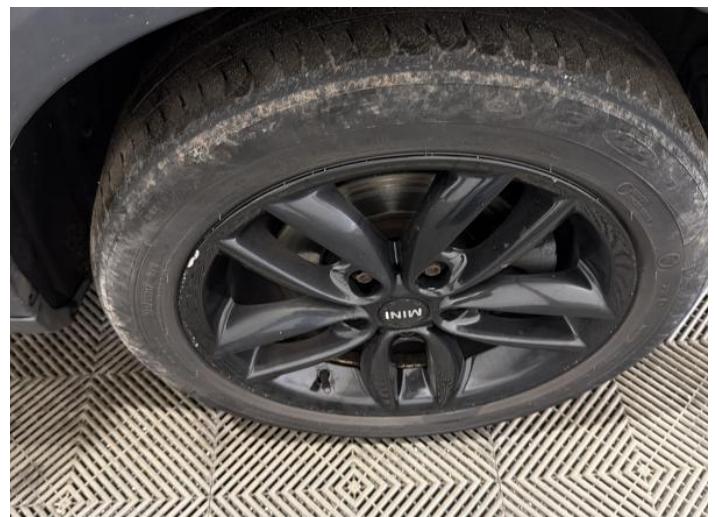
18: Wheel osf
Scratched
Over 50mm

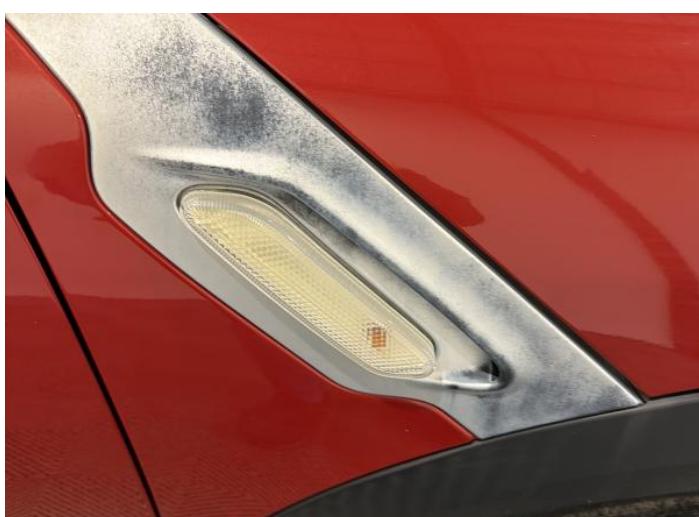
19: Wing Front Arch Extension os
Scratched (Painted)
Over 25mm Thru Paint

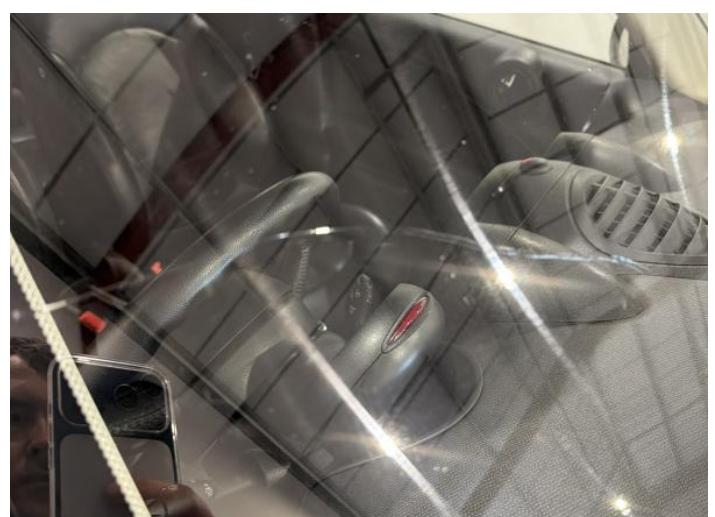
20: Screen Front
Cracked
Replace
