# VEHICLE INSPECTION REPORT

LG67LXY

## Audi A3 1.5 TFSI S Line 5dr

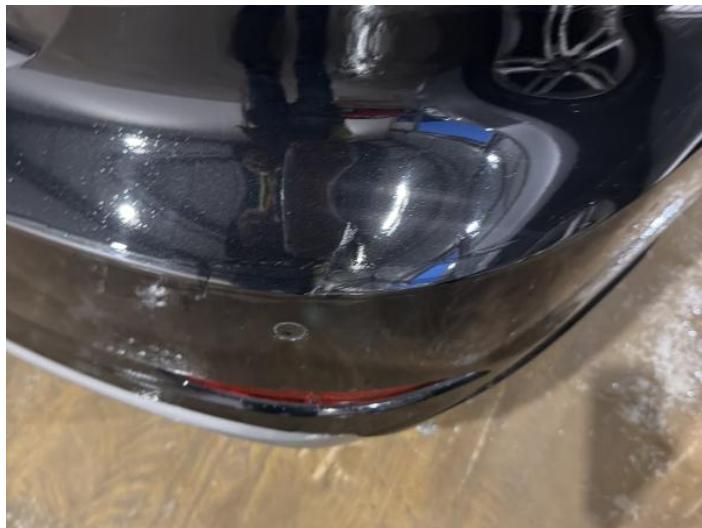
1: Bumper Rear  
Scratched  
25 to 100mm Thru Paint

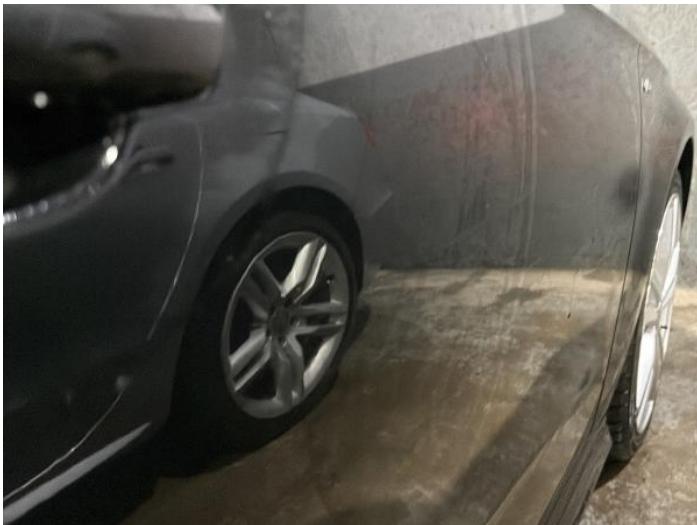
8: Door osr  
Scratched  
Over 25mm Not Thru Paint

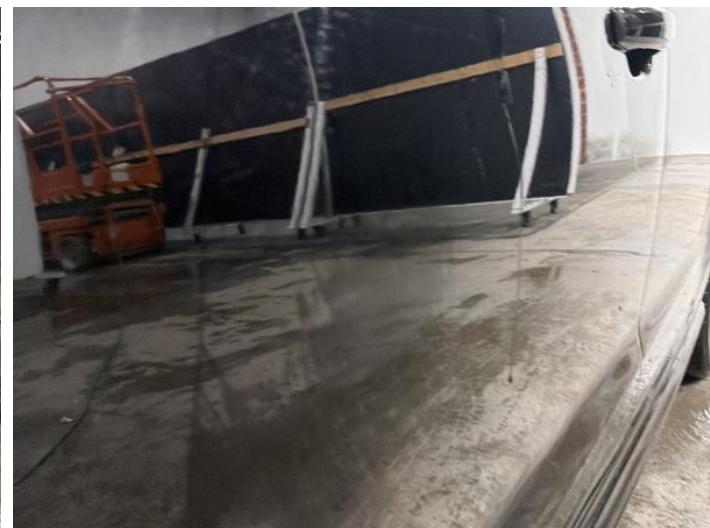
17: Wing nsf  
Chipped  
1 To 5

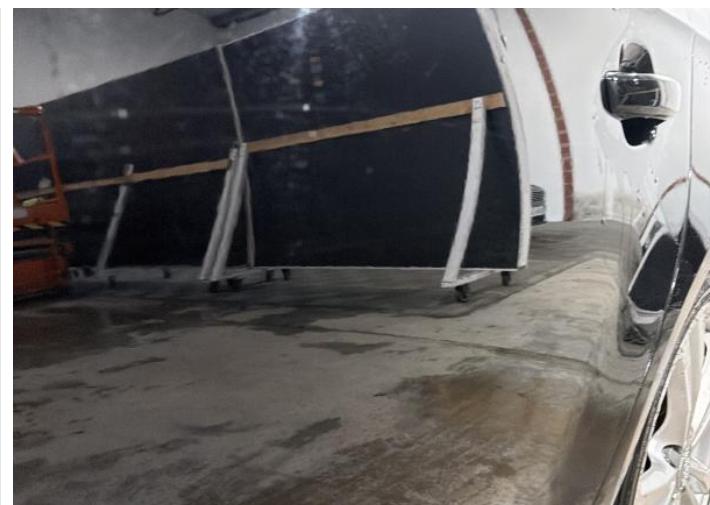
19: Door nsf  
Scratched  
Over 25mm Not Thru Paint

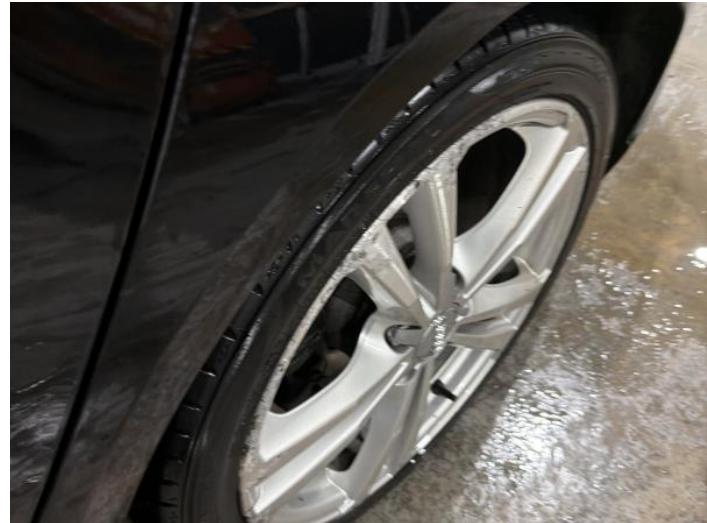
21: Door nsr  
Scratched  
Over 25mm Not Thru Paint
