# VEHICLE INSPECTION REPORT

GM64CXP

## Ford Focus 1.0 EcoBoost Zetec 5dr

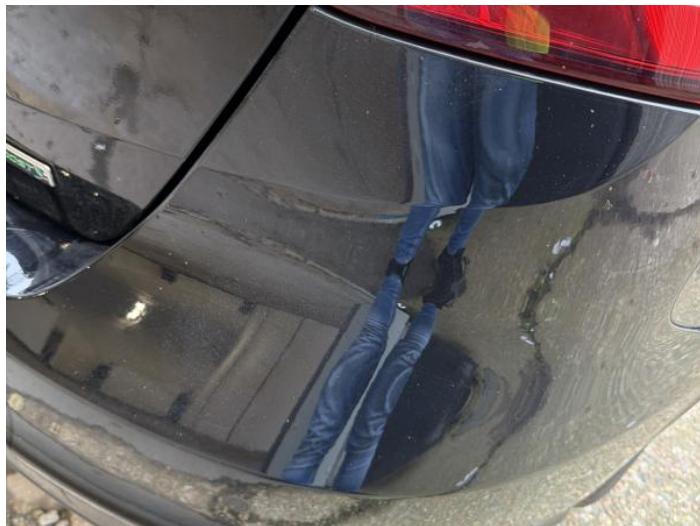
1: Bumper Rear  
Poor Previous Repair  
Poor Paint

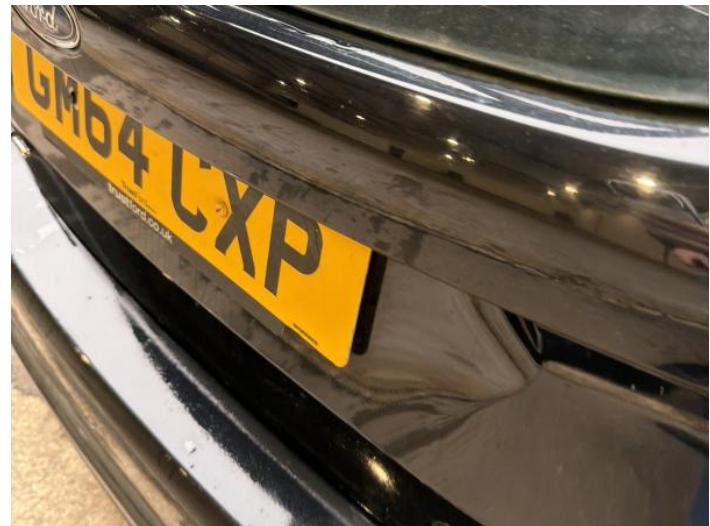
2: Boot Lid  
Dented  
Over 2 UpTo 10mm

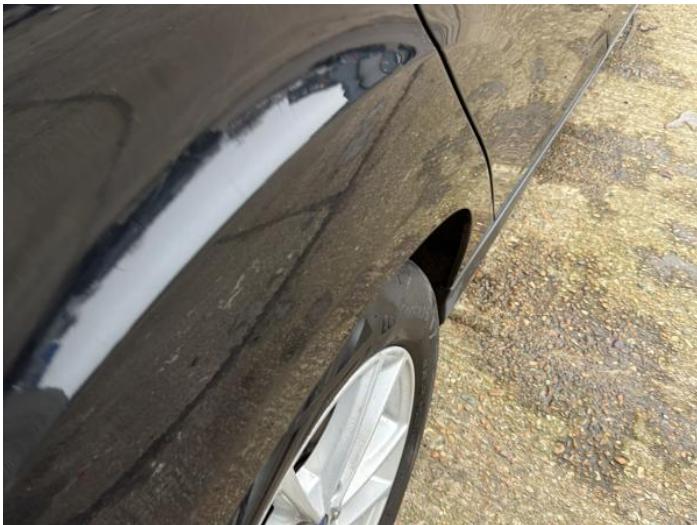
3: Qtr Panel osr  
Dented  
2 Or Less UpTo 10mm

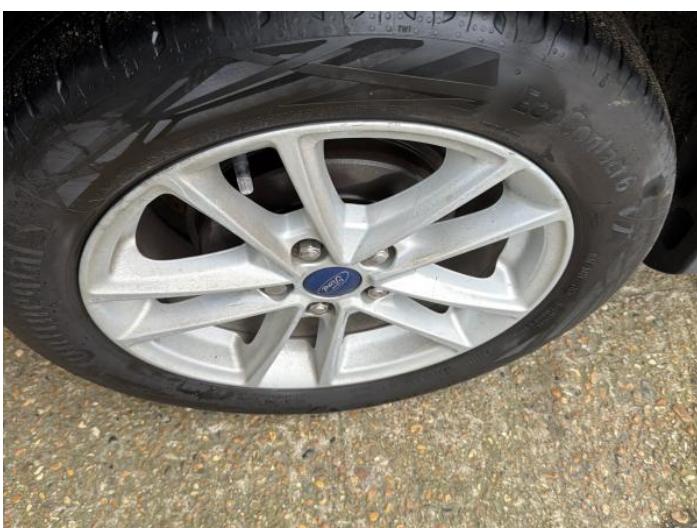
5: Wheel osr  
Scratched  
Over 50mm

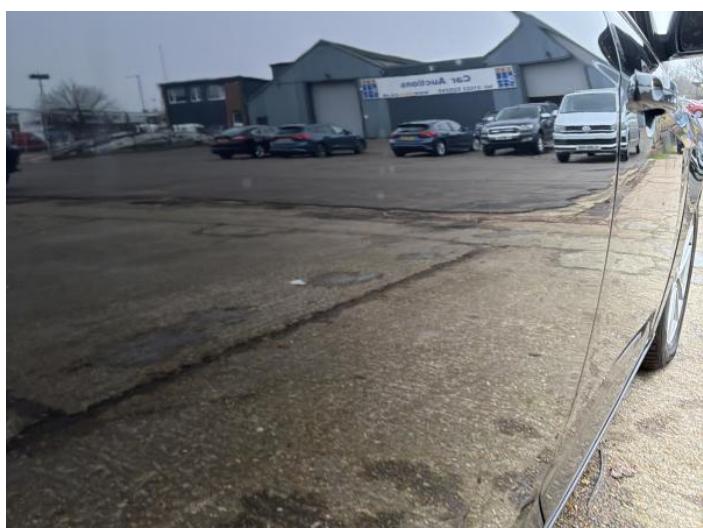
6: Door osr  
Chipped  
1 To 5

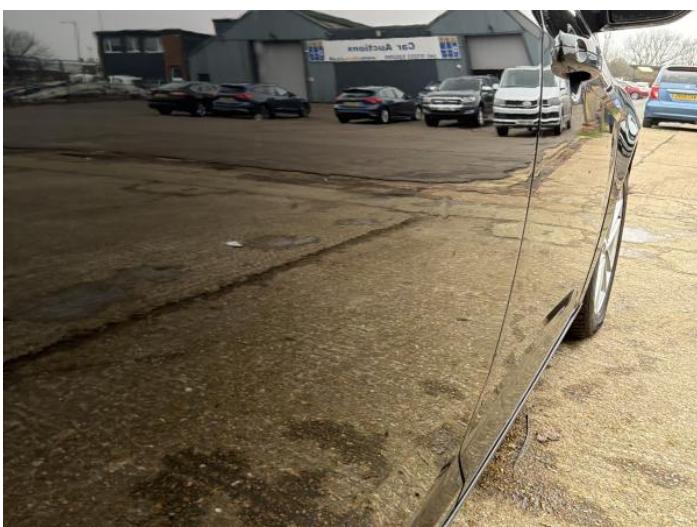
7: Door osr  
Dented  
Over 2 UpTo 10mm

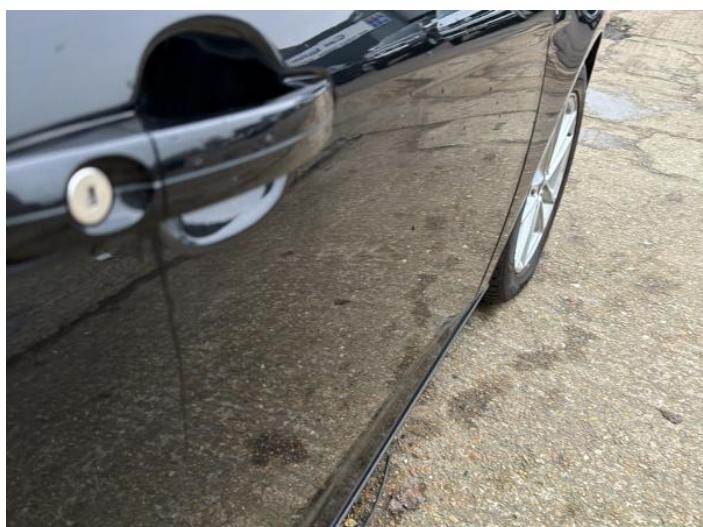
8: Door osf  
Poor Previous Repair  
Poor Paint

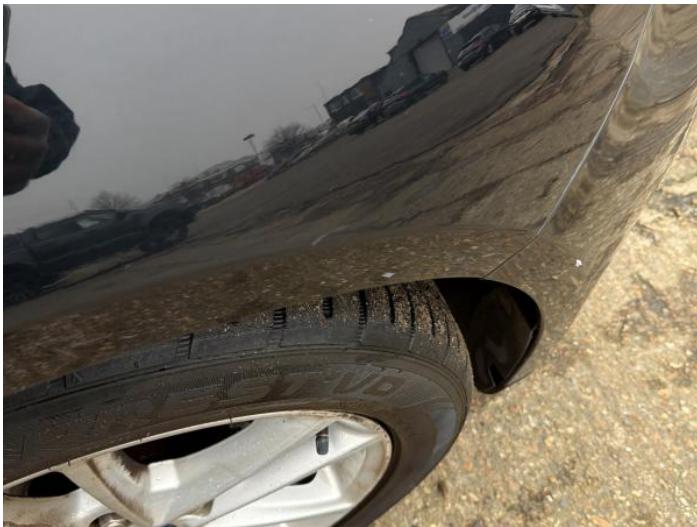
9: Wing osf  
Scratched  
UpTo 25mm Thru Paint

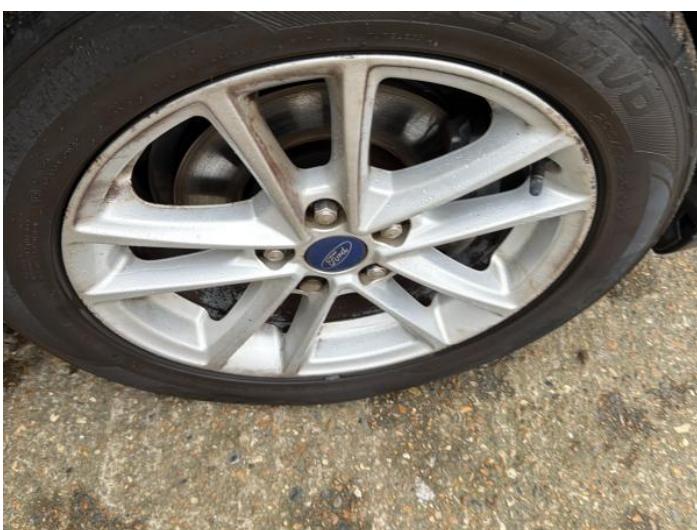
11: Wheel osf  
Scratched  
Over 50mm

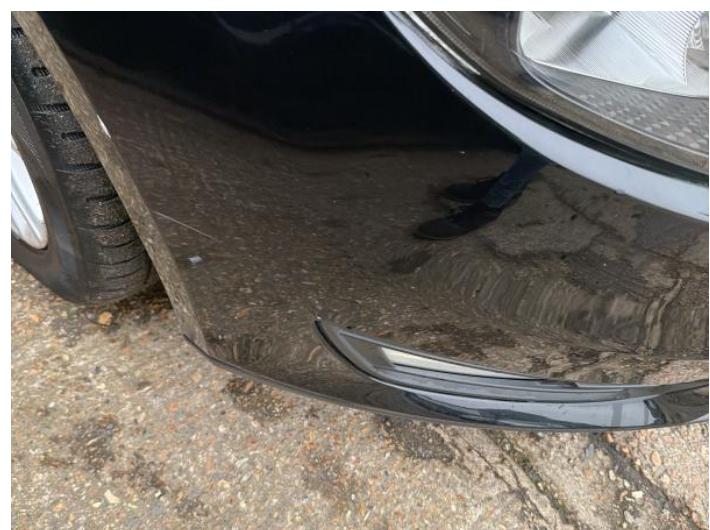
12: Bumper Front  
Scratched  
25 to 100mm Thru Paint

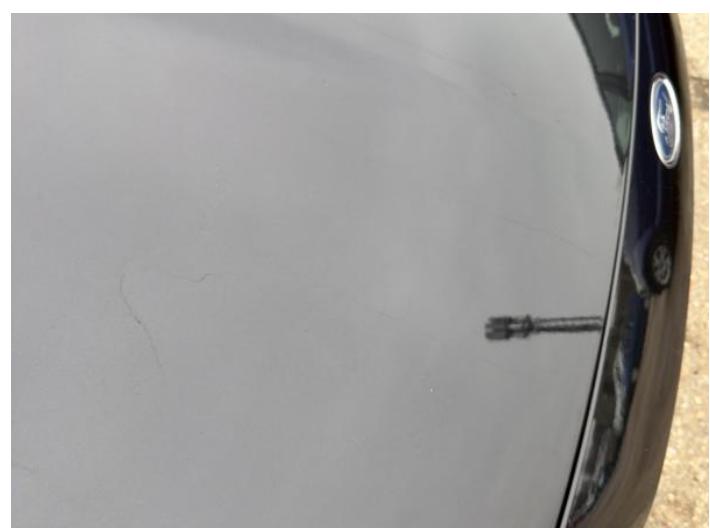
14: Bonnet  
Chipped  
1 To 5

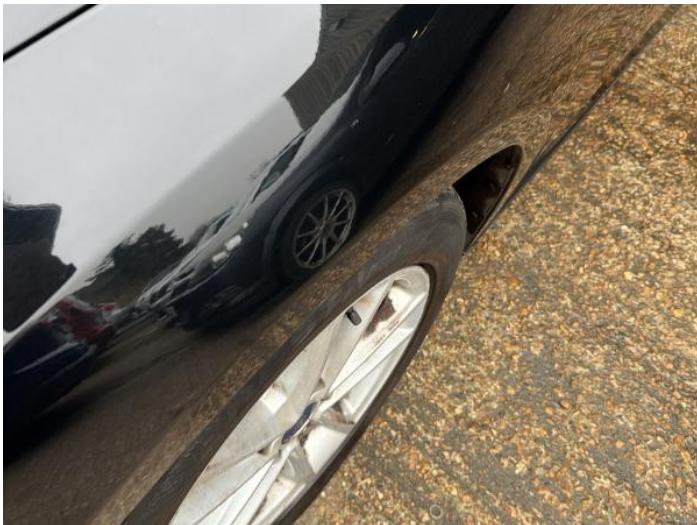
15: Wing nsf  
Chipped  
1 To 5

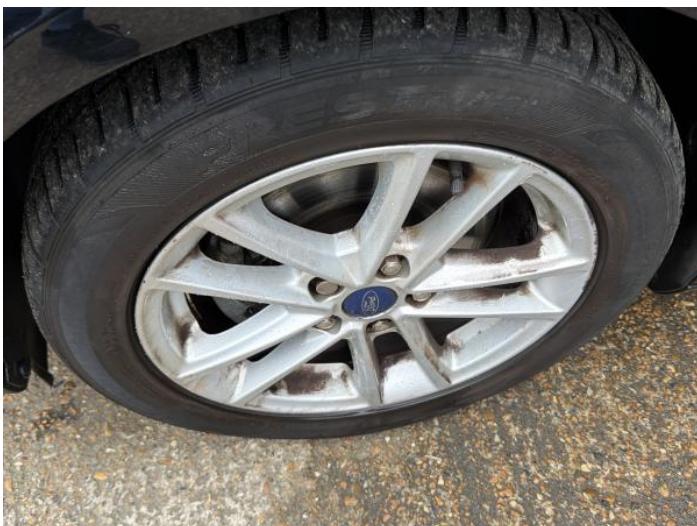
17: Wheel nsf  
Scratched  
Over 50mm

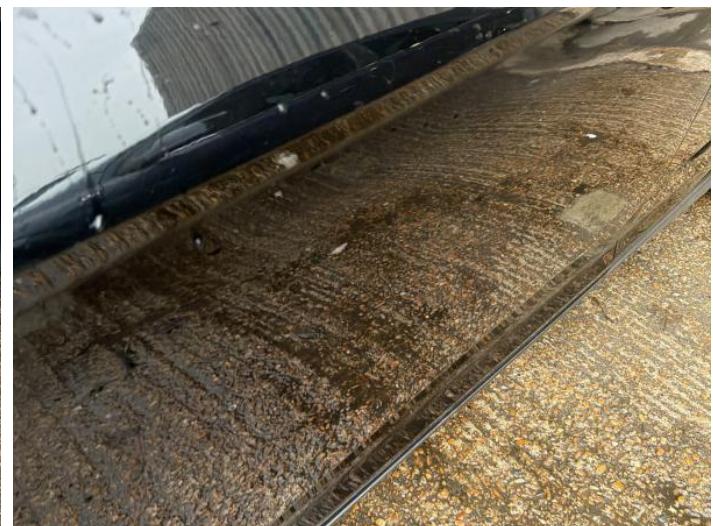
18: Door nsf  
Chipped  
Multiple Chips

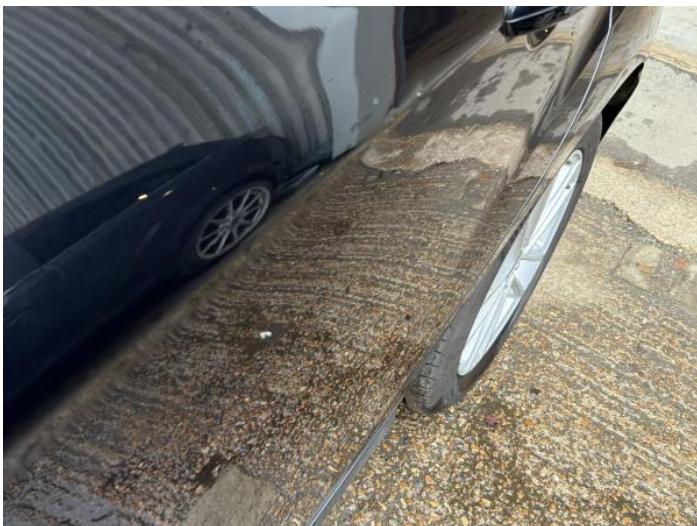
19: Door nsr  
Dented  
With Paint Damage

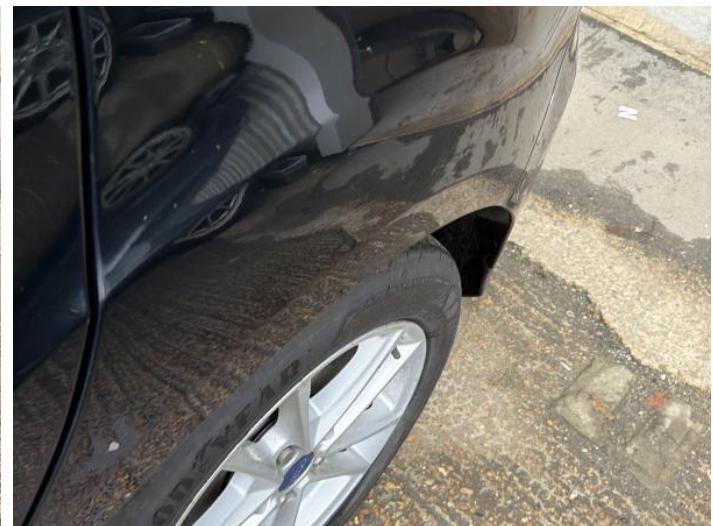
20: Qtr Panel nsr  
Chipped  
1 To 5

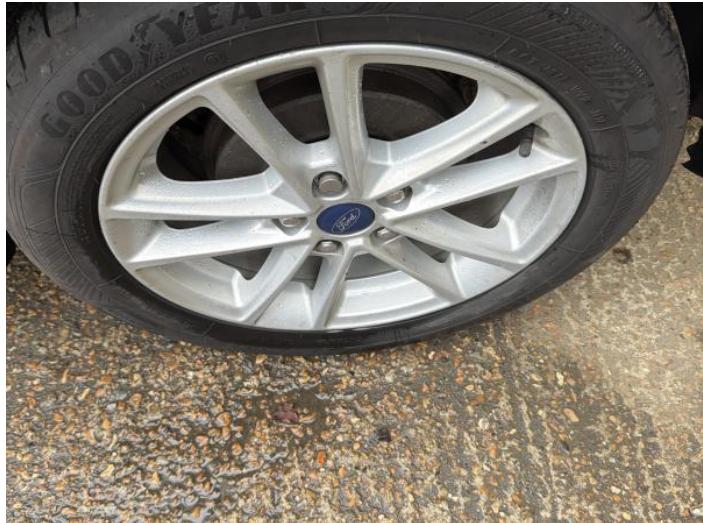
22: Wheel nsr  
Scratched  
Over 50mm
