VEHICLE INSPECTION REPORT

LV21XNC

Ford Mondeo 2.0 EcoBlue ST-Line Edition 5dr

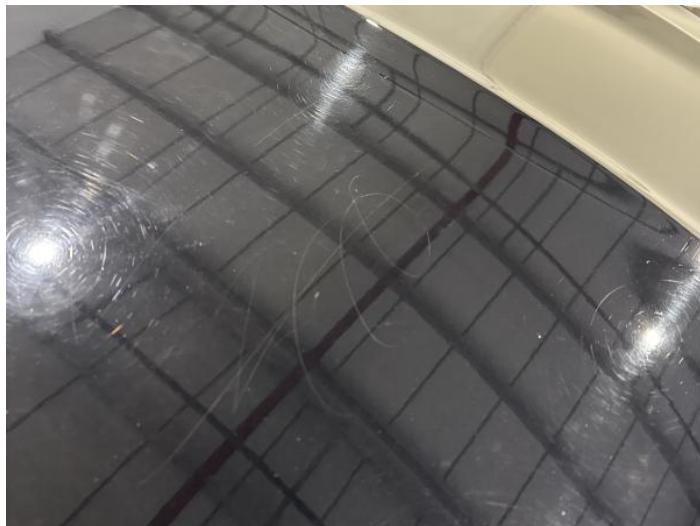
1: Bonnet
Scratched
Over 25mm Thru Paint

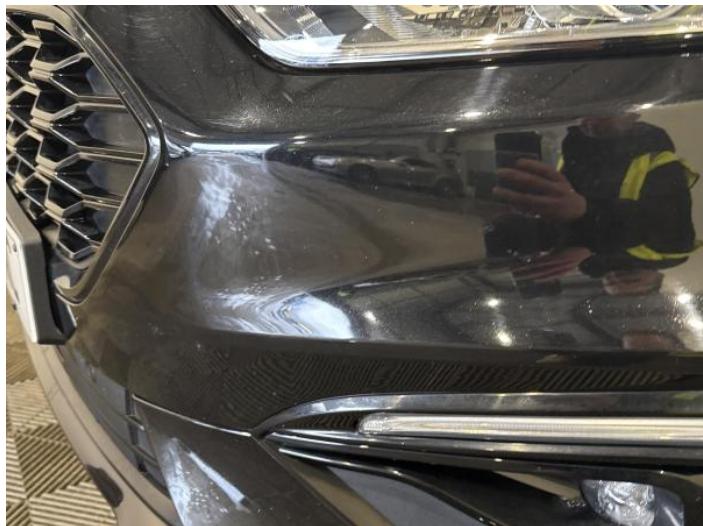
2: Bumper Front
Chipped
Multiple Chips

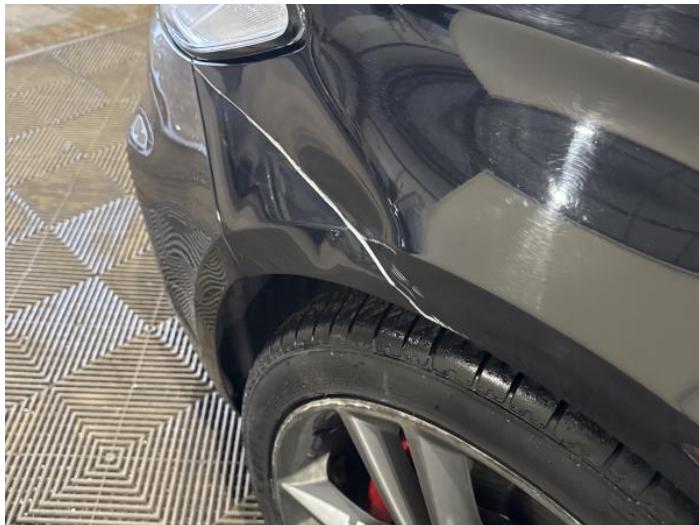
3: Wing nsf
Dented
With Paint Damage

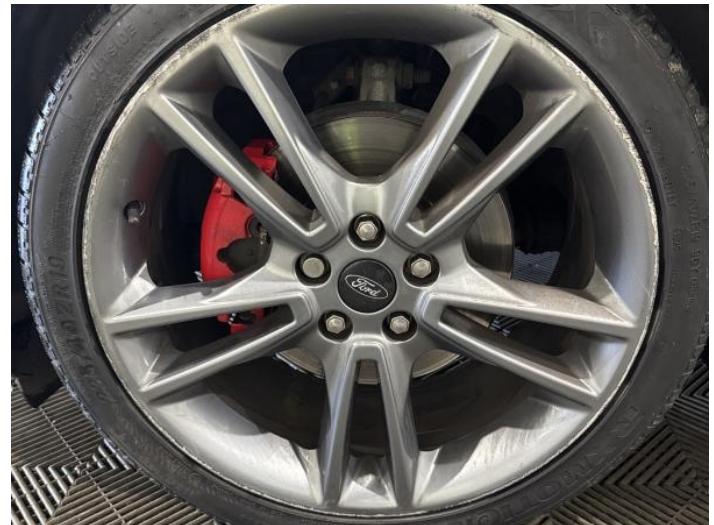
4: Wheel nsf
Scratched
Over 50mm

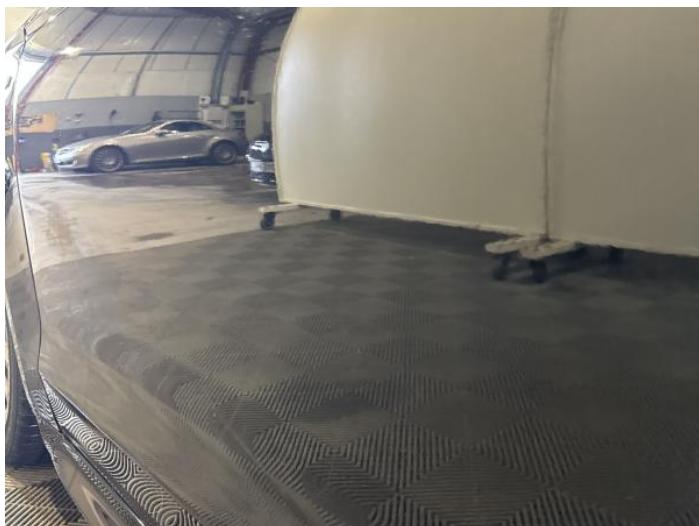
5: Door nsf
Dented
Between 10mm + 30mm

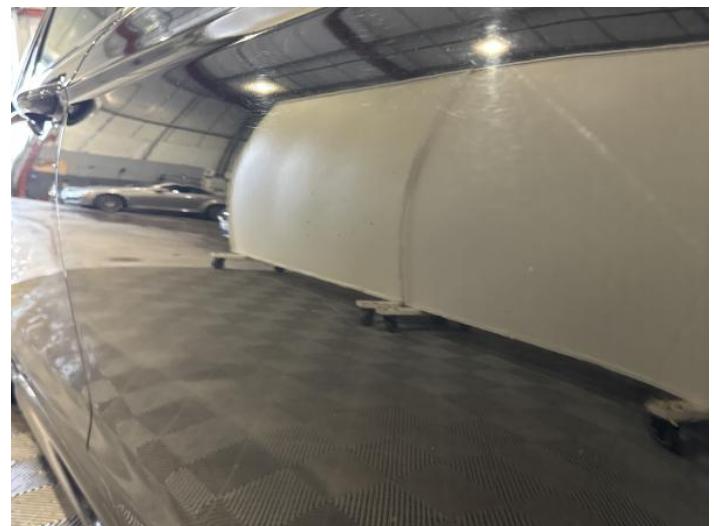
6: Door nsr
Poor Previous Repair
Rippled UpTo 30%

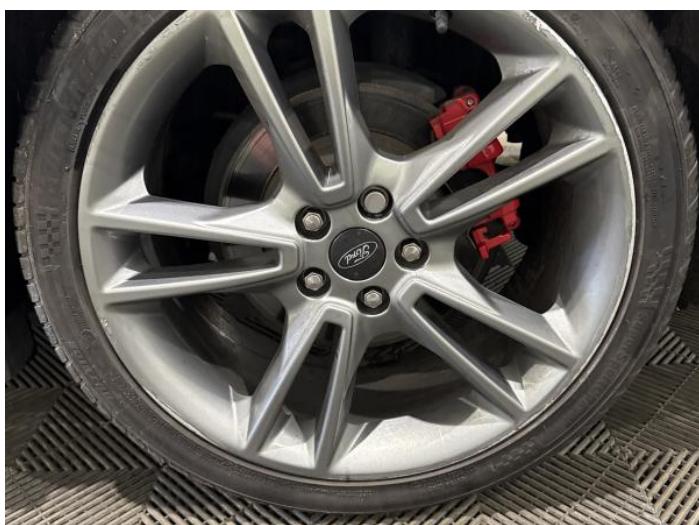
7: Wheel nsr
Scratched
Over 50mm

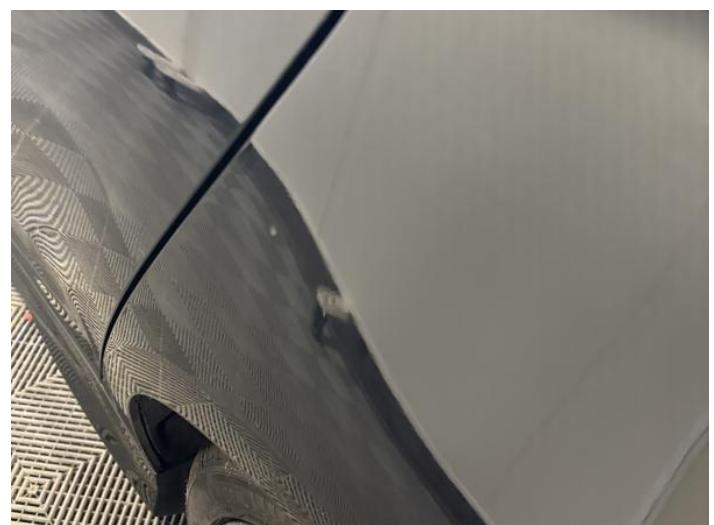
8: Qtr Panel nsr
Chipped
1 To 5

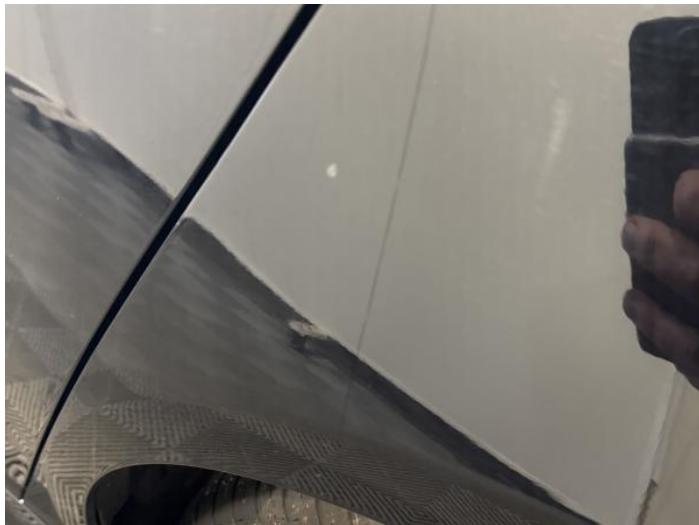
9: Qtr Panel nsr
Dented
2 Or Less UpTo 10mm

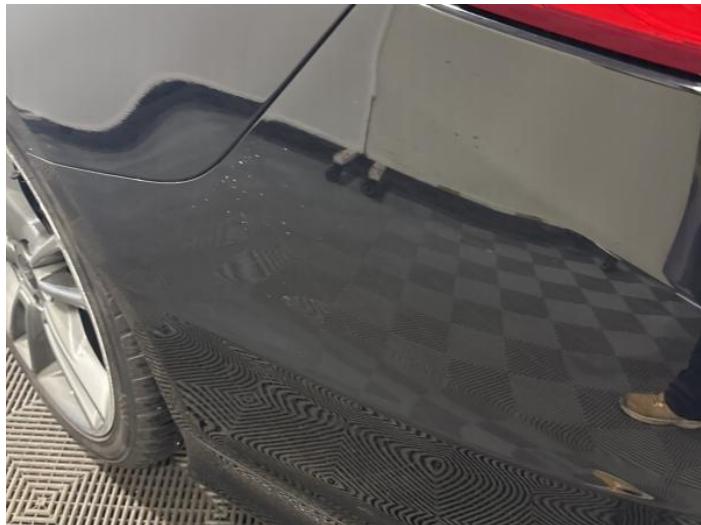
10: Bumper Rear
Scratched
25 to 100mm Thru Paint

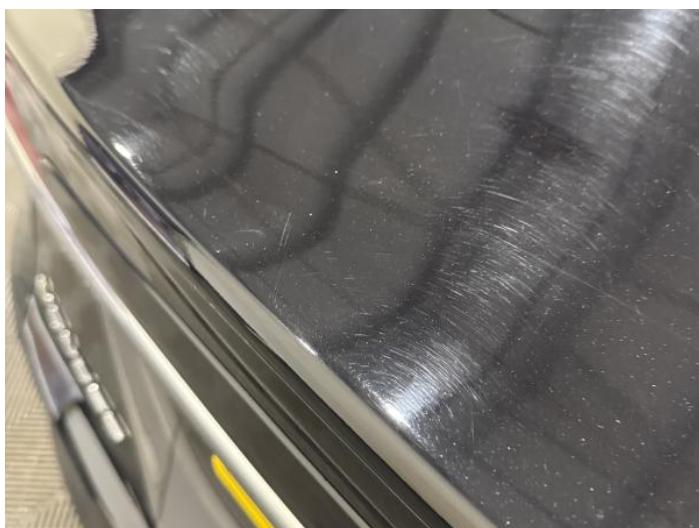
11: Tailgate
Scratched
UpTo 25mm Thru Paint

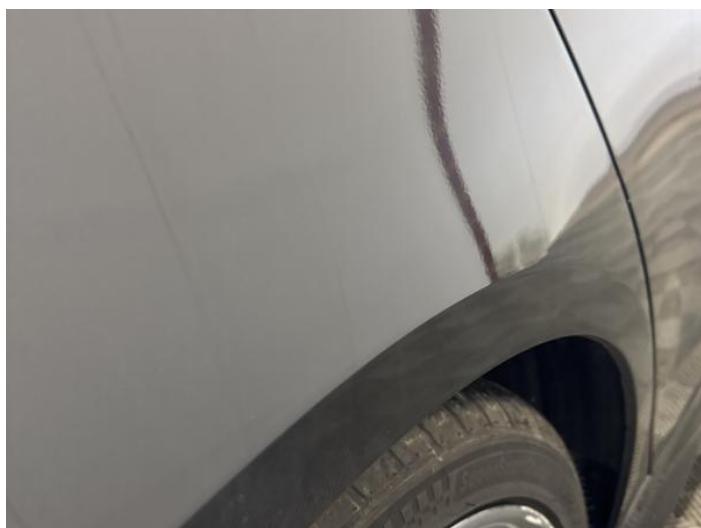
12: Qtr Panel osr
Dented
Between 10mm + 30mm

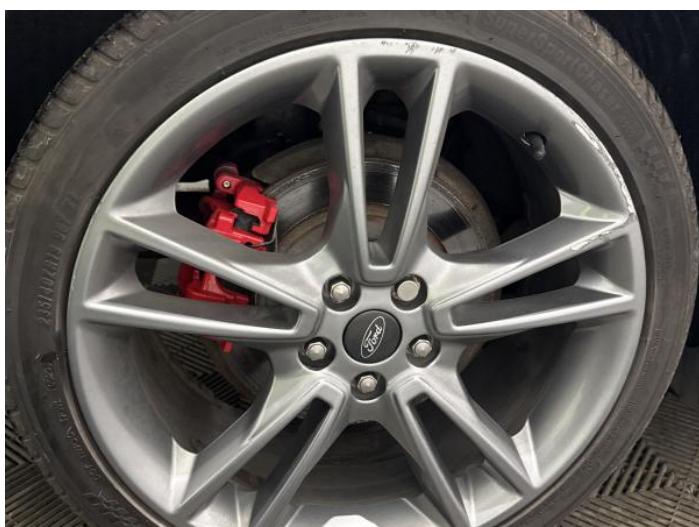
13: Wheel osr
Scratched
Over 50mm

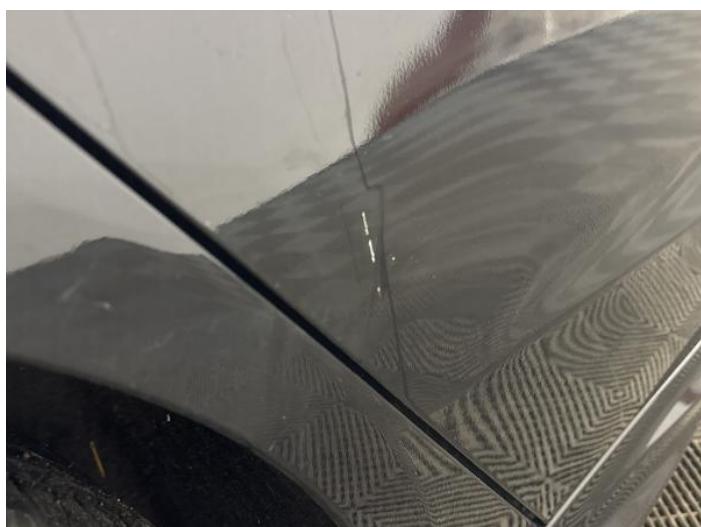
14: Door osr
Scratched
UpTo 25mm Thru Paint

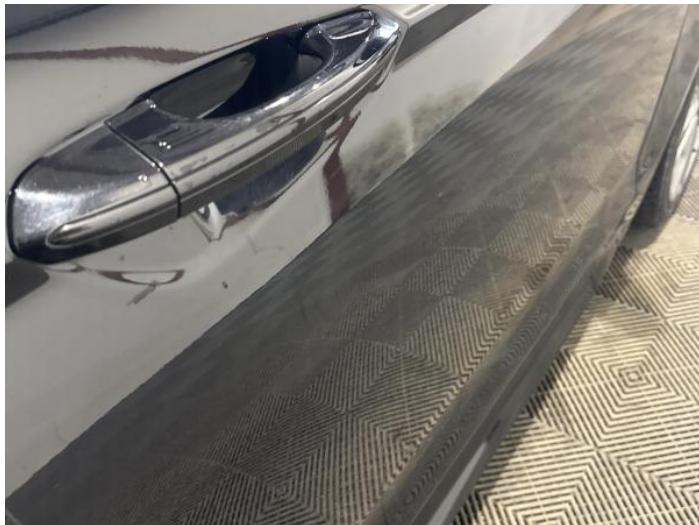
15: Door osf
Dented
Between 10mm + 30mm

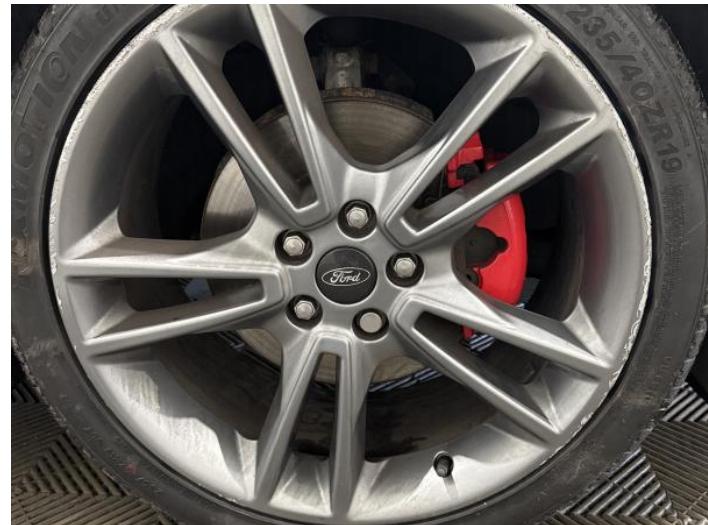
16: Wheel osf
Scratched
Over 50mm
