VEHICLE INSPECTION REPORT

DE15UCR

Audi A5 3.0 TDI 245 Quattro S Line 5dr S Tronic [5 Seat]

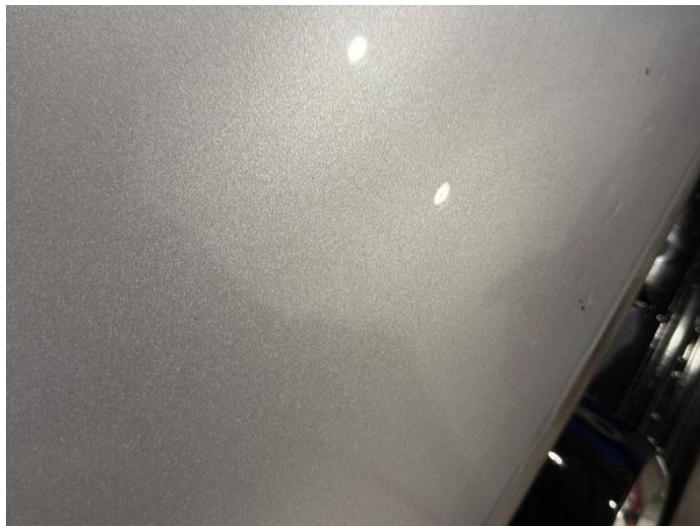
1: Bonnet
Chipped
1 To 5

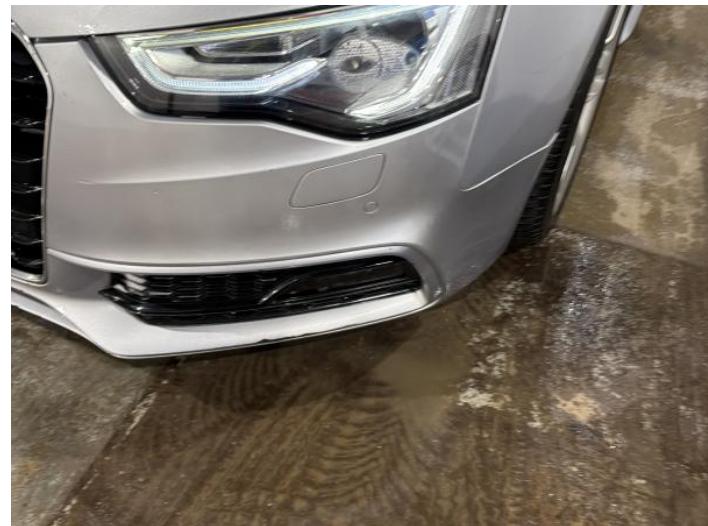
2: Bumper Front
Scratched
Over 100mm Thru Paint

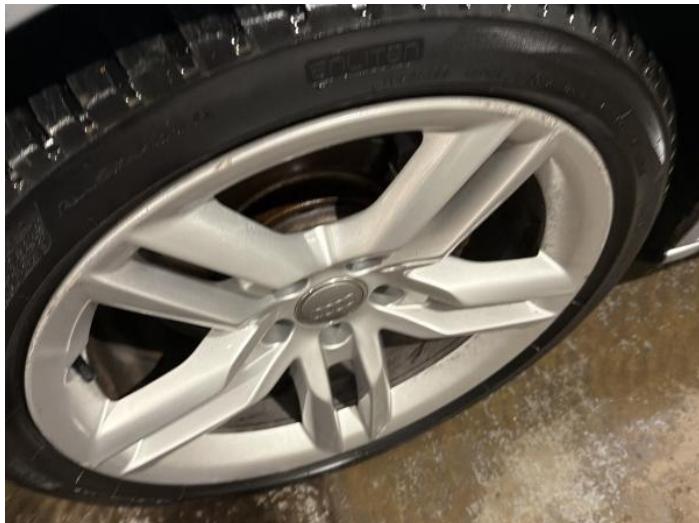
3: Wheel nsf
Scratched
Over 50mm

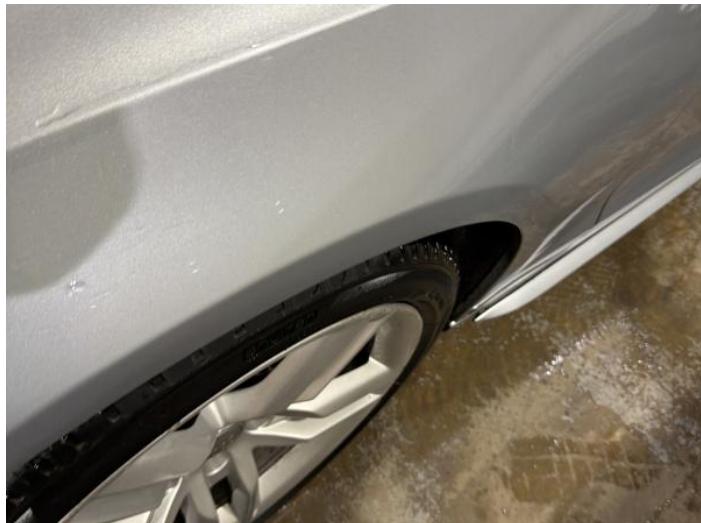
4: Wing nsf
Chipped
1 To 5

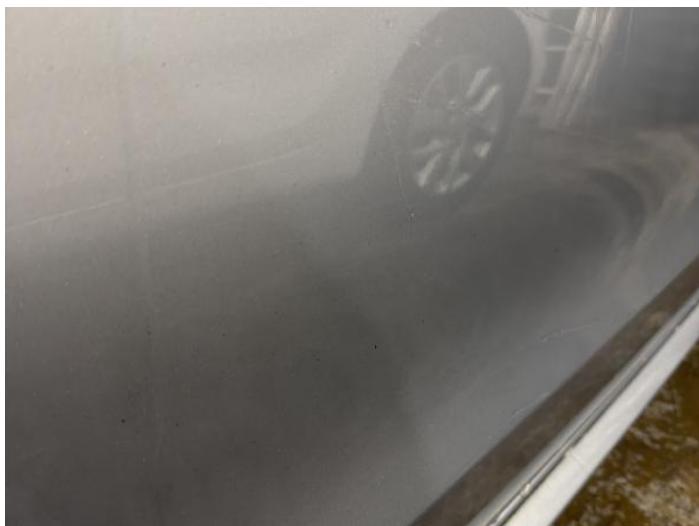
5: Door nsf
Chipped
1 To 5

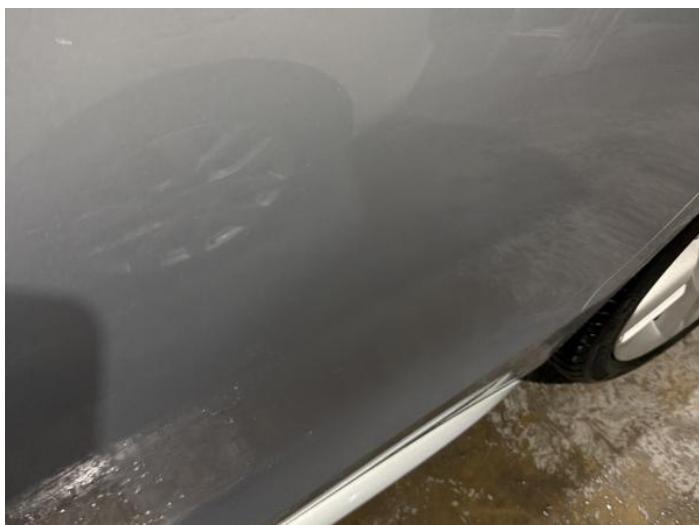
7: Door nsr
Dented
With Paint Damage

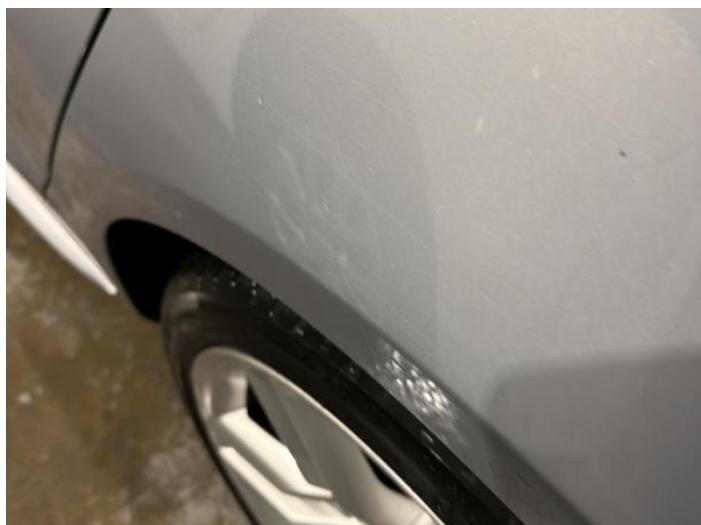
8: Qtr Panel nsr
Dented
Over 2 UpTo 10mm

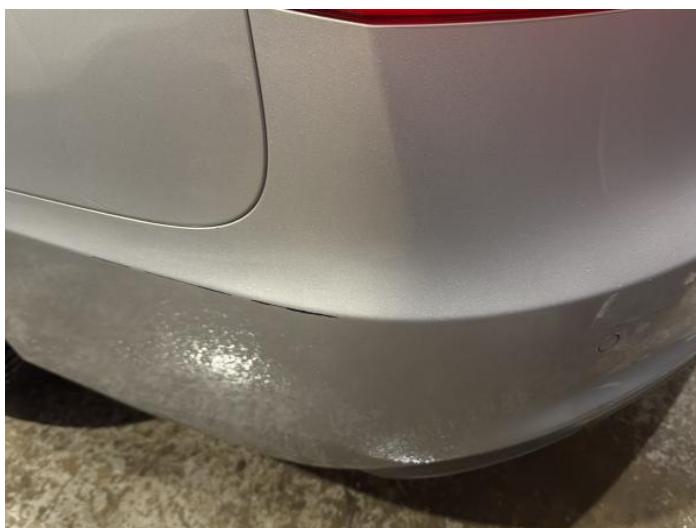
11: Bumper Rear
Scratched
25 to 100mm Thru Paint

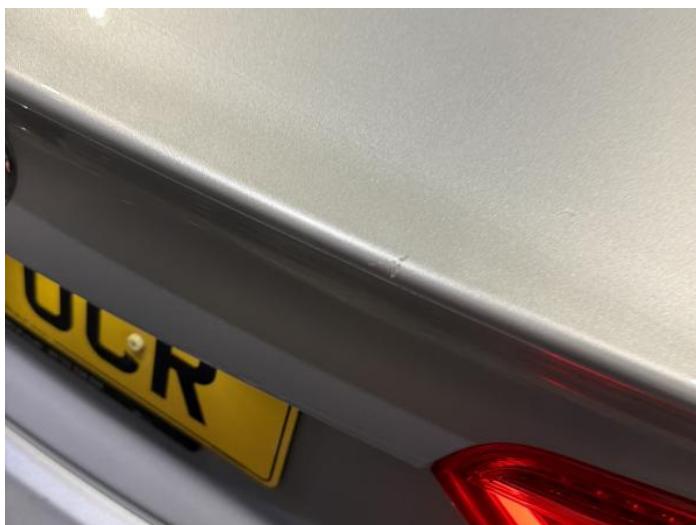
13: Boot Lid
Chipped
1 To 5

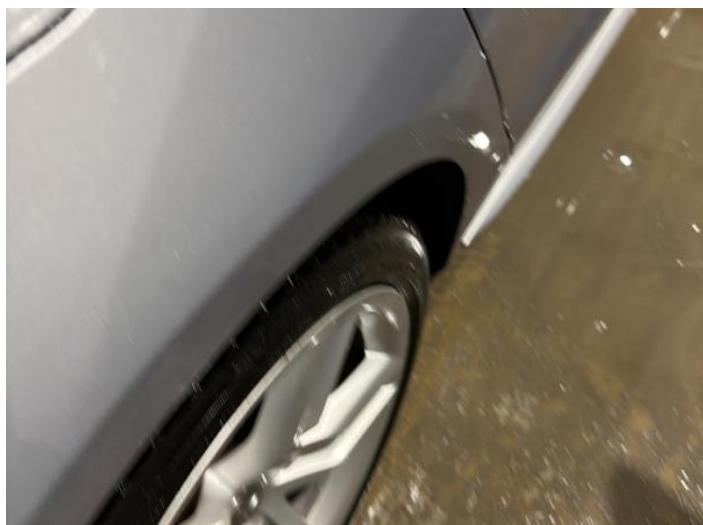
14: Qtr Panel osr
Dented
Between 10mm + 30mm

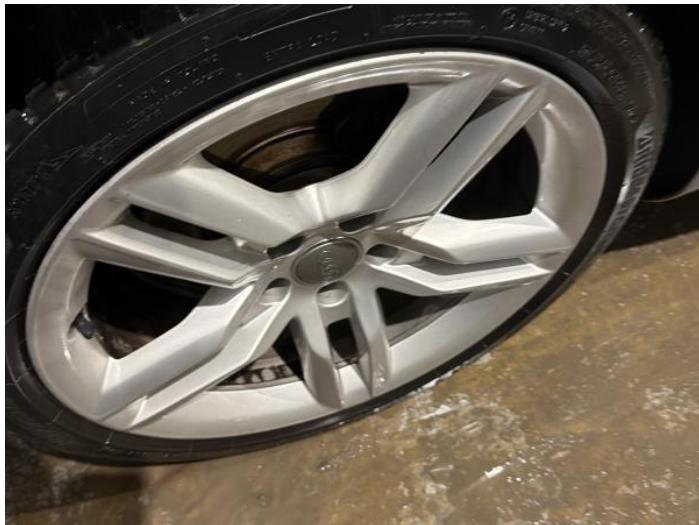
15: Wheel osr
Scratched
Up To 50mm

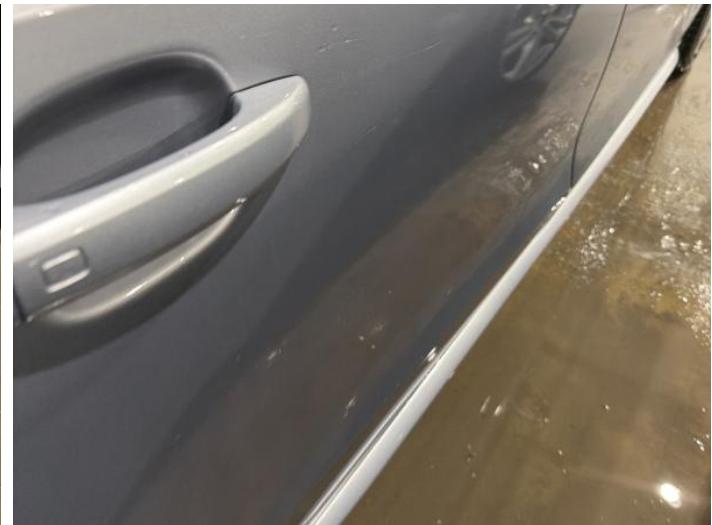
16: Door osr
Poor Previous Repair
Poor Paint

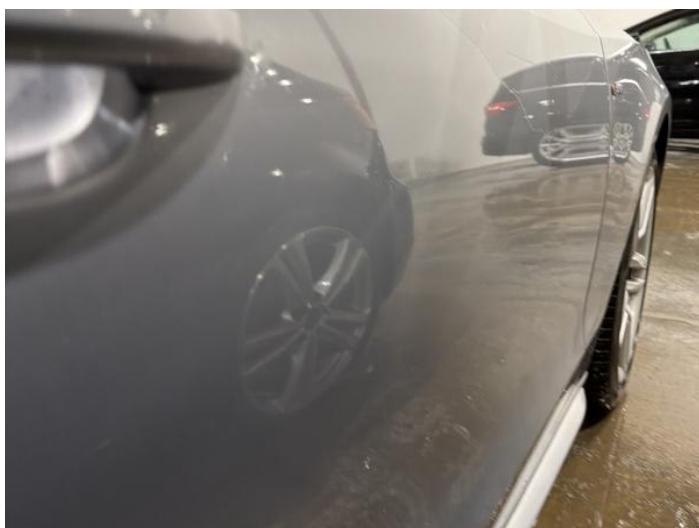
17: Door osf
Dented
Over 2 UpTo 10mm

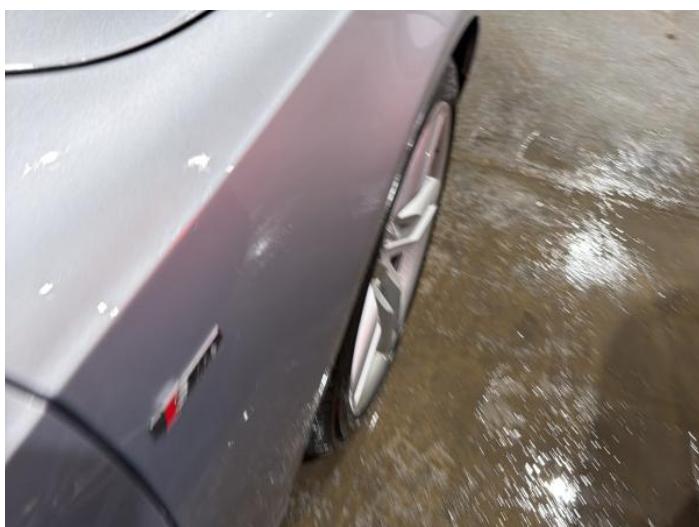
19: Wing osf
Chipped
1 To 5

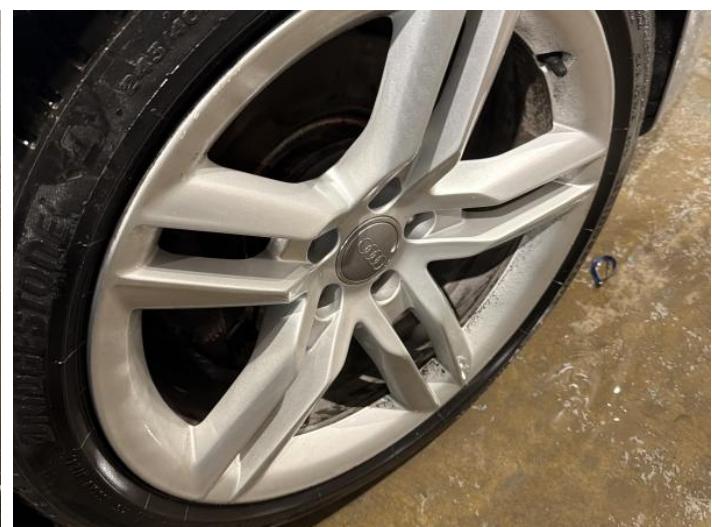
20: Wheel osf
Scratched
Up To 50mm
