VEHICLE INSPECTION REPORT

PJ11LGE

Nissan Qashqai 1.5 dCi [110] N-Tec 5dr

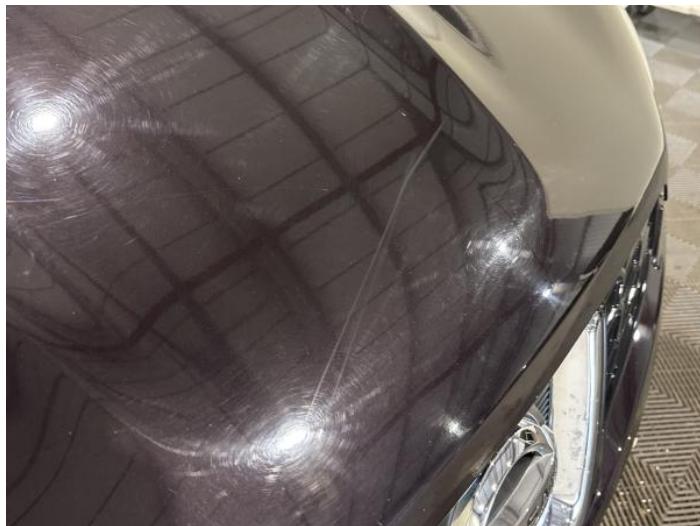
1: Bonnet
Scratched
Over 25mm Thru Paint

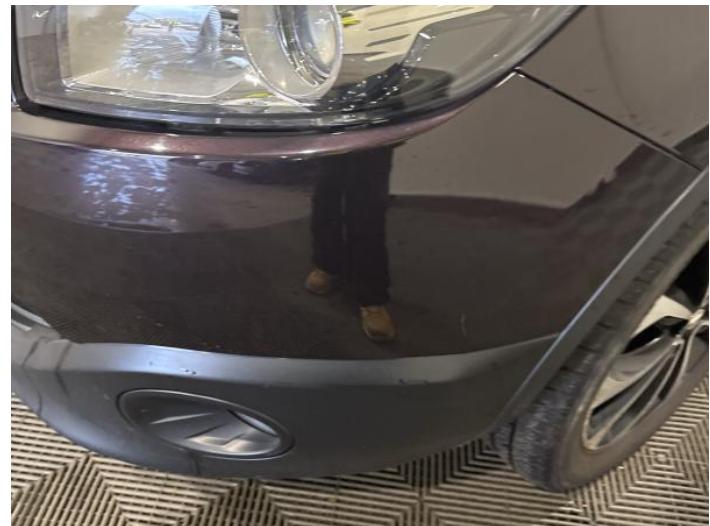
2: Bumper Front
Scratched
25 to 100mm Thru Paint

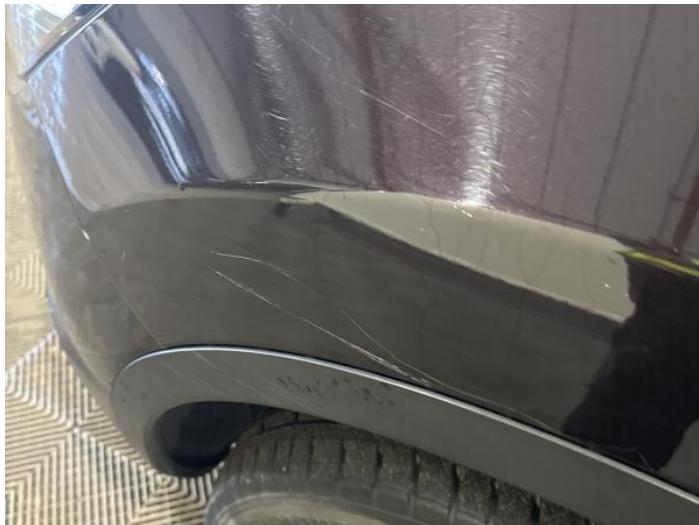
3: Wing nsf
Scratched
Over 25mm Thru Paint

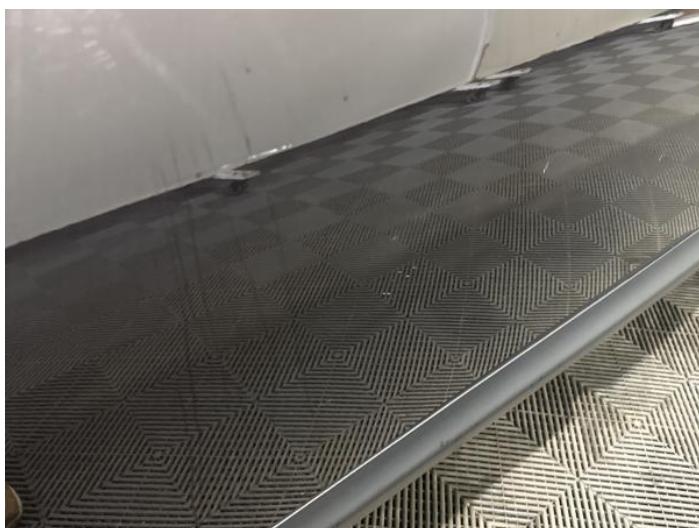
5: Door nsf
Scratched
Over 25mm Thru Paint

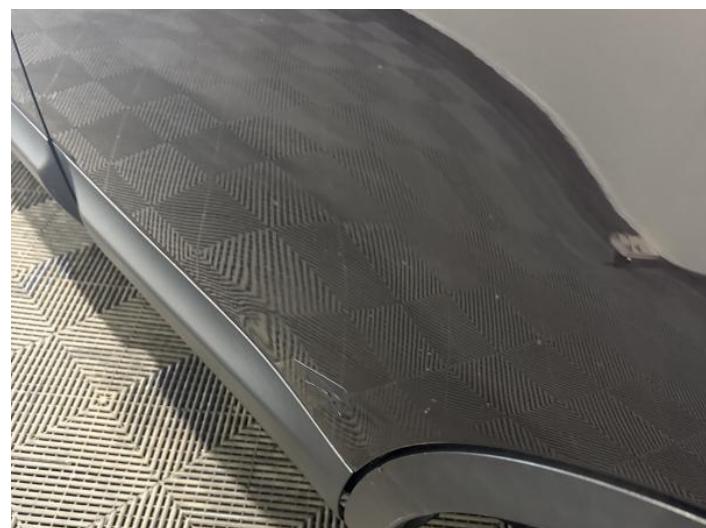
6: Door nsr
Scratched
Over 25mm Thru Paint

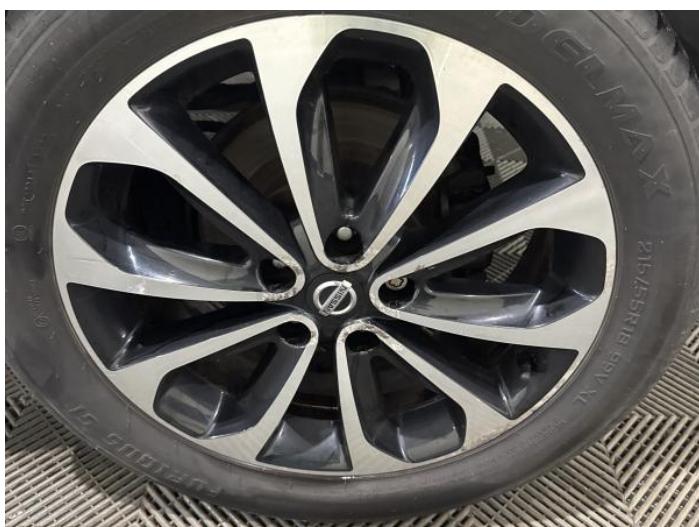
7: Wheel osr
Scratched
Over 50mm

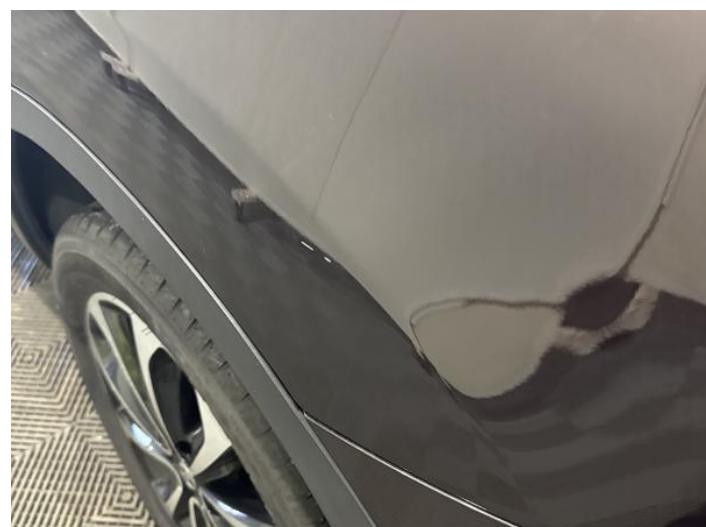
8: Qtr Panel nsr
Scratched
UpTo 25mm Thru Paint

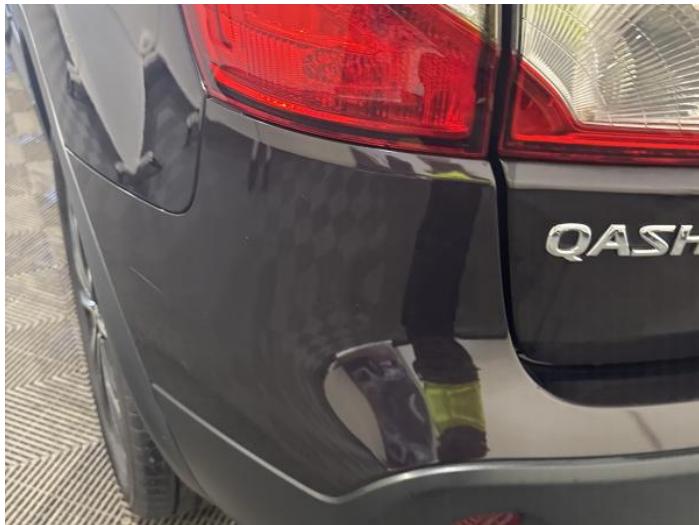
9: Bumper Rear
Scratched
Over 100mm Thru Paint

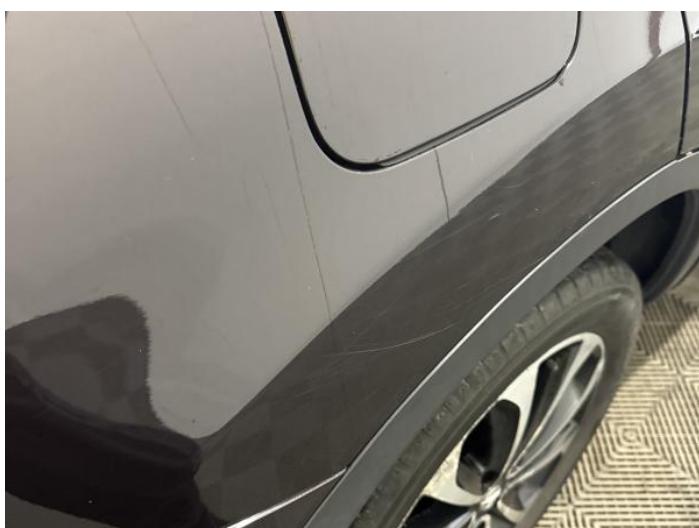
11: Qtr Panel osr
Scratched
Over 25mm Thru Paint

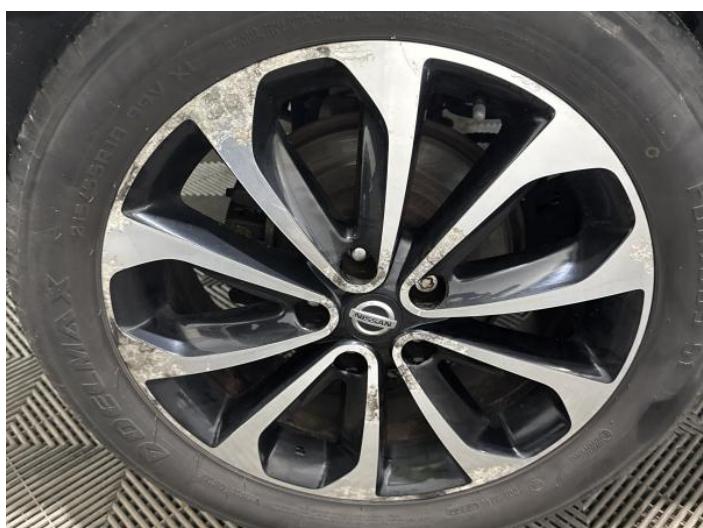
12: Wheel osr
Scratched
Over 50mm

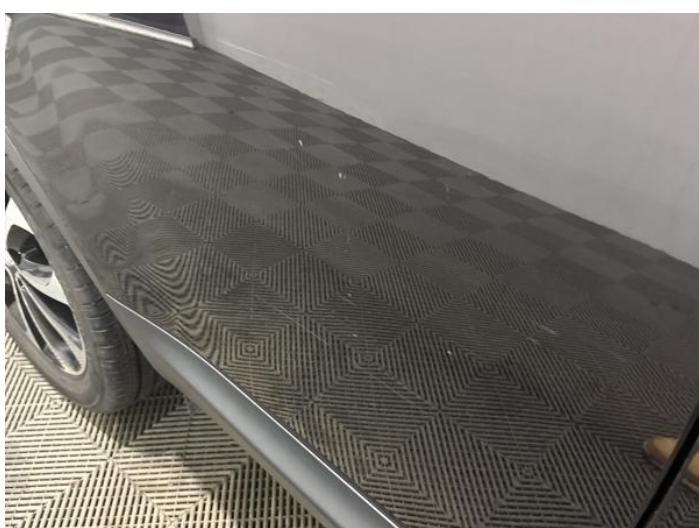
13: Door osr
Scratched
Over 25mm Thru Paint

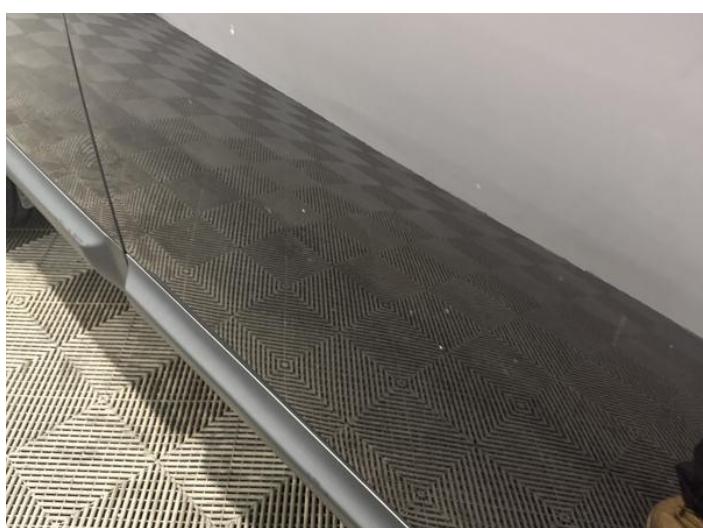
14: Door osf
Scratched
Over 25mm Thru Paint

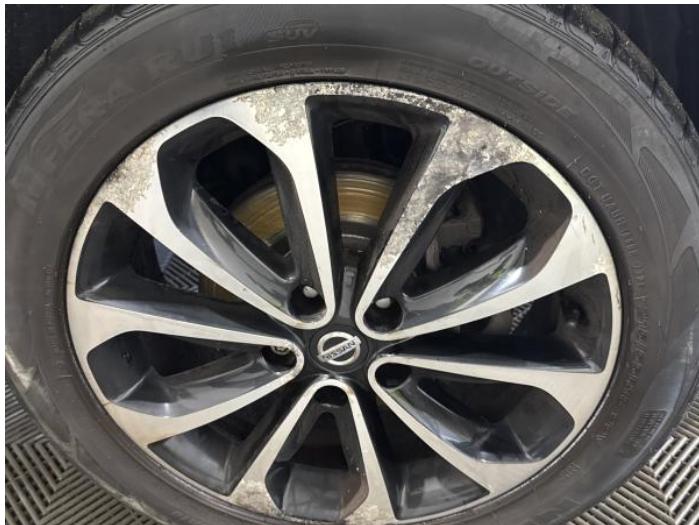
15: Wheel osf
Scratched
Over 50mm

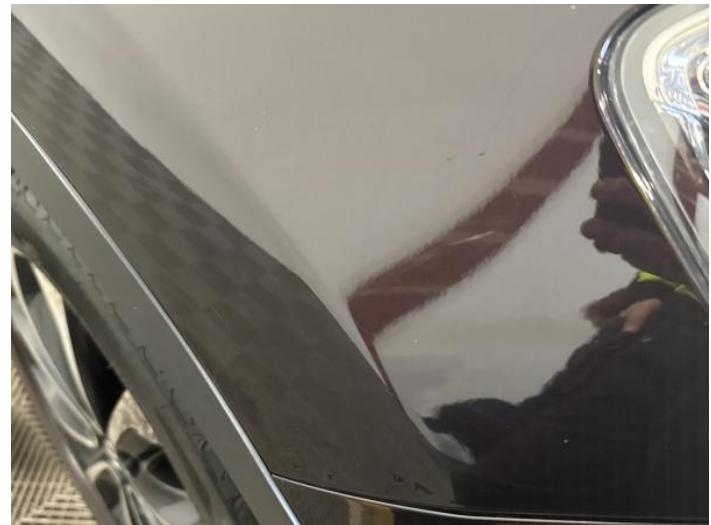
16: Wing osf
Scratched
UpTo 25mm Thru Paint

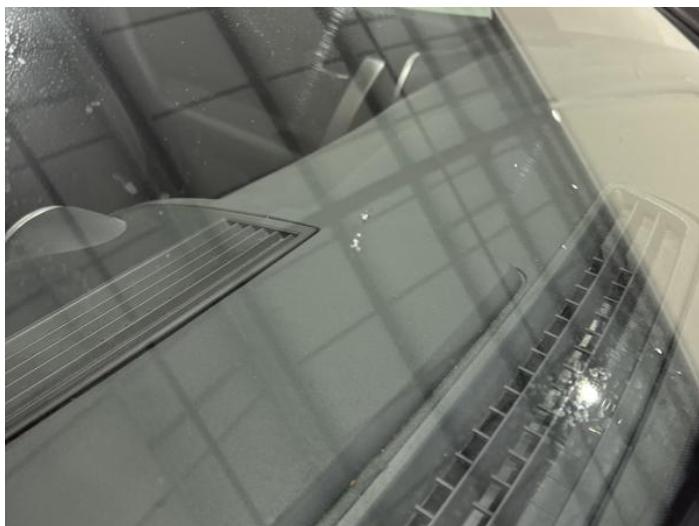
17: Screen Front
Chipped
Over 10mm
