VEHICLE INSPECTION REPORT

MT18WXD

Kia Carens 1.7 CRDi ISG [139] 2 5dr DCT

Inspection	Vehicle		GRADE 4
Serious Damage?	VAT	Margin	
No	V5	Present

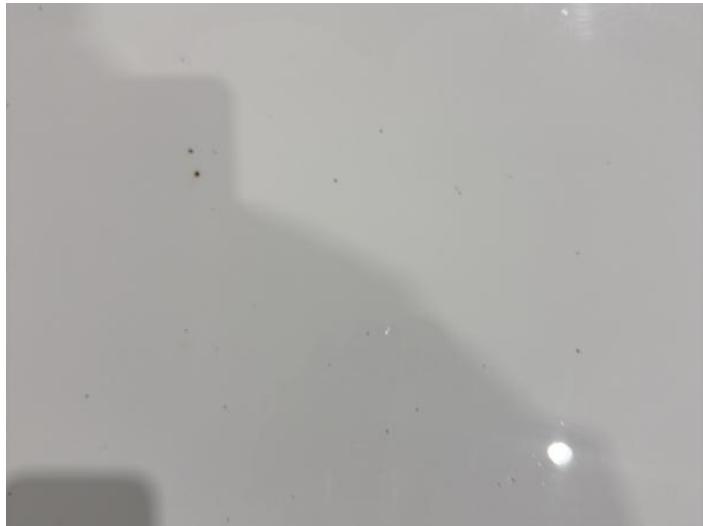
1: Bonnet
Chipped
Multiple Chips

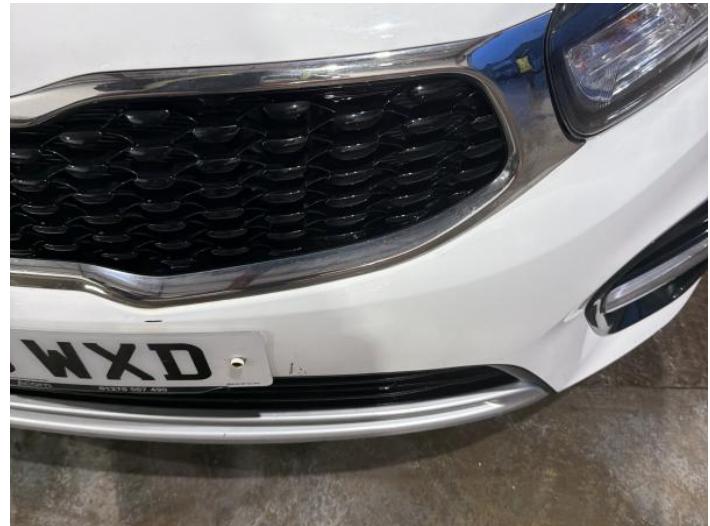
2: Bumper Front
Scratched
Over 100mm Thru Paint

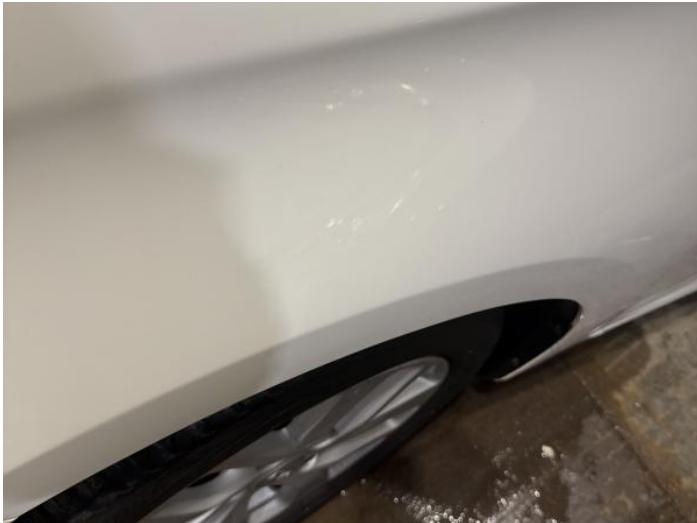
3: Wing nsf
Chipped
1 To 5

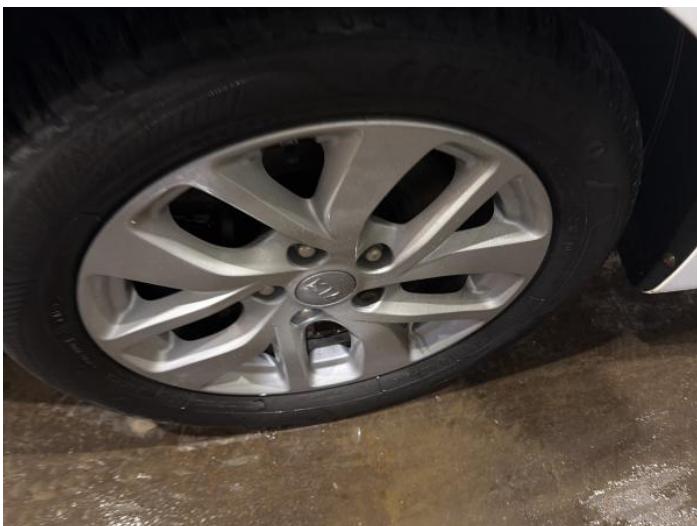
5: Wheel nsf
Scratched
Up To 50mm

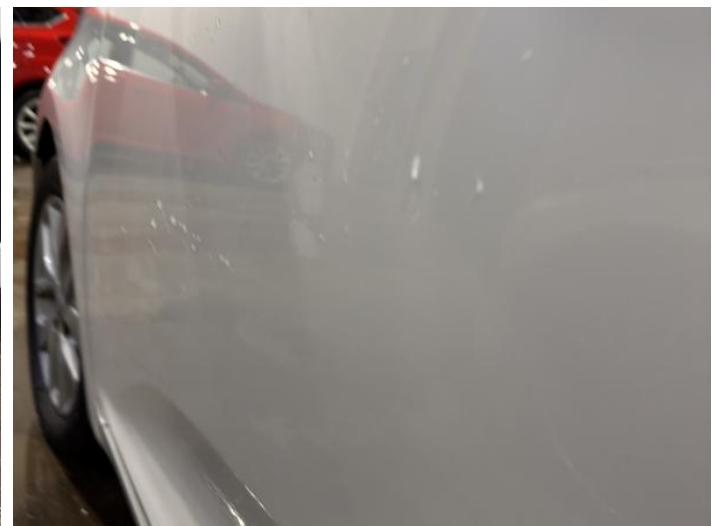
6: Door nsf
Chipped
1 To 5

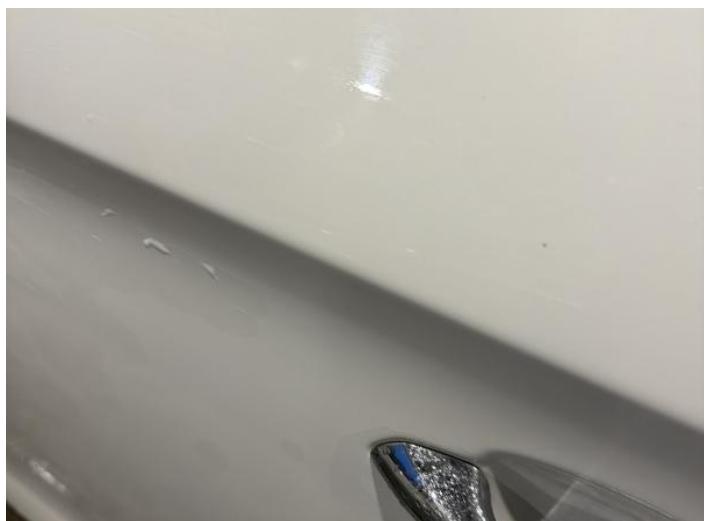
8: Door nsr
Chipped
1 To 5

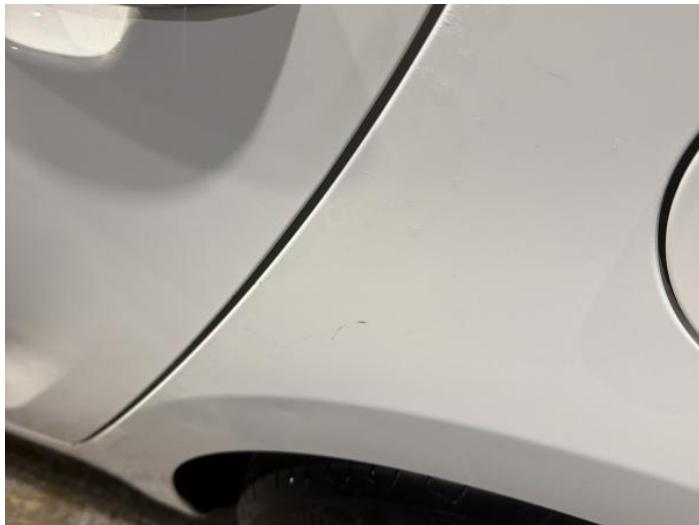
9: Qtr Panel nsr
Dented
With Paint Damage

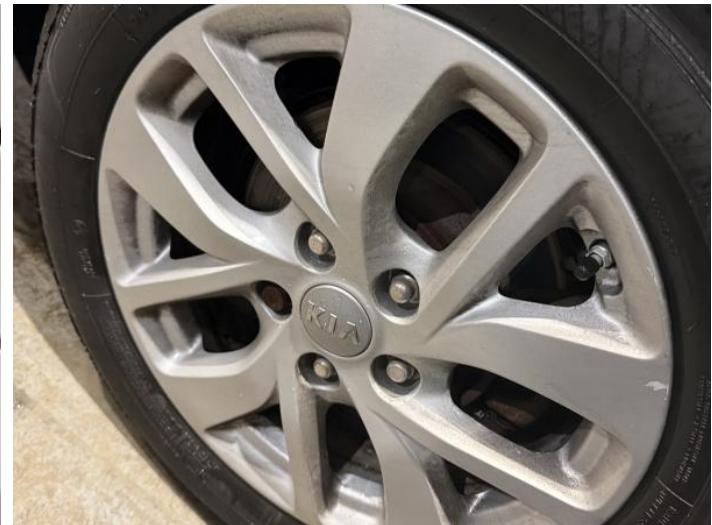
10: Wheel nsr
Scratched
Over 50mm

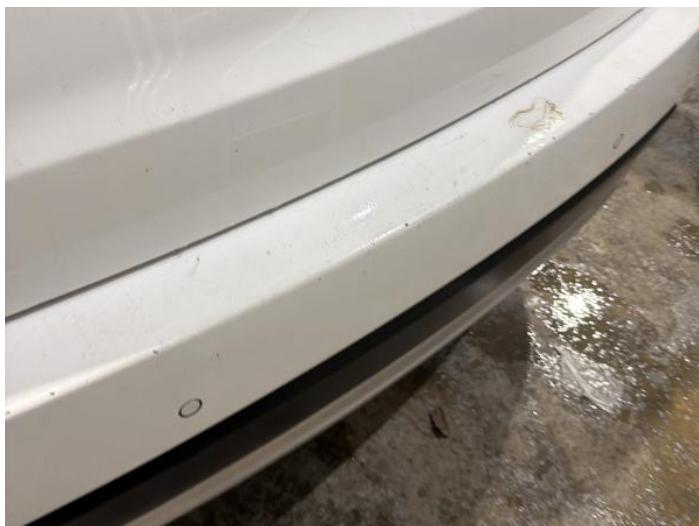
11: Bumper Rear
Poor Previous Repair
Poor Paint

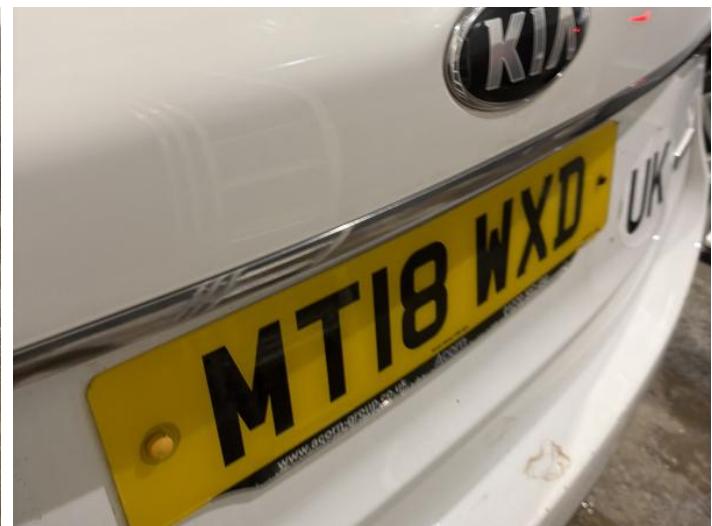
12: Boot Lid
Chipped
1 To 5

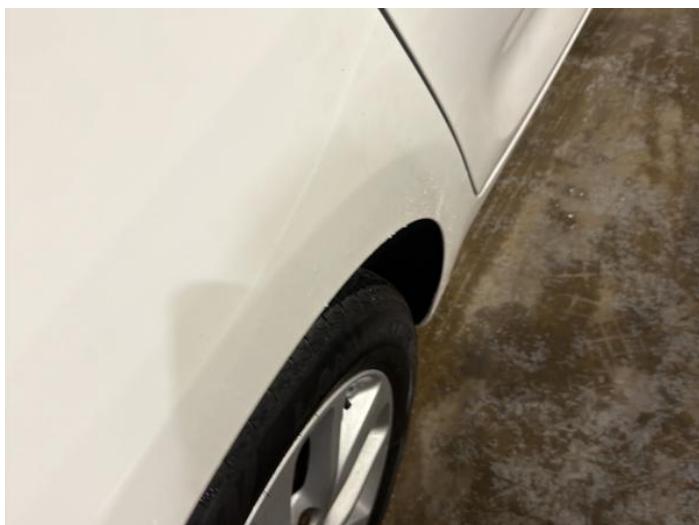
13: Qtr Panel osr
Dented
2 Or Less UpTo 10mm

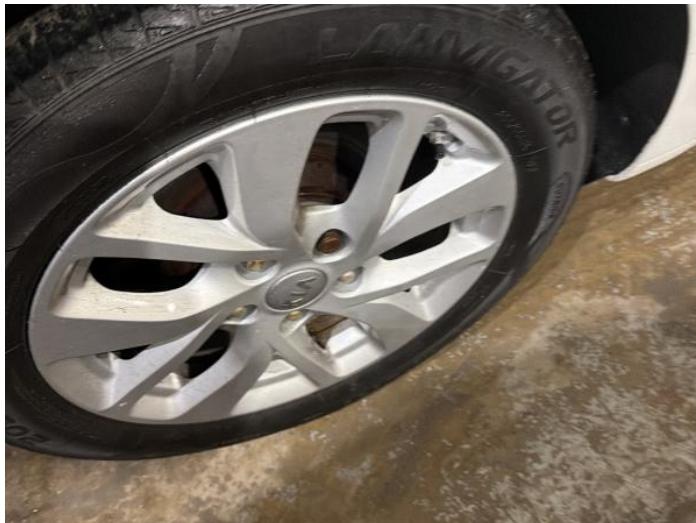
15: Wheel osr
Scratched
Up To 50mm

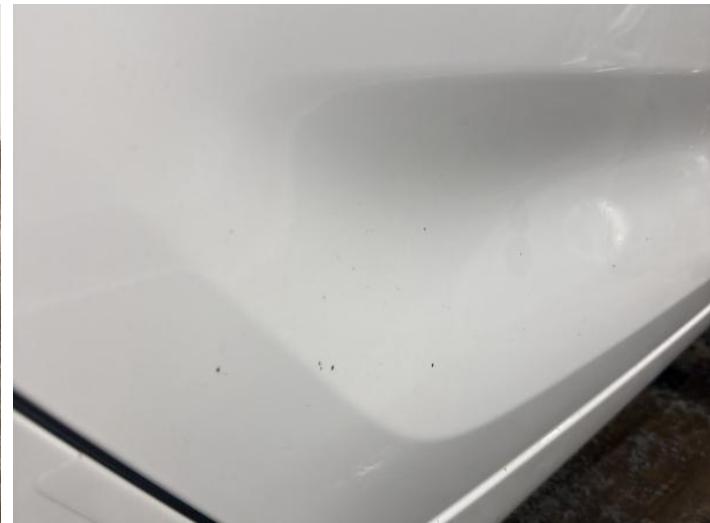
16: Door osr
Chipped
1 To 5

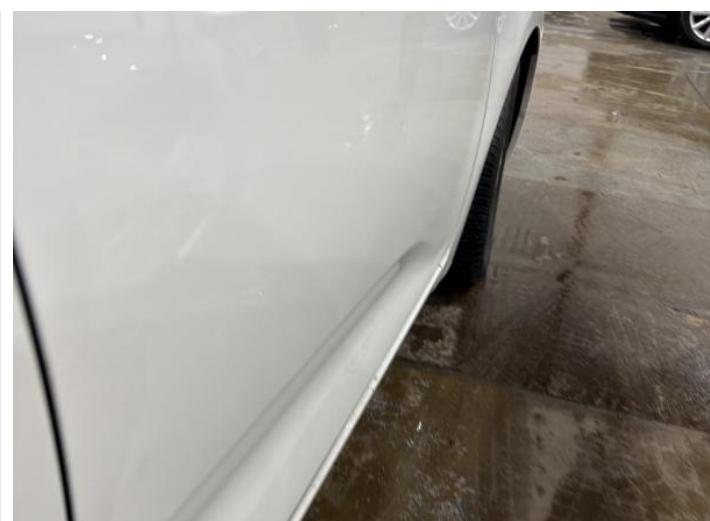
18: Door osf
Chipped
Multiple Chips

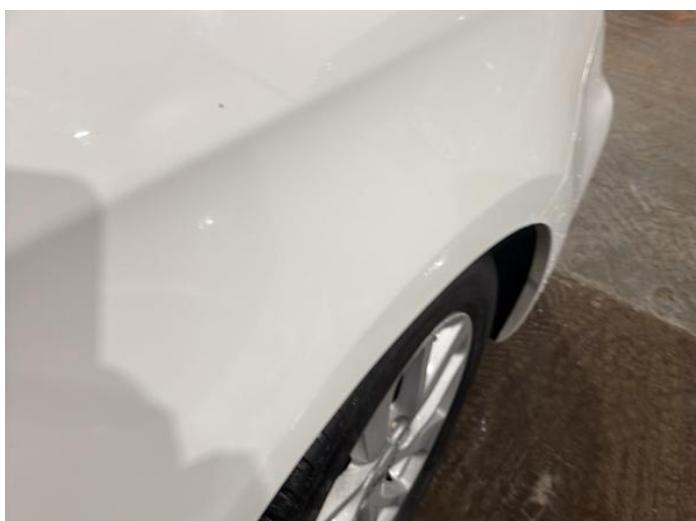
19: Wing osf
Chipped
Multiple Chips

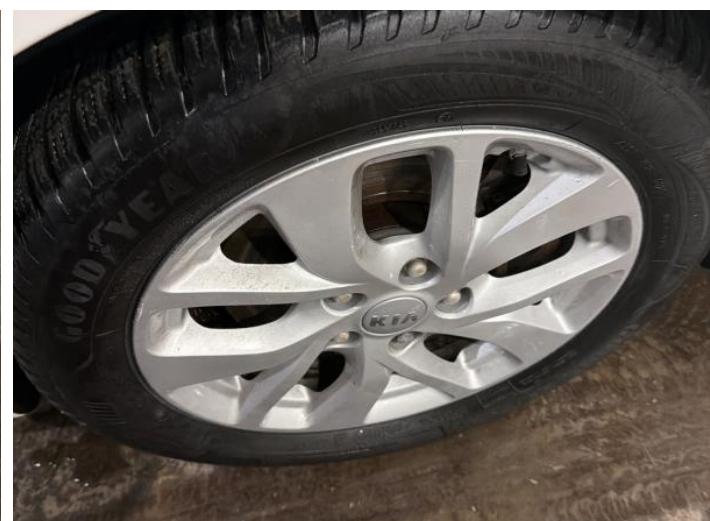
20: Wheel osf
Scratched
Over 50mm

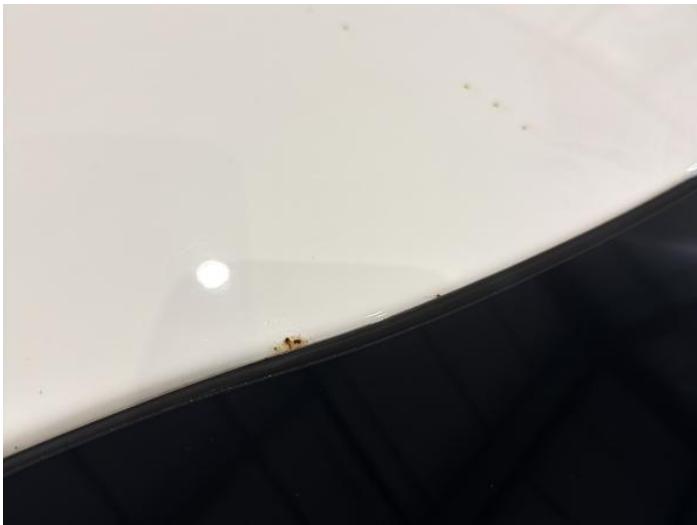
21: Roof
Rusted
UpTo 5mm

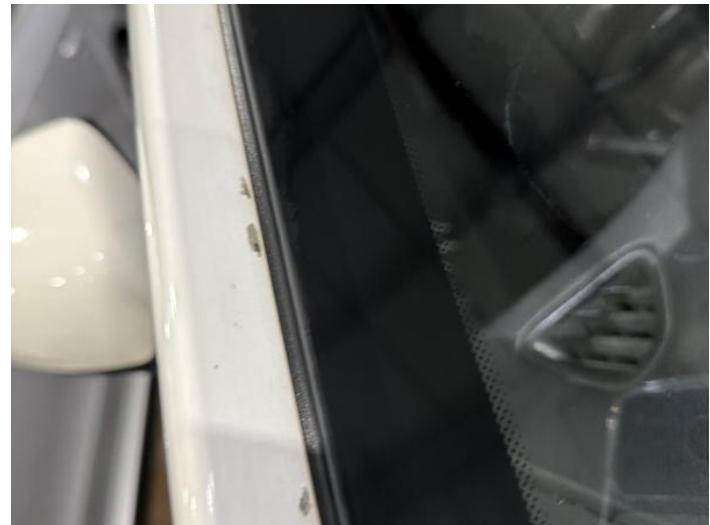
22: A Post os
Poor Previous Repair
Paint Flake

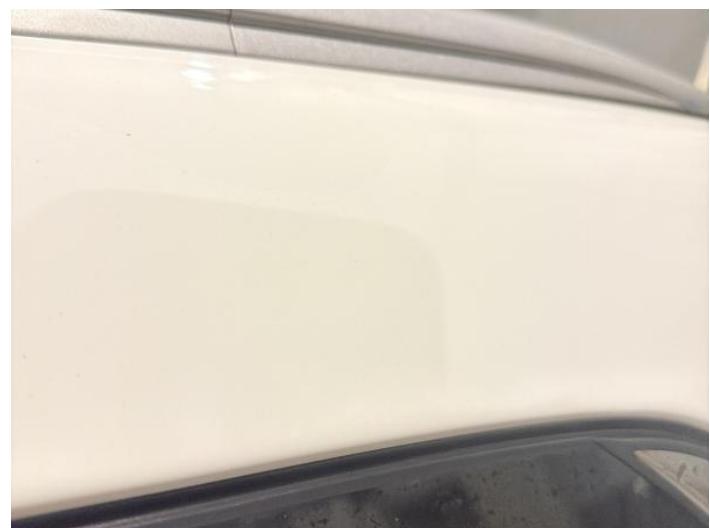
24: C Post ns
Dented
Between 10mm + 30mm
