VEHICLE INSPECTION REPORT

LB20NDV

Kia E-Niro 150kW 4 64kWh 5dr Auto

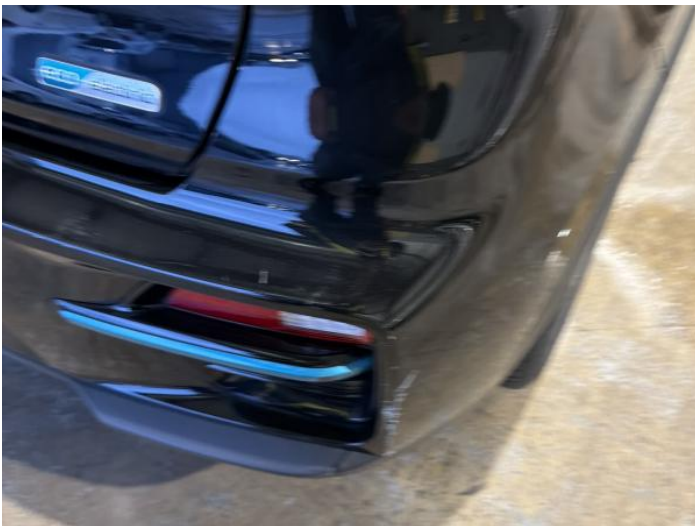
1: Bumper Rear
Scratched
Over 100mm Thru Paint

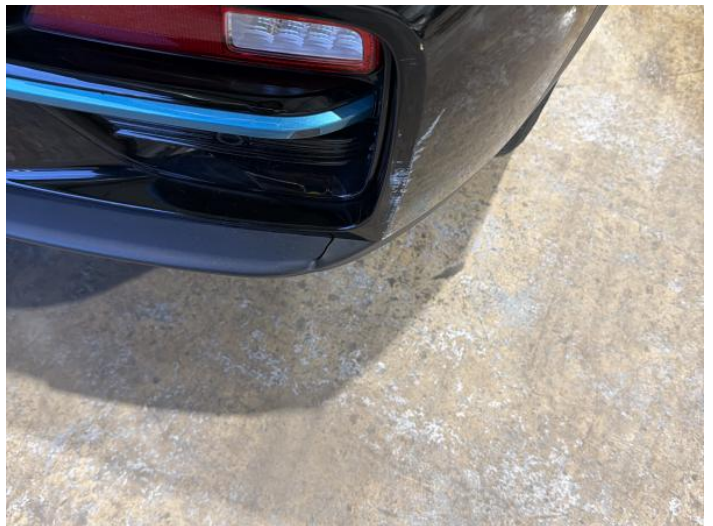
2: Bumper Rear Moulding
Broken
Replace

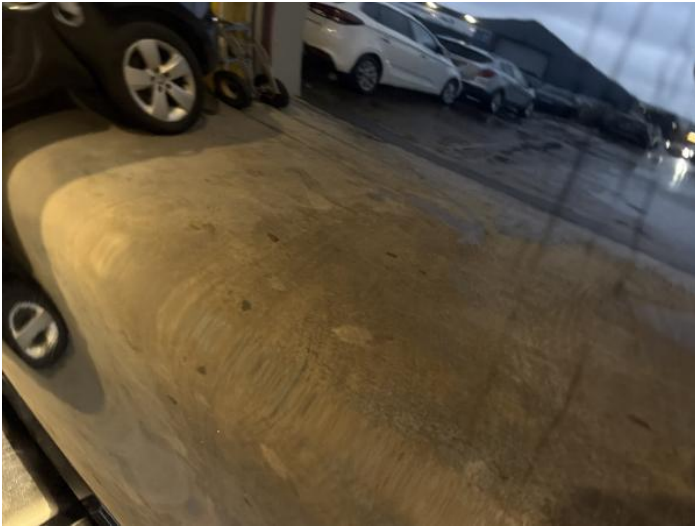
3: Boot Lid
Chipped
1 To 5

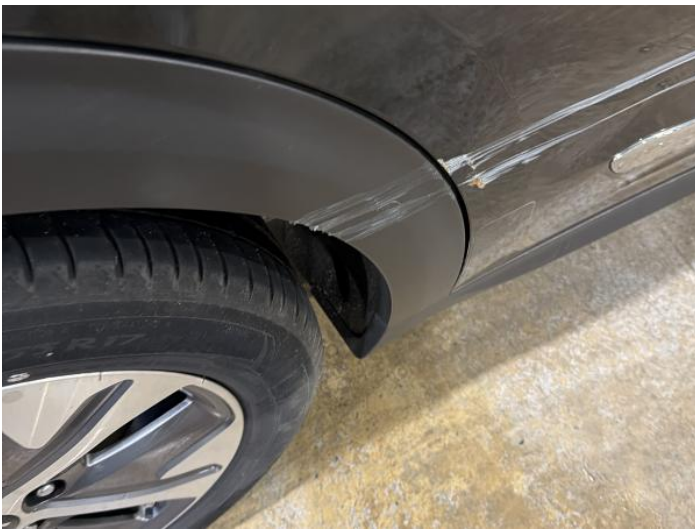
5: Qtr Panel Arch Extension os
Scuffed (Unpainted)
Over 100mm

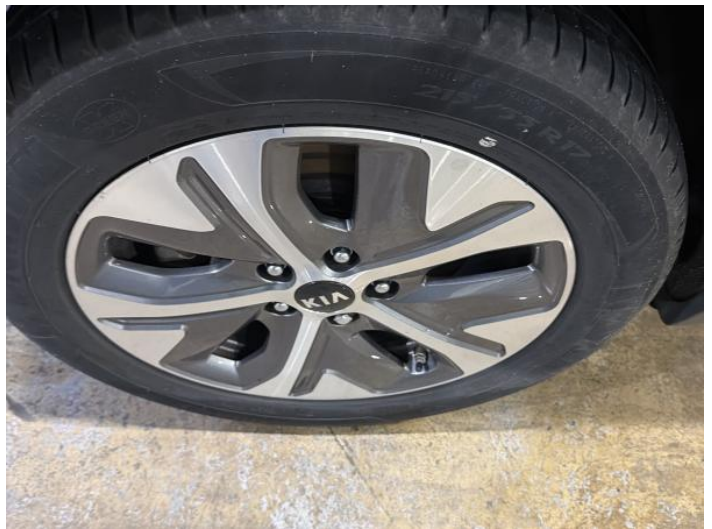
6: Wheel osr
Scratched
Up To 50mm

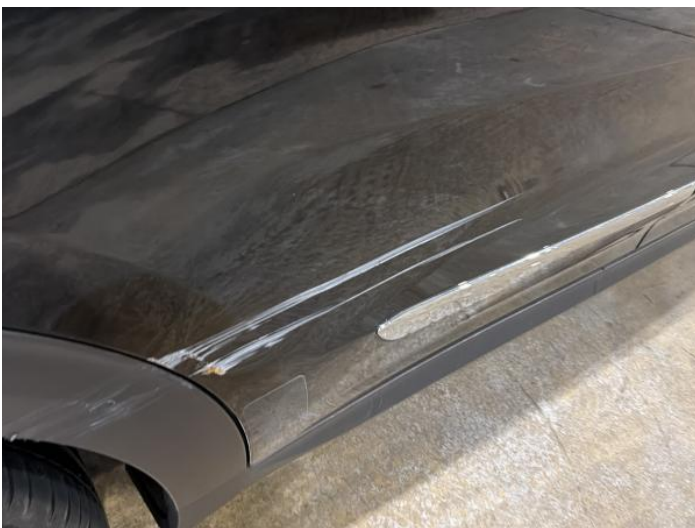
7: Door osr
Dented
With Paint Damage

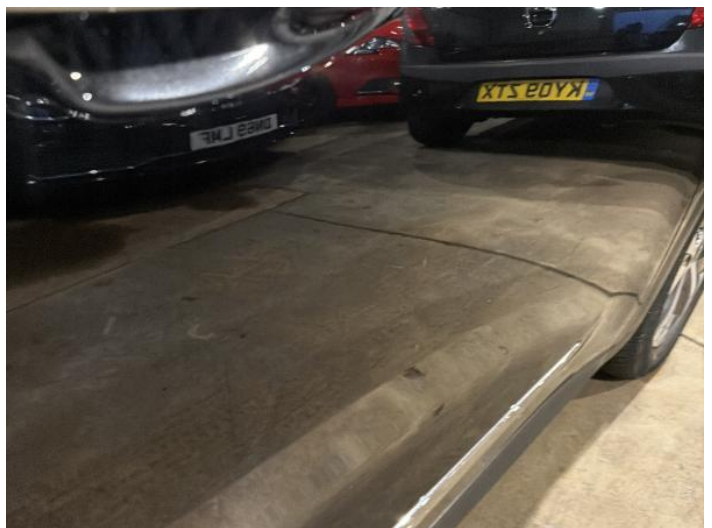
8: Door osf
Chipped
Multiple Chips

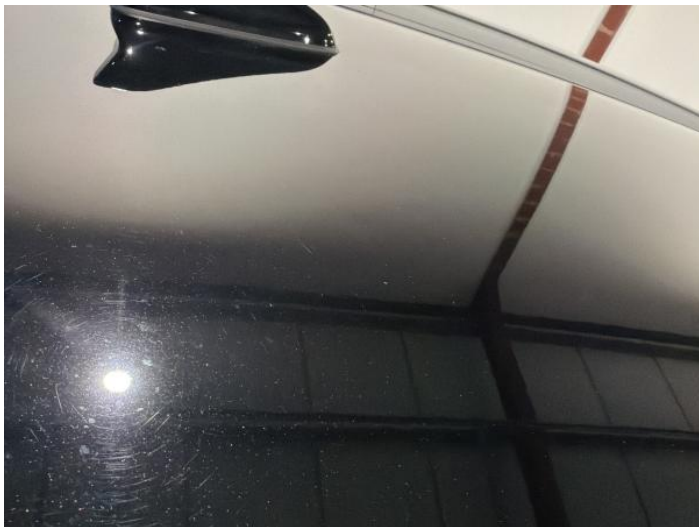
9: Roof
Dented
Hail - Moderate

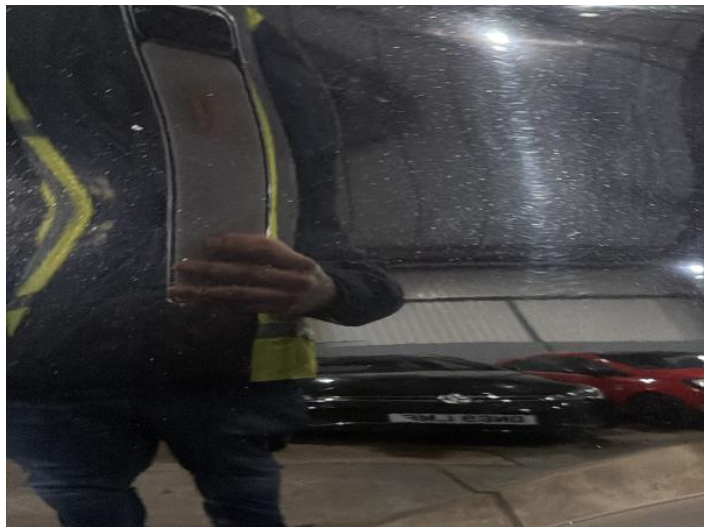
10: Wing osf
Chipped
1 To 5

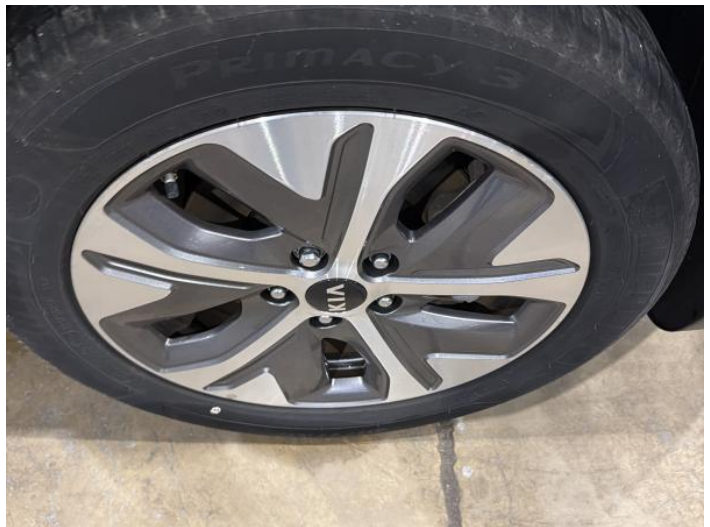
12: Wheel osr
Scratched
Up To 50mm

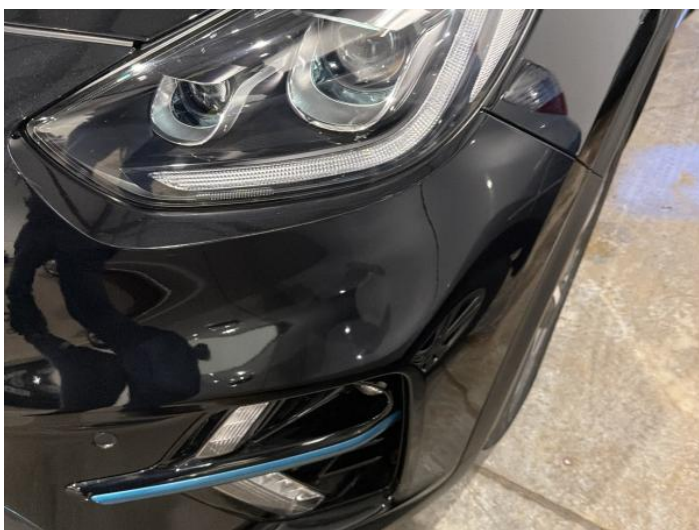
13: Bumper Front
Scratched
25 to 100mm Thru Paint

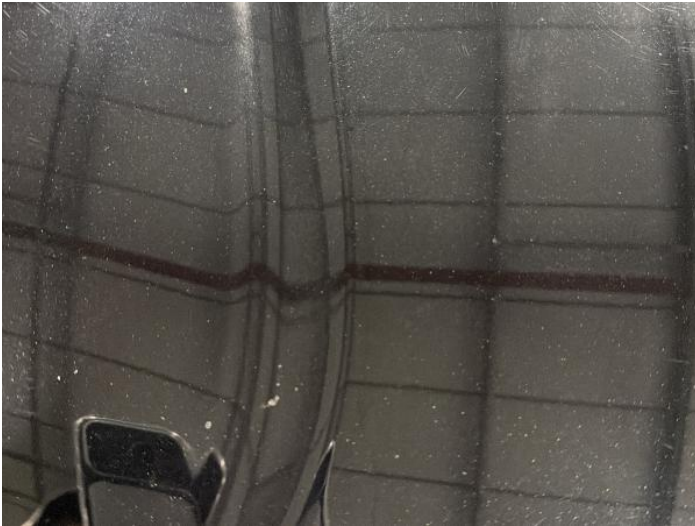
15: Bonnet
Chipped
1 To 5

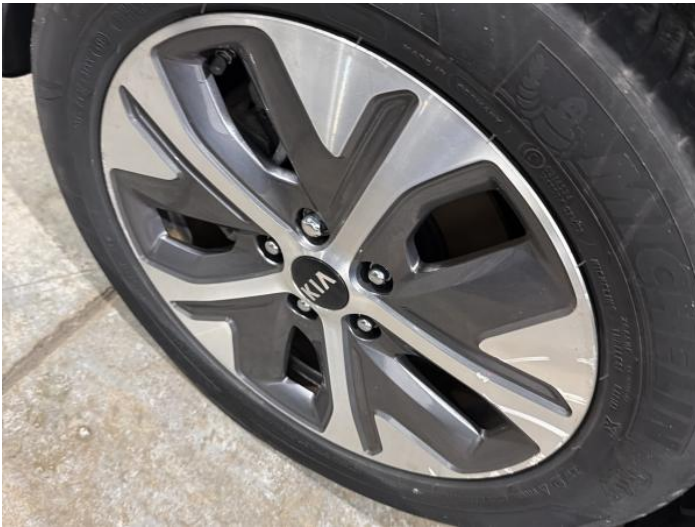
17: Wheel nsf
Scratched
Over 50mm

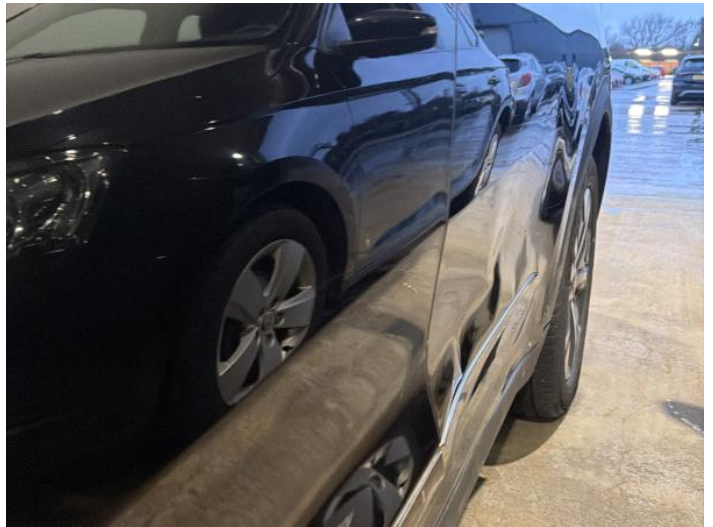
18: Door nsf
Dented
Over 30mm

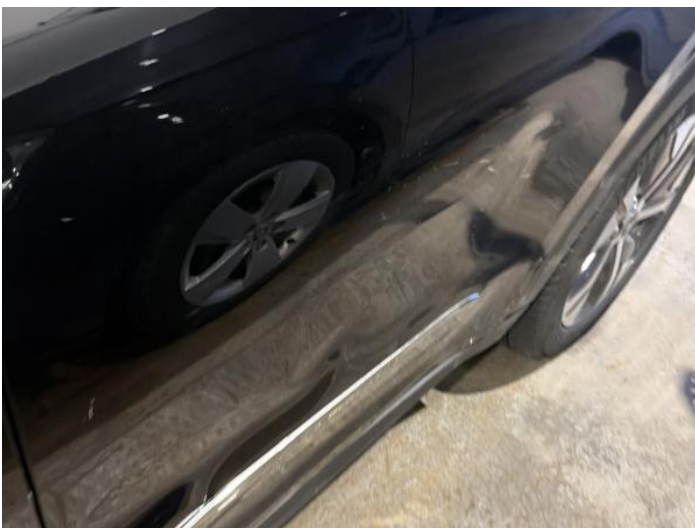
19: Door nsr
Dented
With Paint Damage

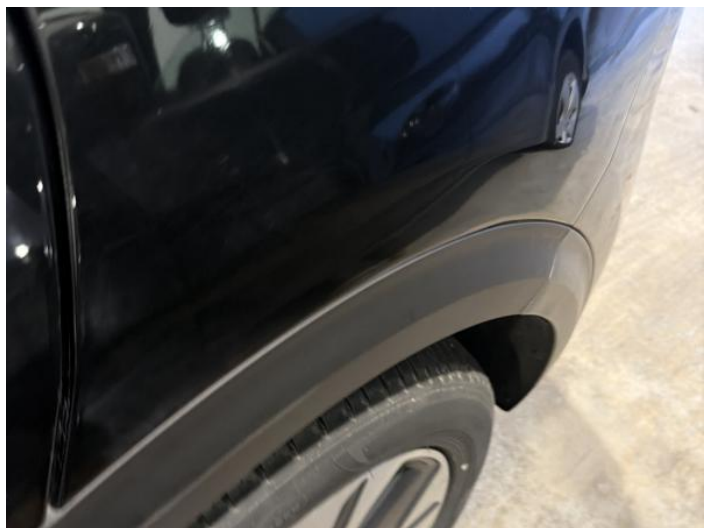
20: Qtr Panel nsr
Chipped
1 To 5

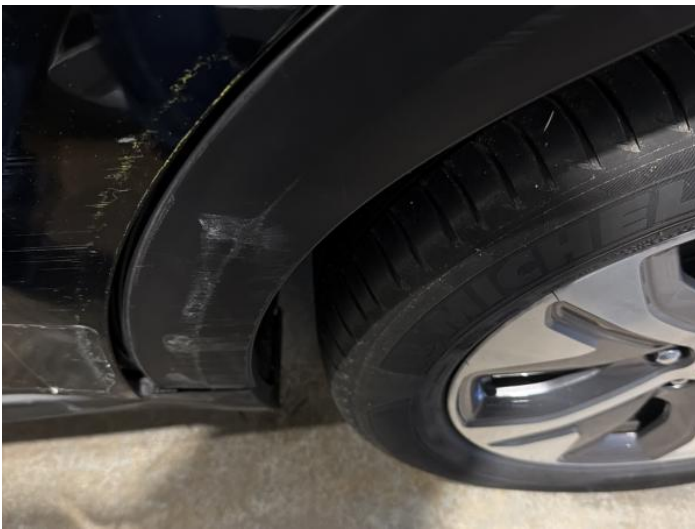
23: Qtr Panel Arch Extension ns
Scuffed (Unpainted)
Over 100mm
