# VEHICLE INSPECTION REPORT

SD65UJX

## Vauxhall Corsa 1.2 Limited Edition 3dr

Inspection	Vehicle	nama GRADE 3
Serious Damage?	VAT	Margin
No	V5	Present

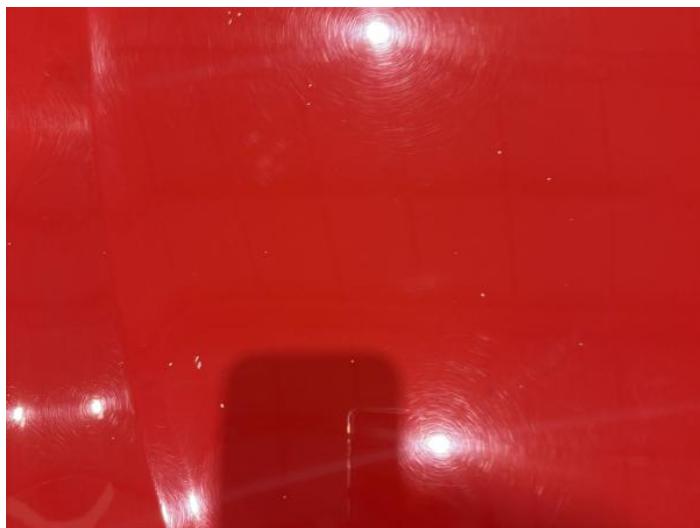
1: Bonnet  
Chipped  
Multiple Chips

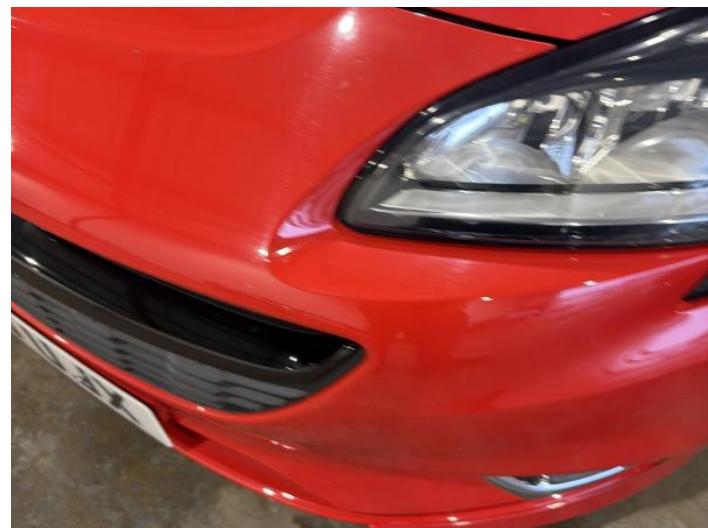
2: Bumper Front  
Chipped  
Multiple Chips

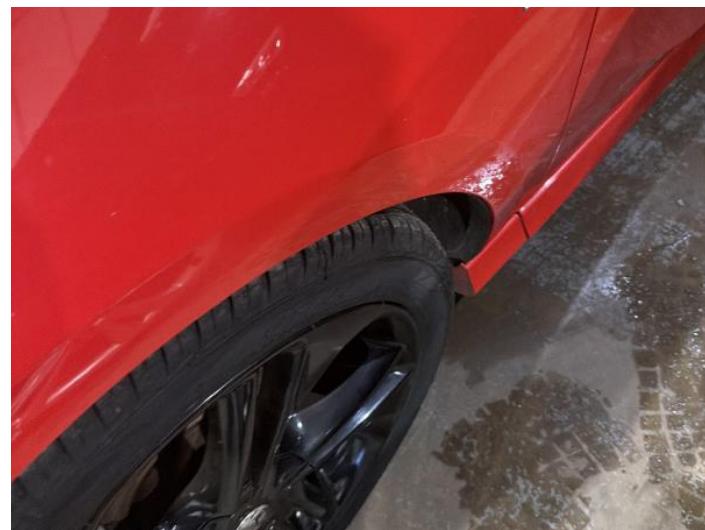
5: Wing nsf  
Chipped  
1 To 5

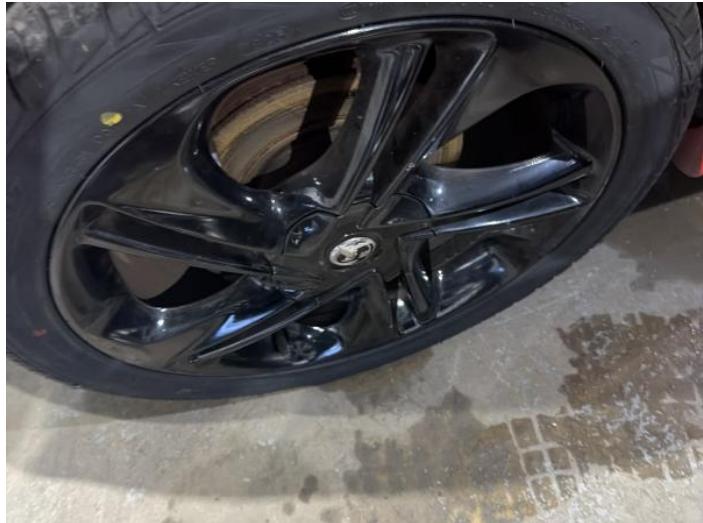
4: Wheel nsf  
Scratched  
Up To 50mm

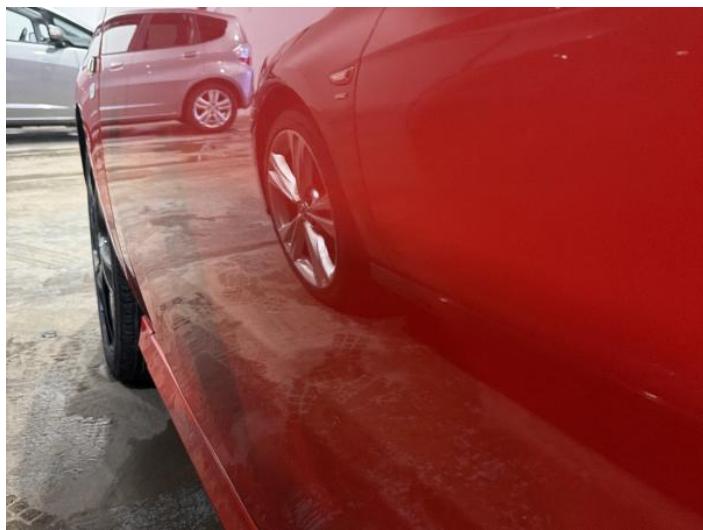
6: Door nsf  
Chipped  
1 To 5

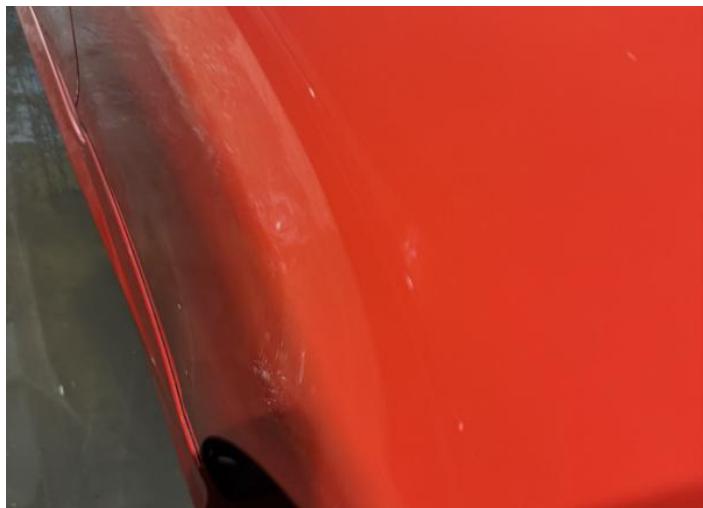
8: Qtr Panel nsf  
Chipped  
1 To 5

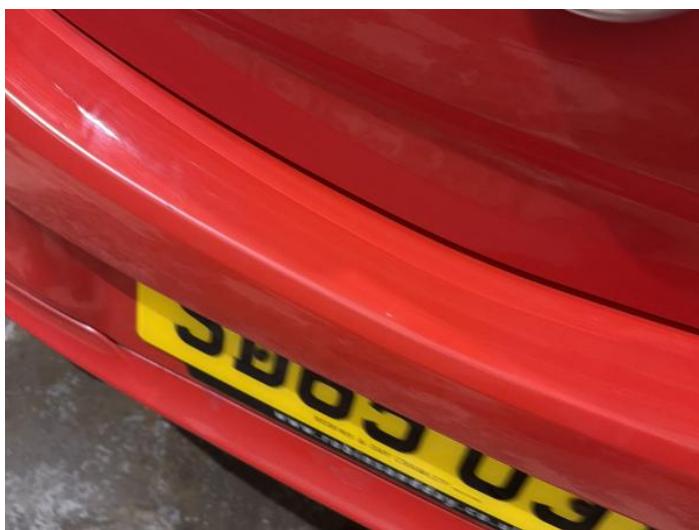
11: Bumper Rear  
Chipped  
1 To 5

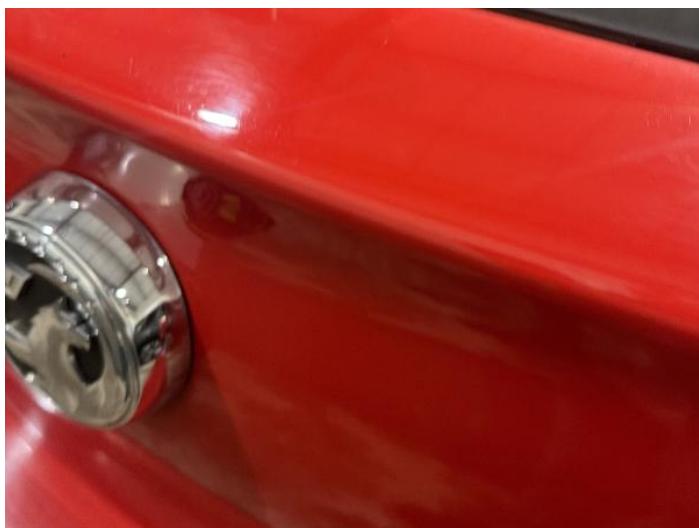
13: Boot Lid  
Chipped  
1 To 5

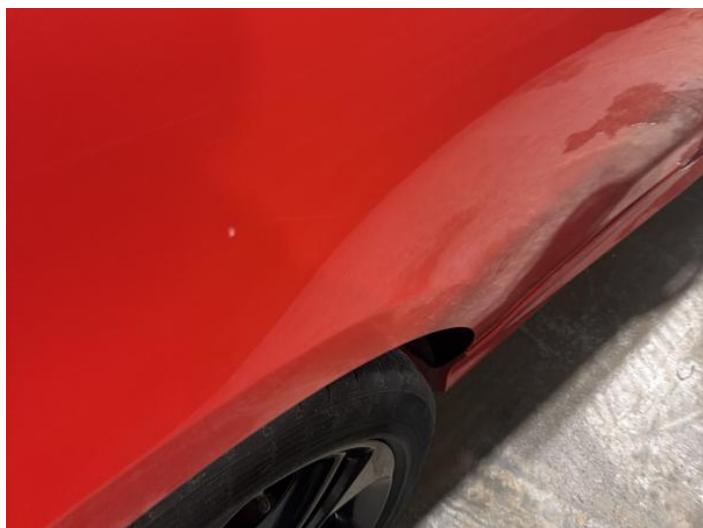
14: Qtr Panel osr  
Dented  
2 Or Less UpTo 10mm

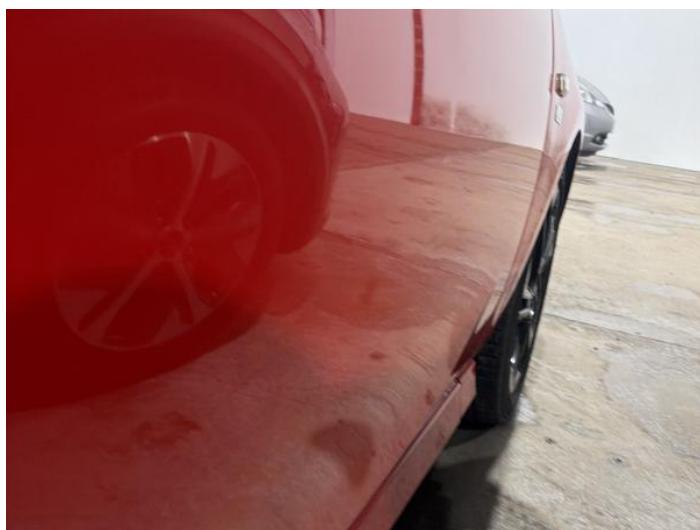
16: Wheel osr  
Scratched  
Up To 50mm
