VEHICLE INSPECTION REPORT

EN12CXJ

Hyundai i30 1.4 Active 5dr

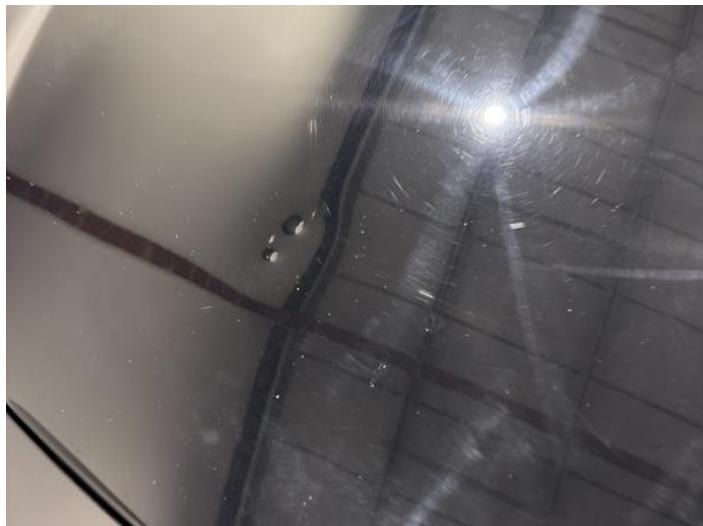
1: Bonnet
Dented
With Paint Damage

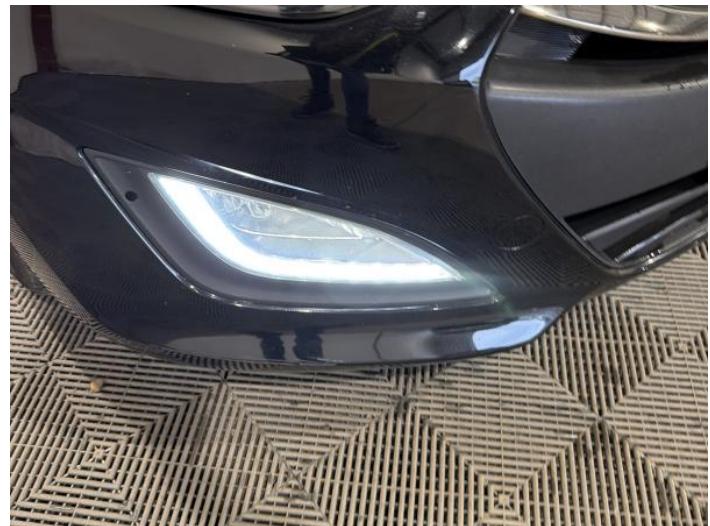
2: Bumper Front
Scratched
Over 100mm Thru Paint

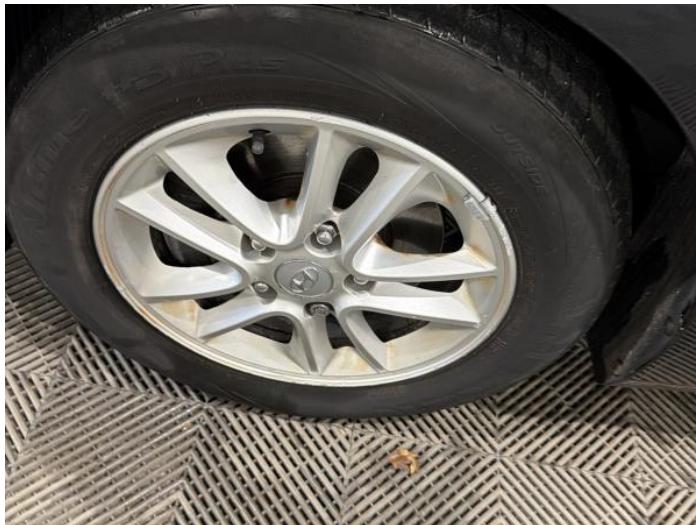
3: Wheel nsf
Scratched
Over 50mm

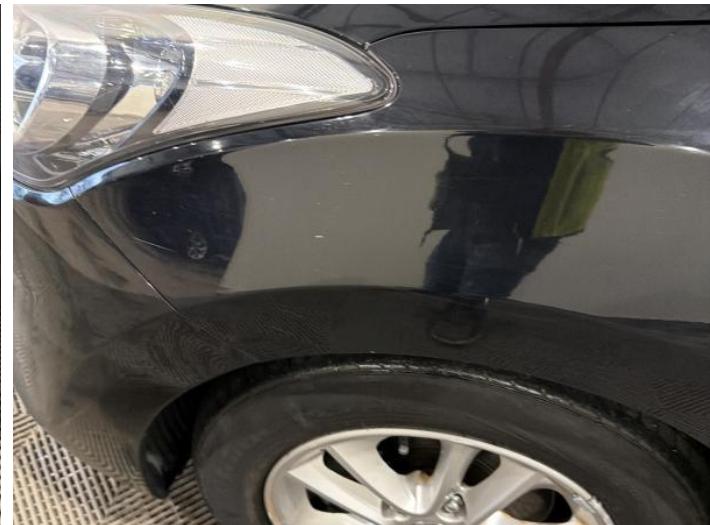
4: Wing nsf
Dented
With Paint Damage

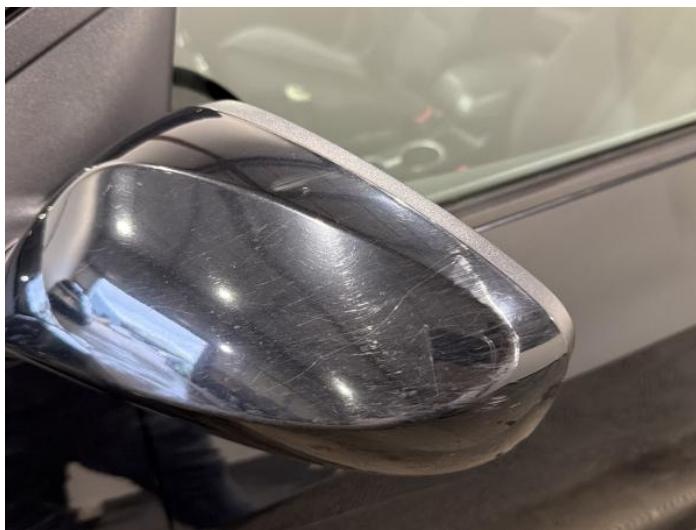
5: Door Mirror Assy nsf
Scratched (Painted)
Over 25mm Thru Paint

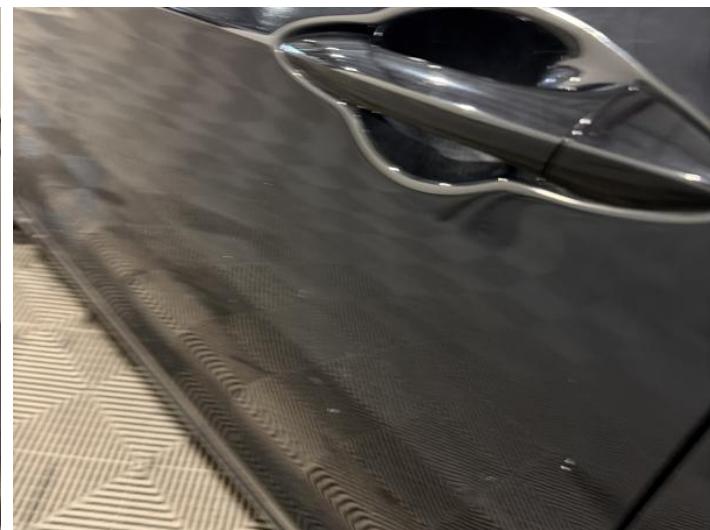
6: Door nsf
Dented
With Paint Damage

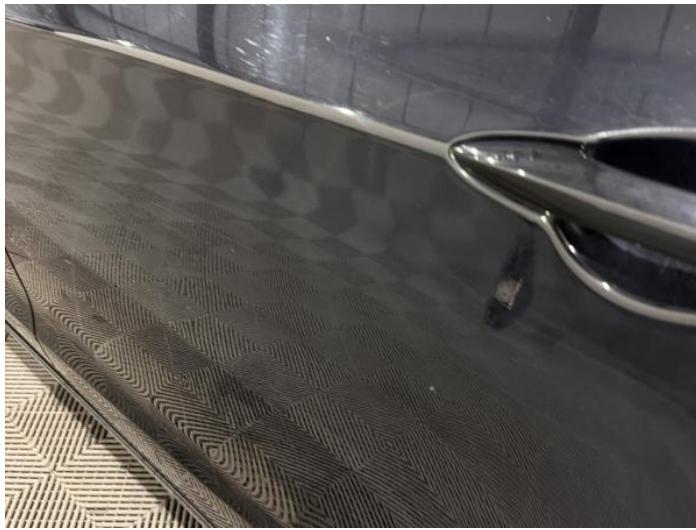
7: Door nsr
Dented
With Paint Damage

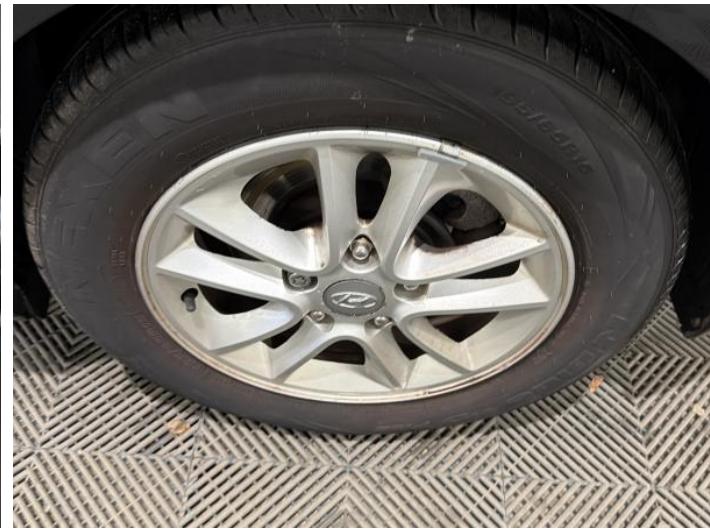
8: Wheel nsr
Scratched
Over 50mm

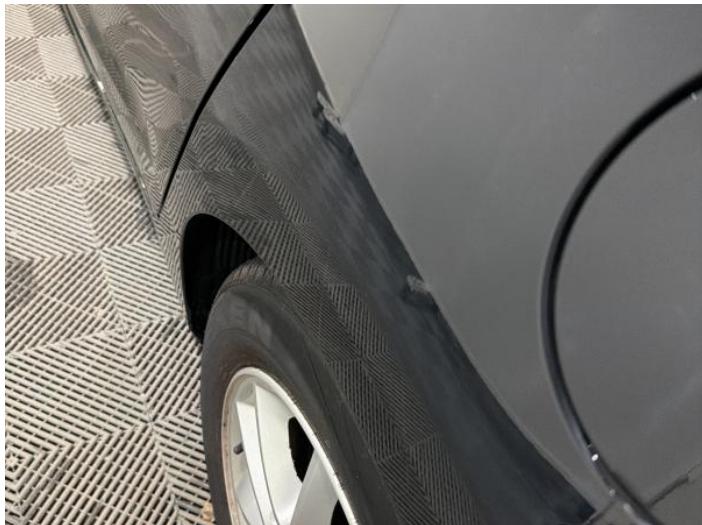
9: Qtr Panel nsr
Dented
With Paint Damage

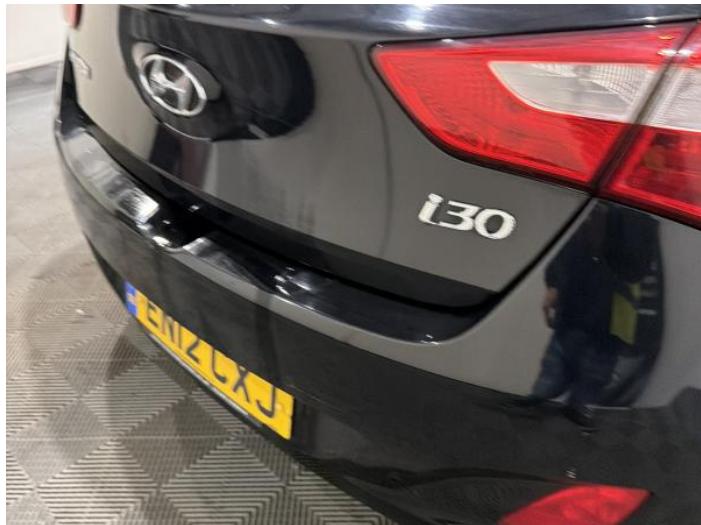
10: Bumper Rear
Scratched
25 to 100mm Thru Paint

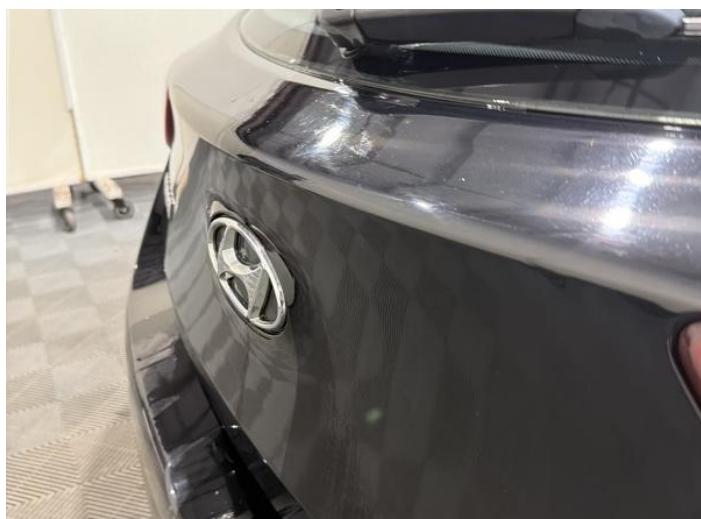
12: Boot Lid
Dented
Over 2 UpTo 10mm

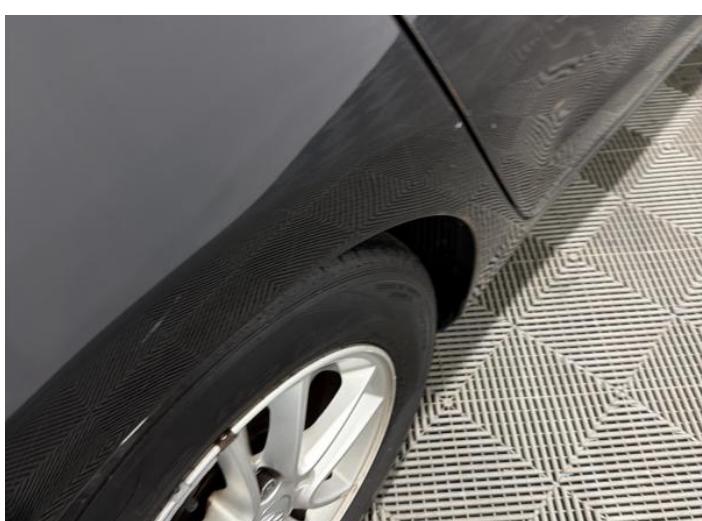
13: Qtr Panel osr
Scratched
Over 25mm Thru Paint

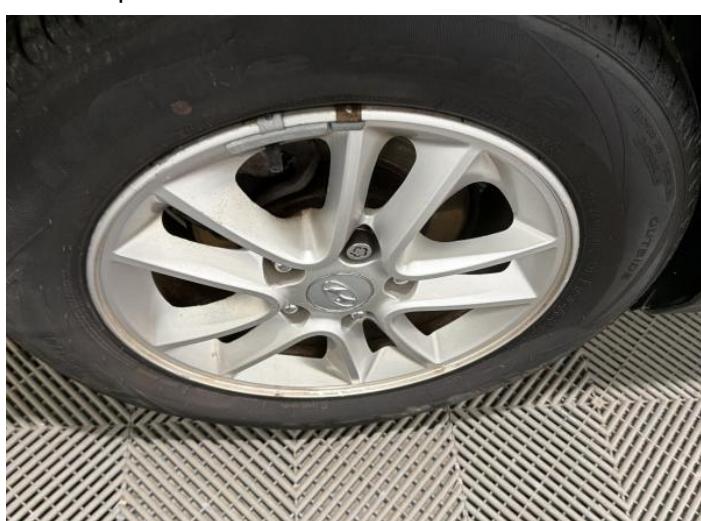
14: Wheel osr
Scratched
Over 50mm

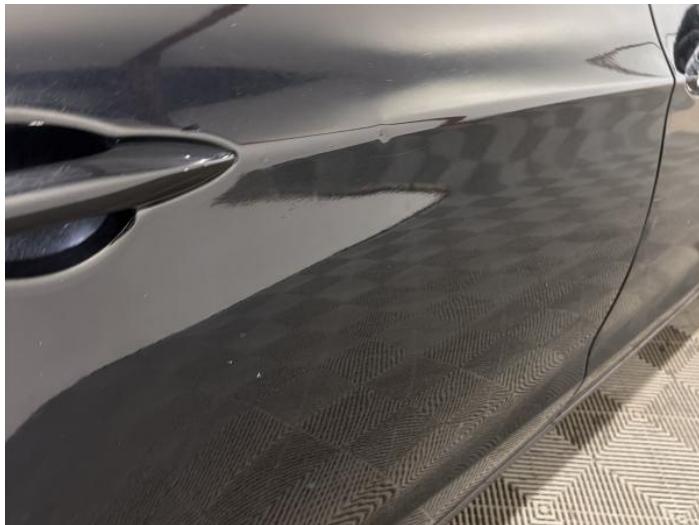
15: Door osr
Dented
With Paint Damage

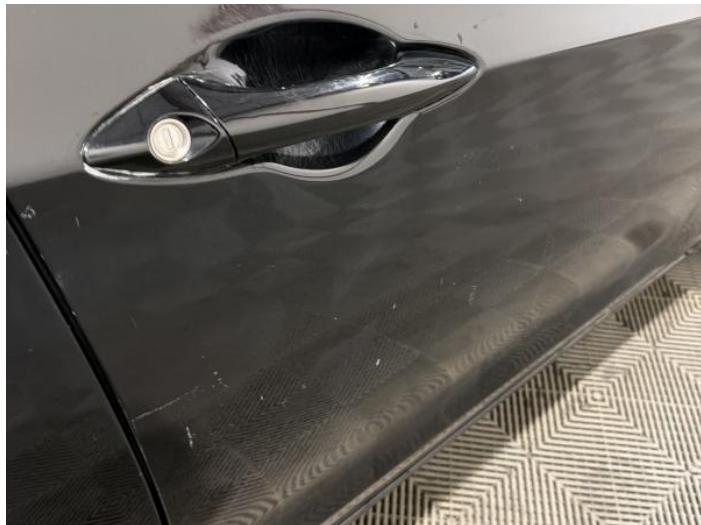
16: Door osf
Poor Previous Repair
Poor Paint

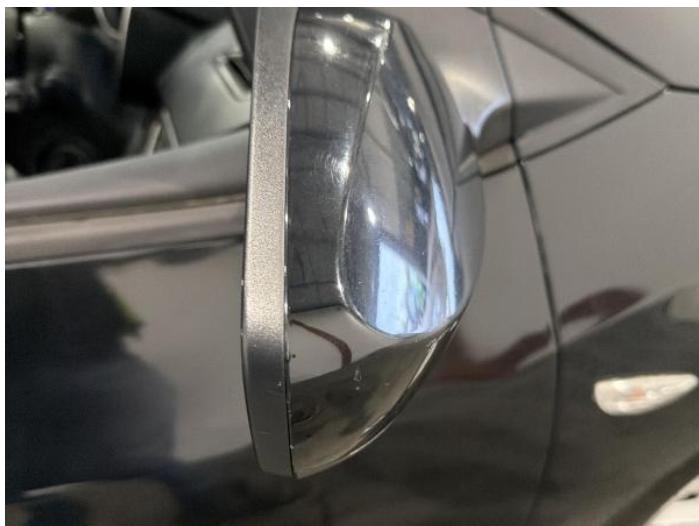
17: Door Mirror Assy osf
Scratched (Painted)
UpTo 25mm Thru Paint

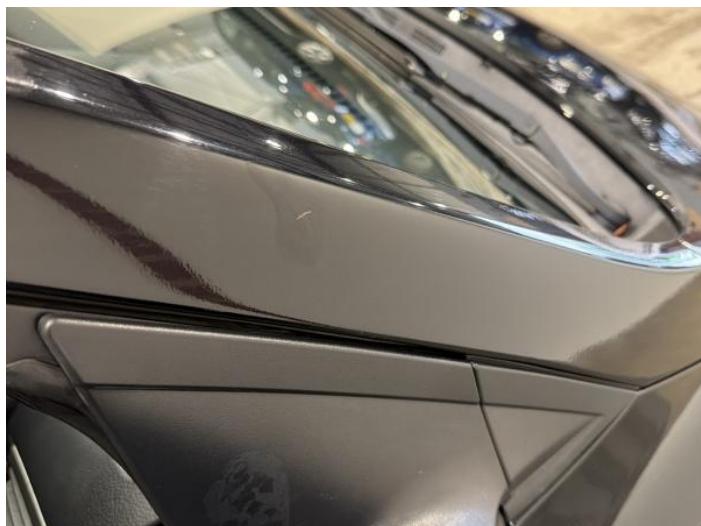
18: A Post osf
Scratched
UpTo 25mm Thru Paint

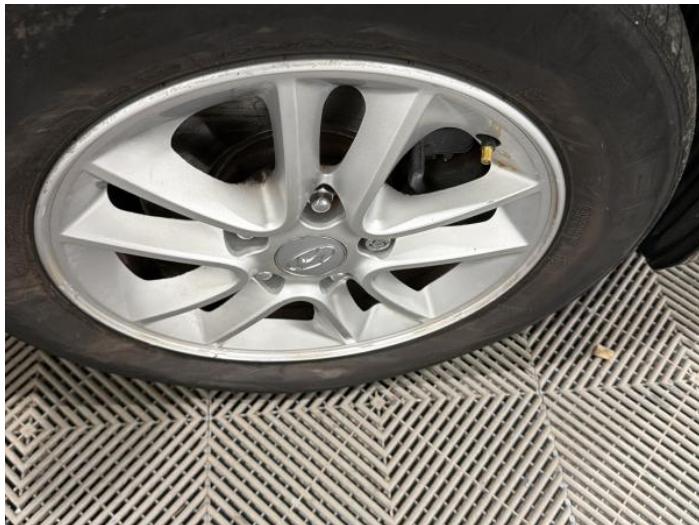
21: Wheel osf
Scratched
Over 50mm

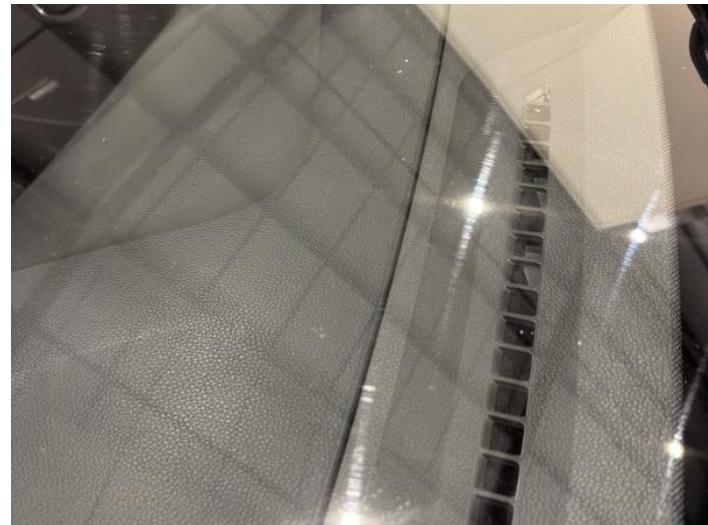
22: Screen Front
Chipped
UpTo 10mm

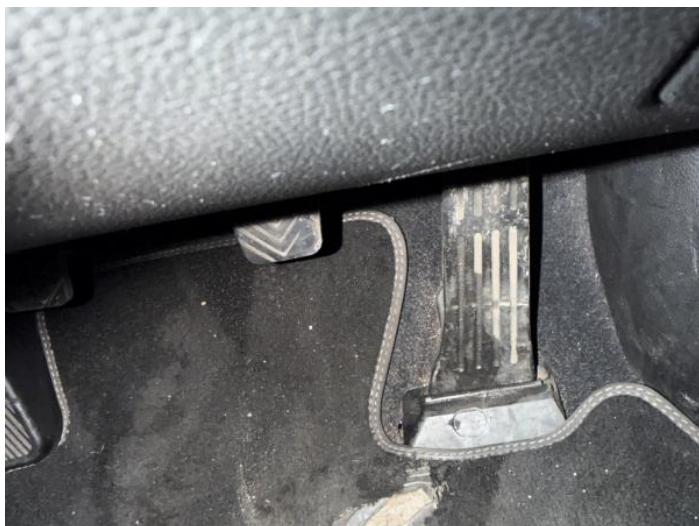
23: Carpets Front
Torn
Over 10mm
