# VEHICLE INSPECTION REPORT

HG12WGK

## Nissan Juke 1.6 DiG-T Kuro 5dr

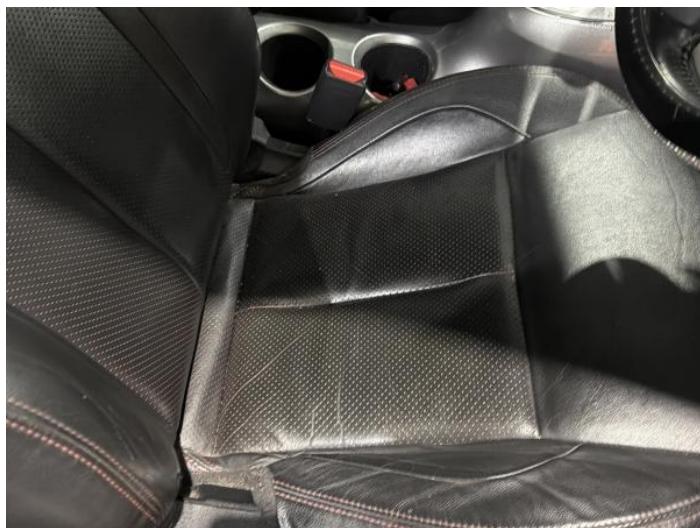
1: Seat Base Cover off  
Scuffed  
Over 25mm

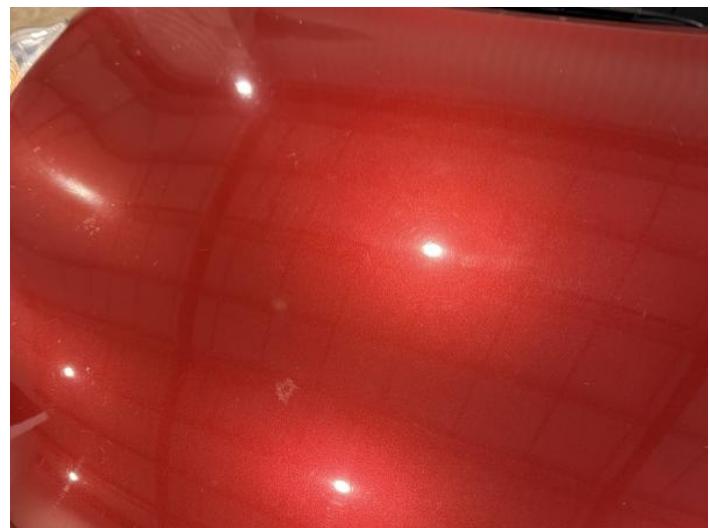
2: Bonnet  
Chipped  
Multiple Chips

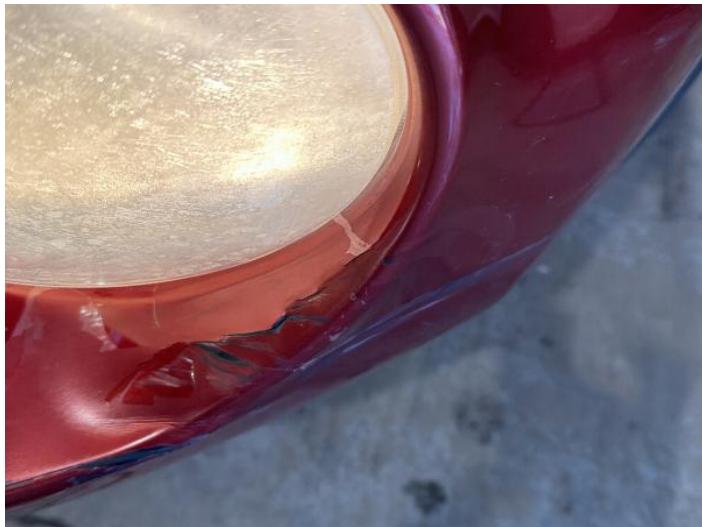
3: Bumper Front  
Cracked  
UpTo 25mm

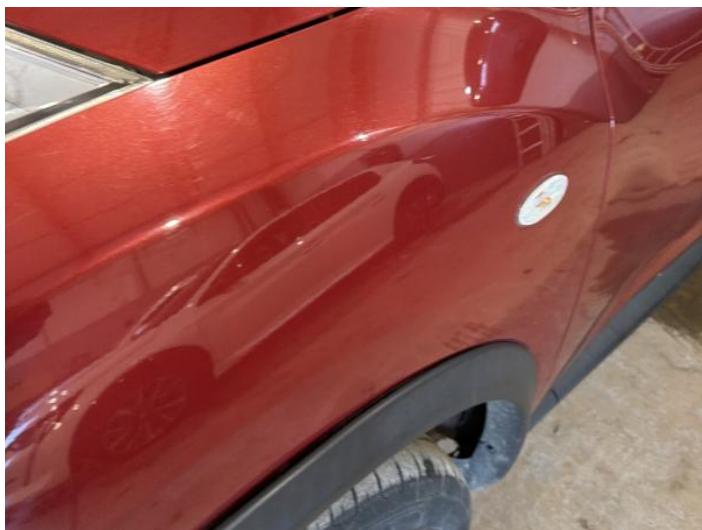
5: Wing nsf  
Chipped  
Multiple Chips

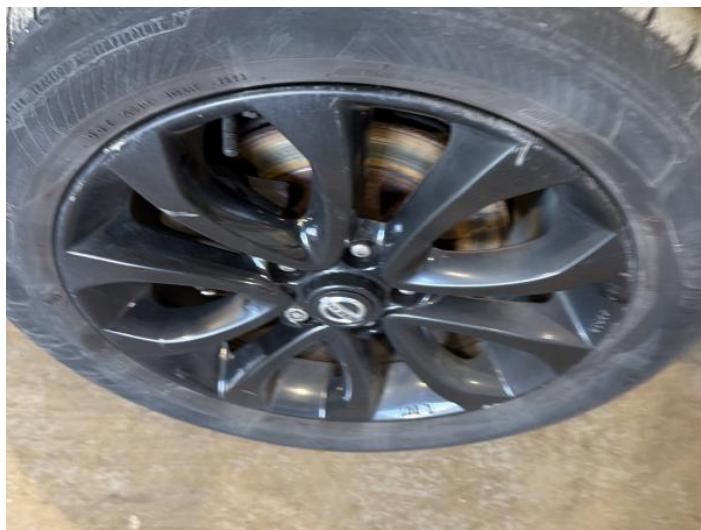
6: Wheel nsf  
Scratched  
Over 50mm

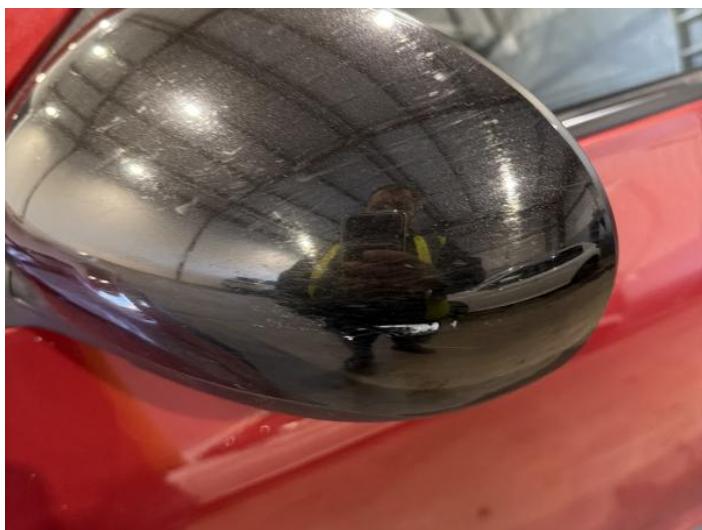
7: Door Mirror Assy nsf  
Scratched (Painted)  
UpTo 25mm Thru Paint

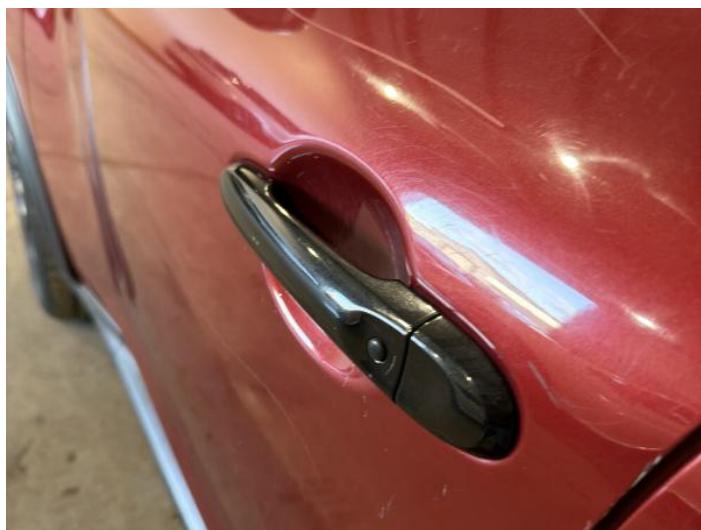
8: Door nsf  
Dented  
With Paint Damage

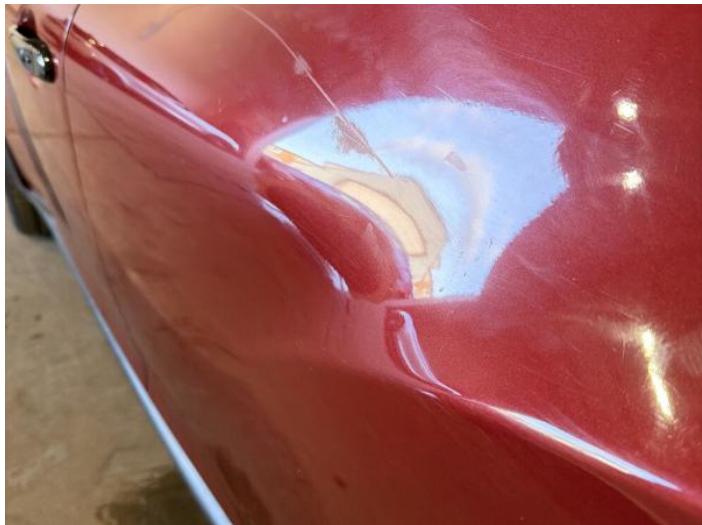
9: Door nsr  
Dented  
With Paint Damage

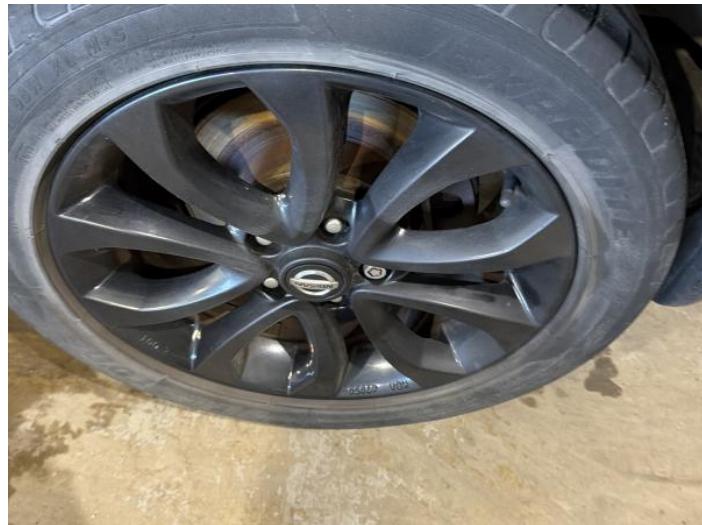
10: Wheel nsr  
Scratched  
Over 50mm

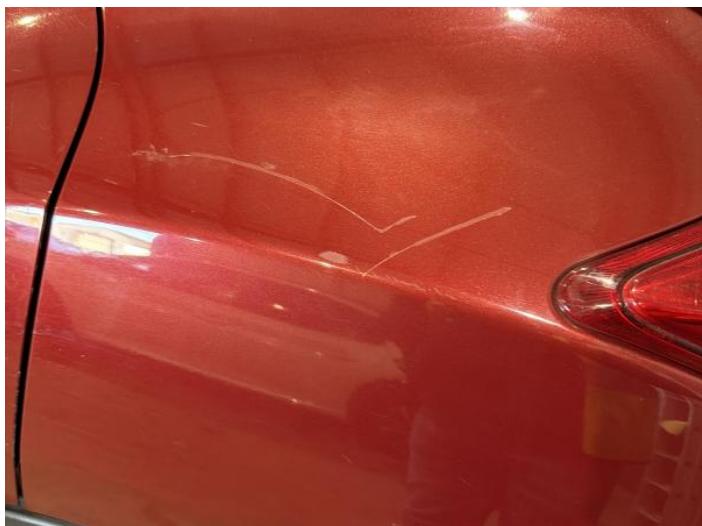
11: Qtr Panel nsr  
Scratched  
Over 25mm Thru Paint

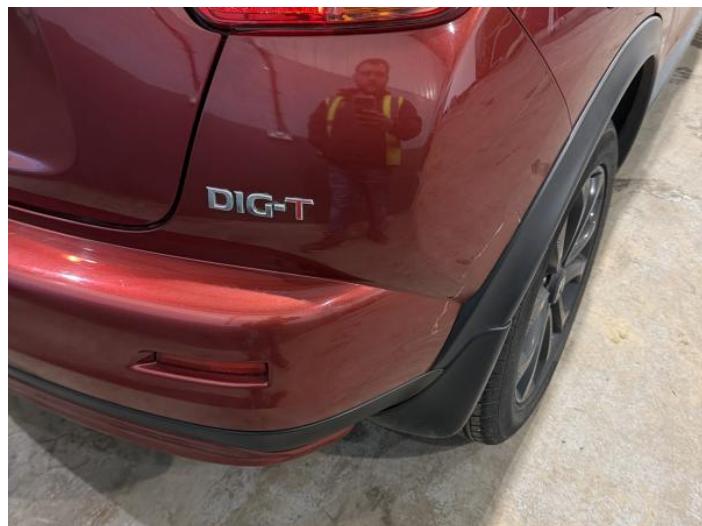
12: Bumper Rear  
Scratched  
Over 100mm Thru Paint

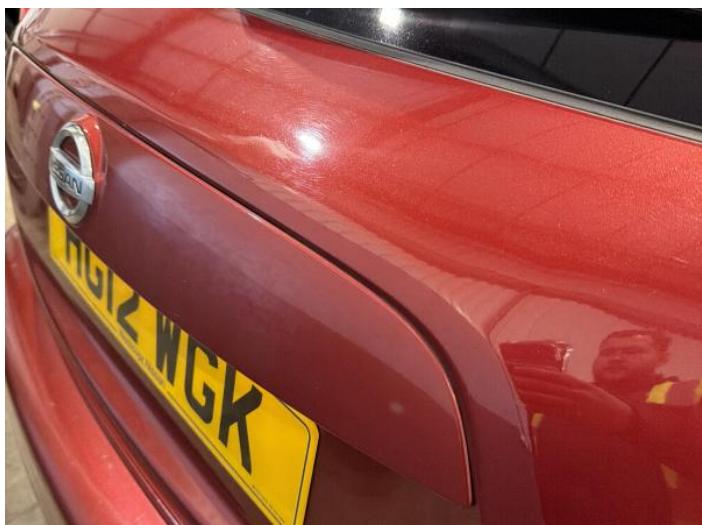
13: Boot Lid  
Dented  
Over 2 UpTo 10mm

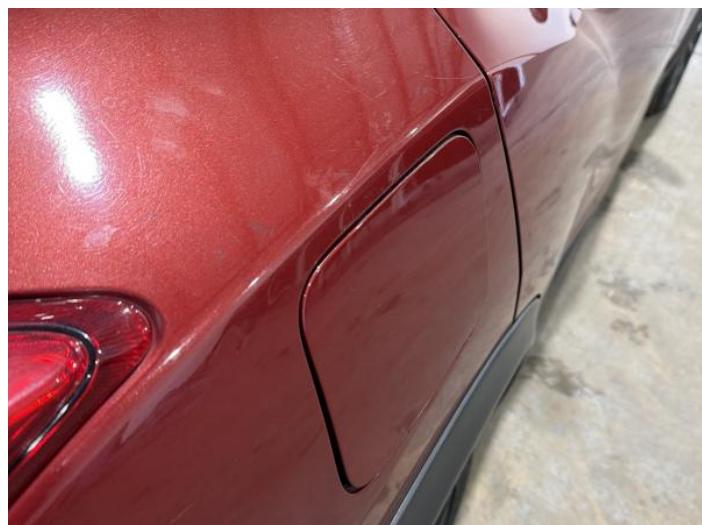
14: Qtr Panel osr  
Scratched  
Over 25mm Thru Paint

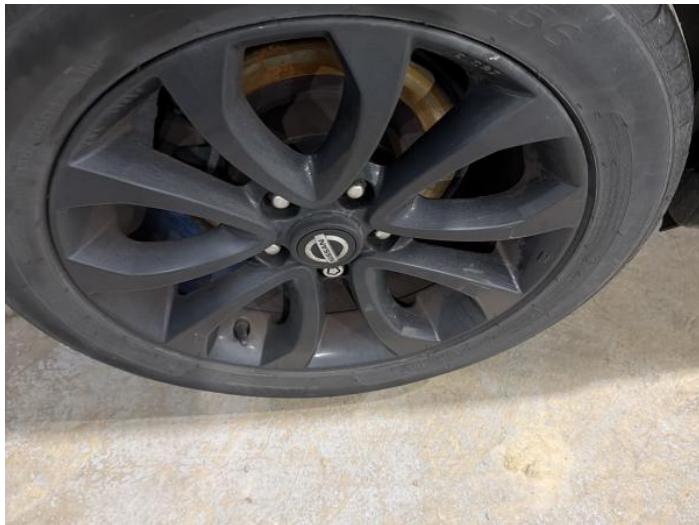
15: Wheel osr  
Scratched  
Over 50mm

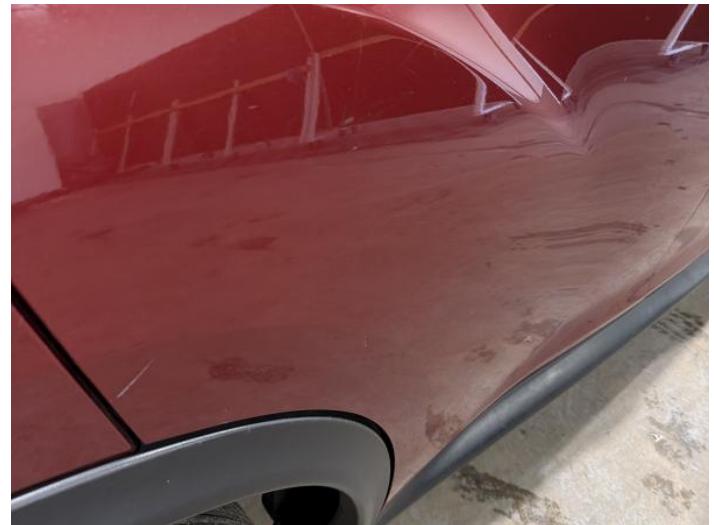
16: Door osr  
Chipped  
Multiple Chips

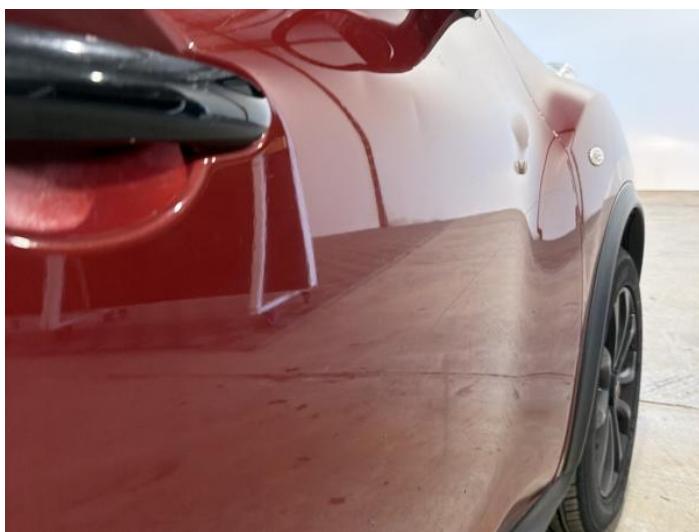
17: Door osf  
Dented  
Over 30mm

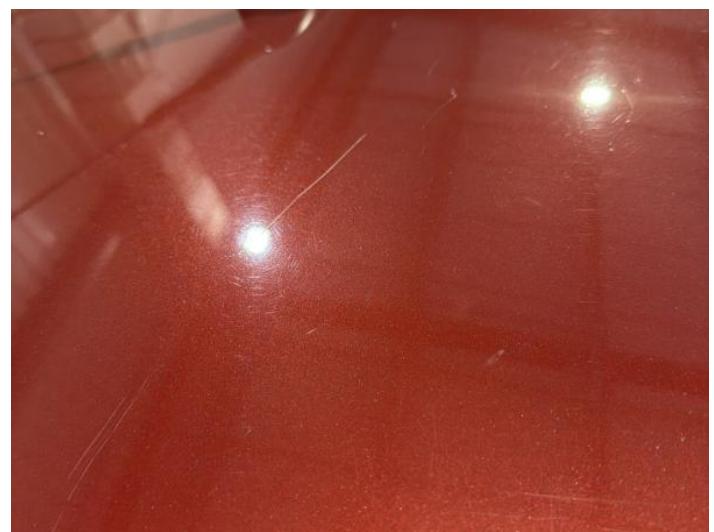
18: Roof  
Scratched  
Over 25mm Thru Paint

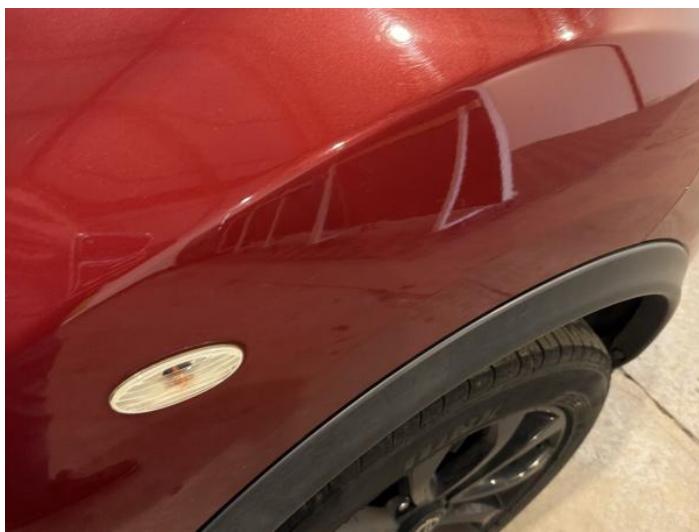
19: Wing osf  
Scratched  
Over 25mm Thru Paint

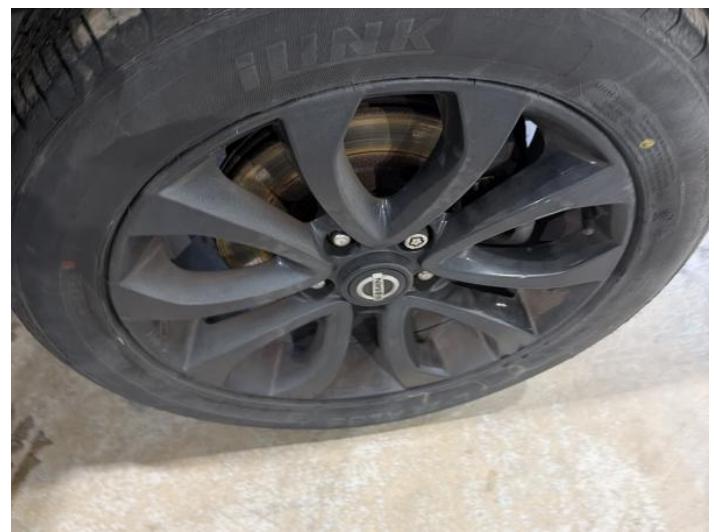
20: Wheel osf  
Scratched  
Over 50mm

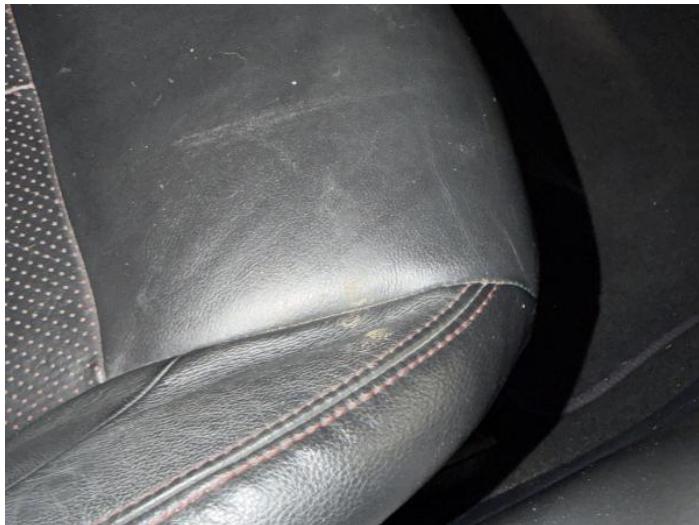
21: Seat Base Cover nsf

Scuffed

UpTo 25mm
