VEHICLE INSPECTION REPORT

GV03AXF

MG Mgtf 135

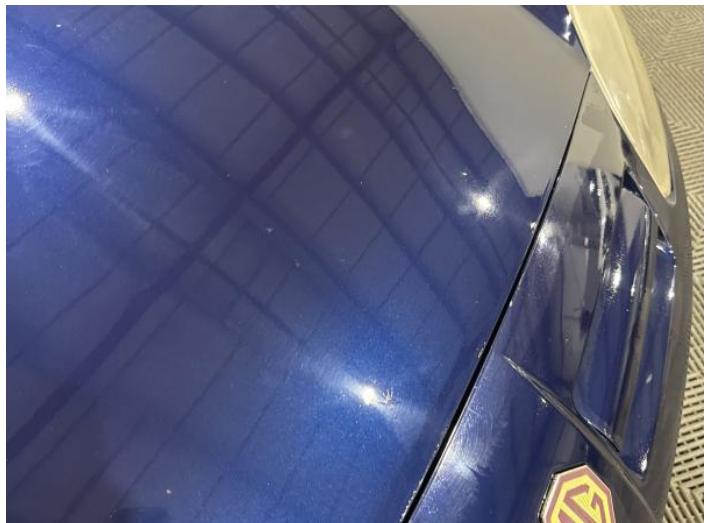
1: Bonnet
Chipped
Multiple Chips

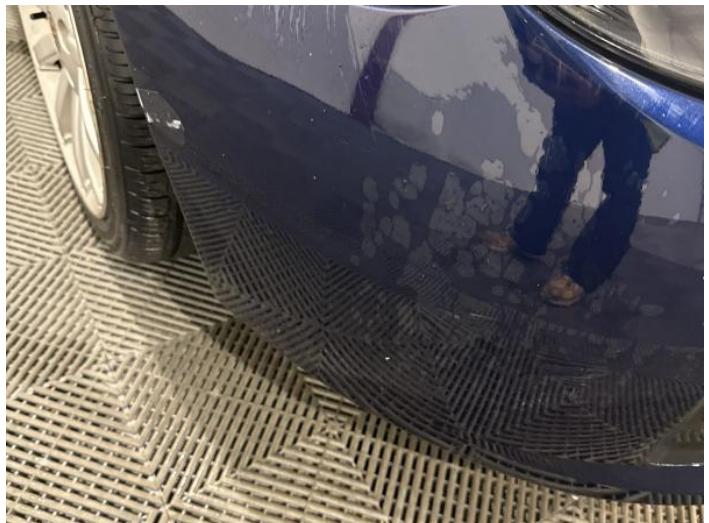
2: Bumper Front
Scratched
Over 100mm Thru Paint

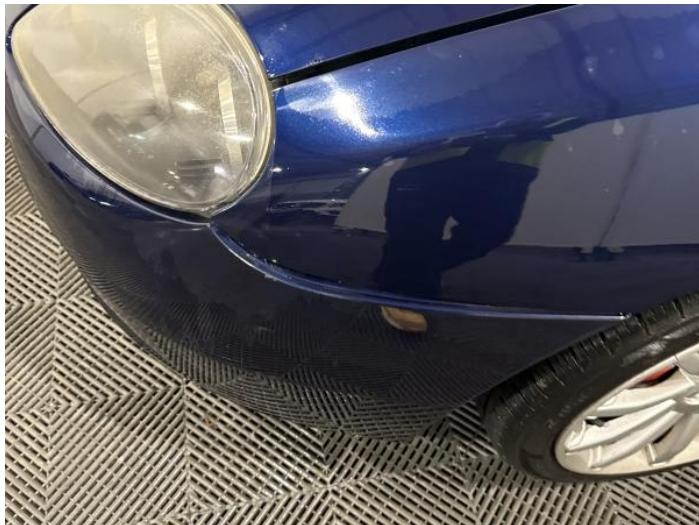
3: Bumper Front
Insecure
Action Required

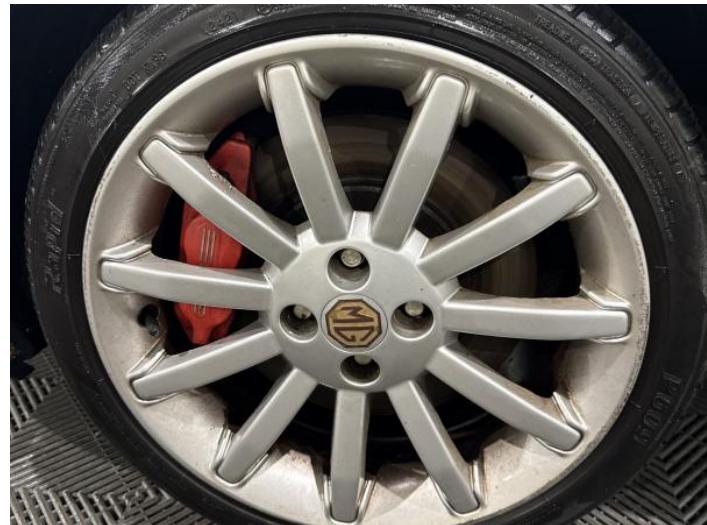
4: Wheel nsf
Scratched
Over 50mm

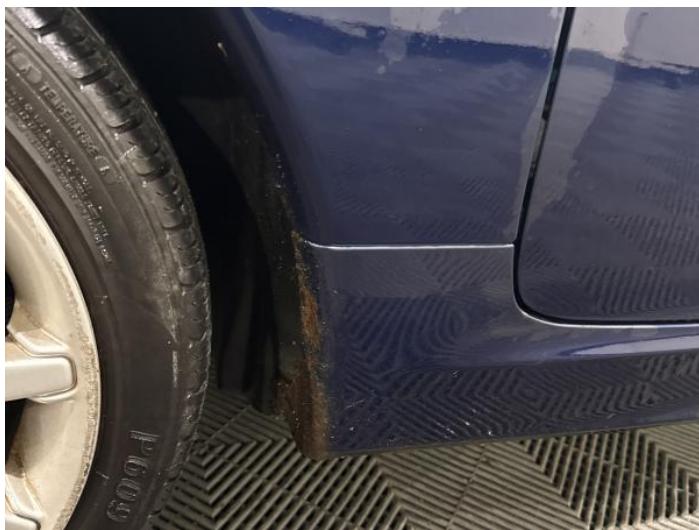
5: Wing nsf
Rusted
Over 5mm

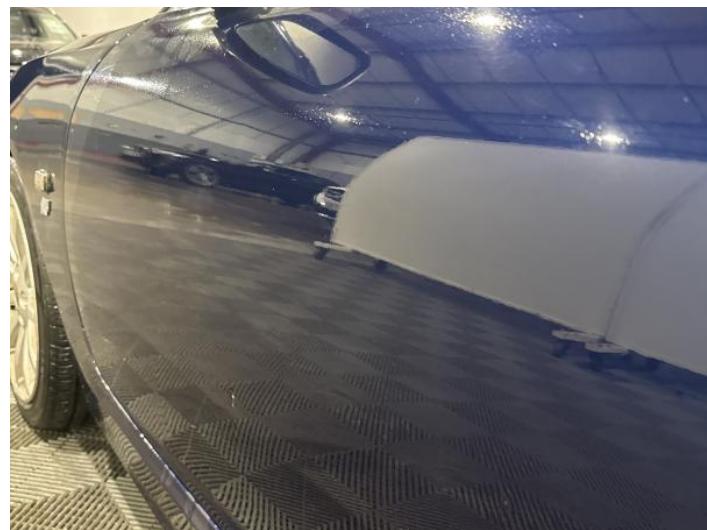
6: Door nsf
Dented
Over 30mm

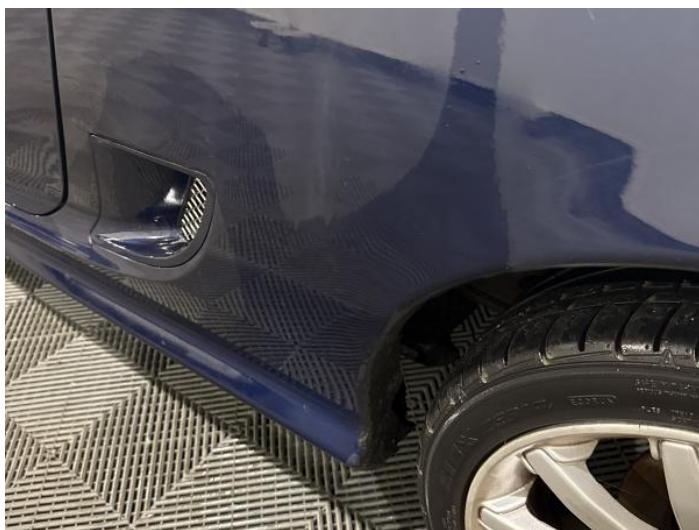
7: Qtr Panel nsr
Scratched
Rusted

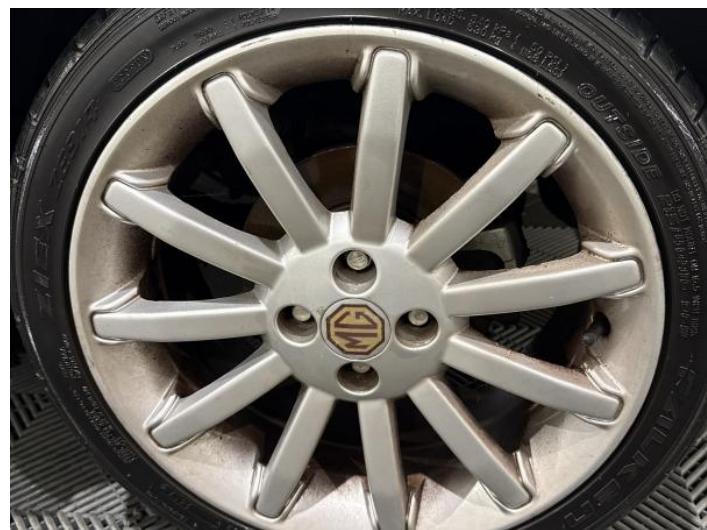
8: Wheel nsr
Scratched
Up To 50mm

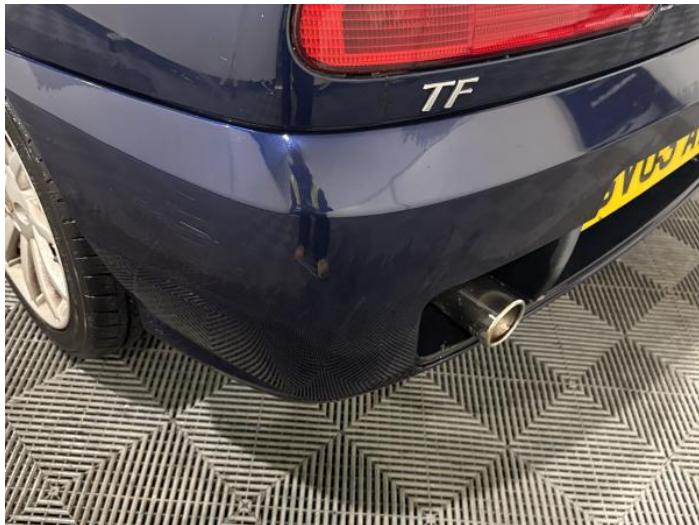
9: Bumper Rear
Scratched
Over 100mm Thru Paint

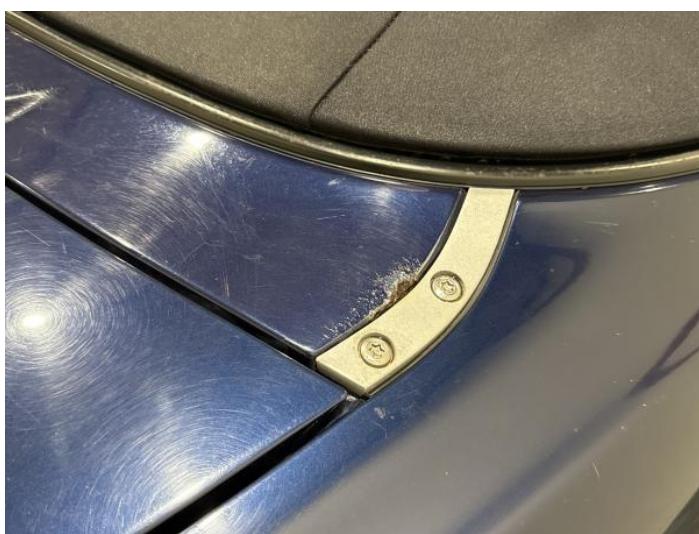
11: Panel Rear
Rusted
Over 5mm

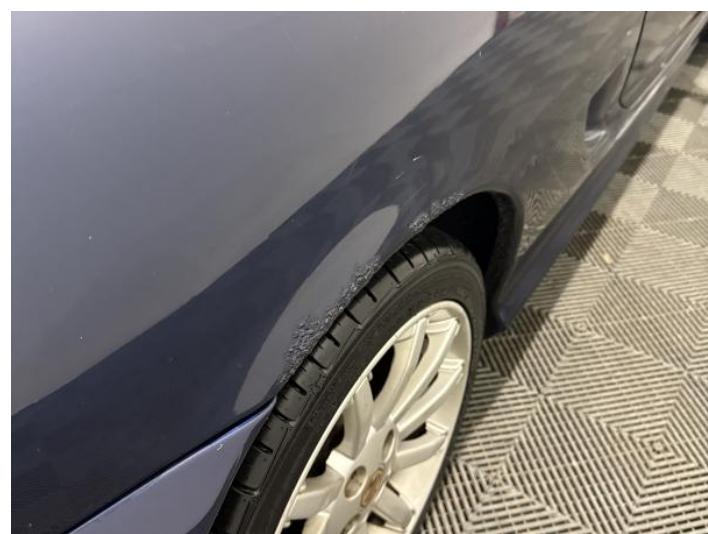
12: Qtr Panel osr
Rusted
Over 5mm

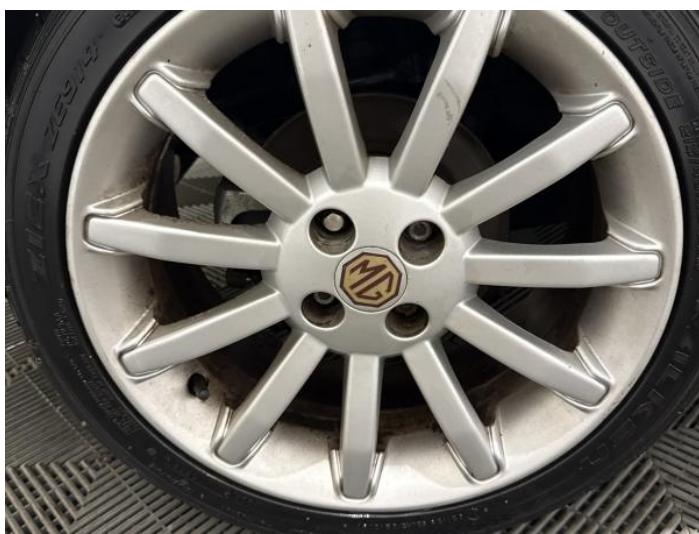
13: Wheel osr
Scratched
Up To 50mm

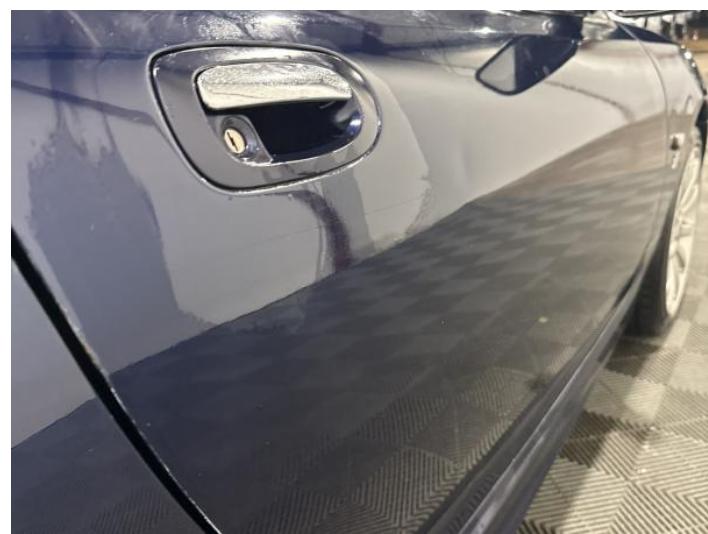
14: Door osr
Dented
Over 30mm

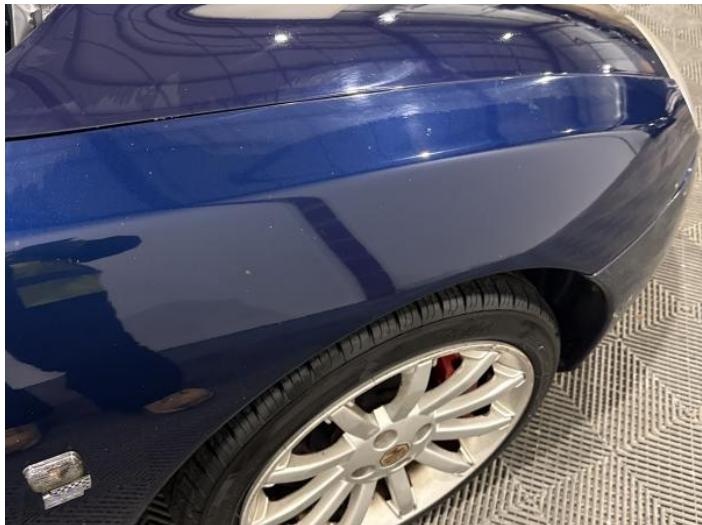
15: Wing osf
Chipped
Multiple Chips

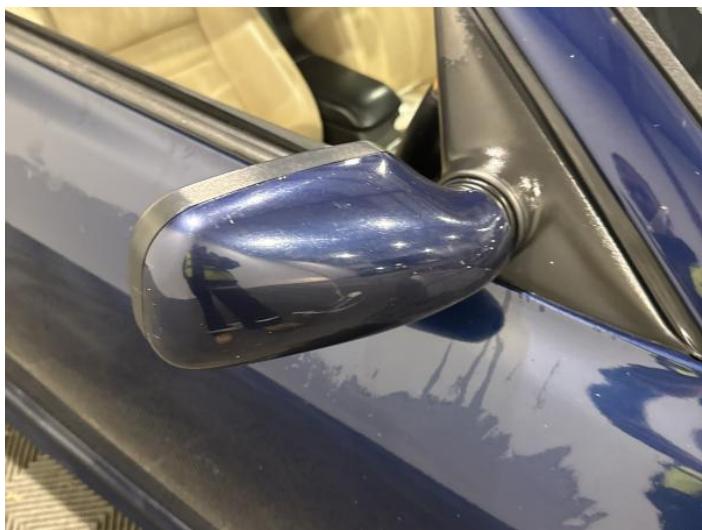
17: Door Mirror Assy osf
Scratched (Painted)
Over 25mm Thru Paint

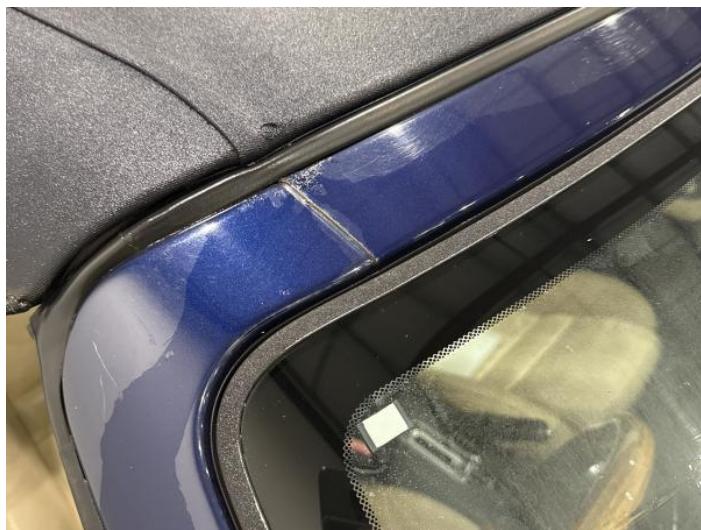
18: A Post os
Rusted
Over 5mm

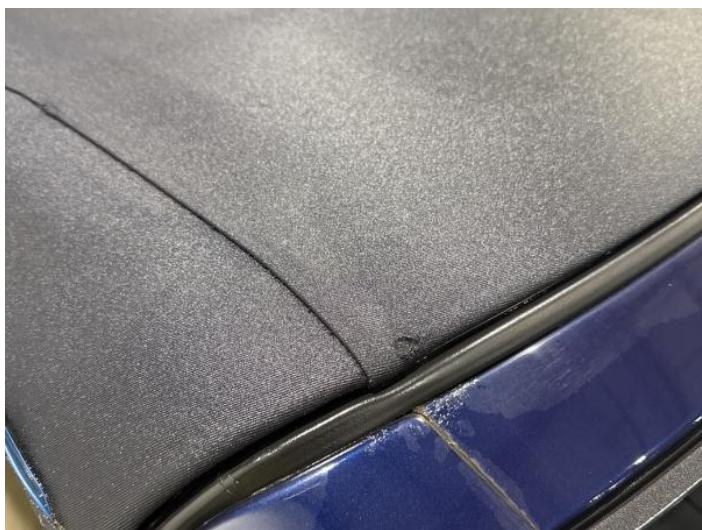
19: Roof Soft Top
Scuffed
Over 25mm

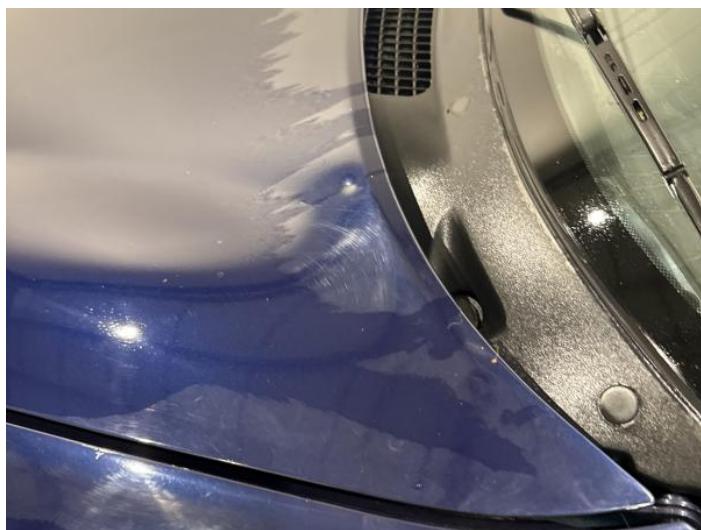
20: Bonnet
Dented
Between 10mm + 30mm
