VEHICLE INSPECTION REPORT

GP56PXK

Honda Jazz 1.4 i-DSi Sport 5dr CVT-7

Inspection	Vehicle		GRADE 5
Serious Damage?	VAT	Margin	
No	V5	Present

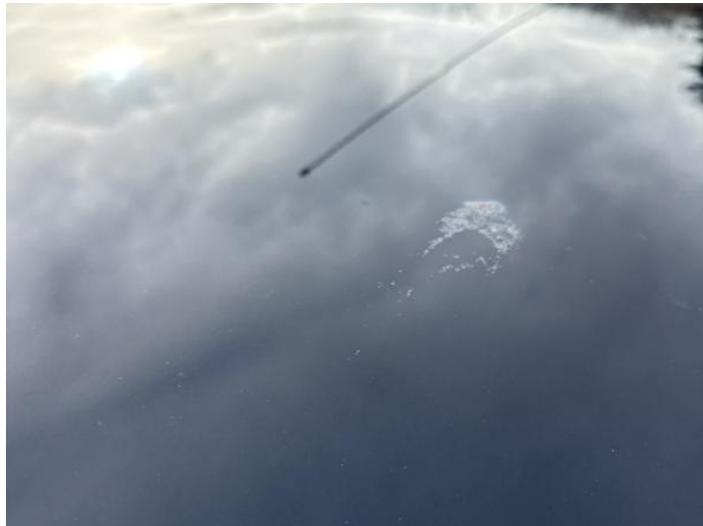
1: Roof
Dented
Between 10mm + 30mm

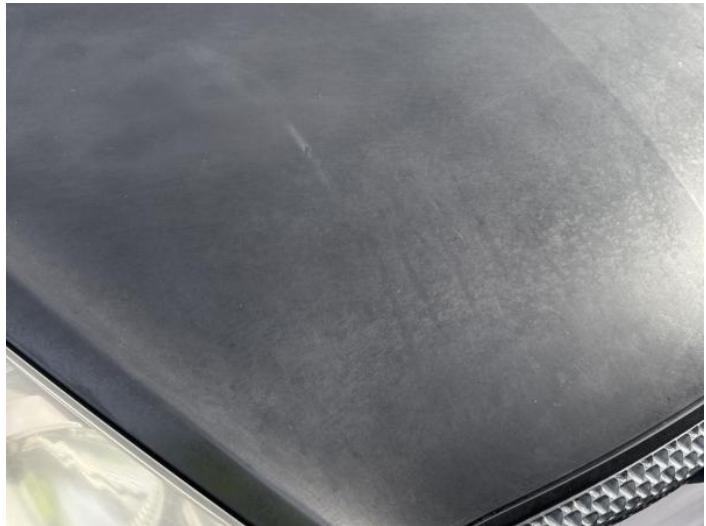
2: Bonnet
Poor Previous Repair
Paint Flake

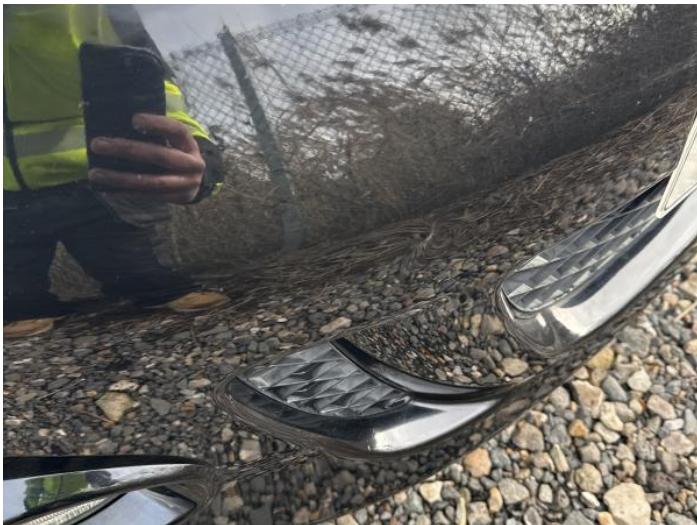
3: Bumper Front
Cracked
UpTo 25mm

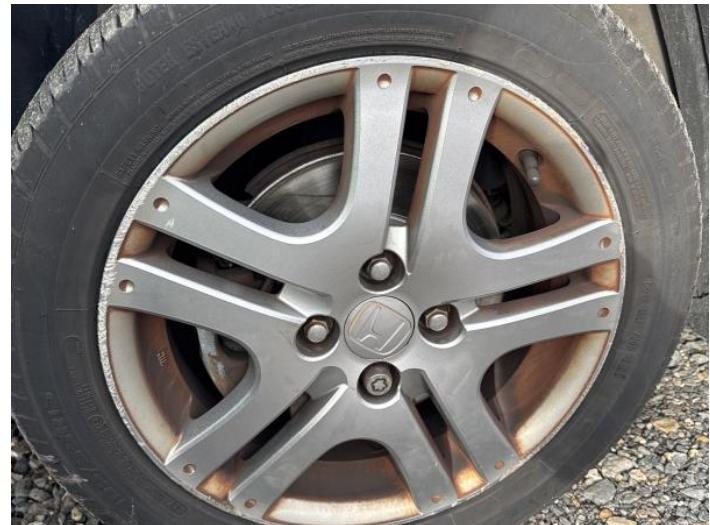
4: Wheel nsf
Scratched
Over 50mm

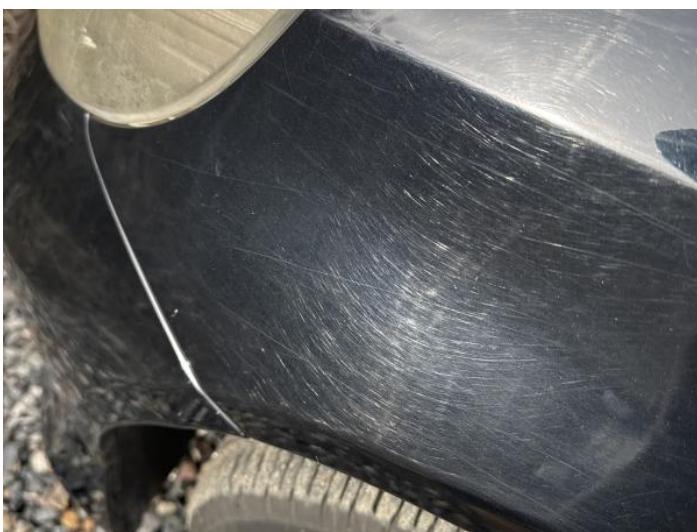
5: Wing nsf
Scratched
UpTo 25mm Thru Paint

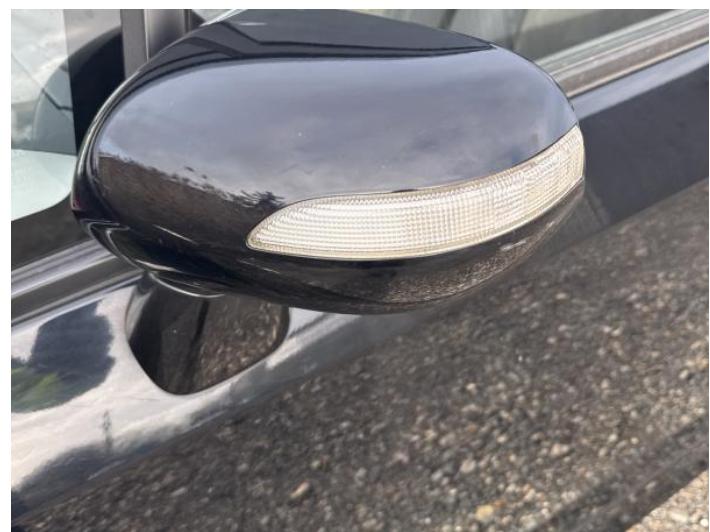
6: Door Mirror Assy nsf
Scratched (Painted)
UpTo 25mm Thru Paint

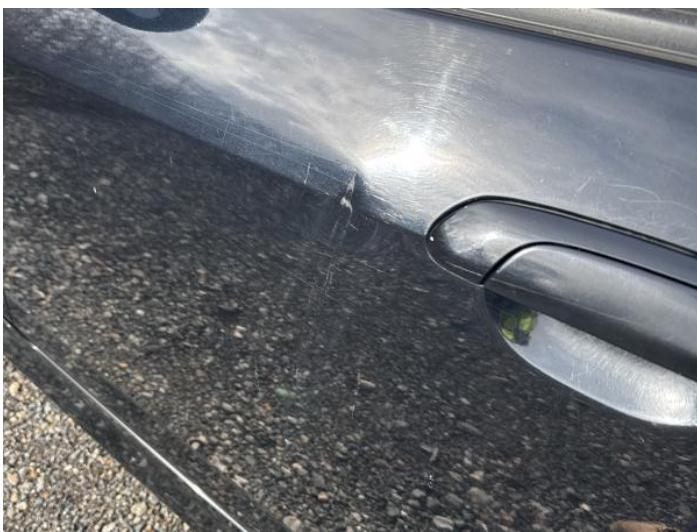
7: Door nsf
Dented
With Paint Damage

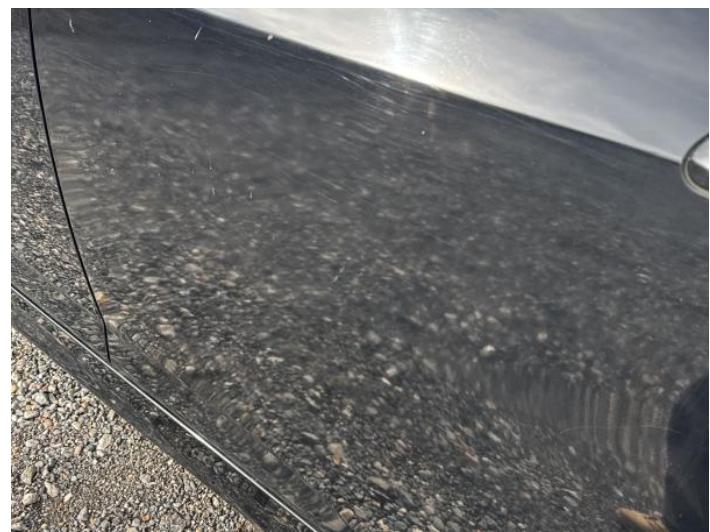
8: Door nsf
Poor Previous Repair
Poor Colour

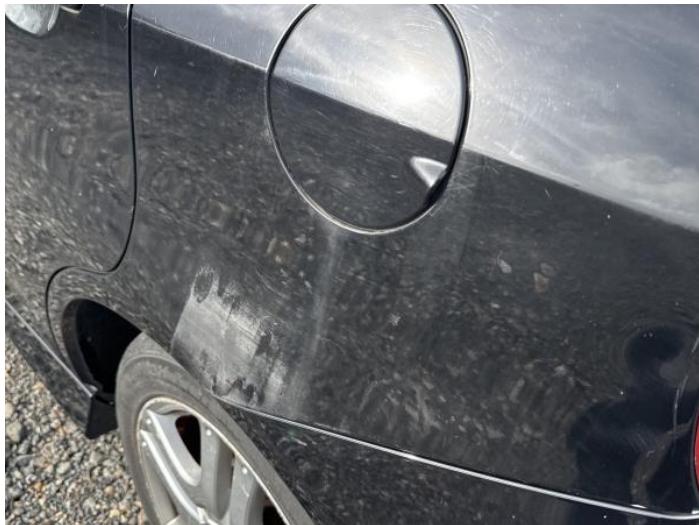
9: Qtr Panel nsr
Scratched
Over 25mm Thru Paint

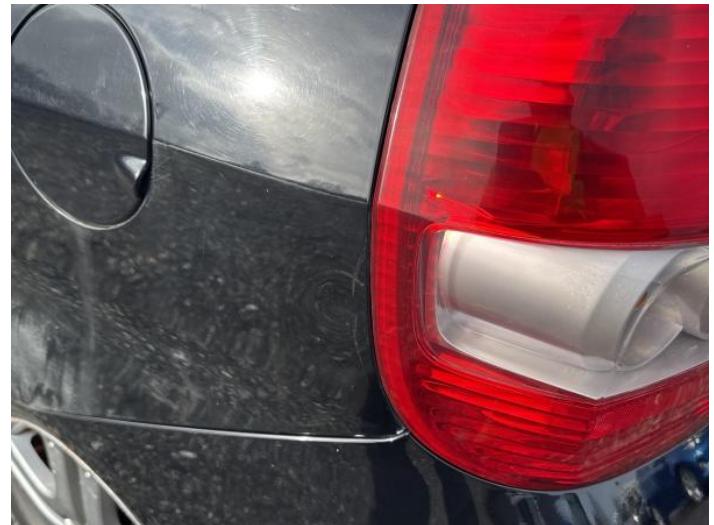
10: Qtr Panel nsr
Dented
Between 10mm + 30mm

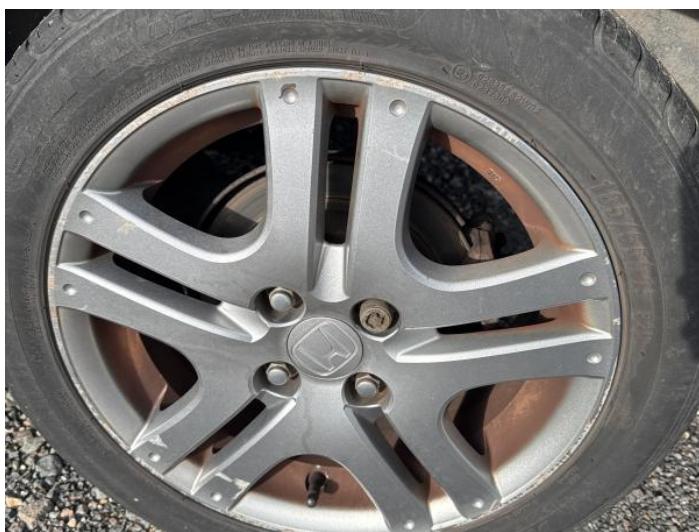
11: Wheel nsr
Scratched
Over 50mm

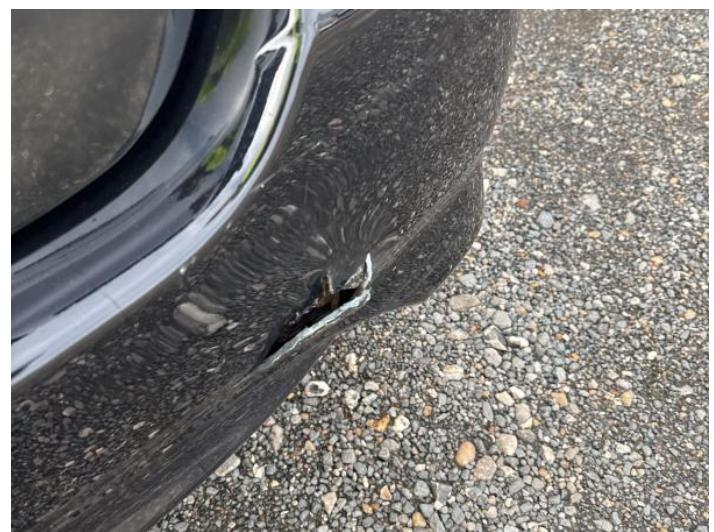
12: Bumper Rear
Cracked
Over 25mm

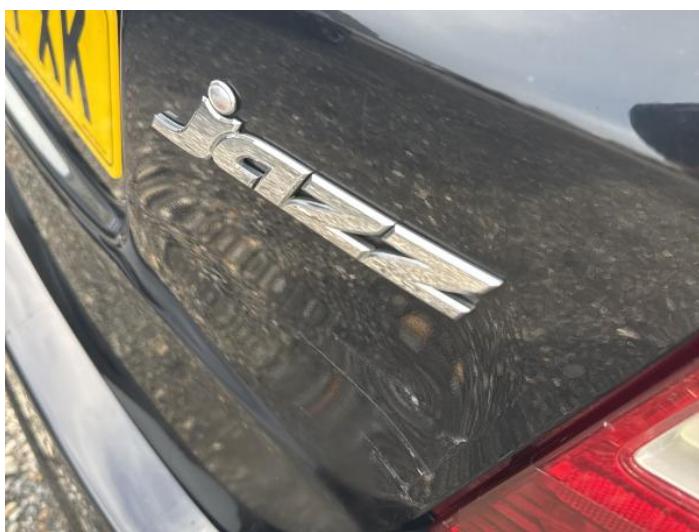
13: Tailgate
Dented
Over 30mm

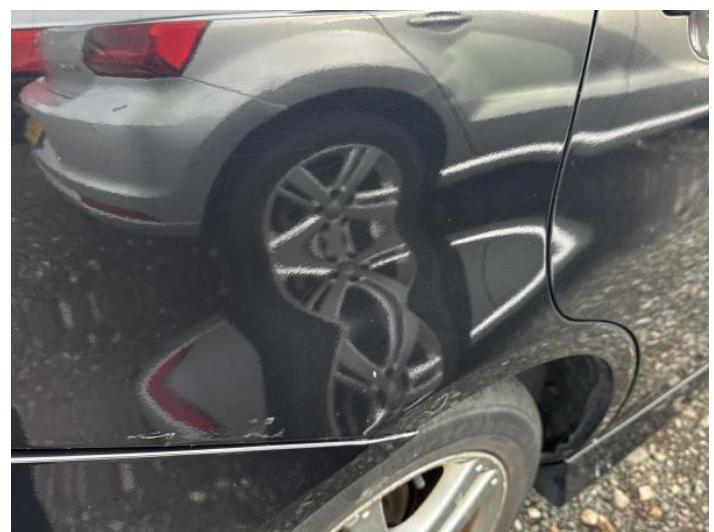
14: Qtr Panel osr
Scratched
Over 25mm Thru Paint

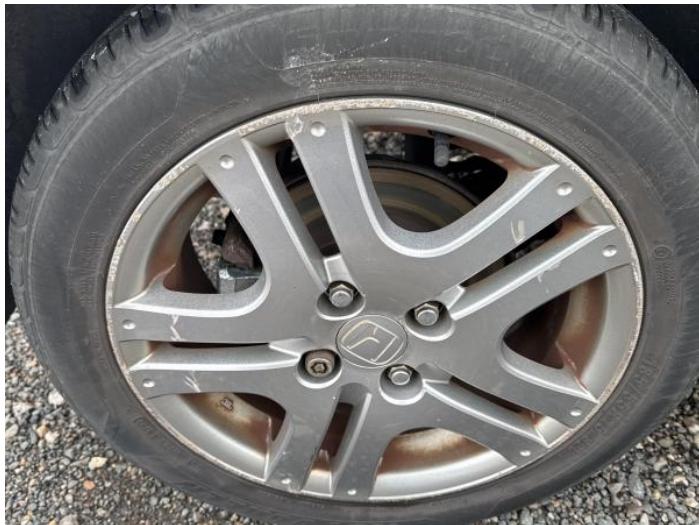
15: Wheel osr
Scratched
Over 50mm

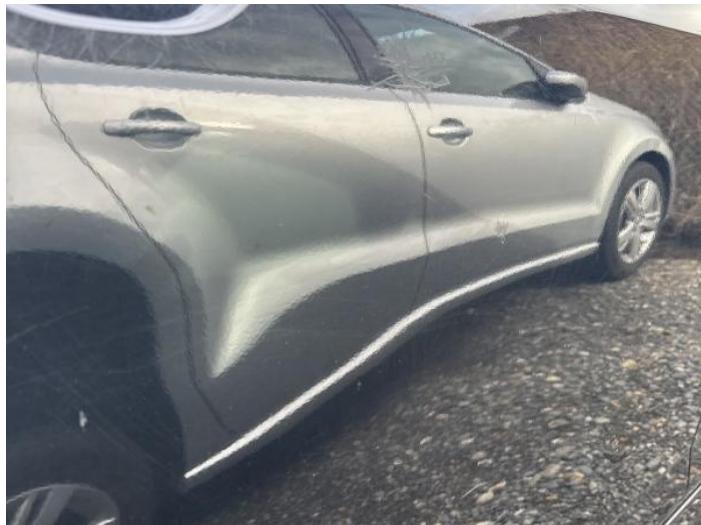
16: Door osr
Scratched
Over 25mm Thru Paint

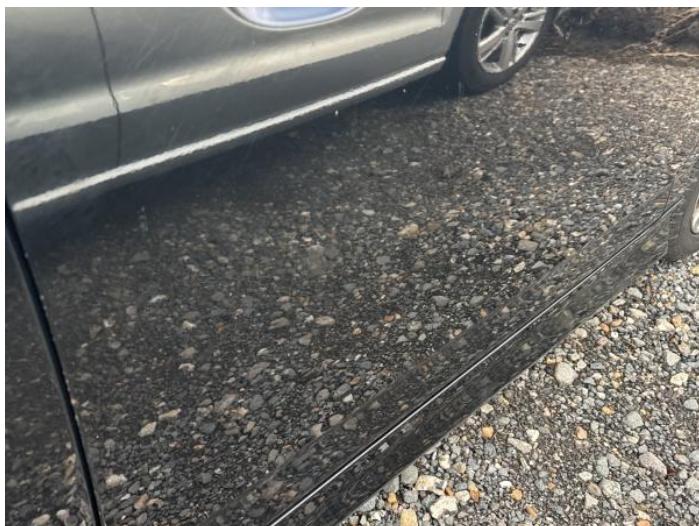
17: Door osf
Dented
Over 30mm

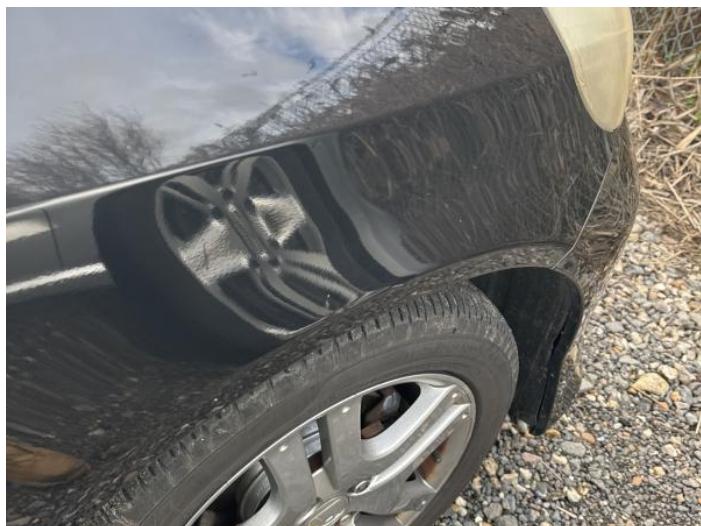
18: Wing osf
Scratched
Over 25mm Thru Paint

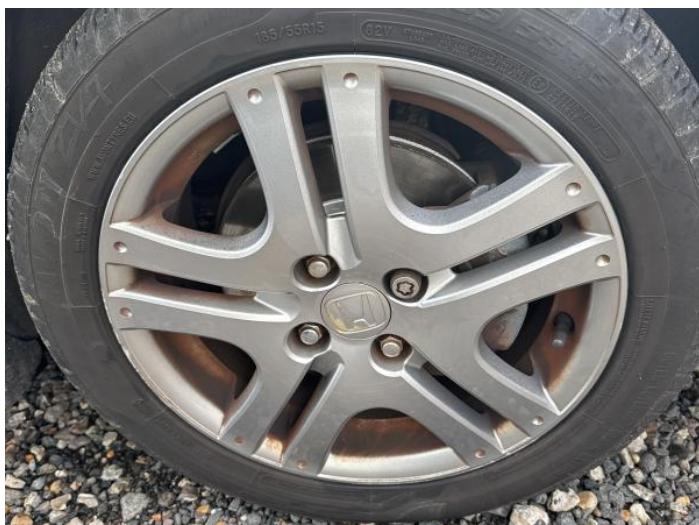
19: Wheel osf
Scratched
Over 50mm
