VEHICLE INSPECTION REPORT

GF18CYK

Nissan Qashqai 1.2 DiG-T Tekna+ 5dr Xtronic

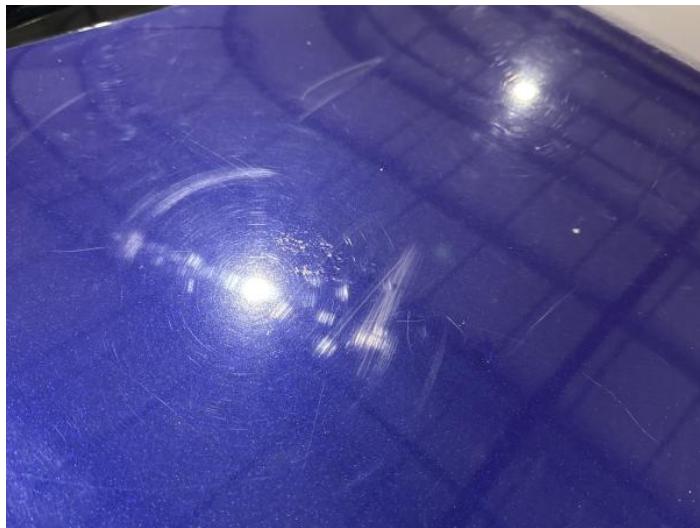
1: Bonnet
Scratched
Over 25mm Thru Paint

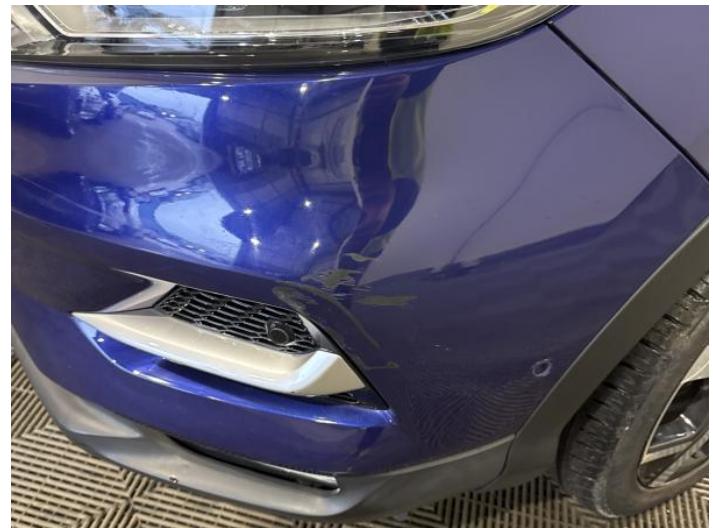
2: Bumper Front
Scratched
25 to 100mm Thru Paint

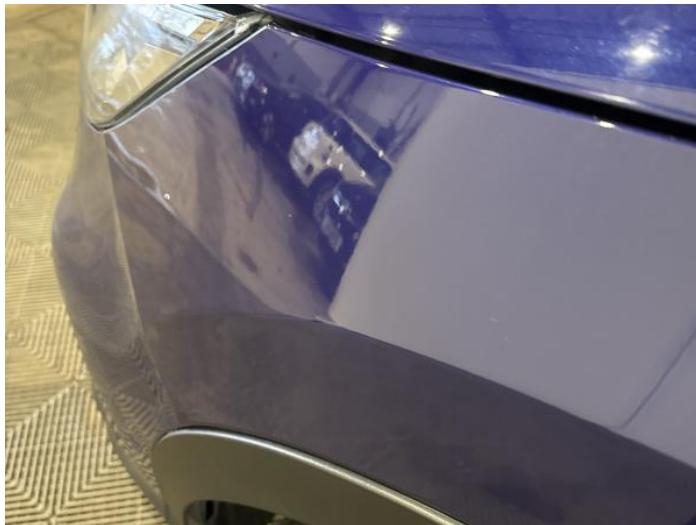
3: Wing nsf
Chipped
1 To 5

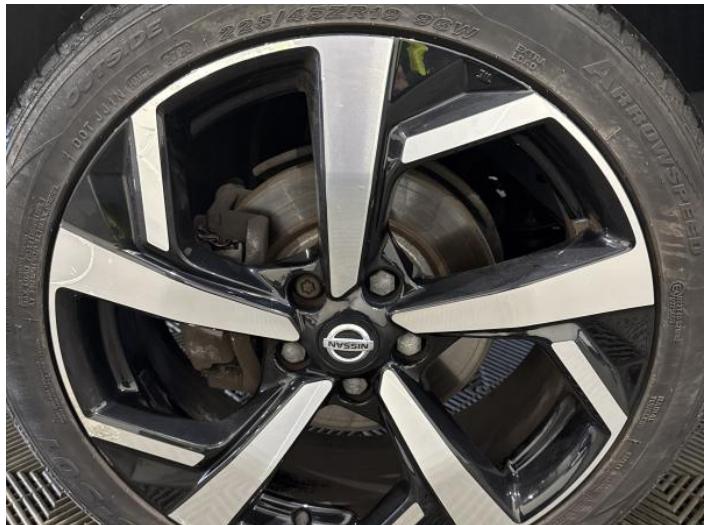
4: Wheel nsf
Scratched
Over 50mm

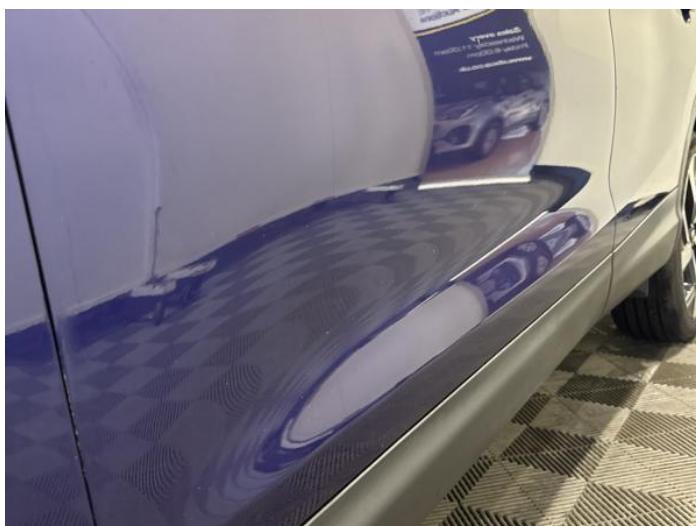
5: Door nsf
Dented
Over 30mm

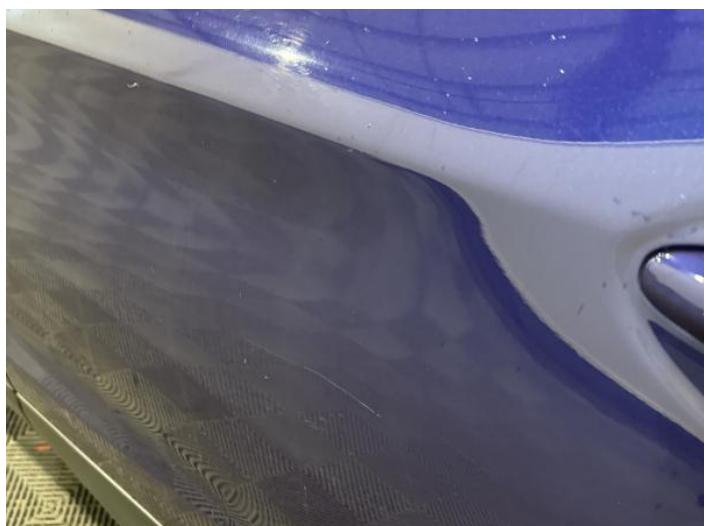
6: Door nsr
Scratched
Over 25mm Thru Paint

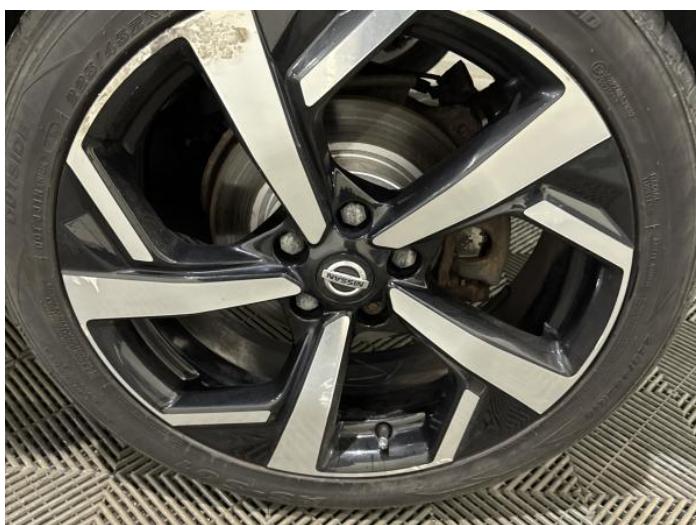
7: Wheel nsr
Scratched
Over 50mm

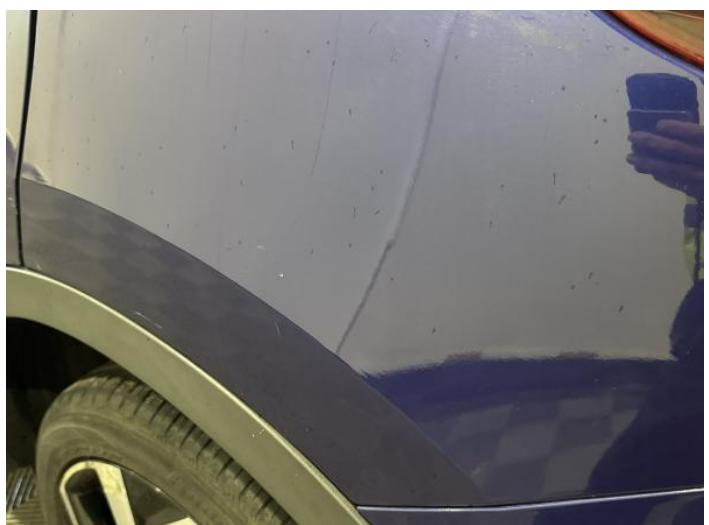
8: Qtr Panel nsr
Scratched
Over 25mm Thru Paint

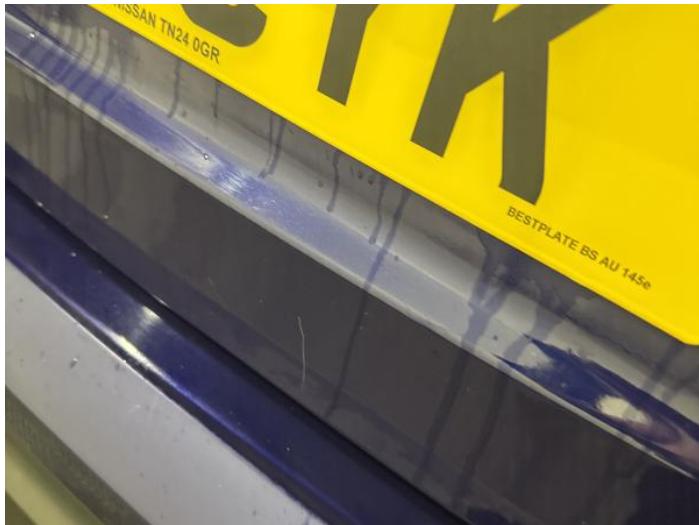
9: Tailgate
Scratched
UpTo 25mm Thru Paint

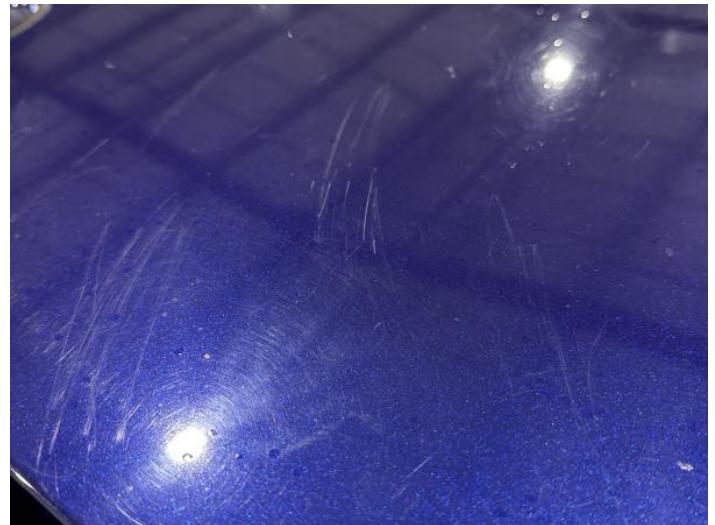
10: Roof
Scratched
Over 25mm Thru Paint

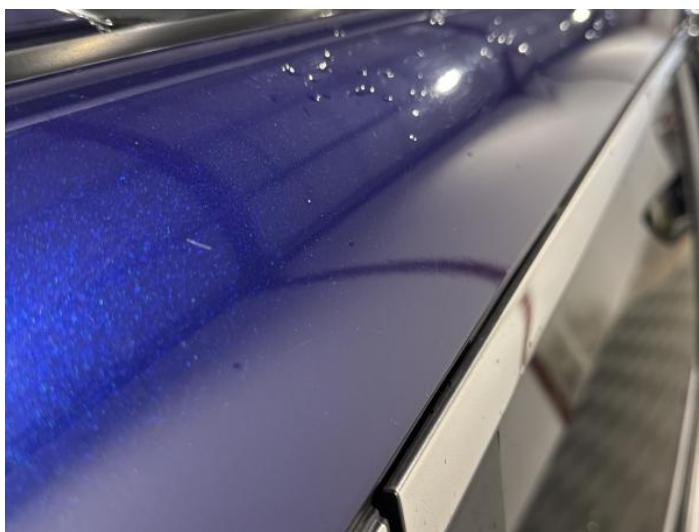
11: B Post osr
Dented
Over 30mm

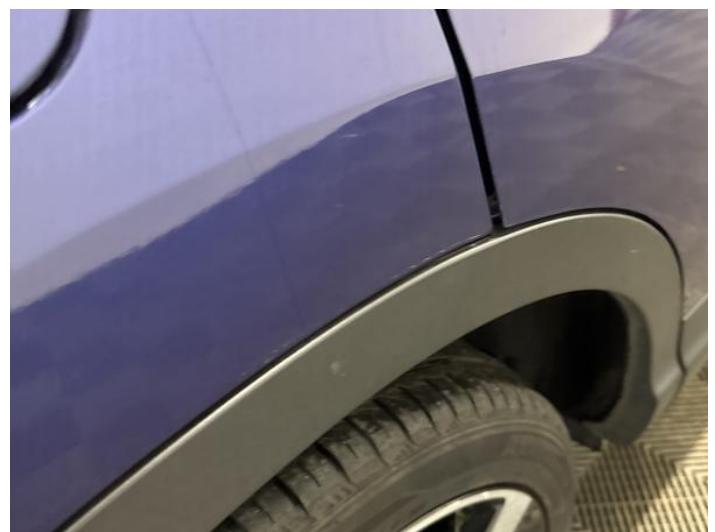
12: Qtr Panel osr
Scratched
Over 25mm Thru Paint

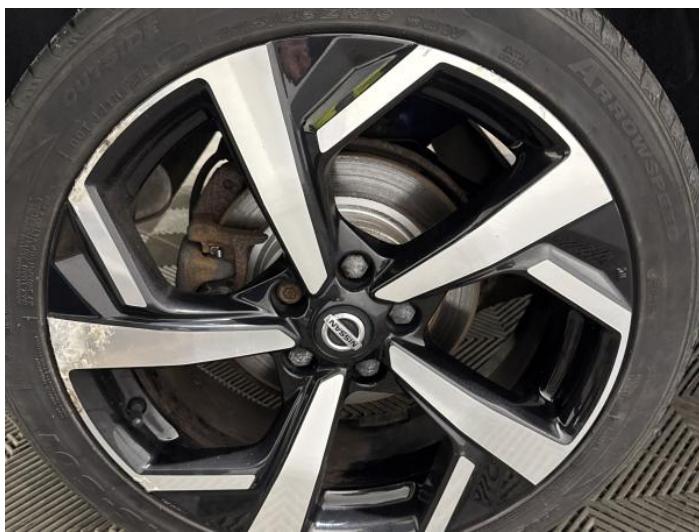
13: Wheel osr
Scratched
Over 50mm

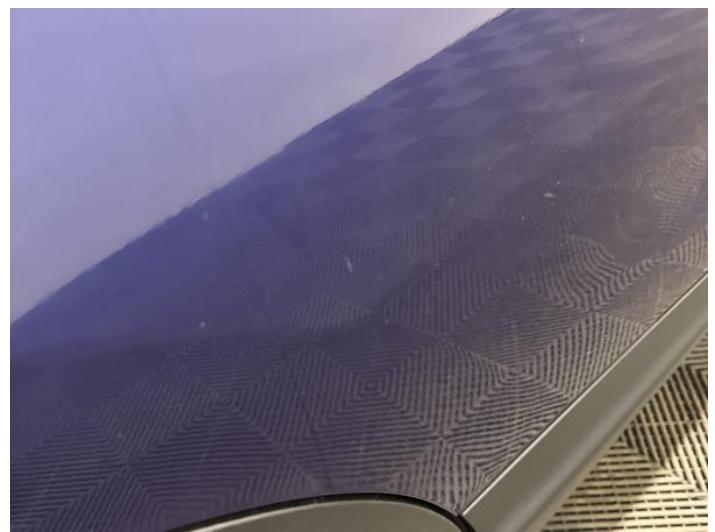
14: Door osr
Scratched
UpTo 25mm Thru Paint

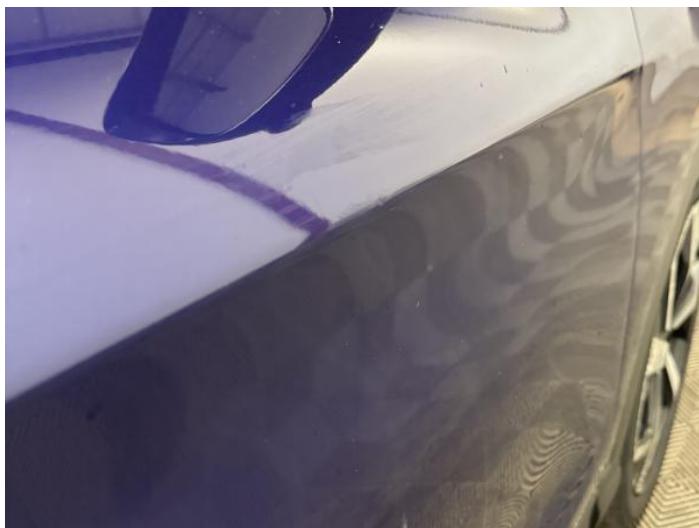
15: Door osf
Dented
Between 10mm + 30mm

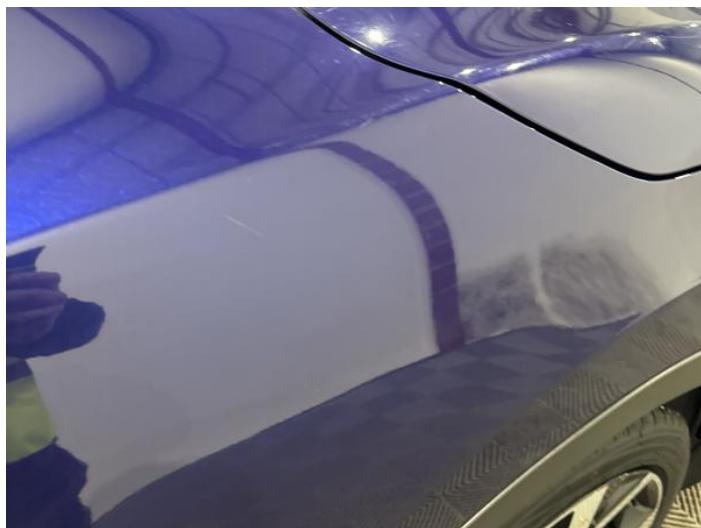
16: Wing osf
Scratched
UpTo 25mm Thru Paint

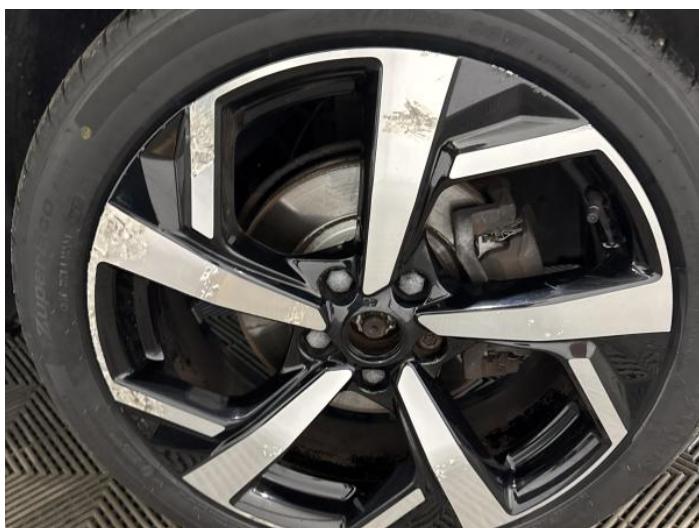
17: Wheel osf
Scratched
Over 50mm
