VEHICLE INSPECTION REPORT

DN69LMF

Vauxhall Astra 1.4T 16V 150 SRi Vx-line Nav 5dr

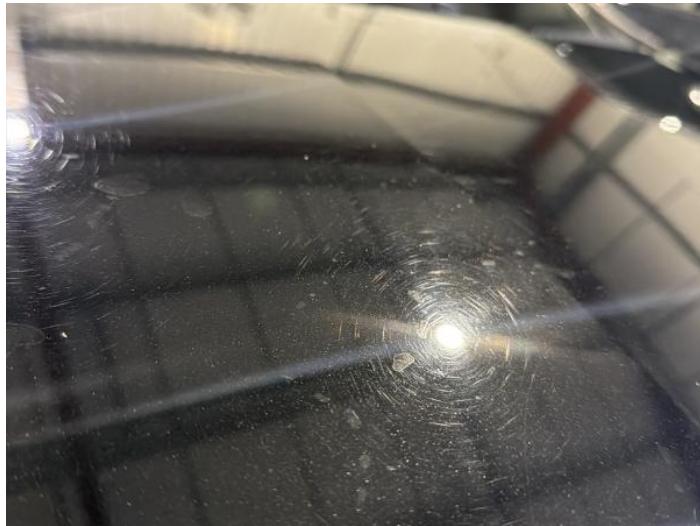
1: Bonnet
Dented
Over 30mm

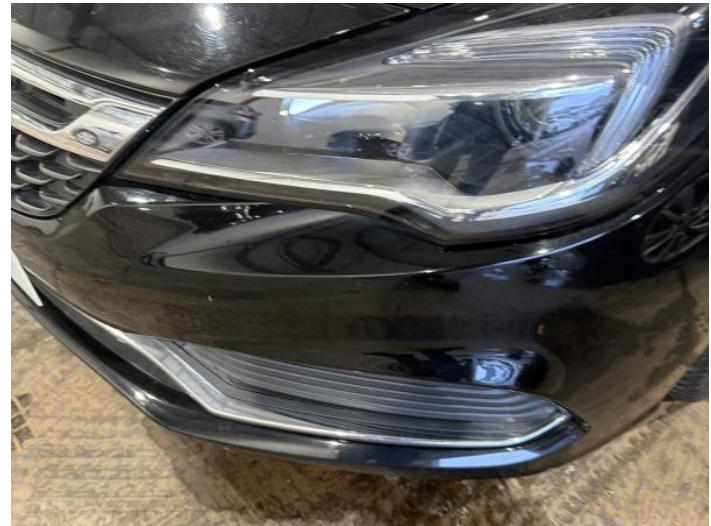
2: Bumper Front
Chipped
Multiple Chips

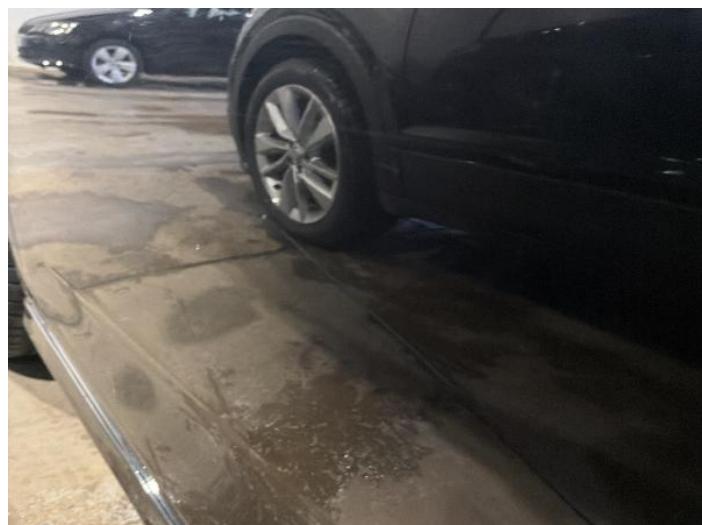
7: Door nsf
Chipped
1 To 5

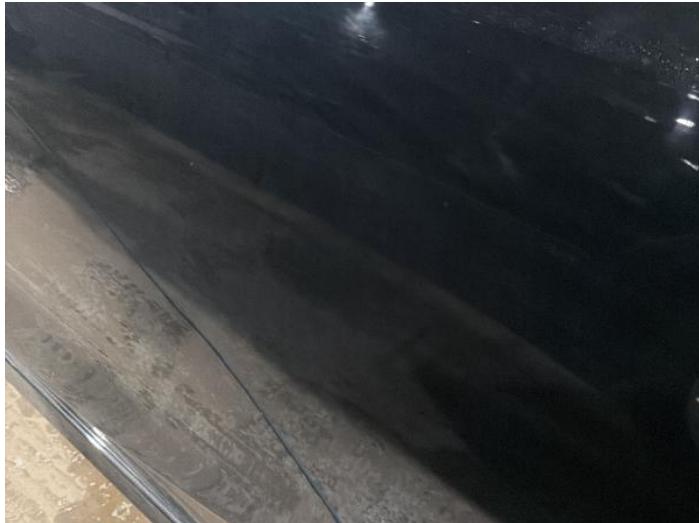
9: Door nsr
Chipped
Multiple Chips

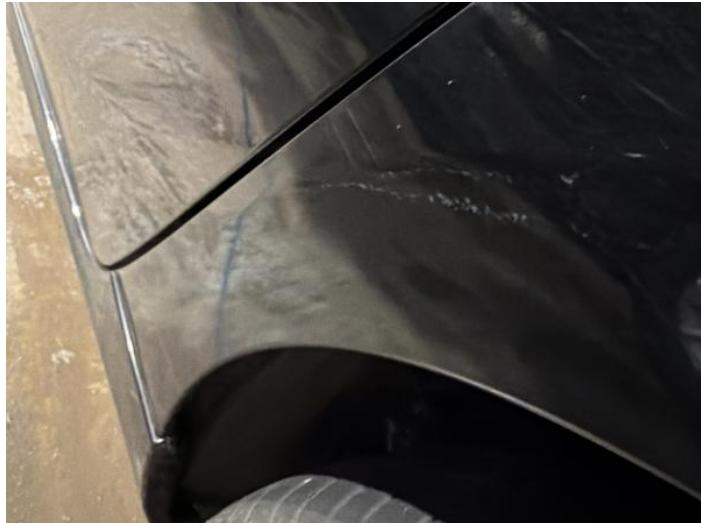
10: Qtr Panel nsr
Dented
Over 2 UpTo 10mm

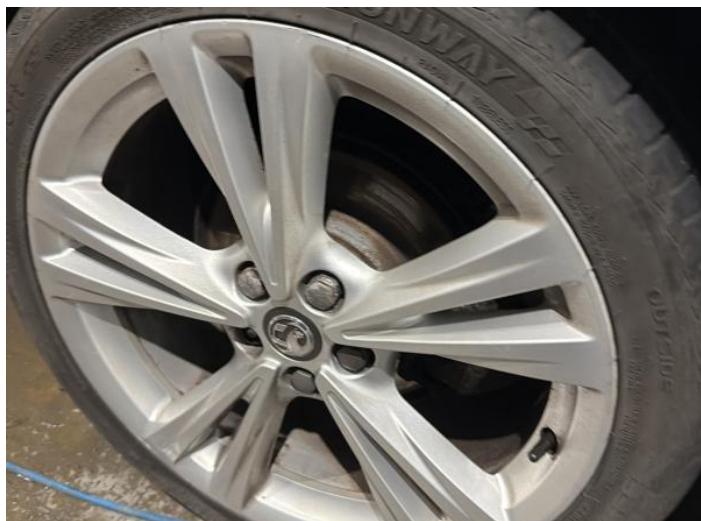
12: Wheel nsr
Scratched
Over 50mm

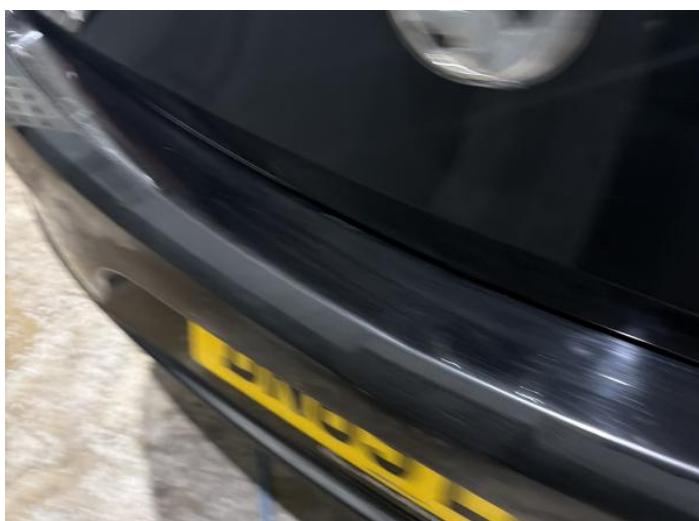
13: Bumper Rear
Chipped
Multiple Chips

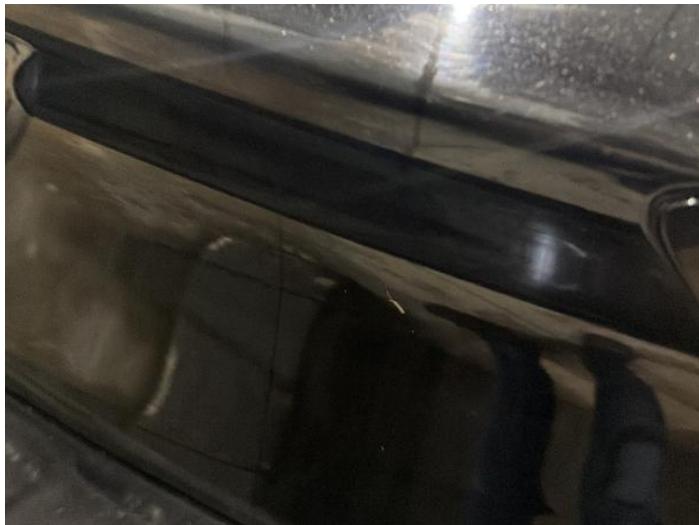
15: Boot Lid
Chipped
1 To 5

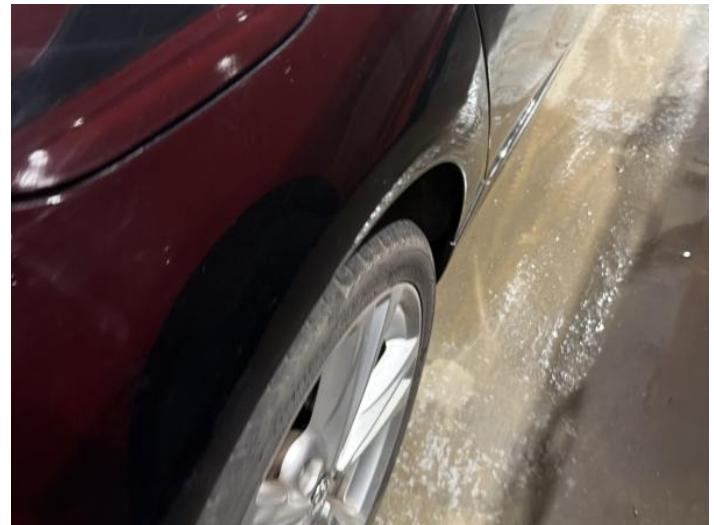
16: Qtr Panel osr
Dented
2 Or Less UpTo 10mm

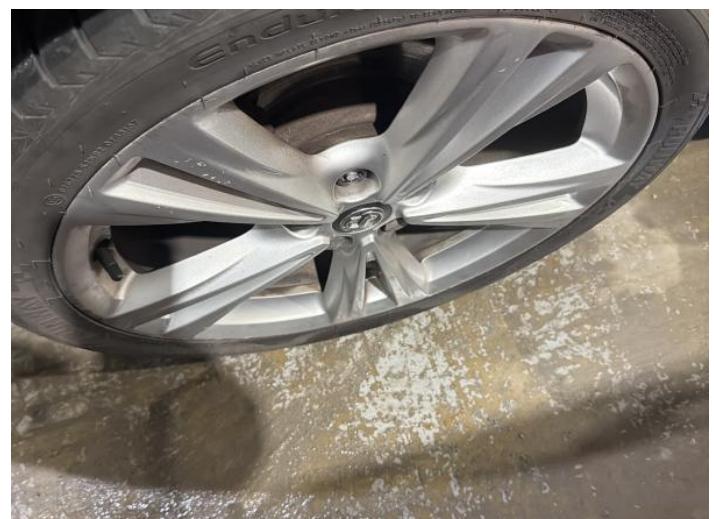
18: Wheel osr
Scratched
Over 50mm

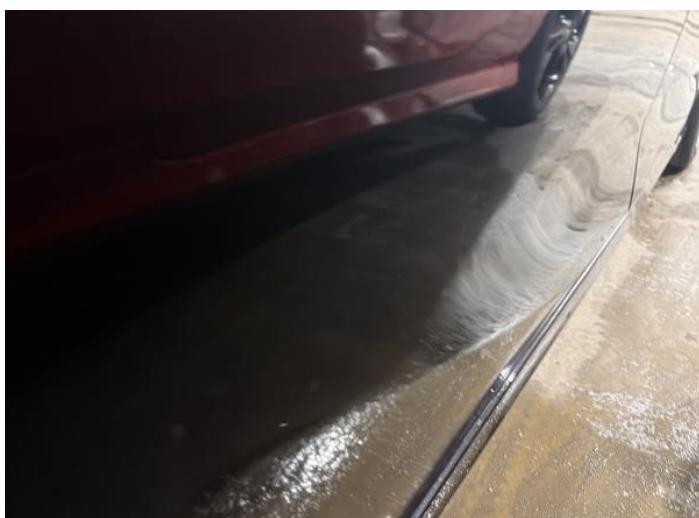
19: Door osr
Poor Previous Repair
Poor Paint

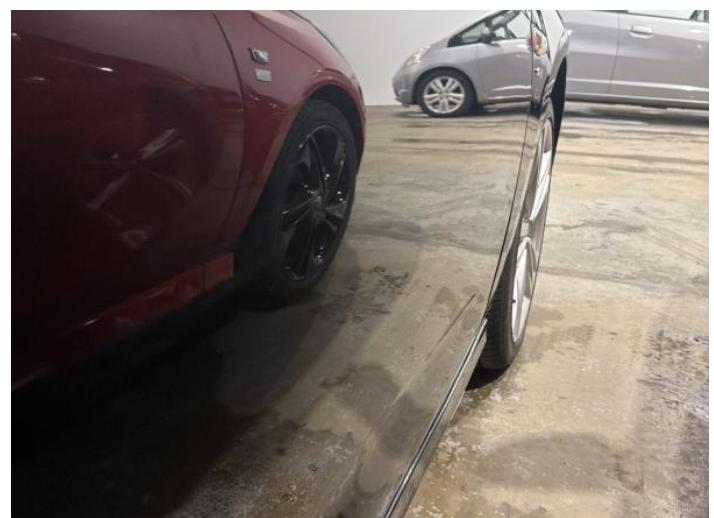
20: Door osf
Dented
Over 2 UpTo 10mm

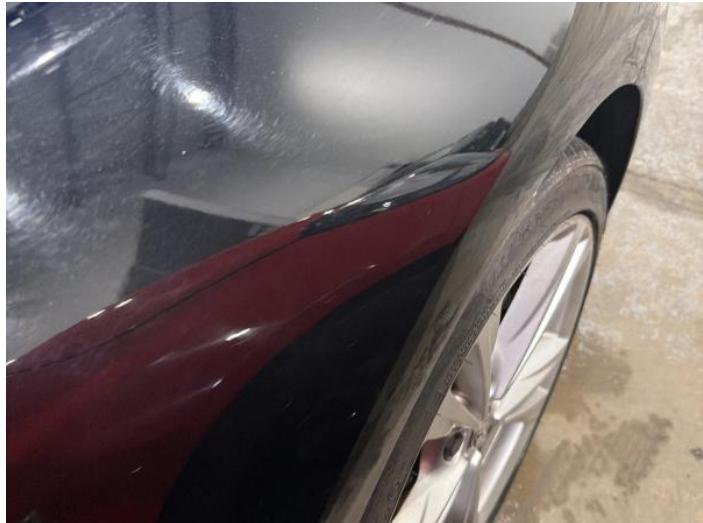
21: Door osf
Scratched
Over 25mm Not Thru Paint

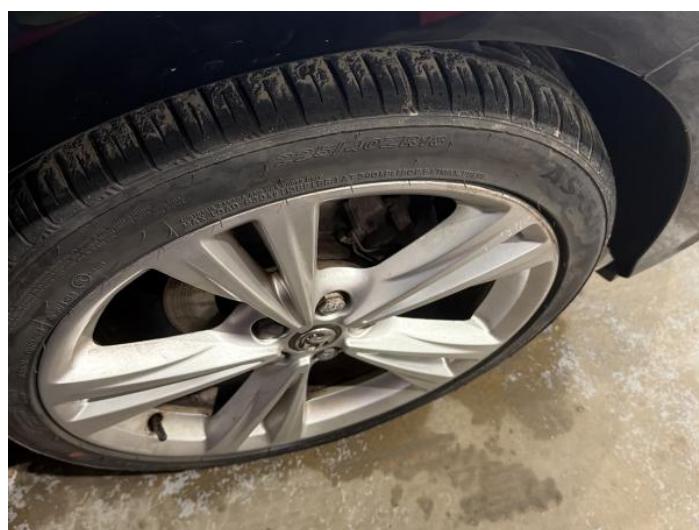
23: Wheel osf
Scratched
Up To 50mm
