VEHICLE INSPECTION REPORT

KN66RLV

Nissan Qashqai 1.2 DiG-T Tekna [Non-Panoramic] 5dr

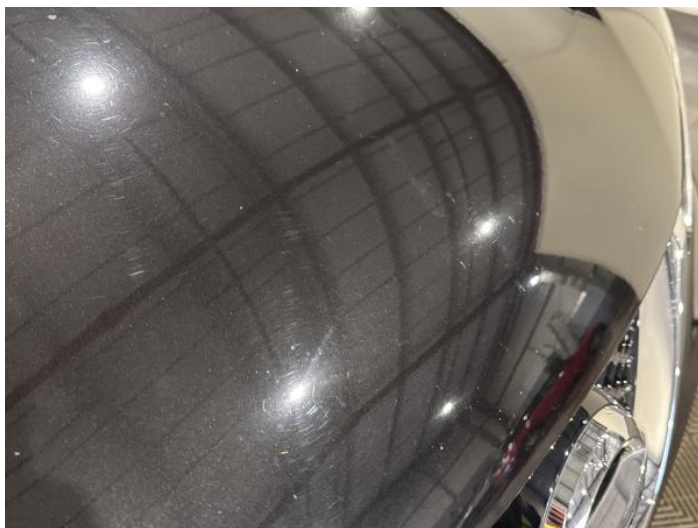
1: Bonnet
Chipped
Multiple Chips

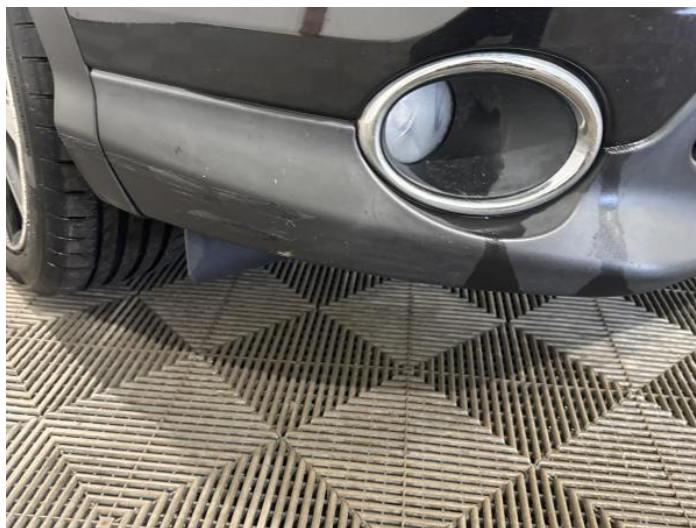
2: Bumper Front Moulding
Scuffed (Unpainted)
Over 100mm

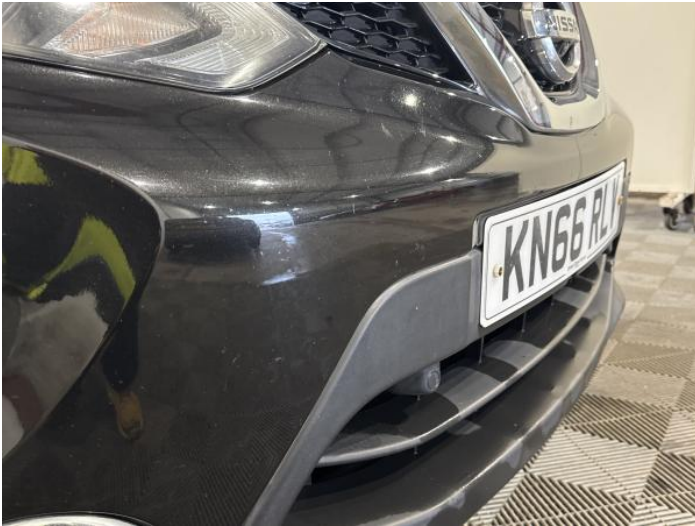
3: Bumper Front
Chipped
Multiple Chips

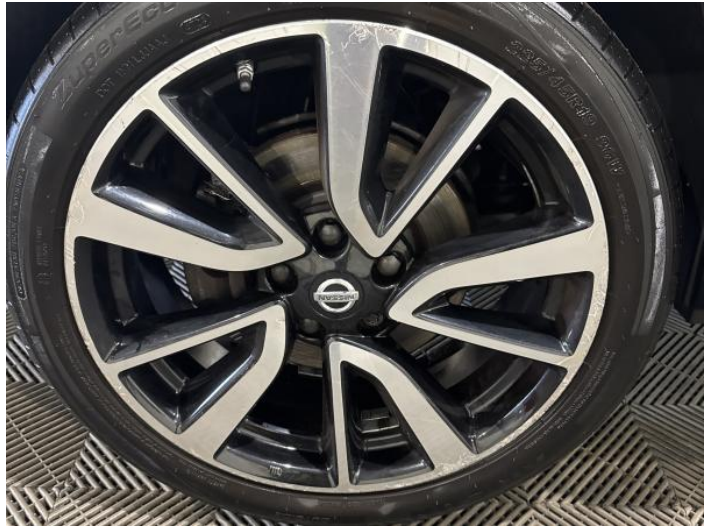
4: Wheel nsf
Scratched
Over 50mm

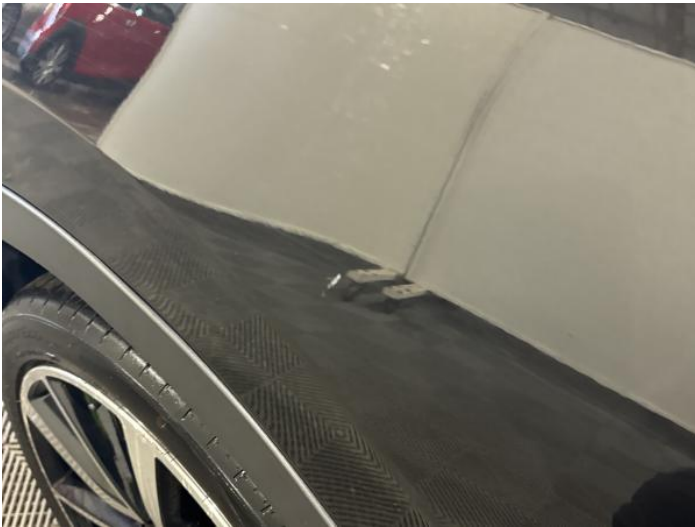
5: Wing nsf
Scratched
UpTo 25mm Thru Paint

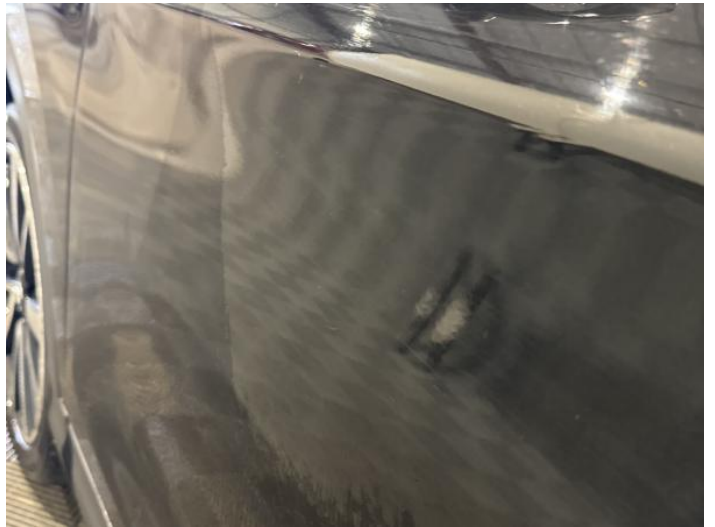
6: Door nsf
Scratched
Over 25mm Thru Paint

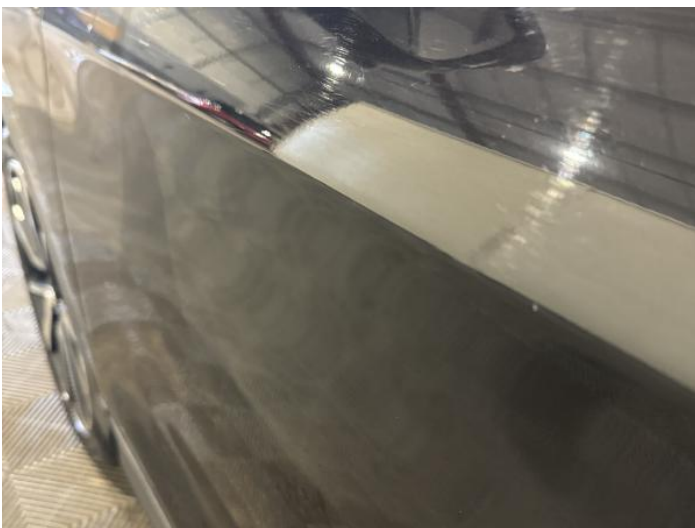
7: Door nsf
Dented
Between 10mm + 30mm

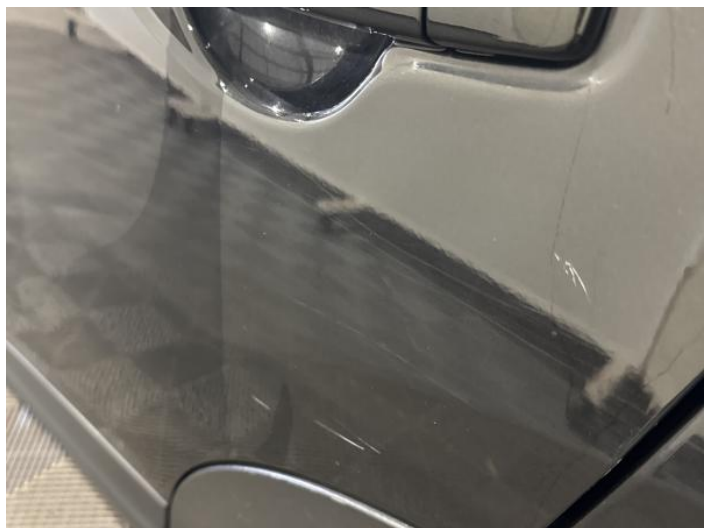
8: Door nsr
Scratched
Over 25mm Thru Paint

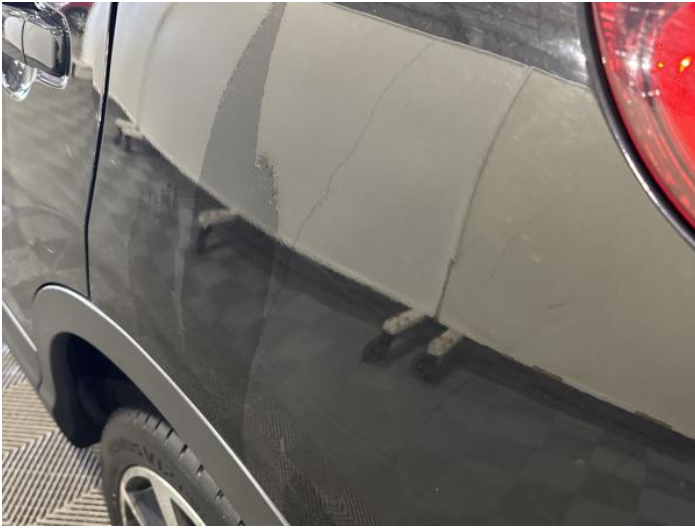
9: Qtr Panel nsr
Scratched
Over 25mm Thru Paint

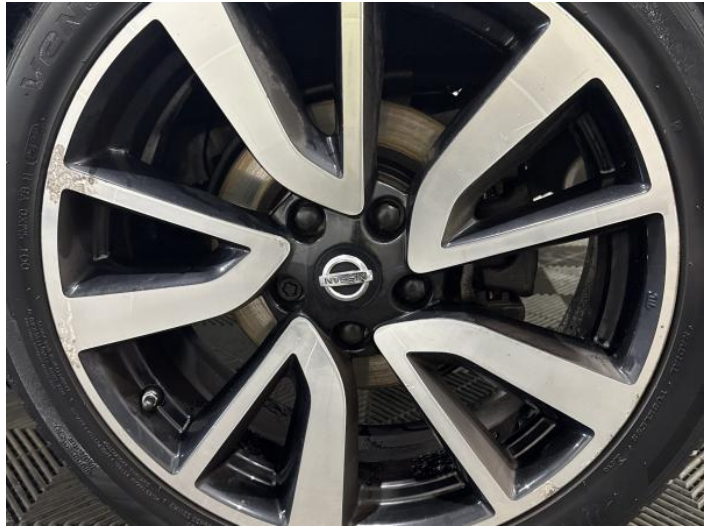
10: Wheel nsr
Scratched
Over 50mm

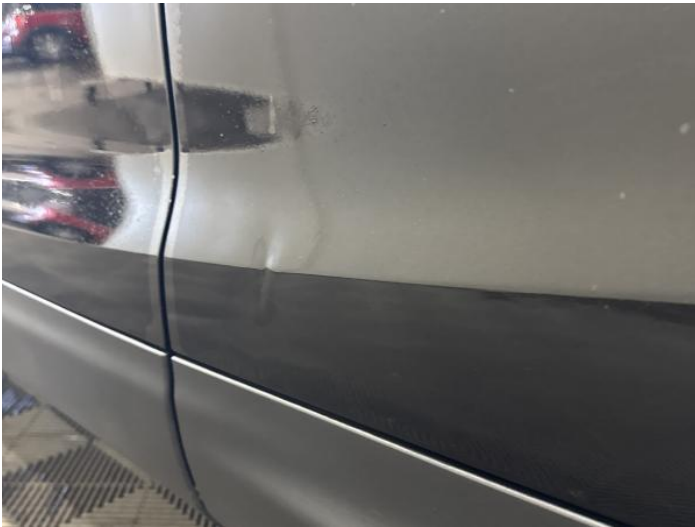
11: Door nsr
Dented
Over 30mm

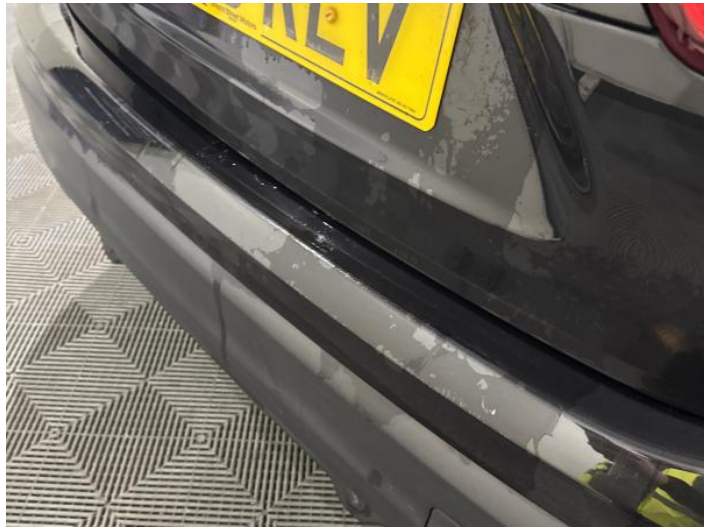
12: Bumper Rear
Scratched
25 to 100mm Thru Paint

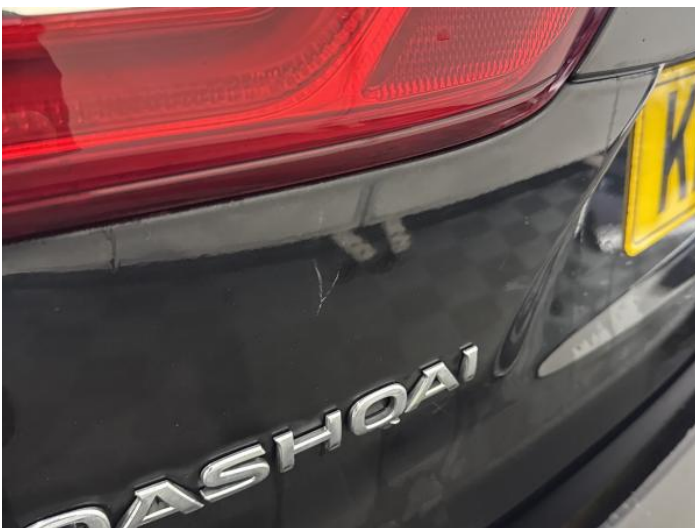
13: Tailgate
Scratched
UpTo 25mm Thru Paint

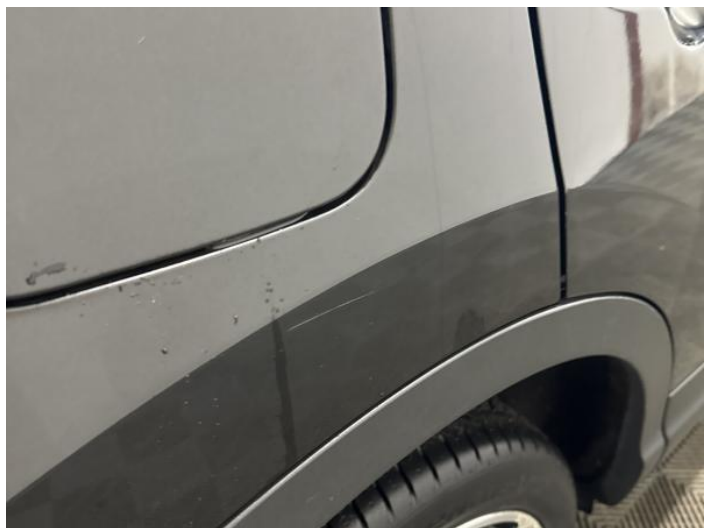
14: Qtr Panel osr
Scratched
Over 25mm Thru Paint

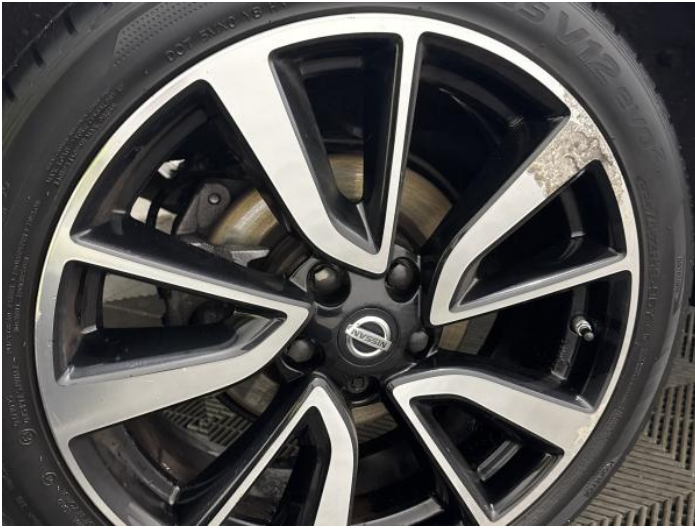
15: Wheel osr
Corroded
Light

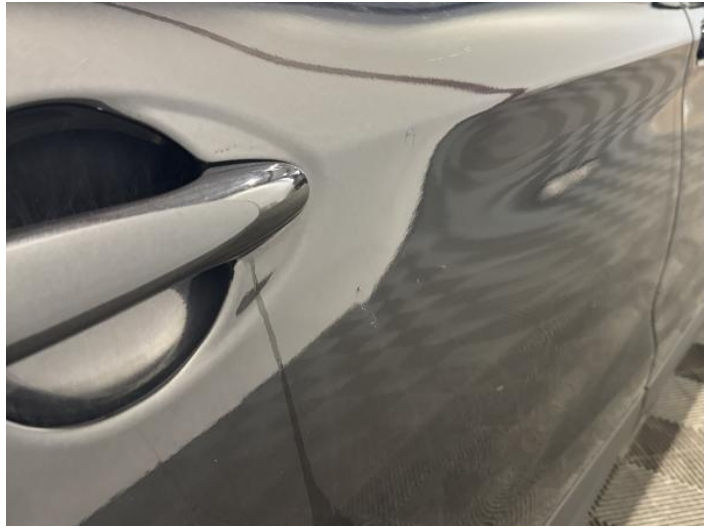
16: Door osr
Dented
Between 10mm + 30mm

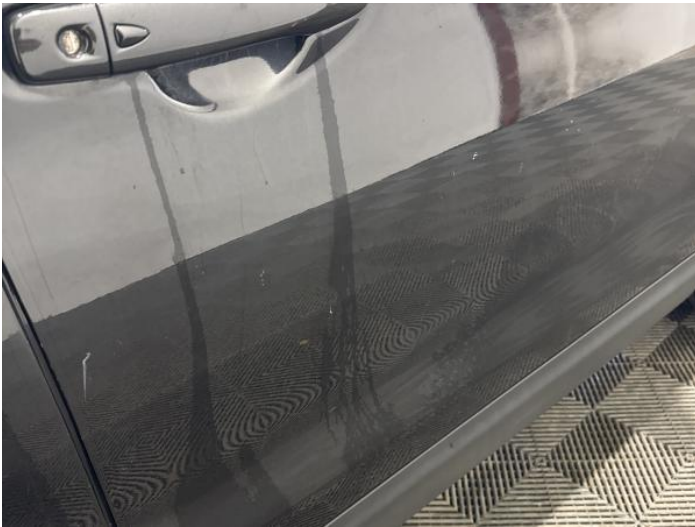
17: Door osf
Scratched
Over 25mm Thru Paint

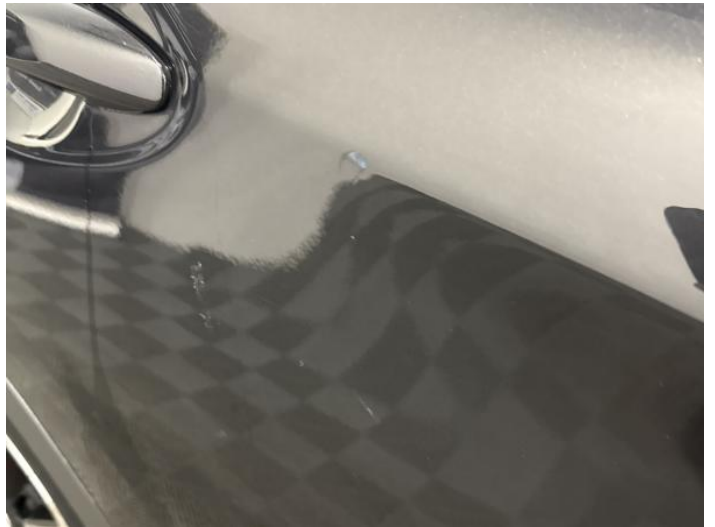
18: Door osr
Scratched
UpTo 25mm Thru Paint

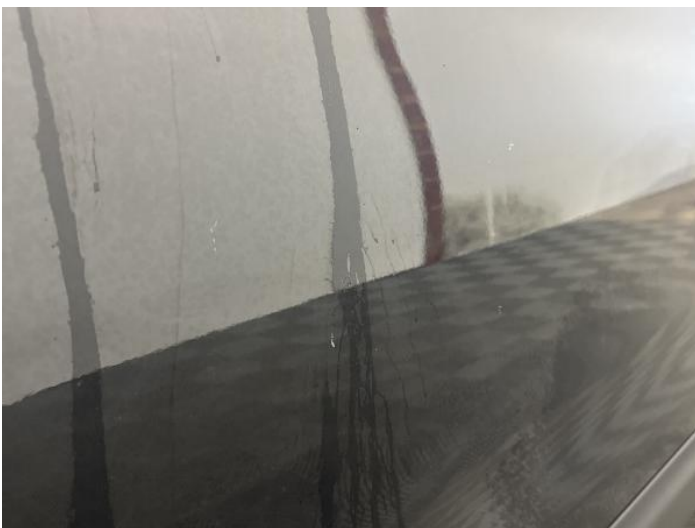
19: Door osf
Dented
Over 30mm

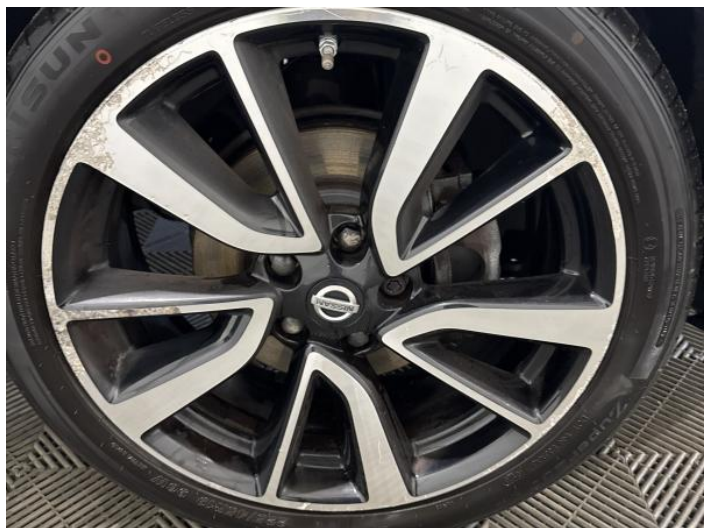
20: Wheel osf
Scratched
Over 50mm

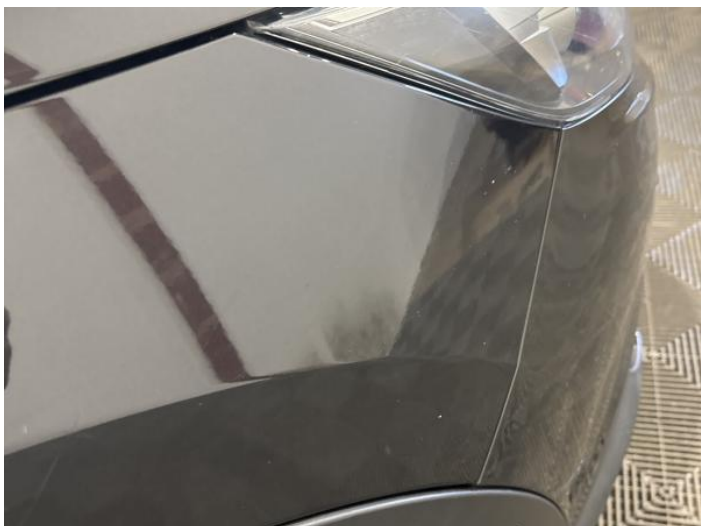
21: Wing osf
Chipped
1 To 5
