VEHICLE INSPECTION REPORT

SE18WWV

Ford Kuga 1.5 TDCi ST-Line X 5dr Auto 2WD

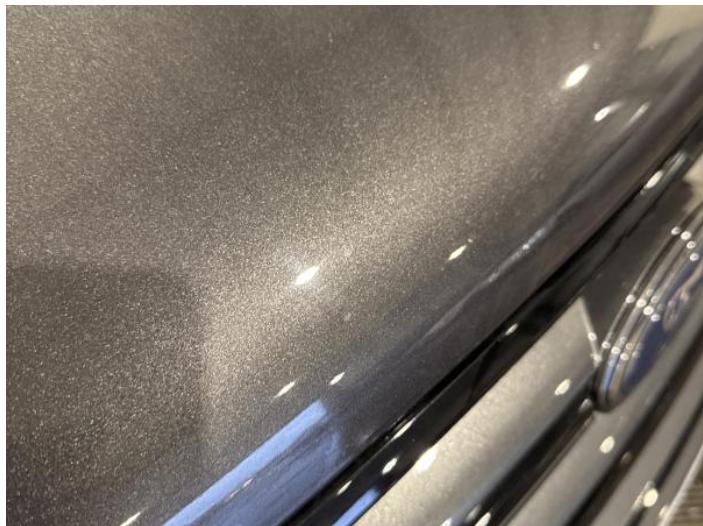
1: Bonnet
Chipped
1 To 5

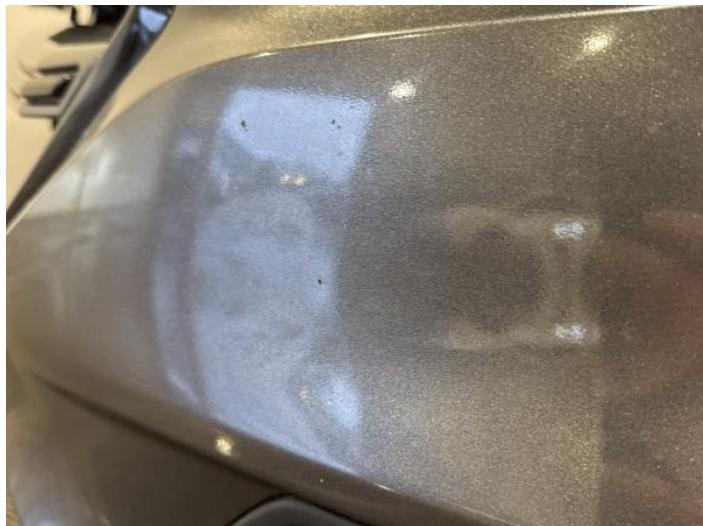
2: Bumper Front
Poor Previous Repair
Poor Colour

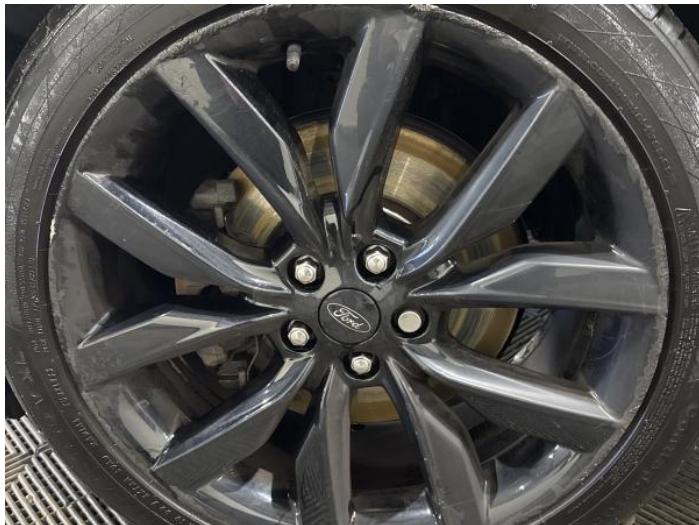
3: Wheel nsf
Scratched
Over 50mm

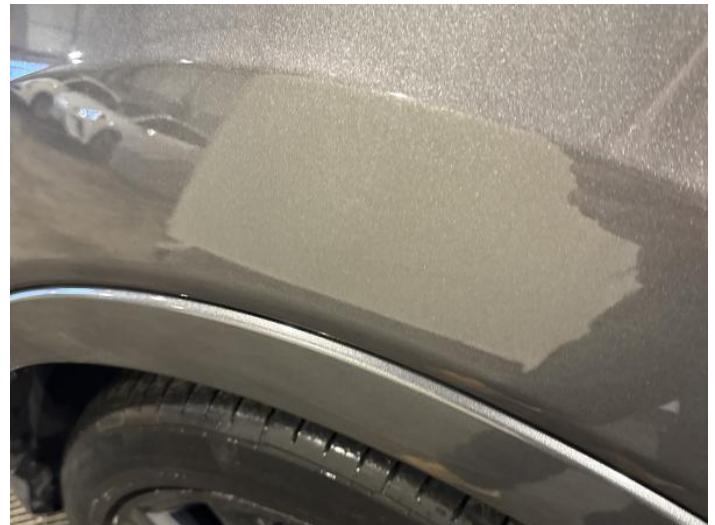
4: Wing nsf
Scratched
UpTo 25mm Thru Paint

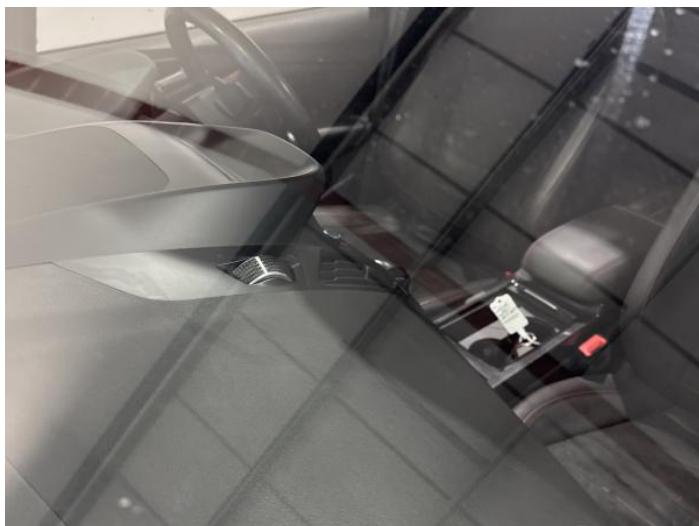
5: Screen Front
Chipped
UpTo 10mm

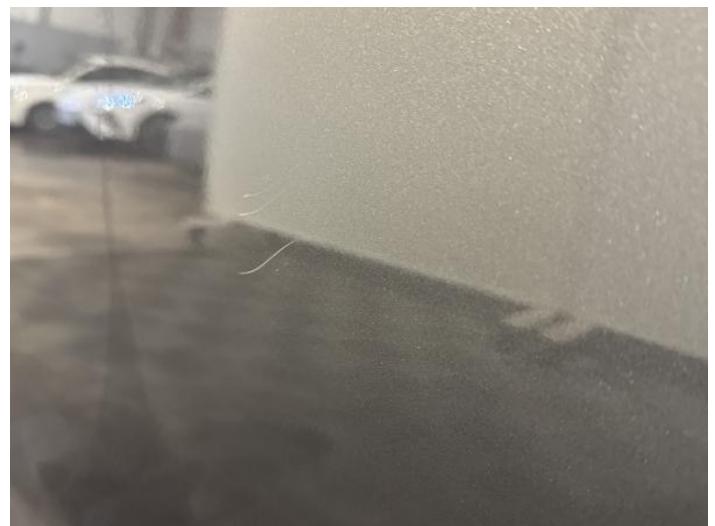
6: Door nsf
Scratched
Over 25mm Thru Paint

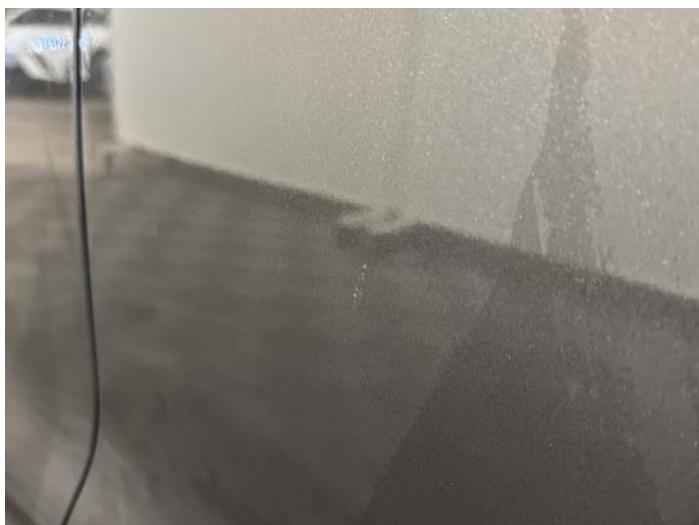
7: Door nsr
Scratched
UpTo 25mm Thru Paint

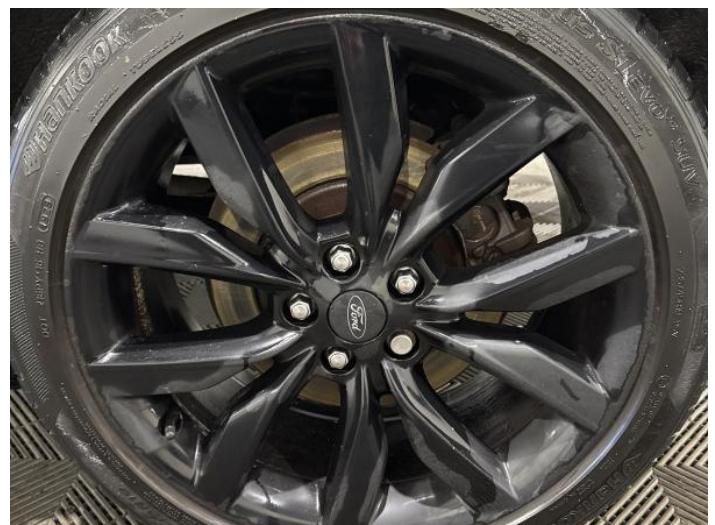
8: Wheel nsr
Scratched
Over 50mm

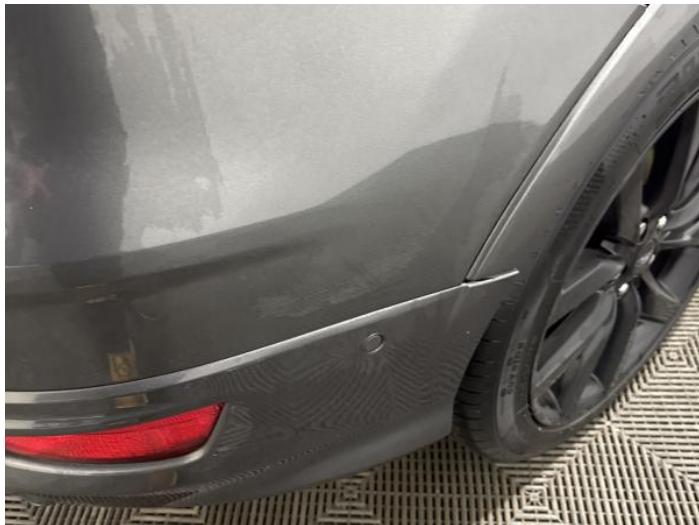
9: Bumper Rear
Scratched
25 to 100mm Thru Paint

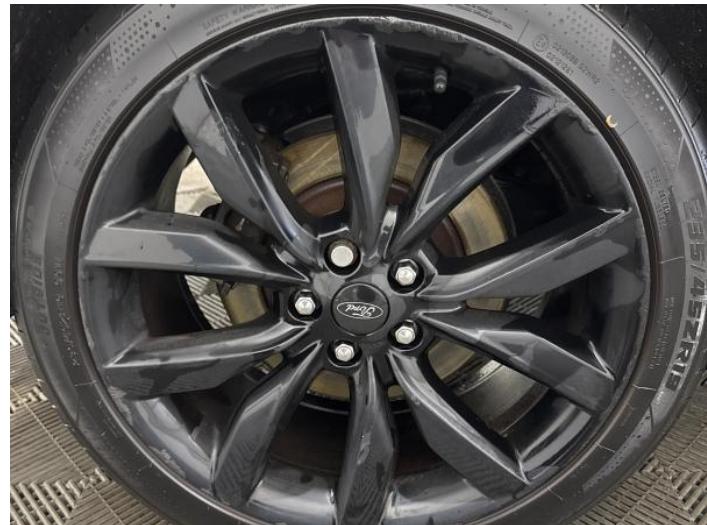
10: Wheel osr
Scratched
Over 50mm

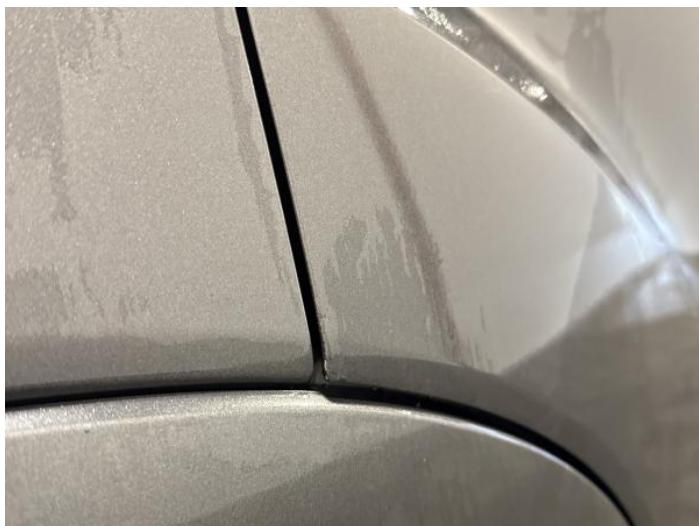
11: Door osr
Chipped
Edge Chip

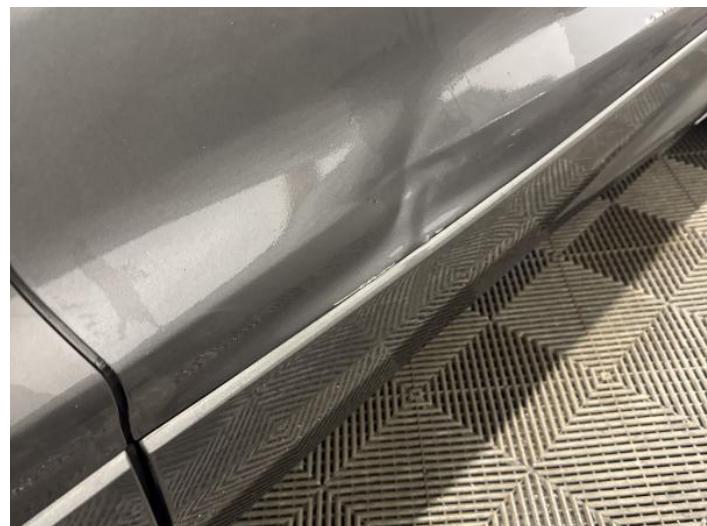
12: Door osf
Dented
Over 30mm

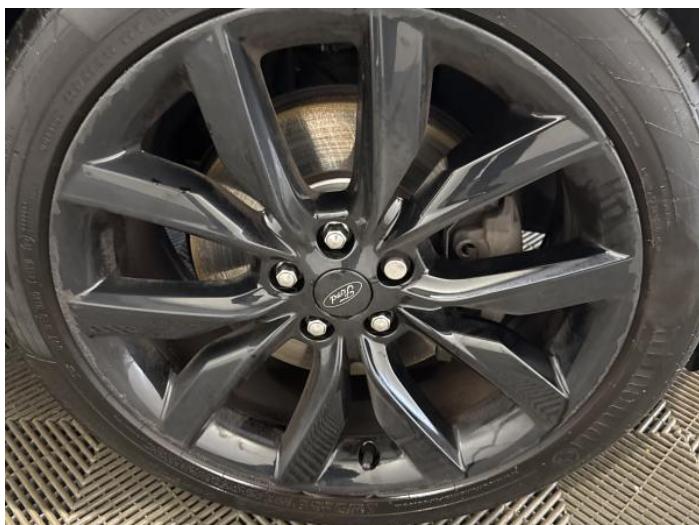
13: Wheel osf
Scratched
Over 50mm

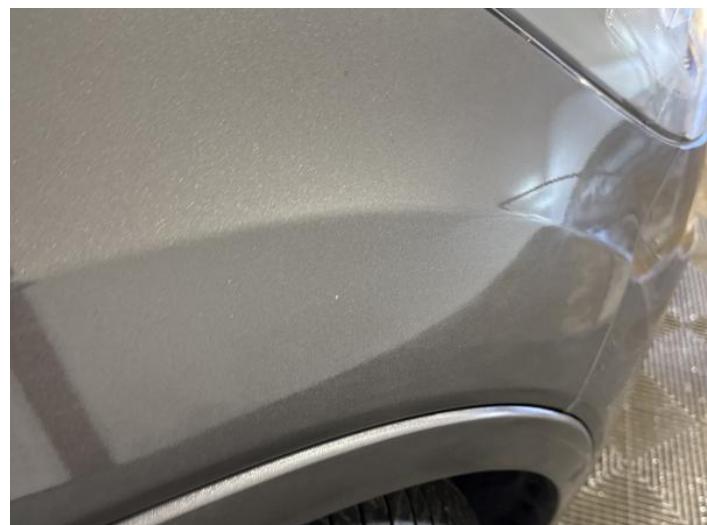
14: Wing osf
Chipped
1 To 5

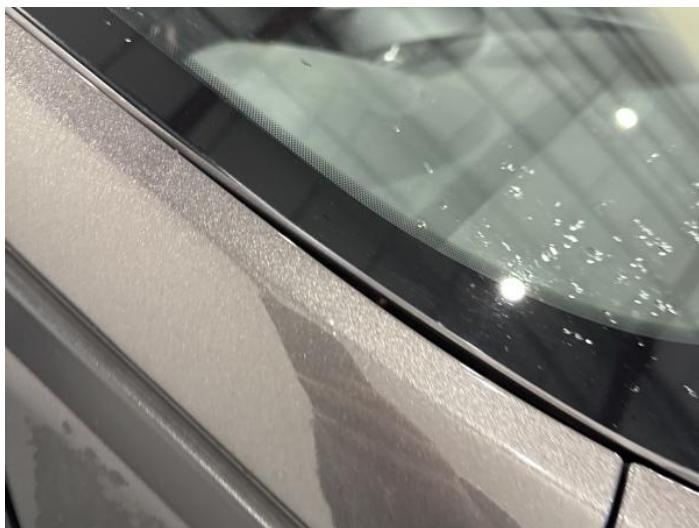
15: A Post os
Chipped
1 To 5
