VEHICLE INSPECTION REPORT

LG65ZLU

Skoda Fabia 1.4 TDI SE 5dr DSG

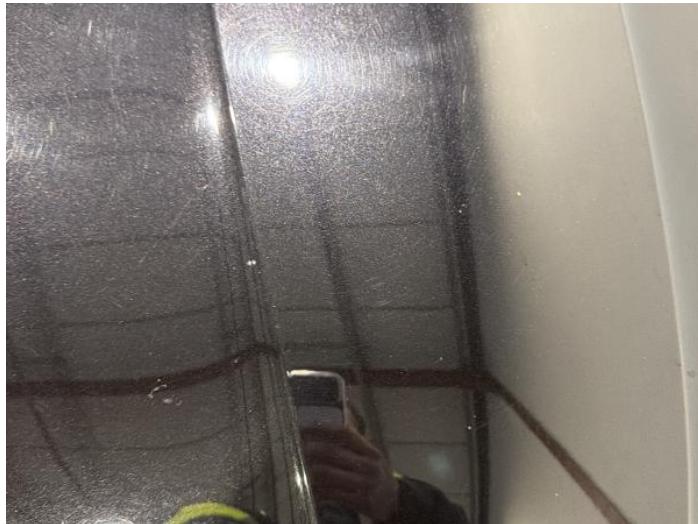
1: Bonnet
Chipped
1 To 5

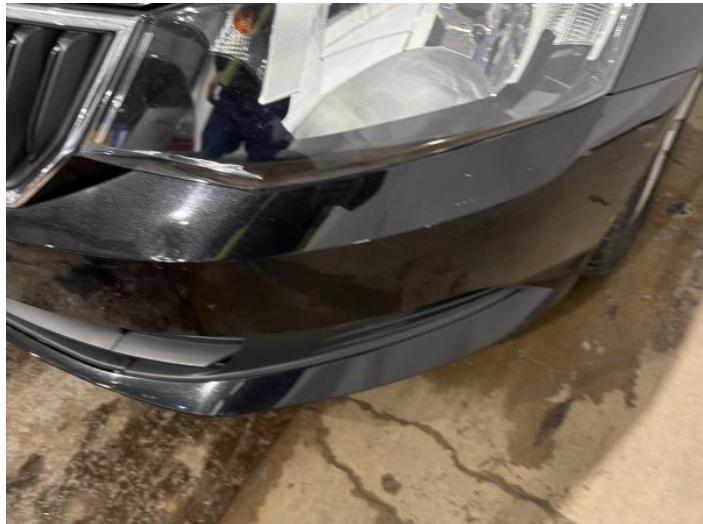
2: Bumper Front
Dented
With Paint Damage

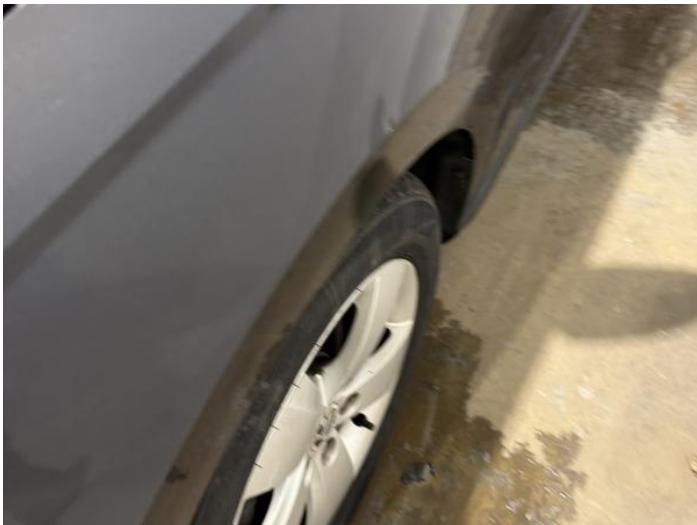
3: Wing nsf
Dented
Between 10mm + 30mm

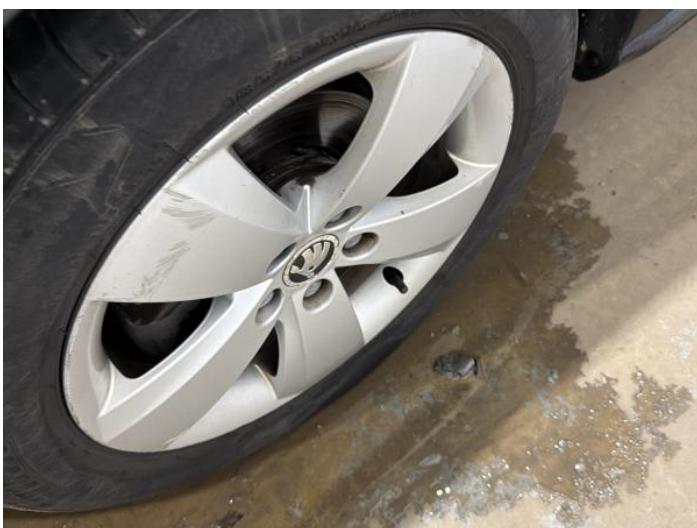
5: Wheel nsf
Scratched
Over 50mm

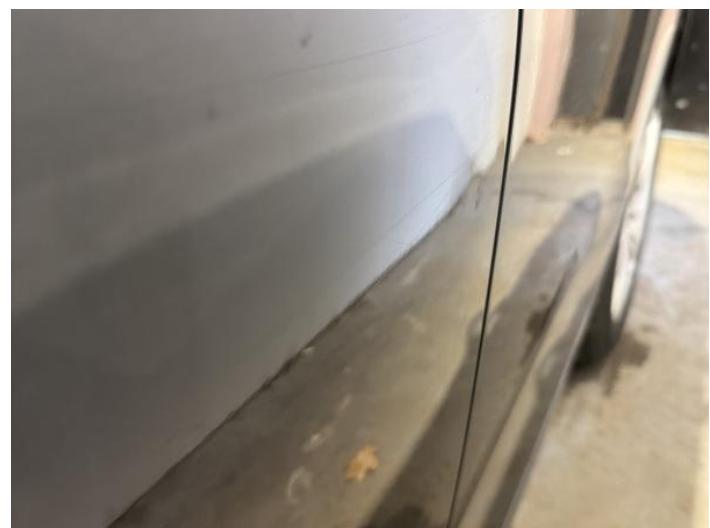
6: Door nsf
Dented
Over 2 UpTo 10mm

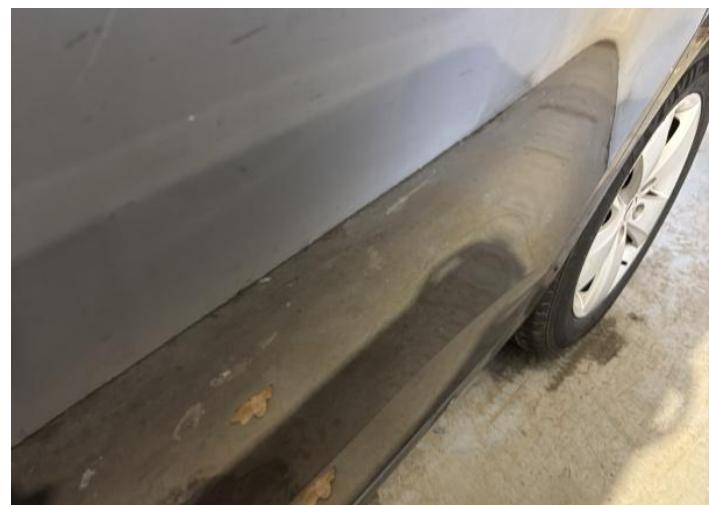
8: Door nsr
Chipped
1 To 5

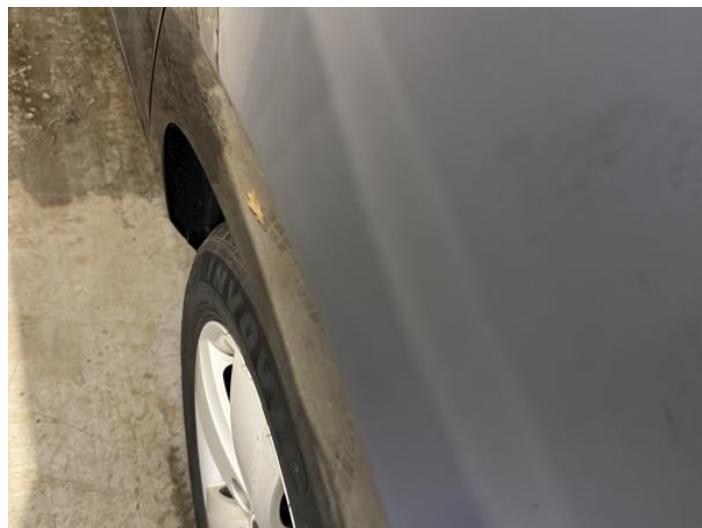
11: Qtr Panel nsr
Dented
Over 2 UpTo 10mm

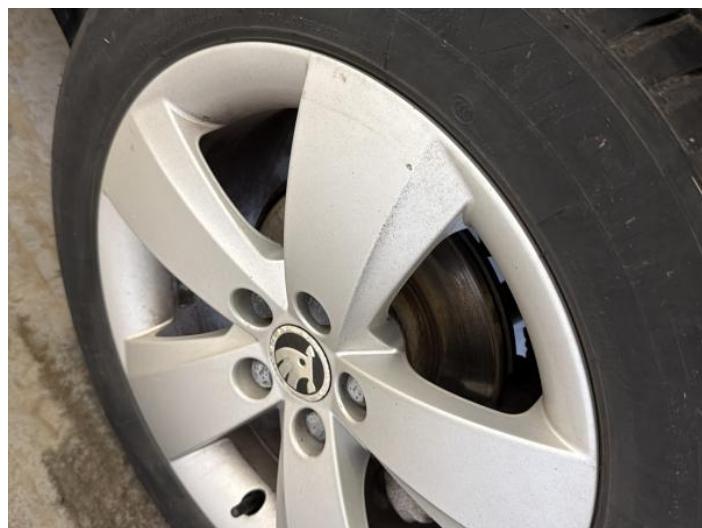
13: Wheel nsr
Scratched
Up To 50mm

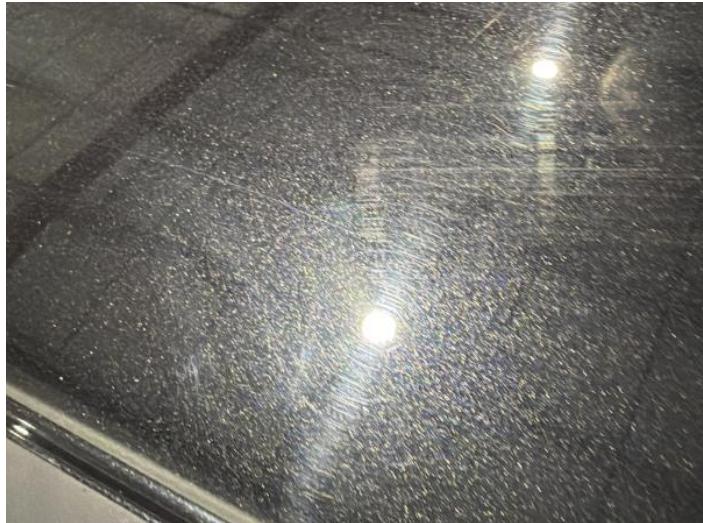
16: Roof
Dented
Between 10mm + 30mm

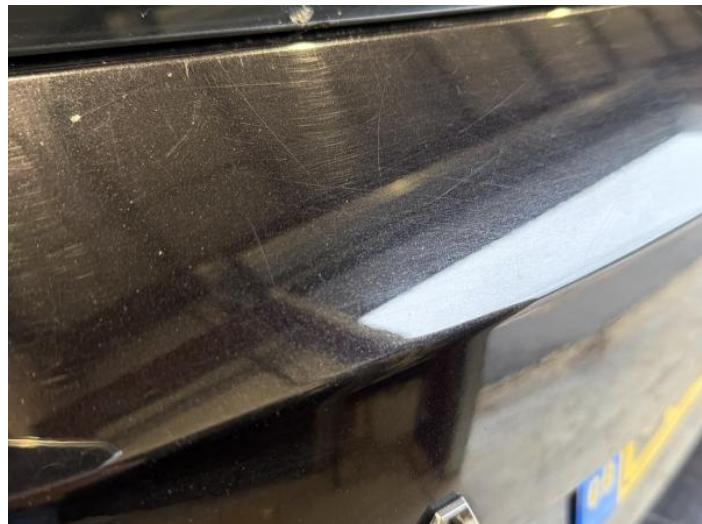
17: Boot Lid
Chipped
1 To 5

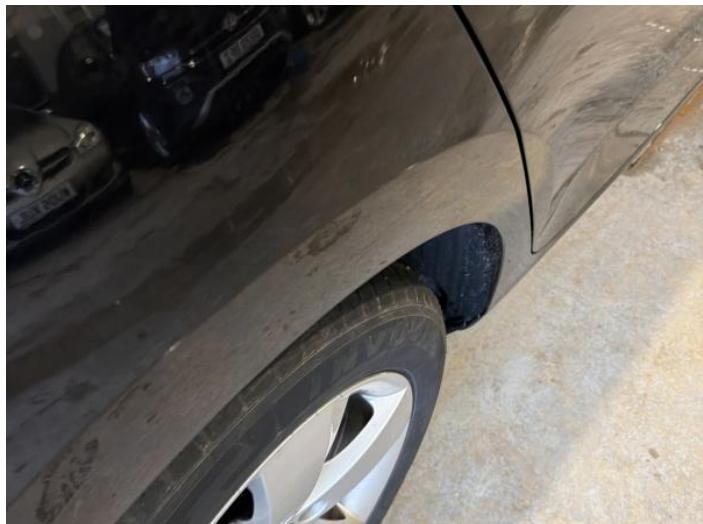
18: Qtr Panel osr
Dented
2 Or Less UpTo 10mm

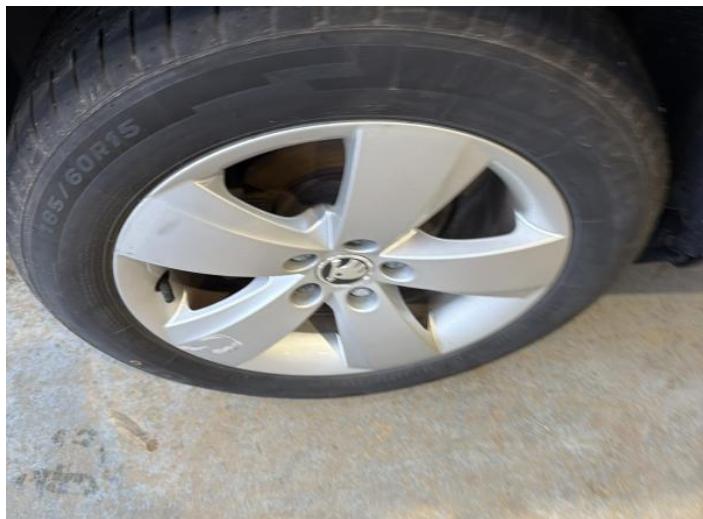
20: Wheel osr
Scratched
Over 50mm

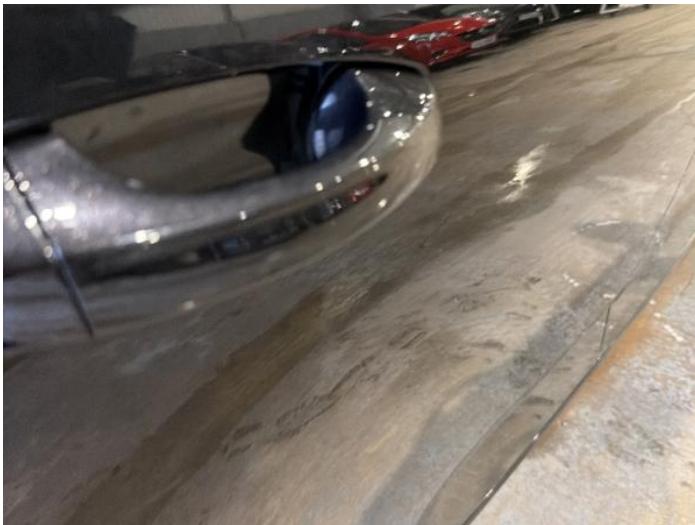
21: Door osr
Dented
Over 2 UpTo 10mm

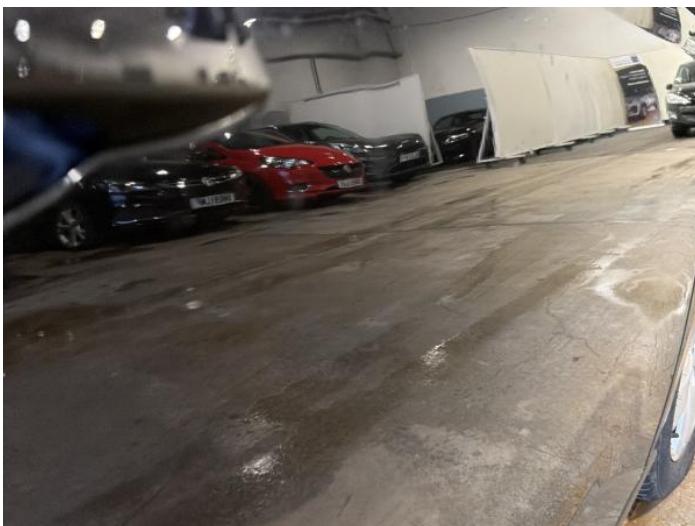
23: Door osf
Dented
Over 30mm

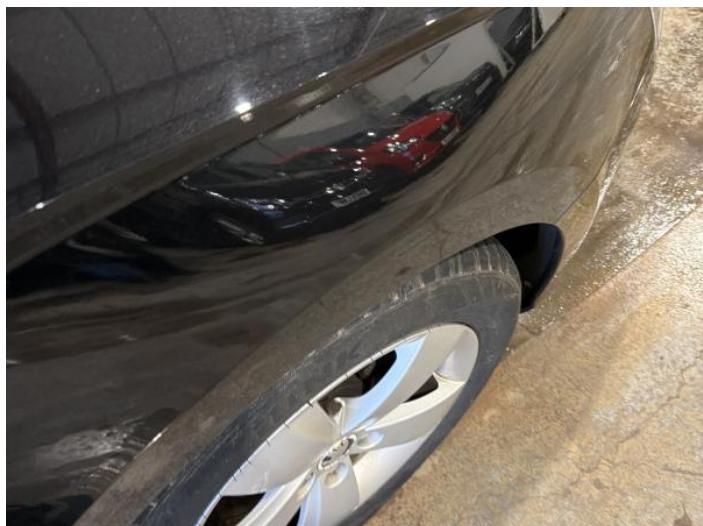
24: Wing osf
Chipped
1 To 5

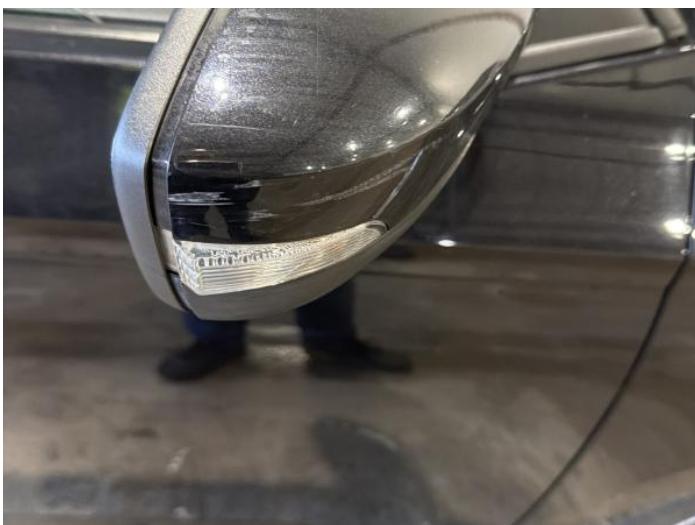
25: Door Mirror Assy osf
Scratched (Painted)
UpTo 25mm Thru Paint

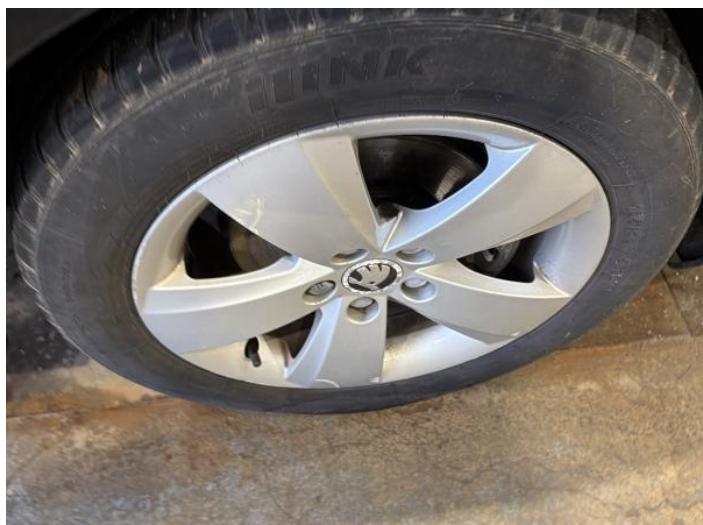
26: Wheel osf
Scratched
Over 50mm

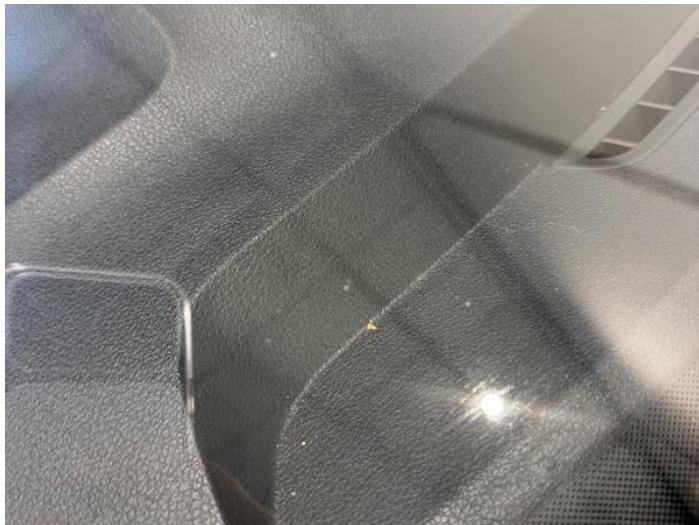
27: Screen Front
Chipped
UpTo 10mm
