VEHICLE INSPECTION REPORT

LX11RFE

Volkswagen Golf 1.4 TSI Match 5dr

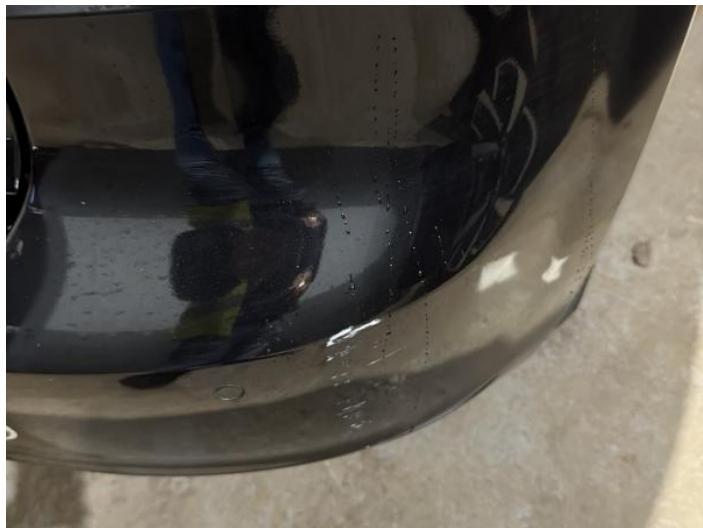
1: Bumper Rear
Scratched
Over 100mm Thru Paint

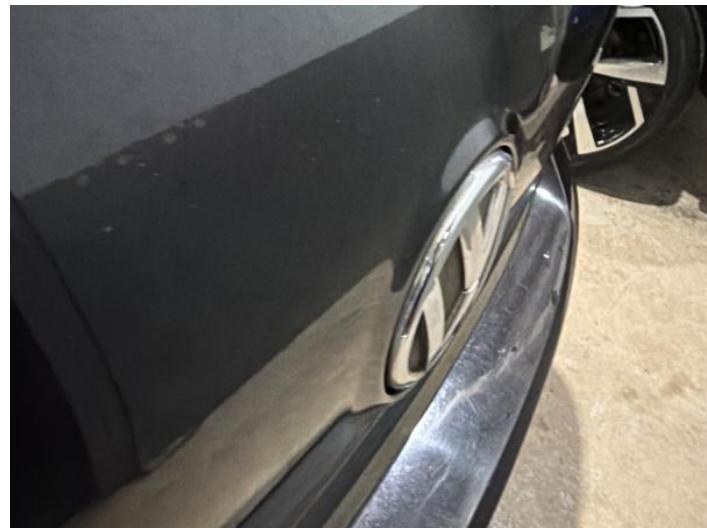
2: Boot Lid
Dented
Between 10mm + 30mm

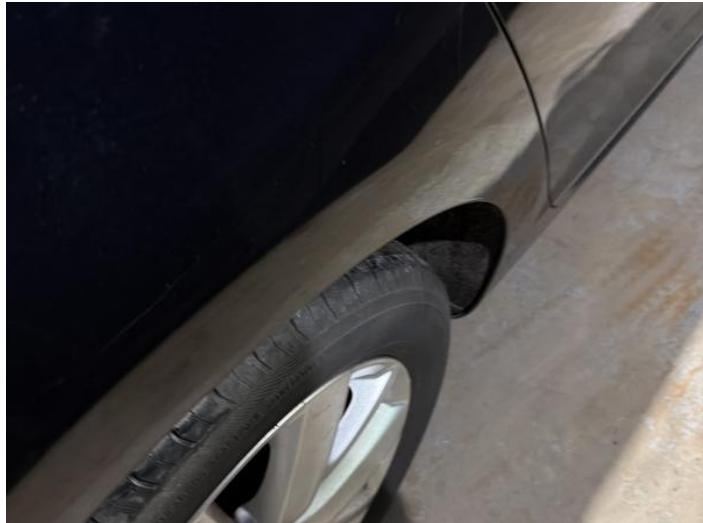
4: Qtr Panel osr
Dented
With Paint Damage

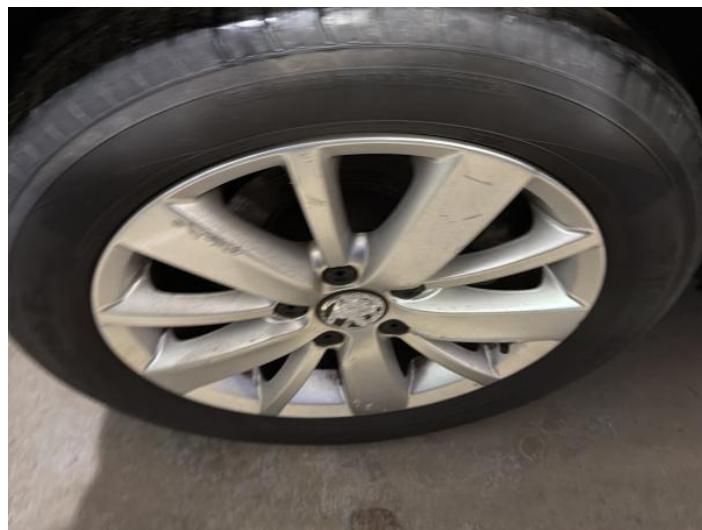
5: Wheel osr
Scratched
Over 50mm

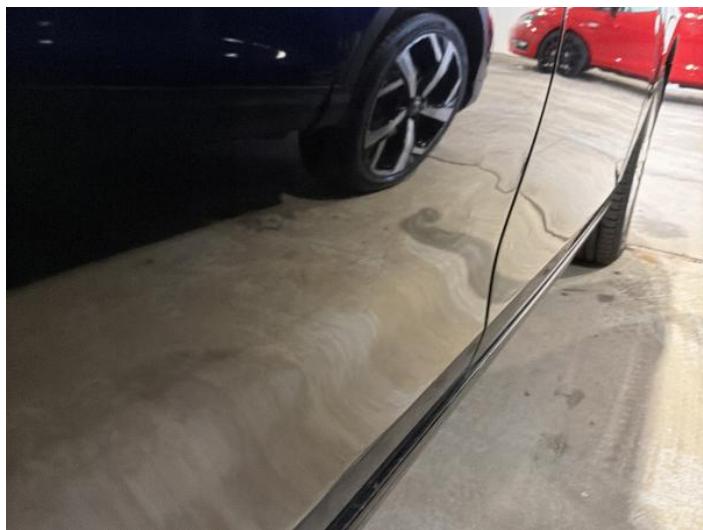
6: Door osr
Dented
Over 30mm

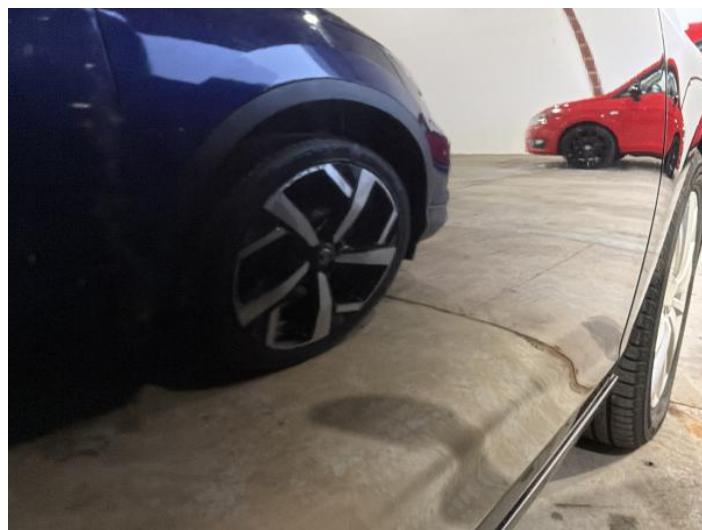
7: Door osf
Poor Previous Repair
Poor Paint

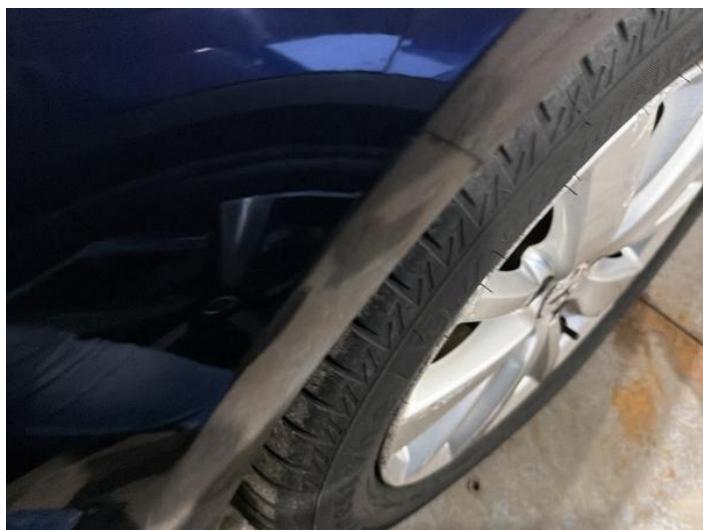
8: Wing osf
Chipped
1 To 5

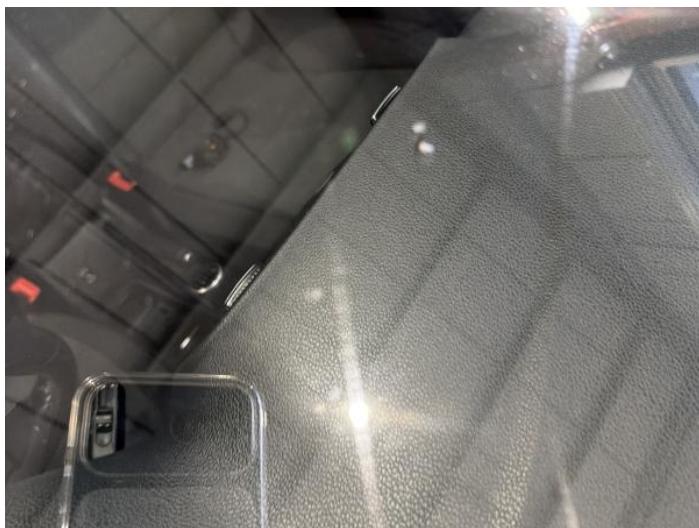
9: Screen Front
Chipped
UpTo 10mm

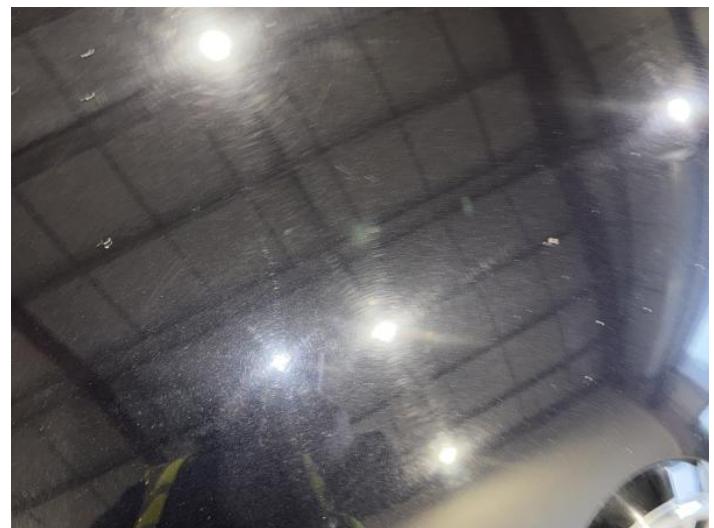
10: Bonnet
Chipped
Multiple Chips

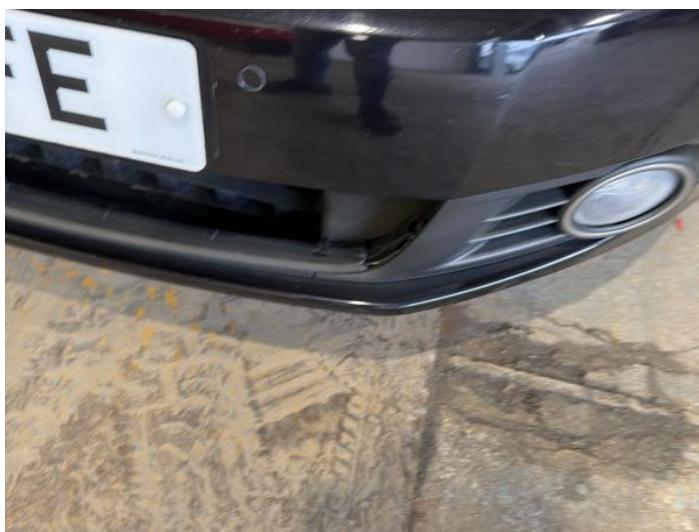
11: Bumper Front
Scratched
Over 100mm Thru Paint

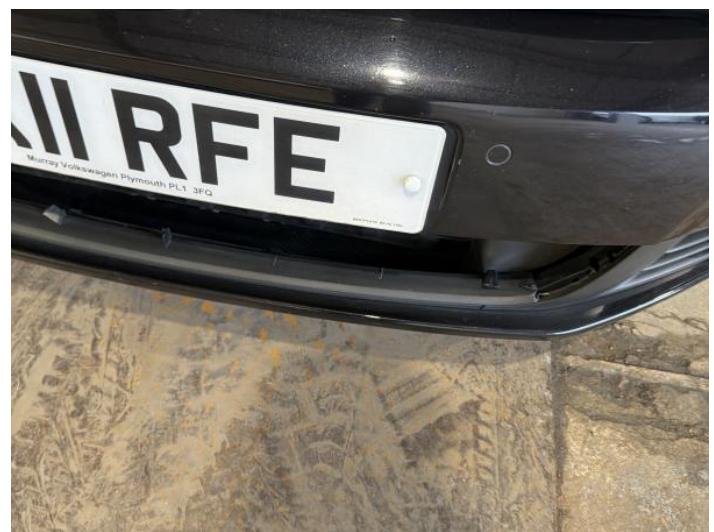
12: Bumper Front Moulding
Broken
Replace

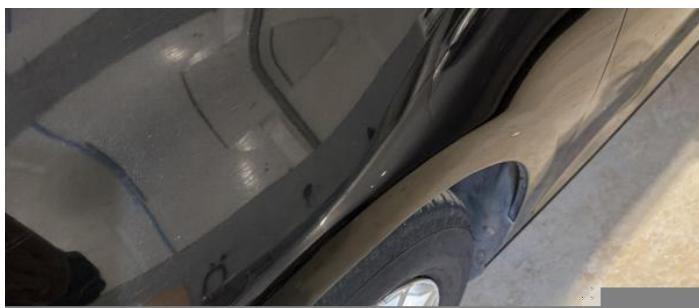
13: Wing nsf
Chipped
1 To 5

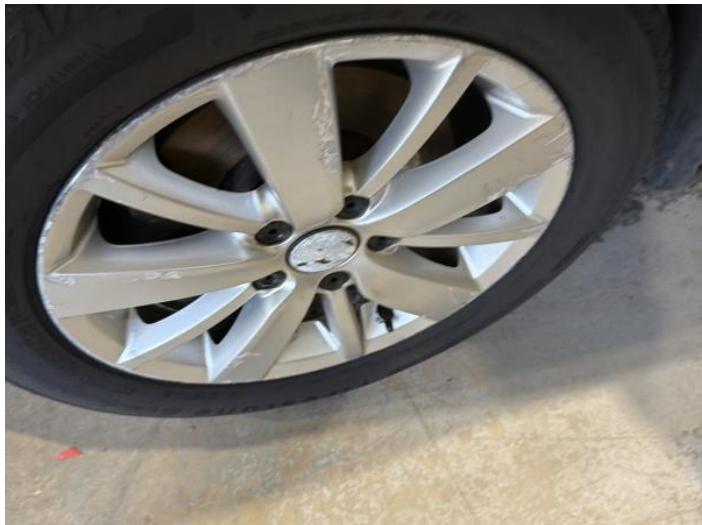
15: Wheel nsf
Scratched
Over 50mm

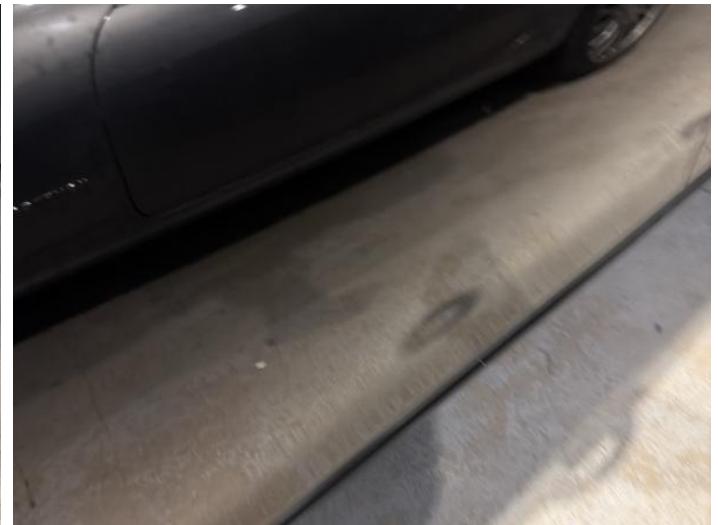
16: Door nsf
Poor Previous Repair
Poor Paint

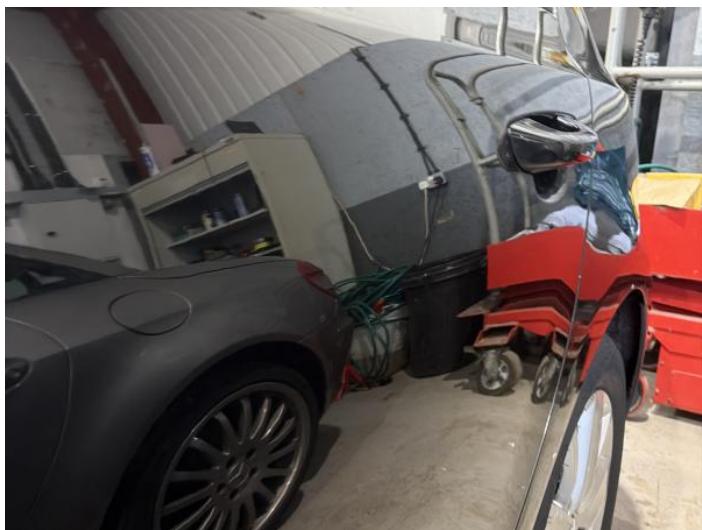
17: Door nsr
Dented
2 Or Less UpTo 10mm

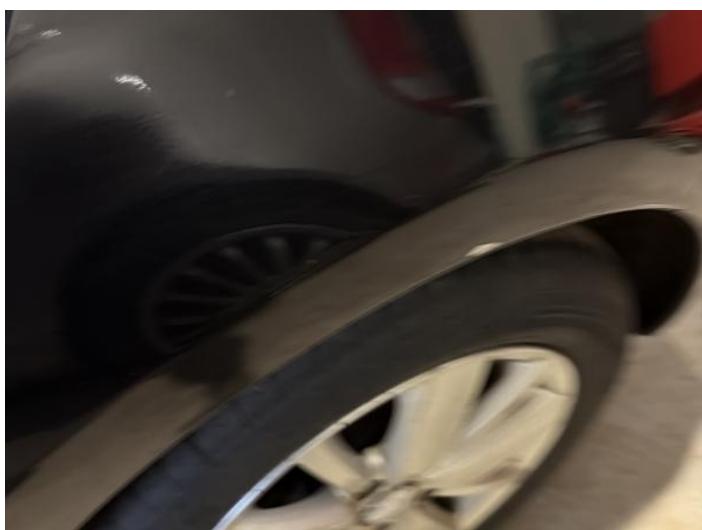
19: Qtr Panel nsr
Dented
With Paint Damage

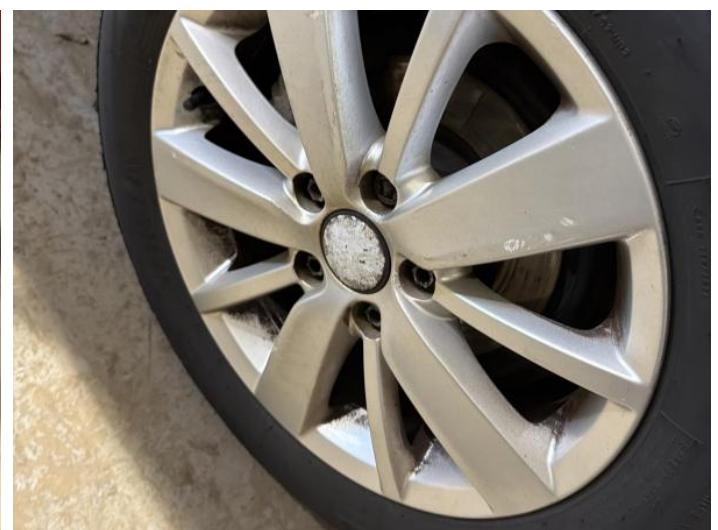
20: Wheel nsr
Scratched
Over 50mm
