## VEHICLE INSPECTION REPORT

DY16HVC

### Vauxhall Astra 1.4T 16V 150 Elite 5dr

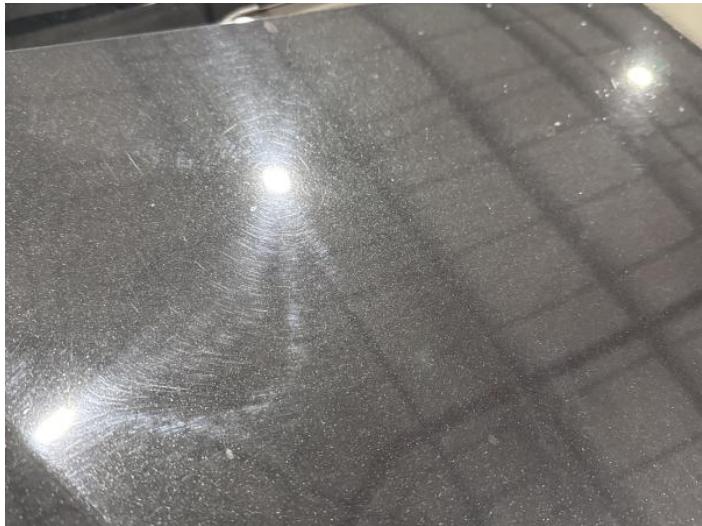
1: Bonnet  
Chipped  
Multiple Chips

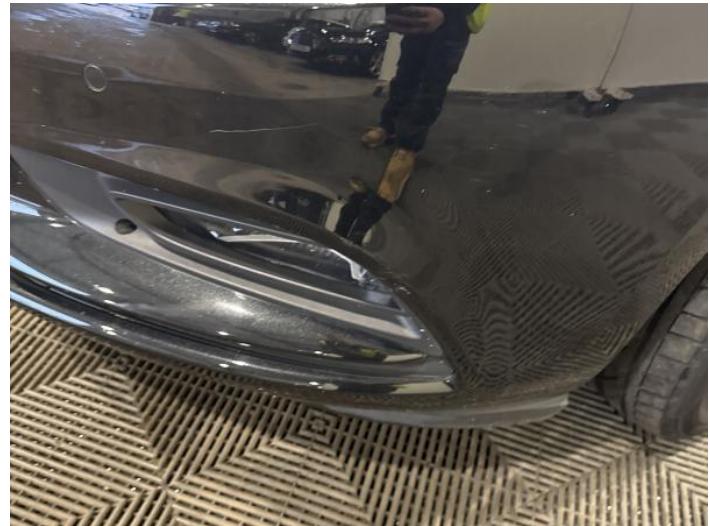
2: Bumper Front  
Scratched  
25 to 100mm Thru Paint

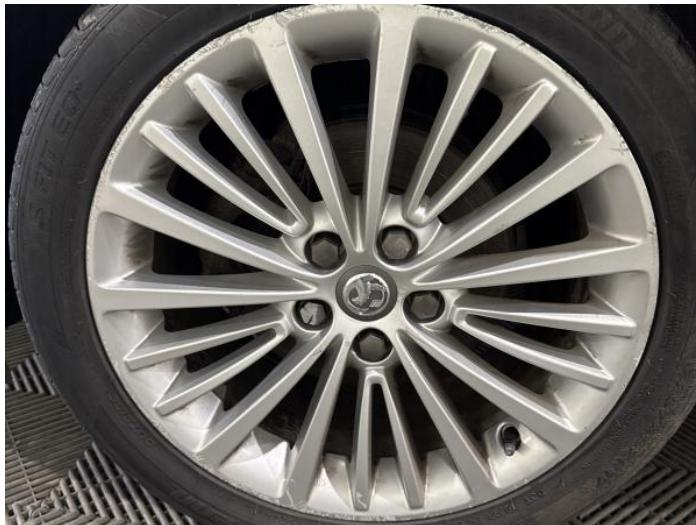
3: Wheel nsf  
Scratched  
Over 50mm

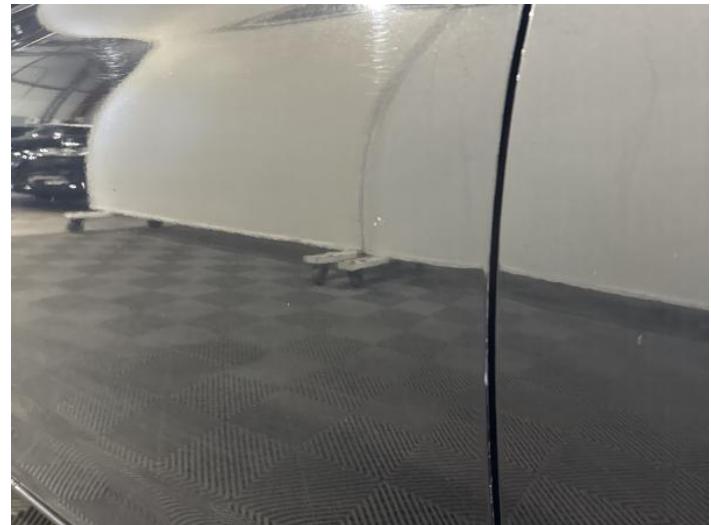
4: Door nsf  
Chipped  
1 To 5

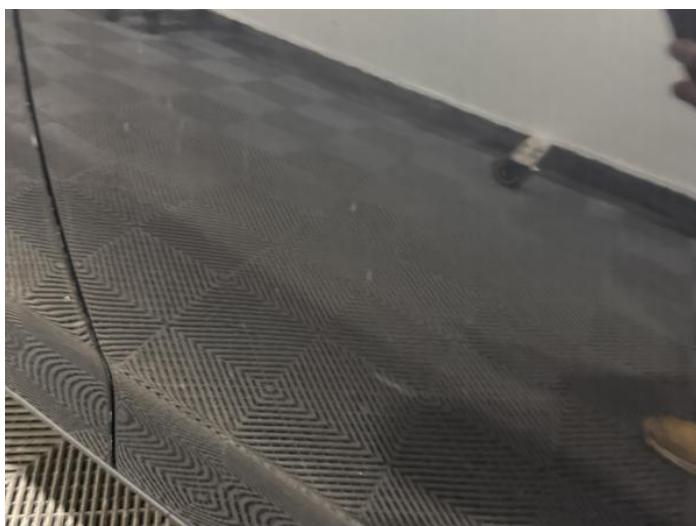
5: Door nsr  
Scratched  
Over 25mm Thru Paint

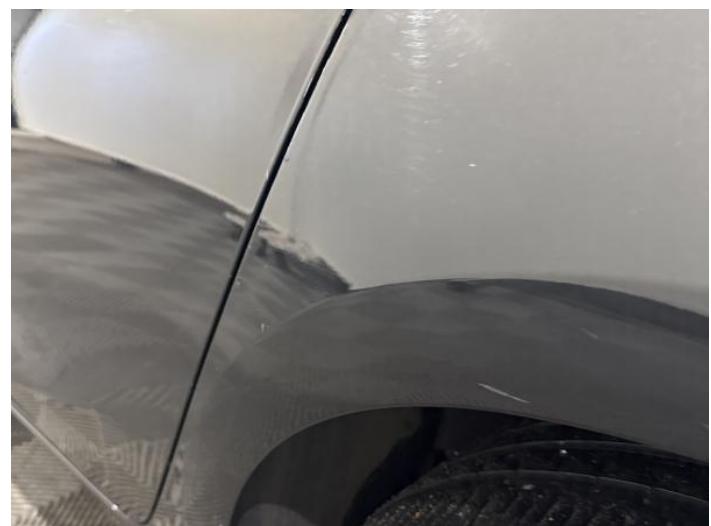
6: Qtr Panel nsr  
Dented  
Between 10mm + 30mm

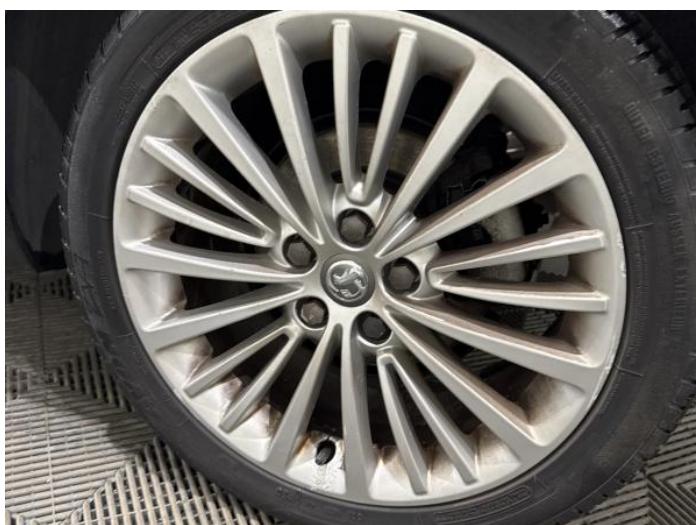
7: Wheel nsr  
Scratched  
Over 50mm

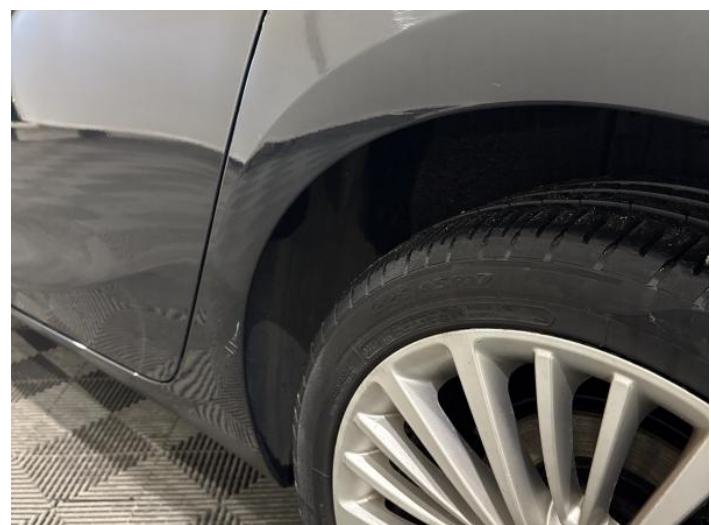
8: Qtr Panel nsr  
Scratched  
Over 25mm Thru Paint

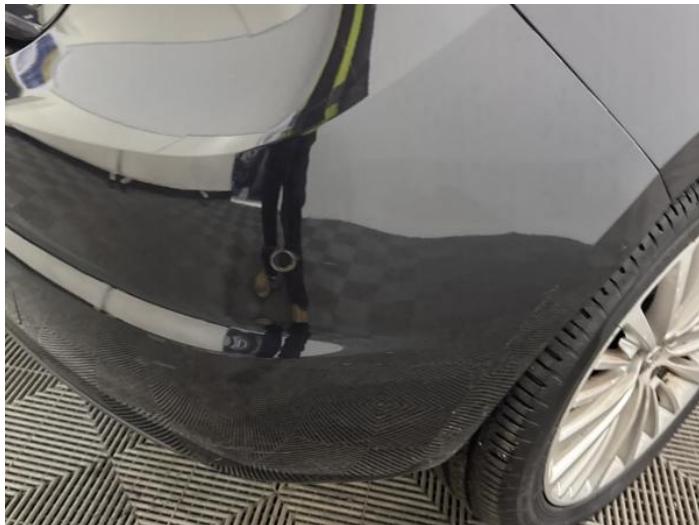
9: Bumper Rear  
Scratched  
Over 100mm Thru Paint

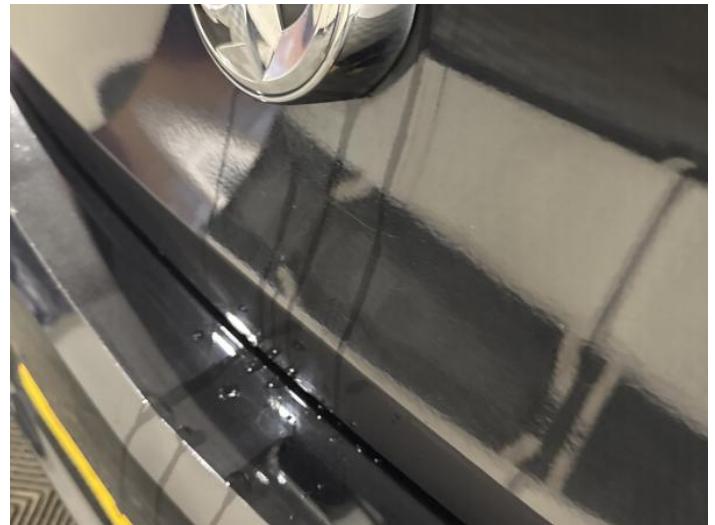
10: Tailgate  
Scratched  
UpTo 25mm Thru Paint

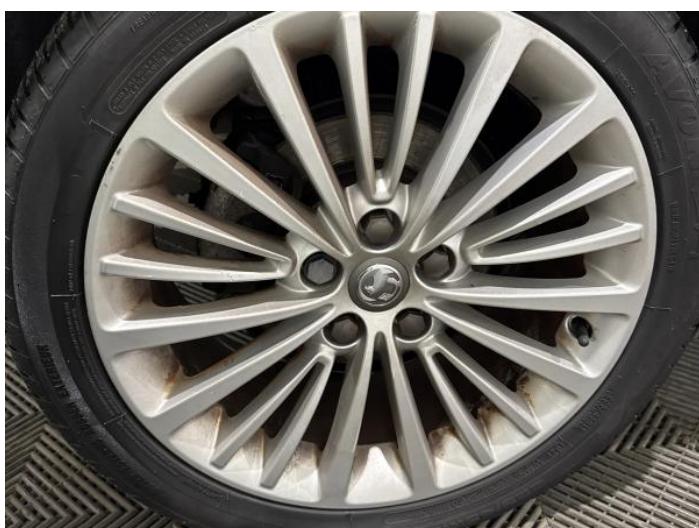
11: Wheel osr  
Scratched  
Up To 50mm

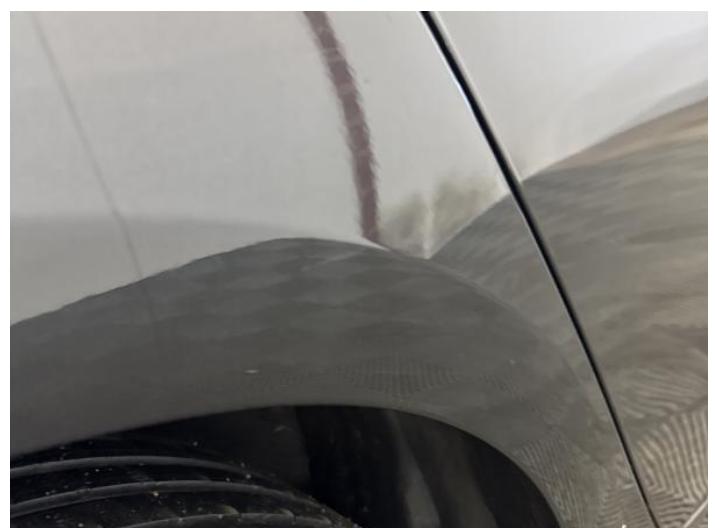
12: Qtr Panel osr  
Scratched  
UpTo 25mm Thru Paint

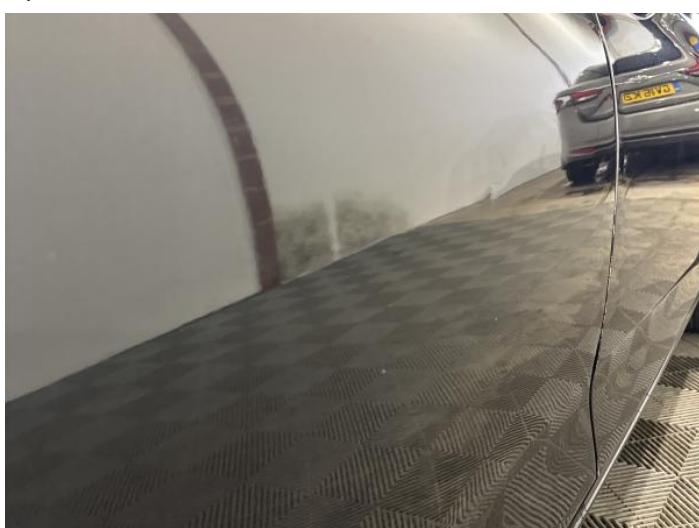
13: Door osr  
Dented  
Between 10mm + 30mm

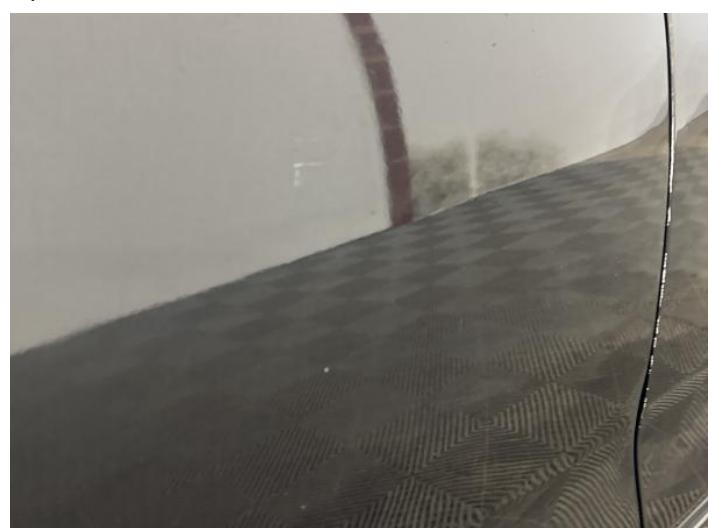
14: Door osr  
Scratched  
Over 25mm Thru Paint

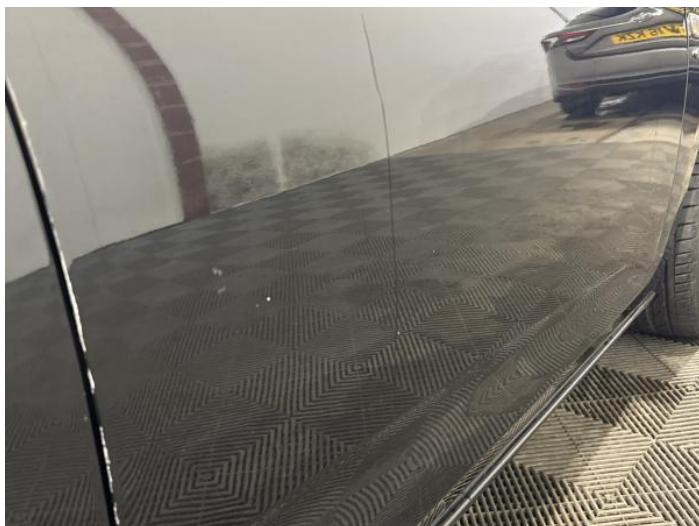
15: Door osf  
Scratched  
Over 25mm Thru Paint

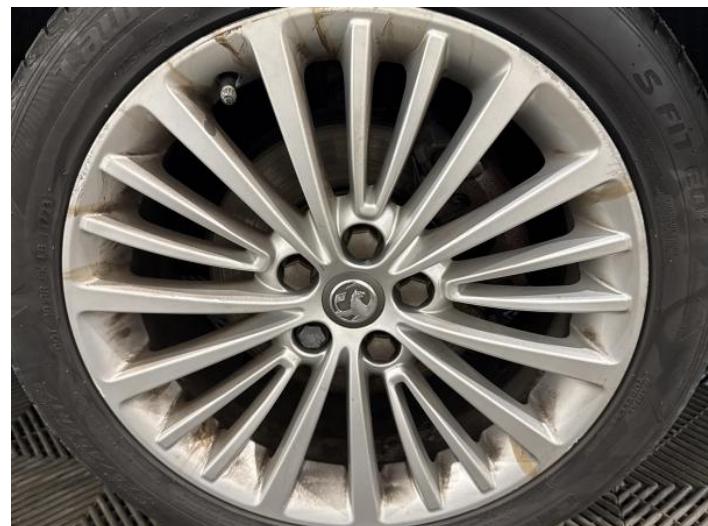
16: Wheel osf  
Scratched  
Over 50mm

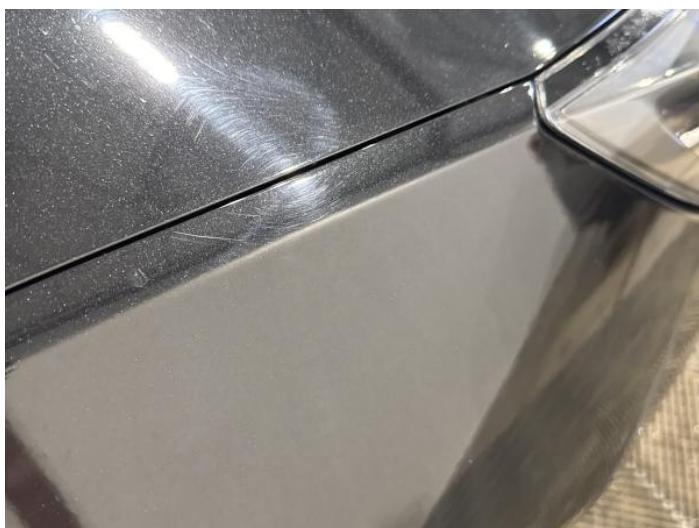
17: Wing osf  
Scratched  
UpTo 25mm Thru Paint
