VEHICLE INSPECTION REPORT

DW18SGY

Vauxhall Mokka X 1.4T ecoTEC Elite Nav 5dr

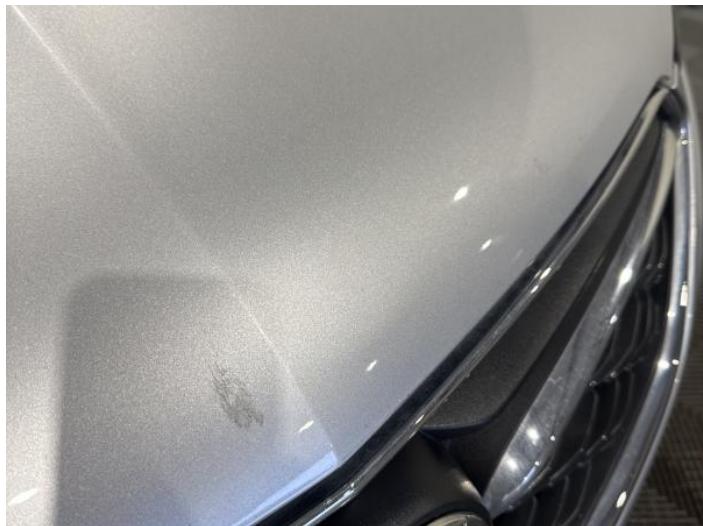
1: Bonnet
Dented
Over 30mm

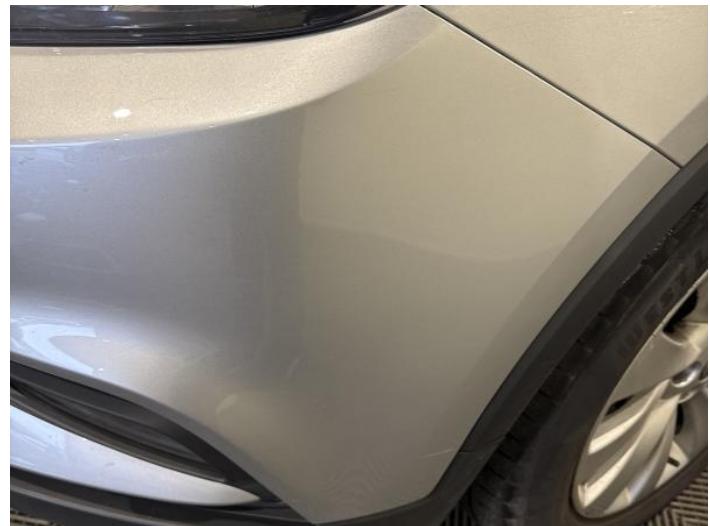
2: Bumper Front
Scratched
25 to 100mm Thru Paint

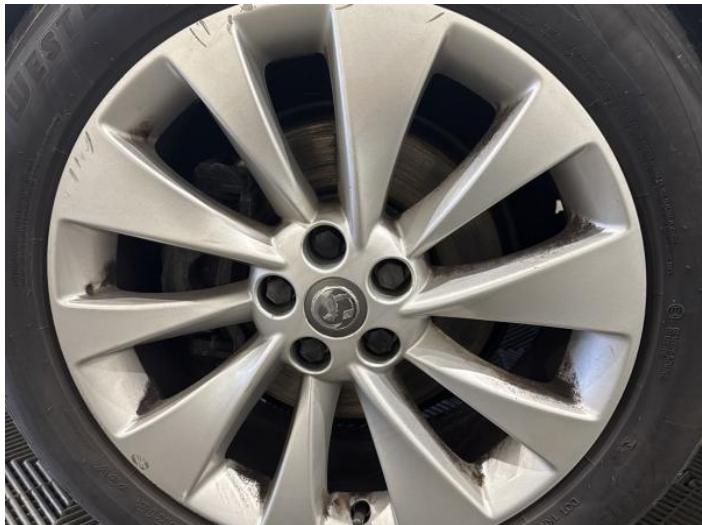
3: Wheel nsf
Scratched
Over 50mm

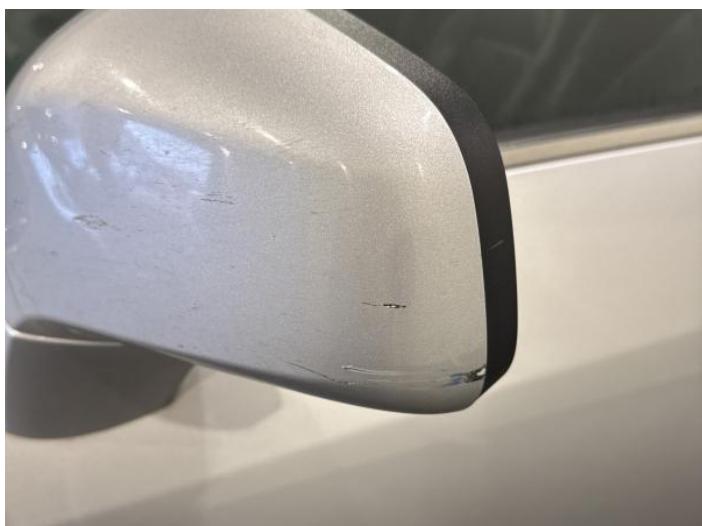
5: Door Mirror Assy nsf
Scratched (Painted)
Over 25mm Thru Paint

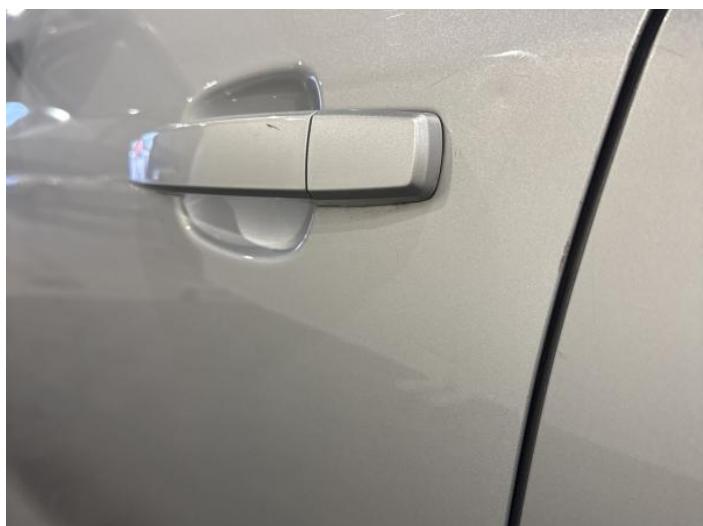
6: Door nsf
Dented
Between 10mm + 30mm

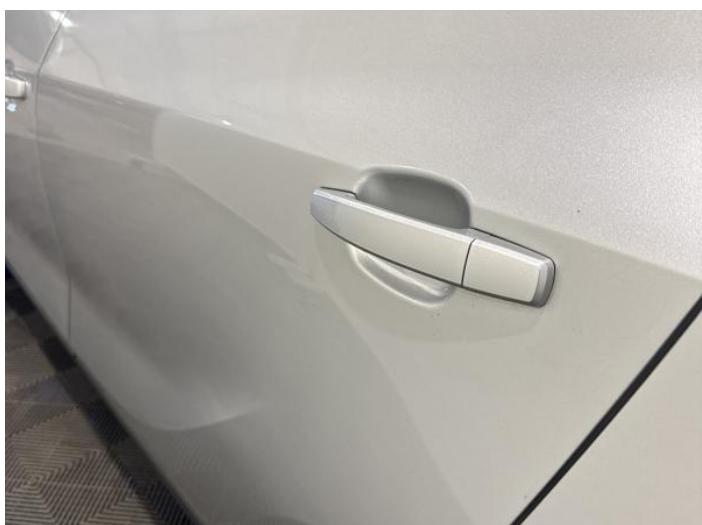
7: Door nsr
Poor Previous Repair
Poor Paint

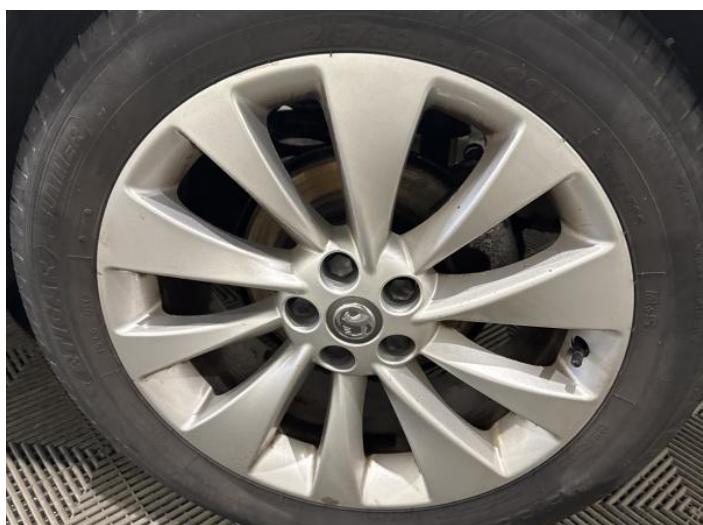
8: Wheel nsr
Scratched
Over 50mm

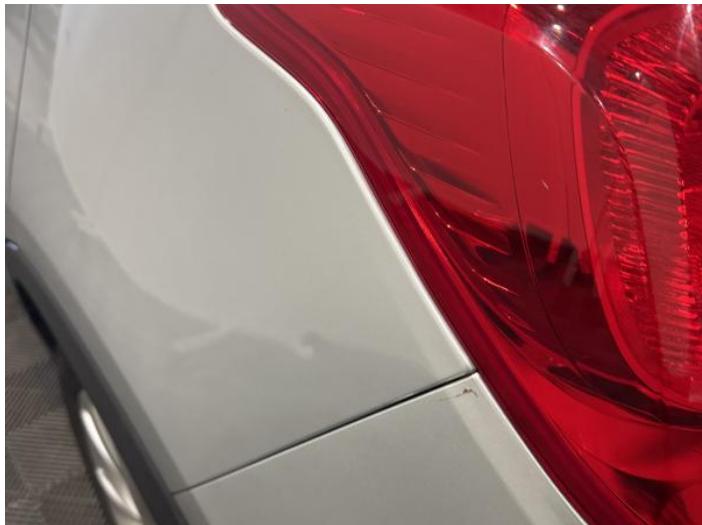
9: Qtr Panel nsr
Dented
Between 10mm + 30mm

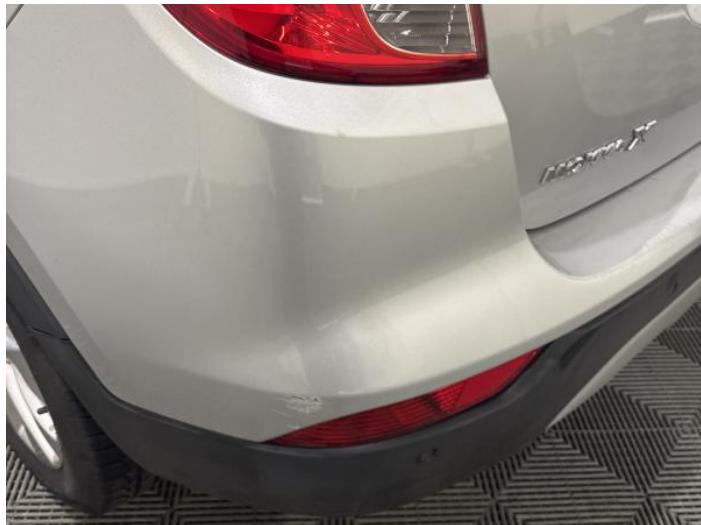
10: Bumper Rear
Scratched
25 to 100mm Thru Paint

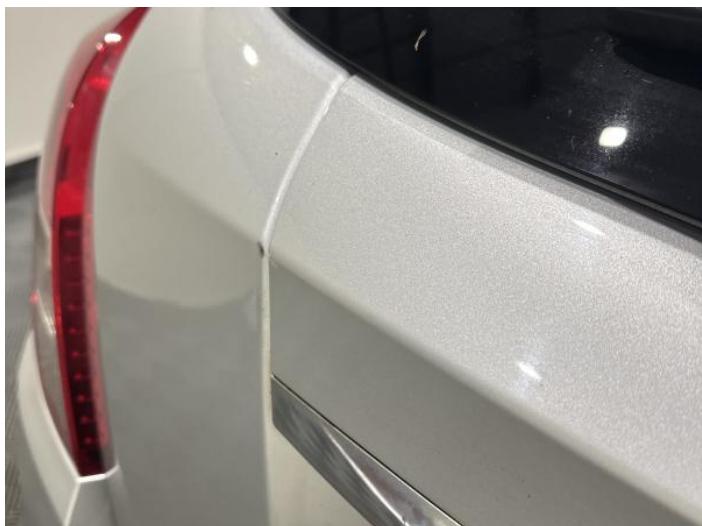
11: Tailgate
Scratched
UpTo 25mm Thru Paint

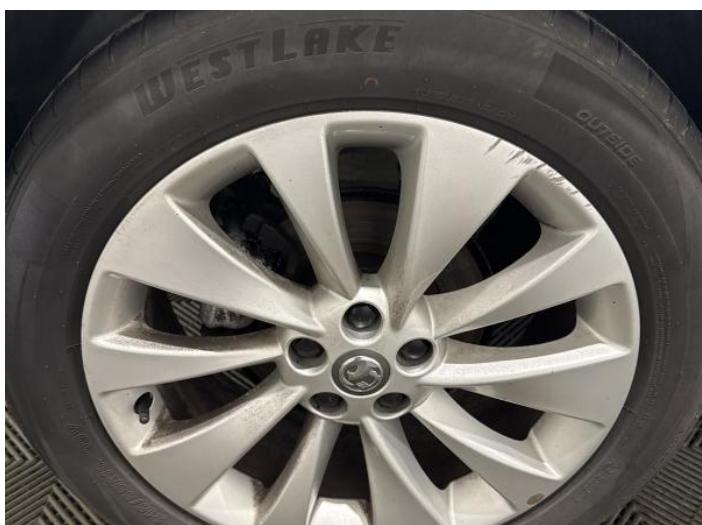
13: Wheel osr
Scratched
Over 50mm

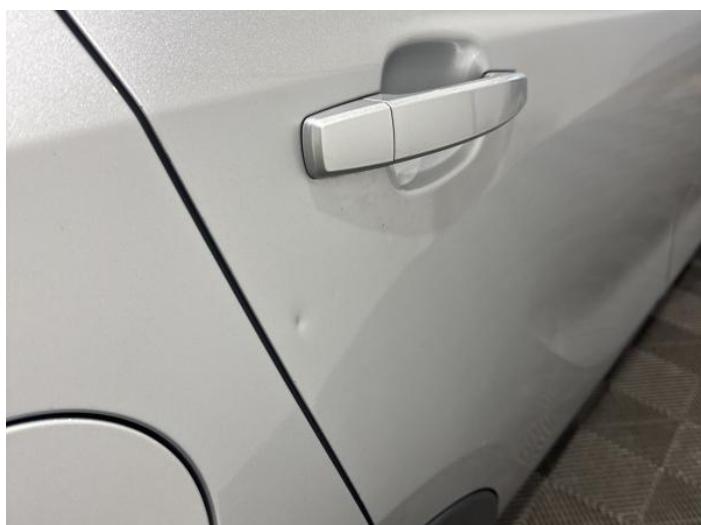
14: Door osr
Dented
Between 10mm + 30mm

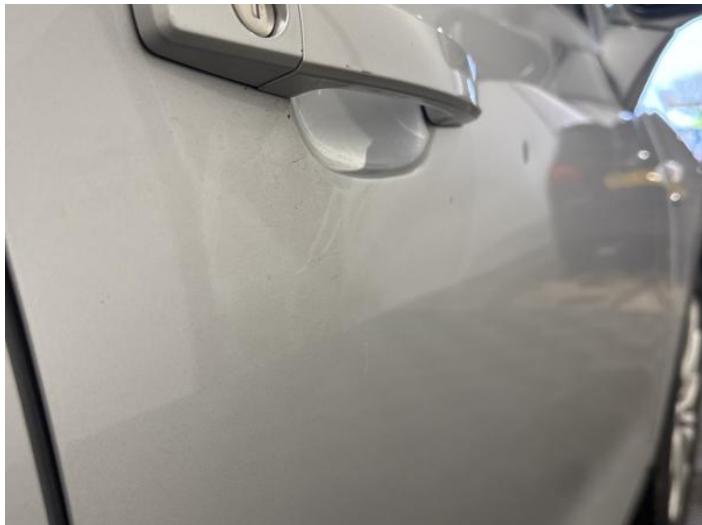
15: Door osf
Dented
Over 30mm

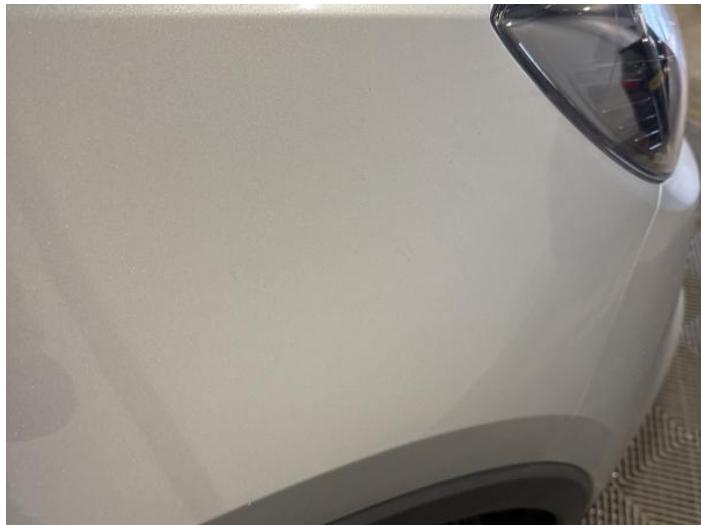
16: Wing osf
Chipped
1 To 5

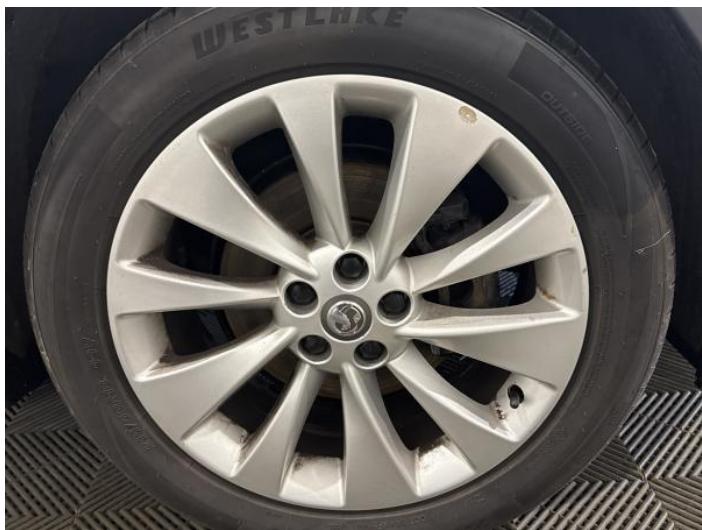
17: Wheel osf
Scratched
Up To 50mm

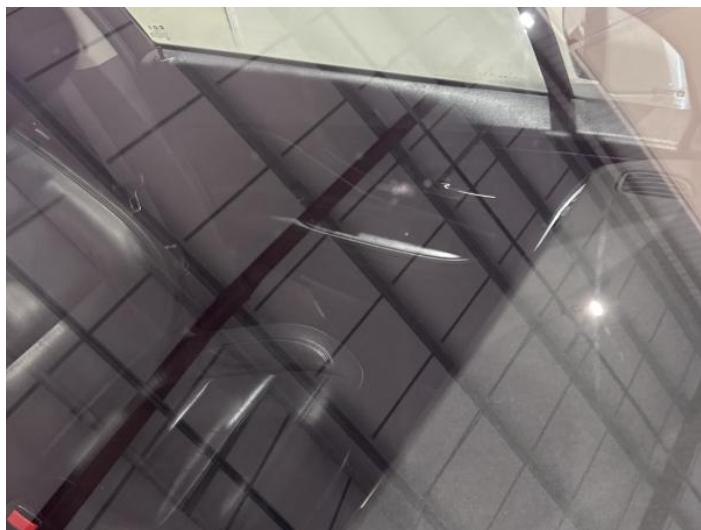
18: Screen Front
Chipped
Over 10mm

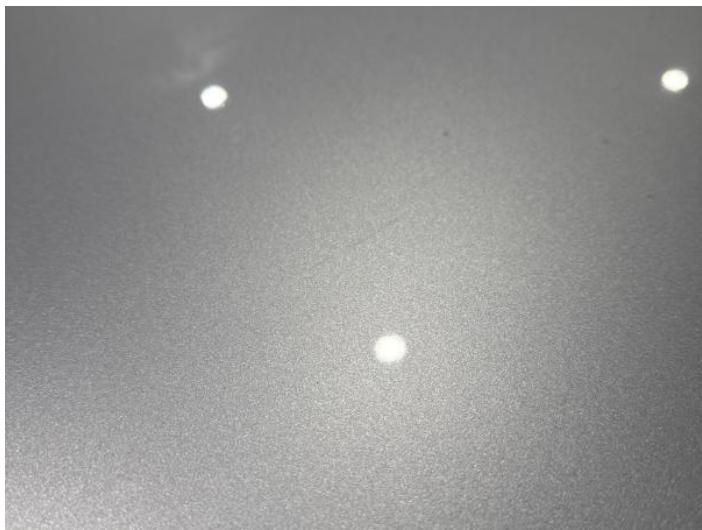
19: Roof
Scratched
UpTo 25mm Thru Paint
