VEHICLE INSPECTION REPORT

LC60FOK

Honda Jazz 1.4 i-VTEC EX 5dr i-SHIFT Auto

nama
GRADE 4

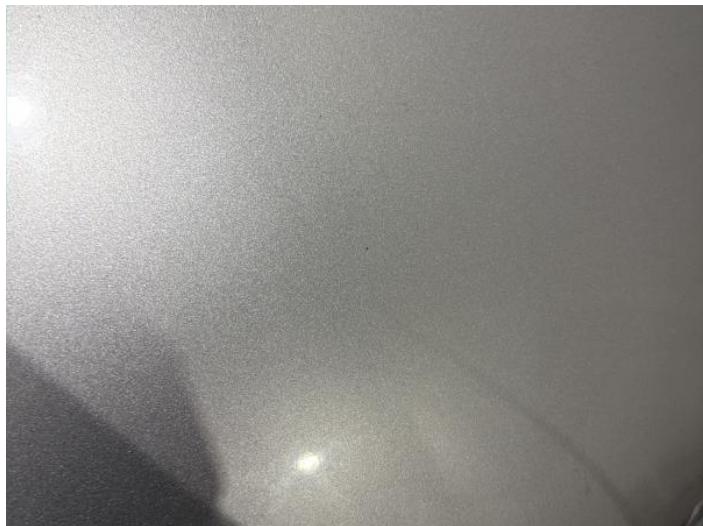
1: Bonnet
Chipped
1 To 5

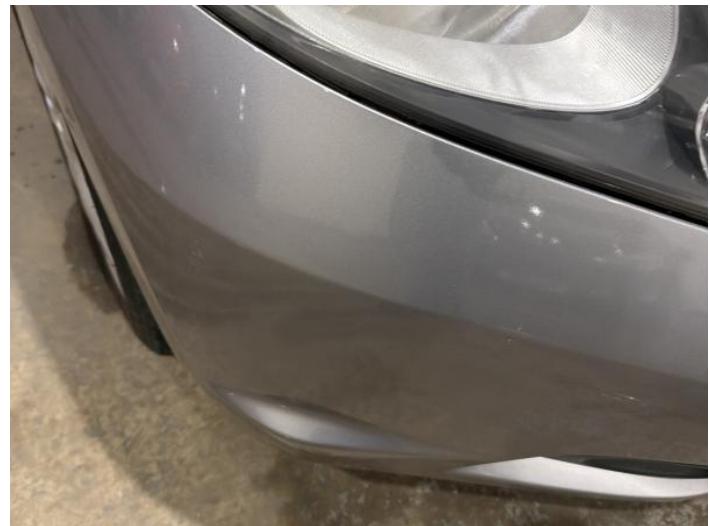
2: Bumper Front
Scratched
25 to 100mm Thru Paint

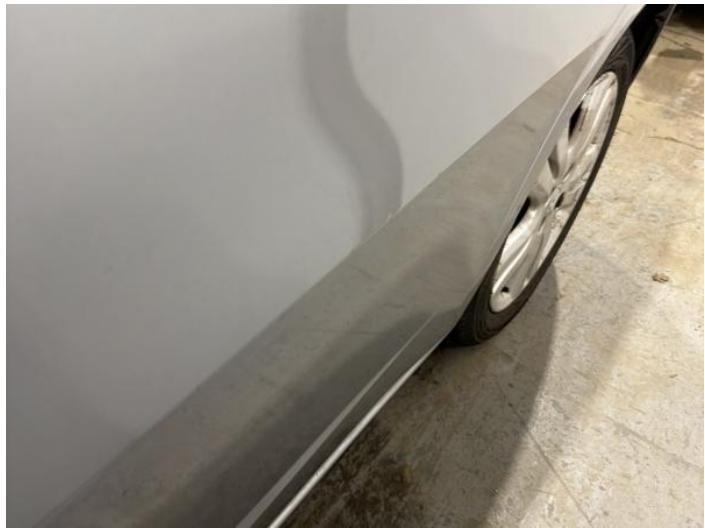
7: Door nsf
Scratched
UpTo 25mm Not Thru Paint

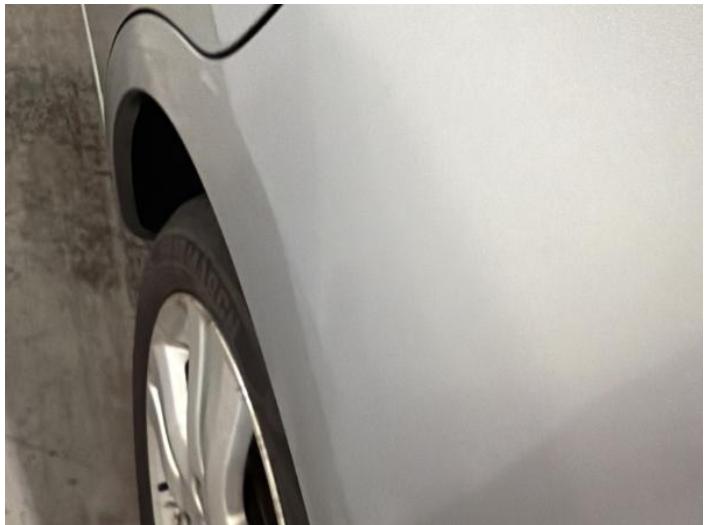
9: Qtr Panel nsr
Dented
Over 2 UpTo 10mm

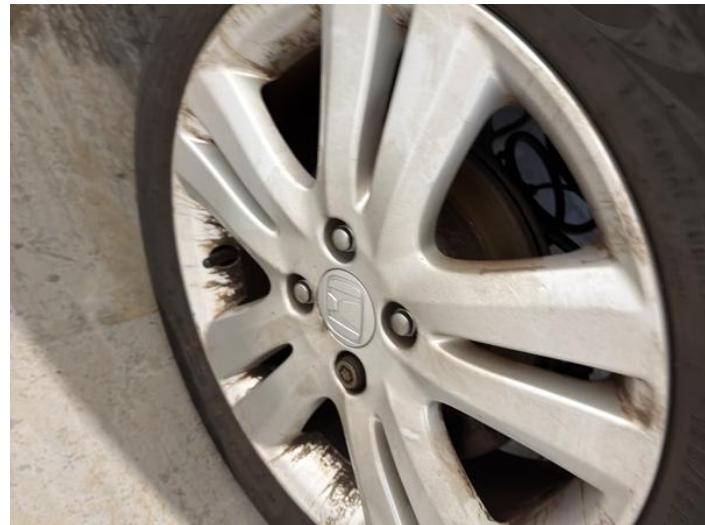
10: Wheel nsr
Scratched
Over 50mm

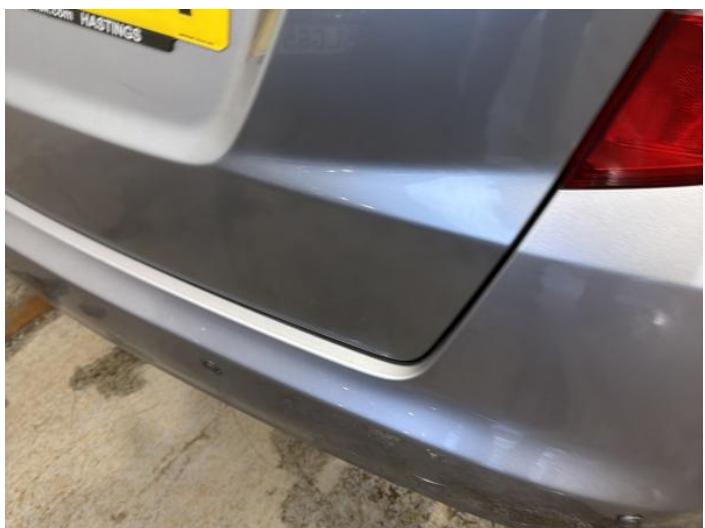
11: Bumper Rear
Chipped
Multiple Chips

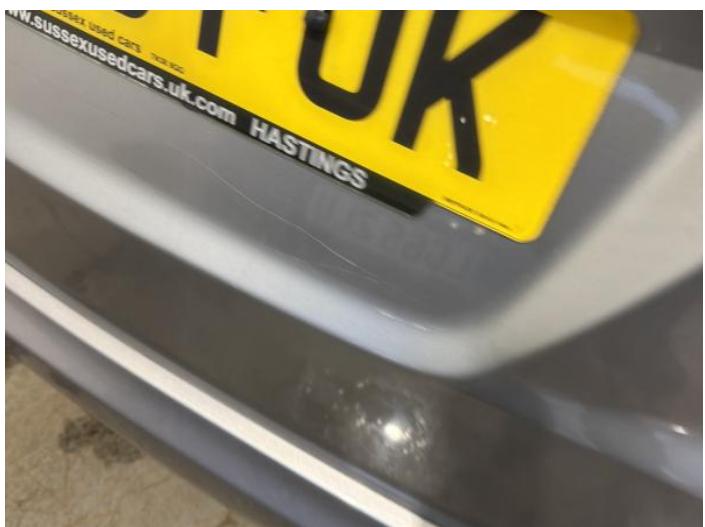
13: Boot Lid
Scratched
Over 25mm Thru Paint

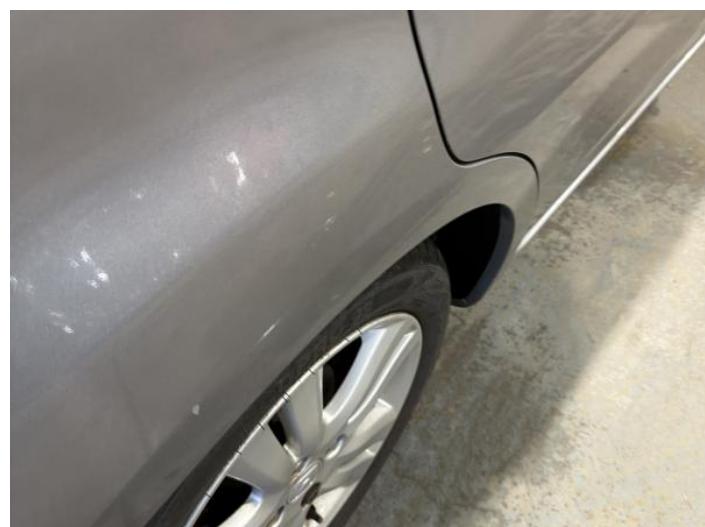
14: Qtr Panel osr
Poor Previous Repair
Poor Paint

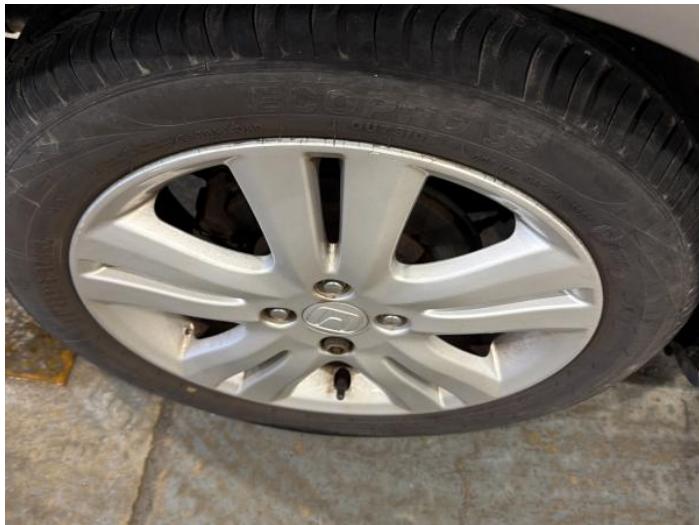
15: Wheel osr
Scratched
Over 50mm

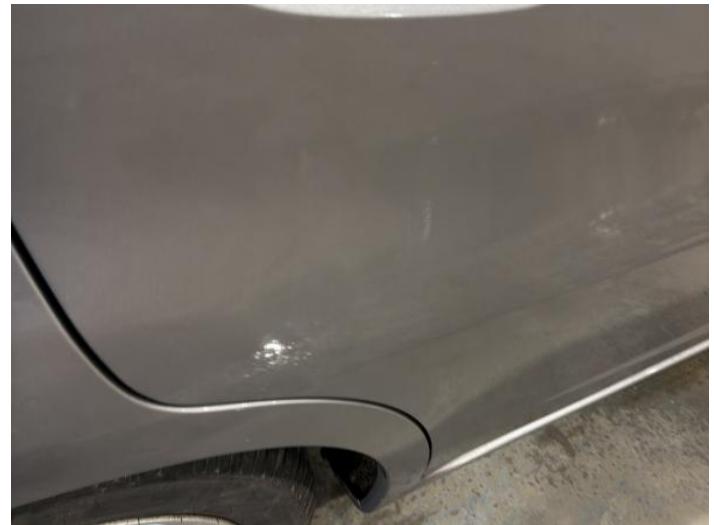
16: Door osr
Poor Previous Repair
Poor Paint

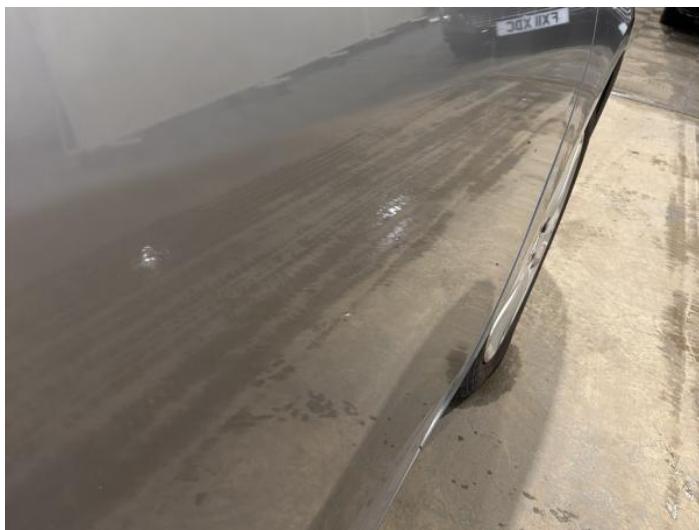
17: Door osf
Dented
Over 2 UpTo 10mm

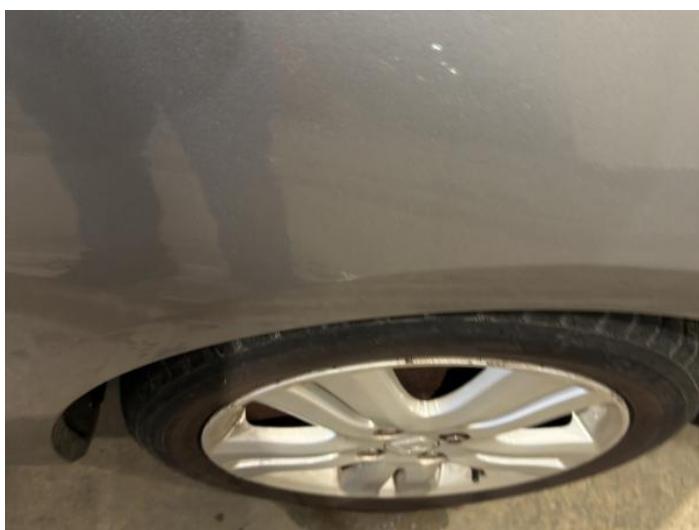
19: Wing osf
Chipped
1 To 5

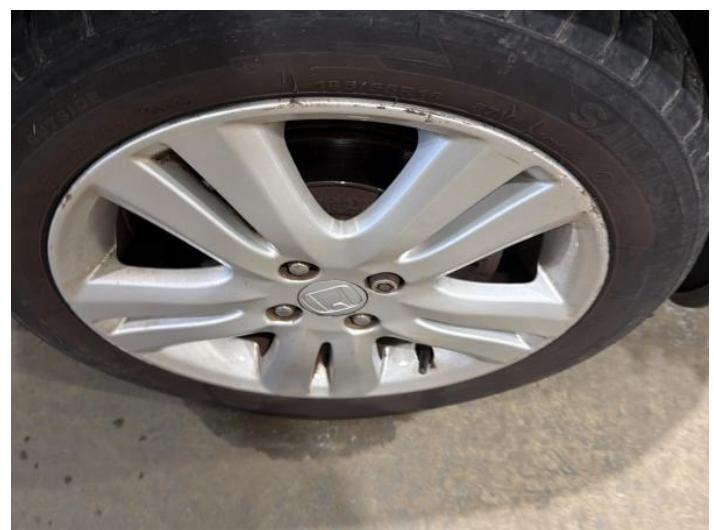
20: Wheel osf
Scratched
Over 50mm
