VEHICLE INSPECTION REPORT

GV16KZK

Toyota Avensis 1.8 Business Edition Plus 4dr

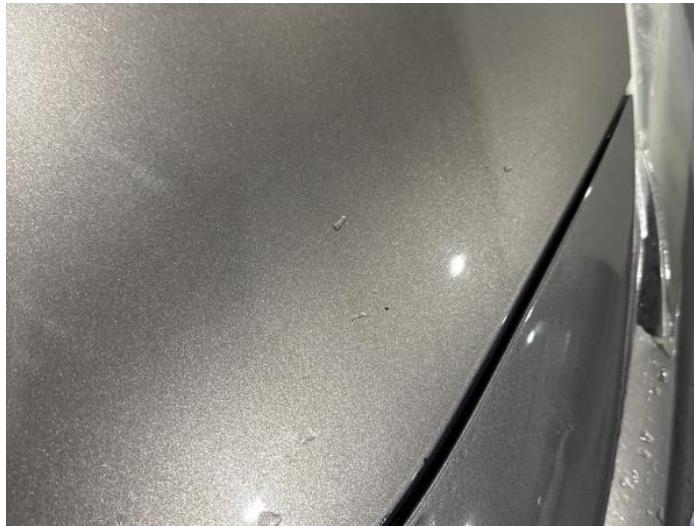
1: Bonnet
Chipped
1 To 5

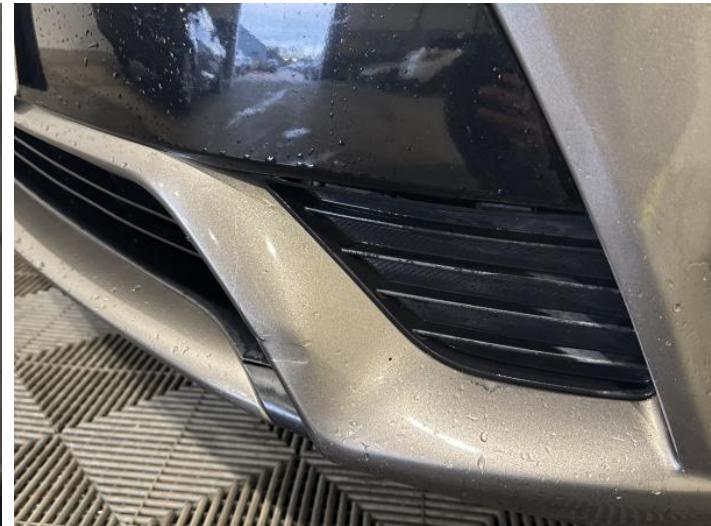
2: Bumper Front
Dented
With Paint Damage

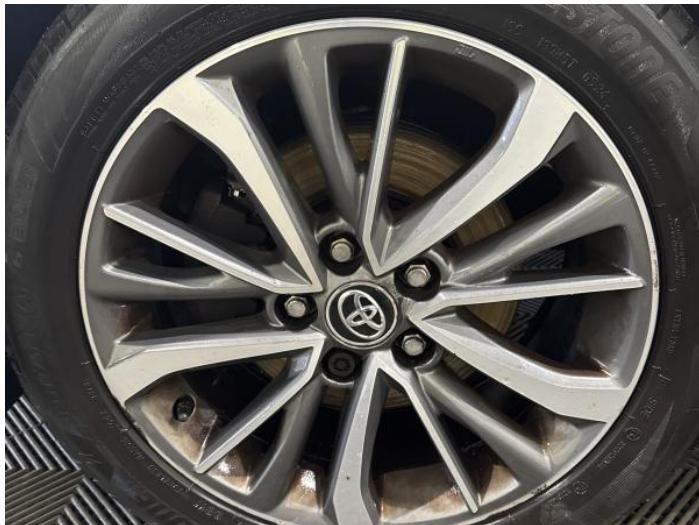
3: Wheel nsf
Scratched
Up To 50mm

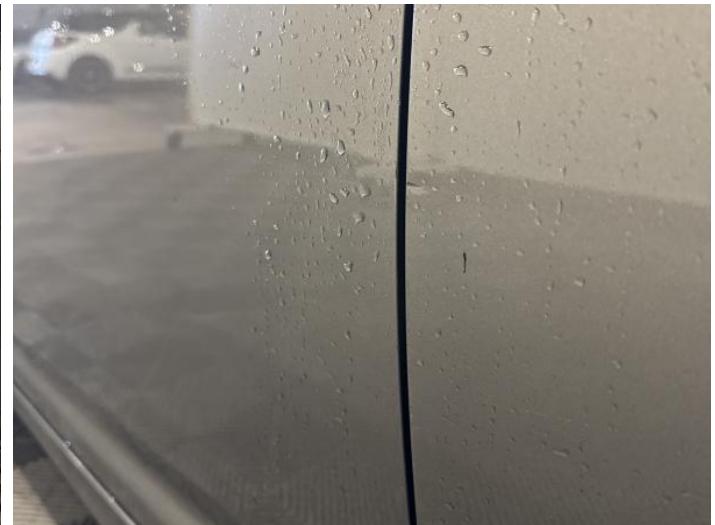
4: Door nsf
Chipped
Edge Chip

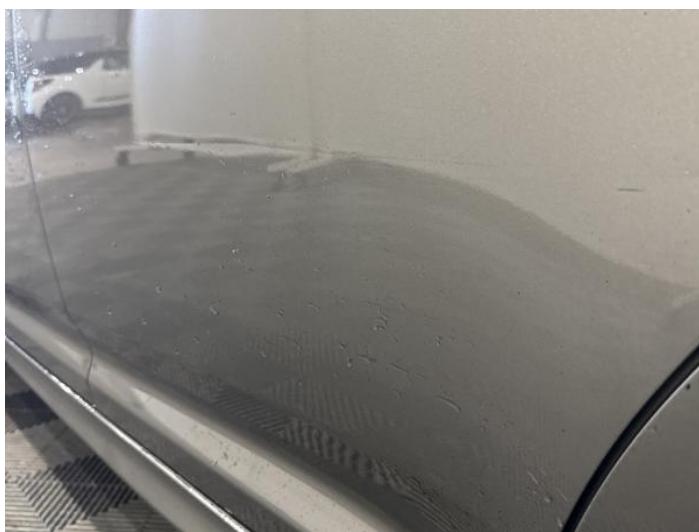
5: Door nsr
Dented
Over 30mm

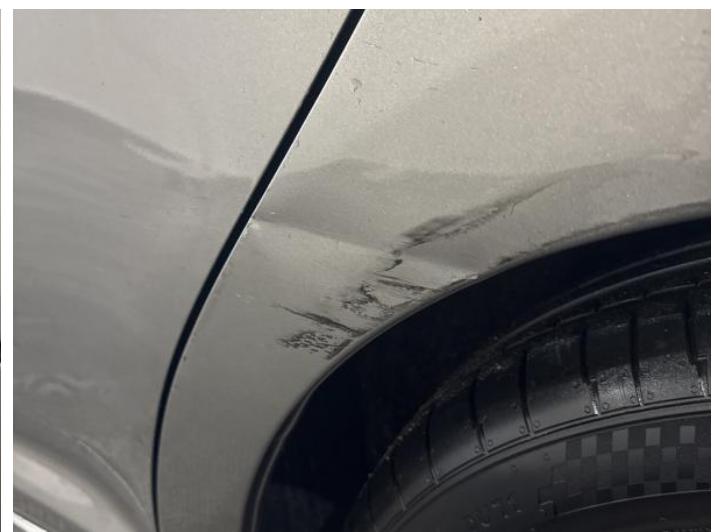
6: Qtr Panel nsr
Dented
Over 30mm

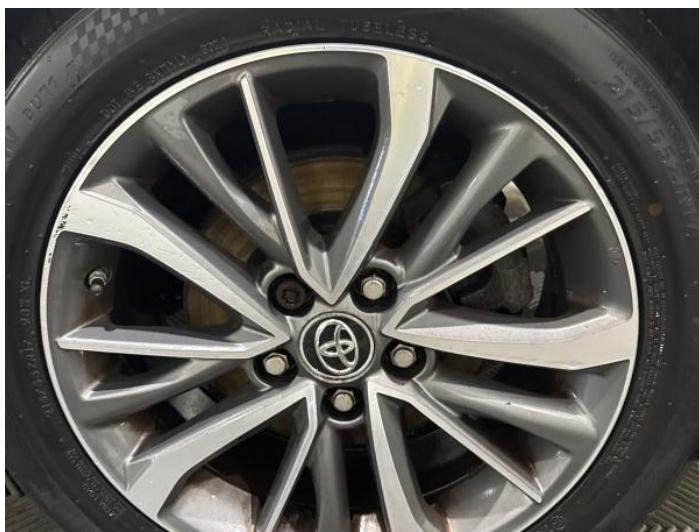
7: Wheel nsr
Scratched
Up To 50mm

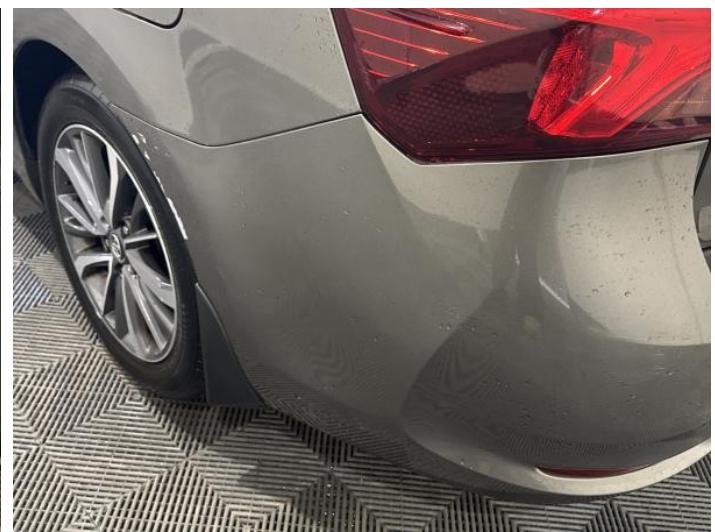
8: Bumper Rear
Scratched
Over 100mm Thru Paint

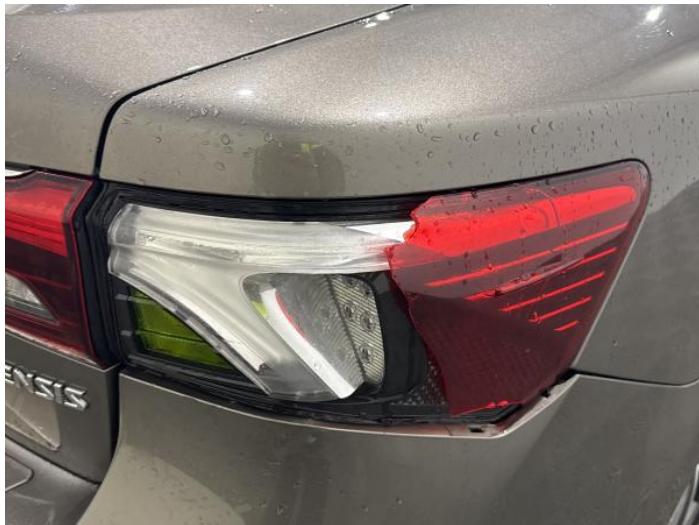
9: Fog Lamp osr
Broken
Replace

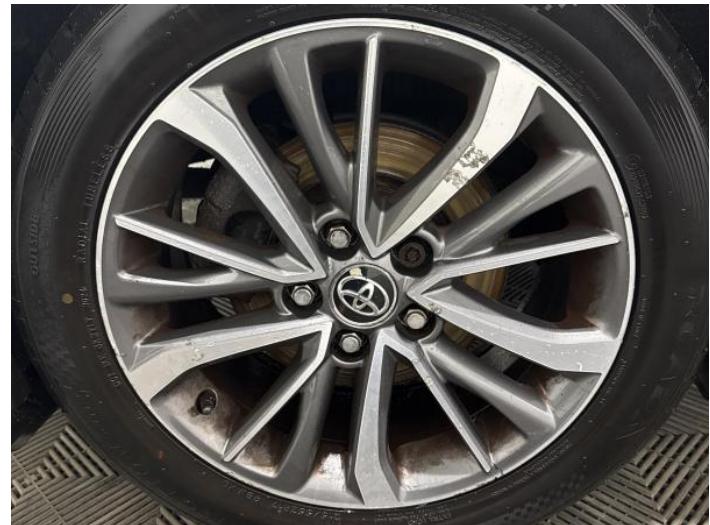
10: Wheel osr
Corroded
Light

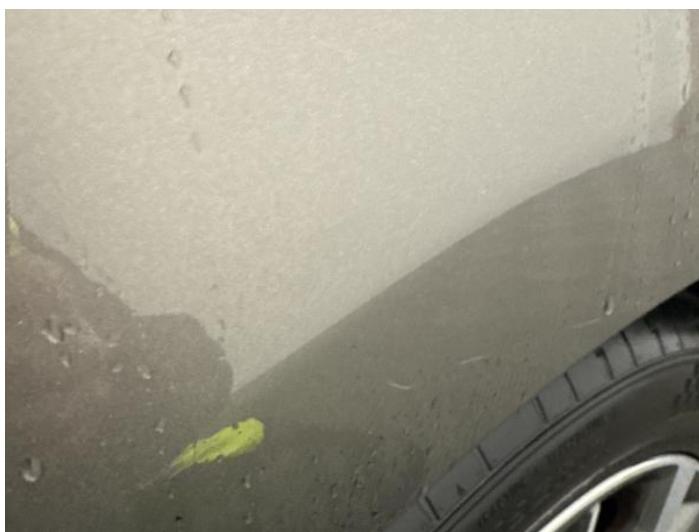
11: Qtr Panel osr
Scratched
Over 25mm Thru Paint

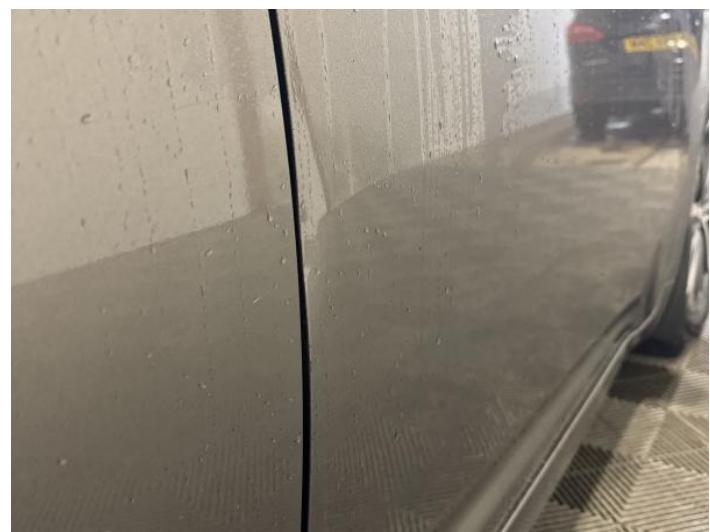
12: Door osr
Dented
Over 30mm

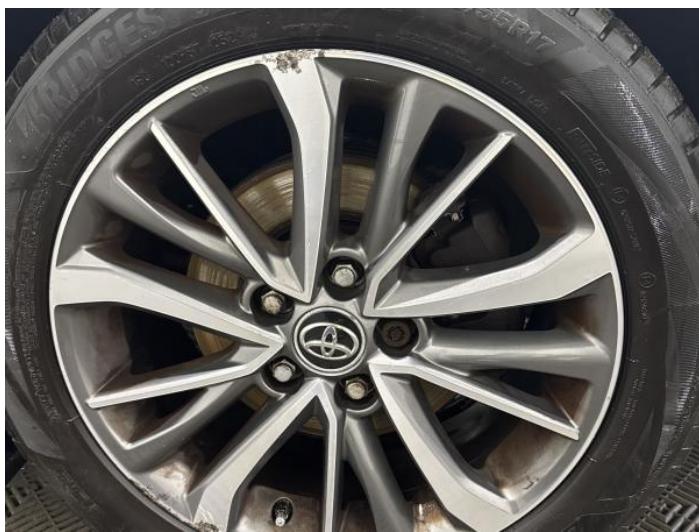
13: Wheel osr
Scratched
Over 50mm

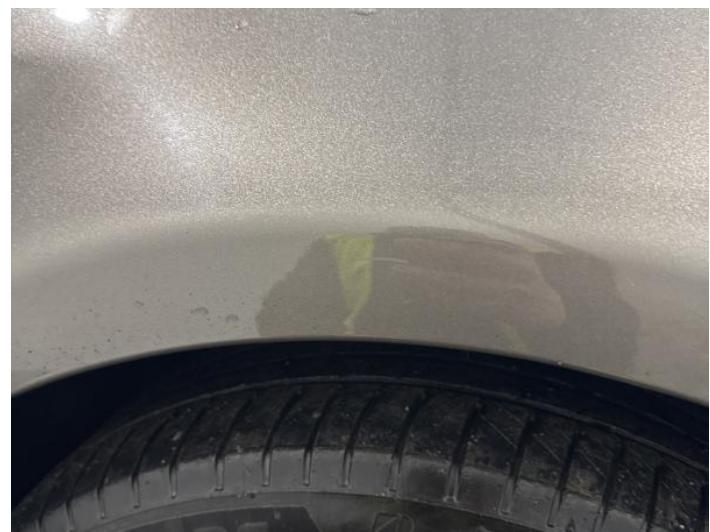
14: Wing osr
Scratched
UpTo 25mm Thru Paint
