VEHICLE INSPECTION REPORT

GU23JFK

Toyota C-Hr 1.8 Hybrid GR Sport 5dr CVT

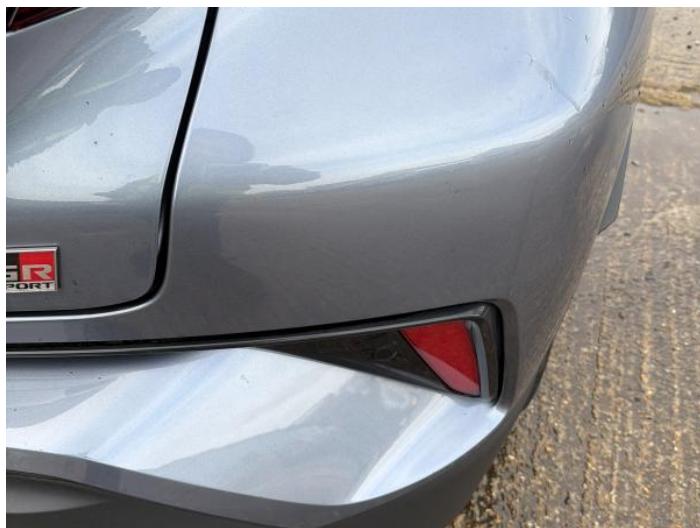
1: Bumper Rear
Chipped
Multiple Chips

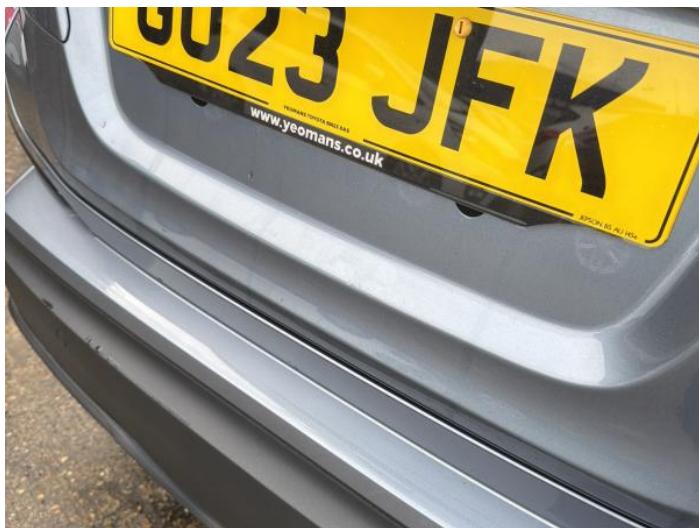
3: Boot Lid
Dented
Over 2 UpTo 10mm

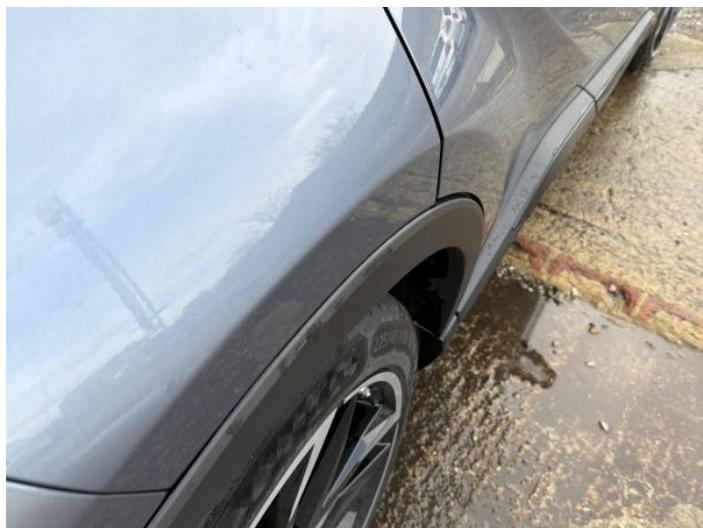
4: Qtr Panel osr
Chipped
1 To 5

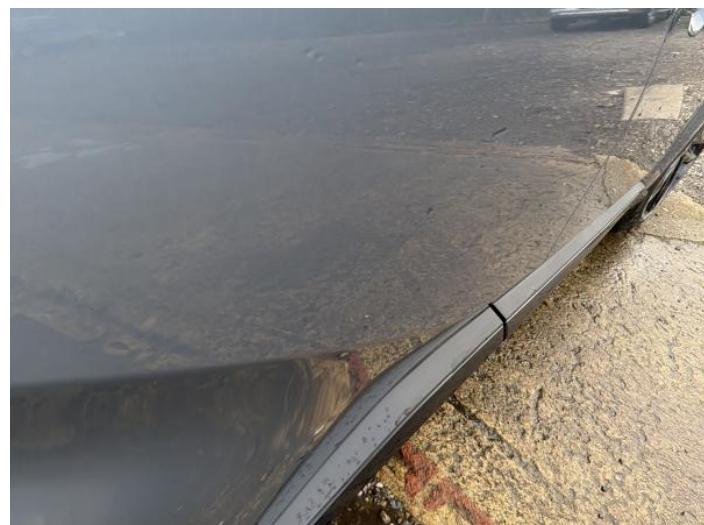
7: Door osr
Dented
Over 2 UpTo 10mm

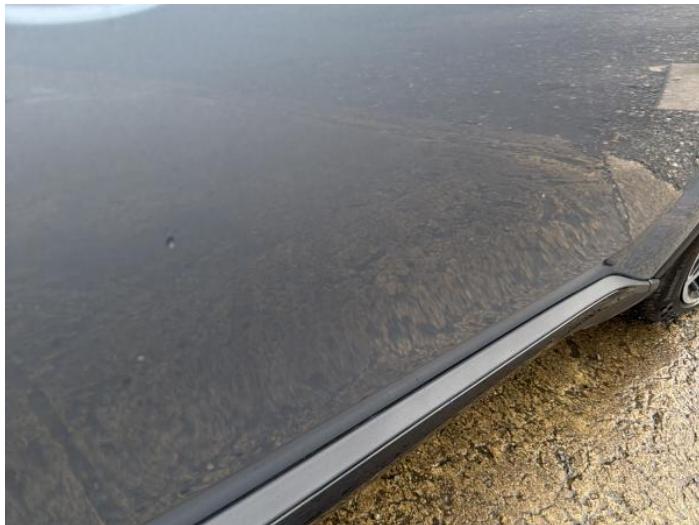
9: Door osf
Chipped
1 To 5

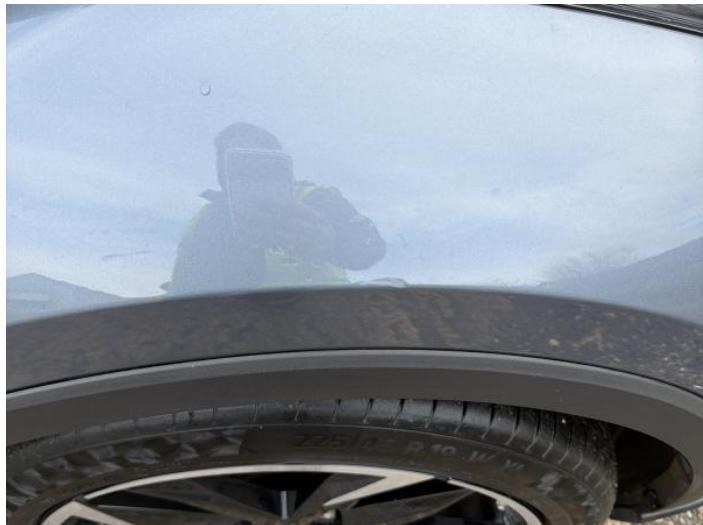
10: Wing osf
Chipped
1 To 5

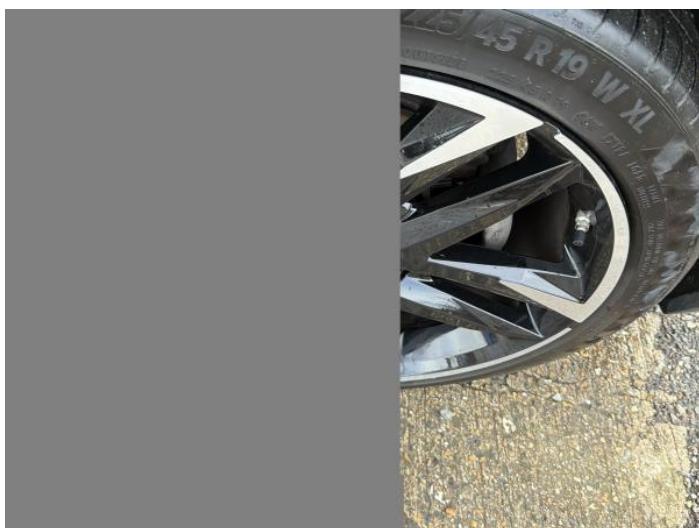
11: Wheel osf
Scratched
Up To 50mm

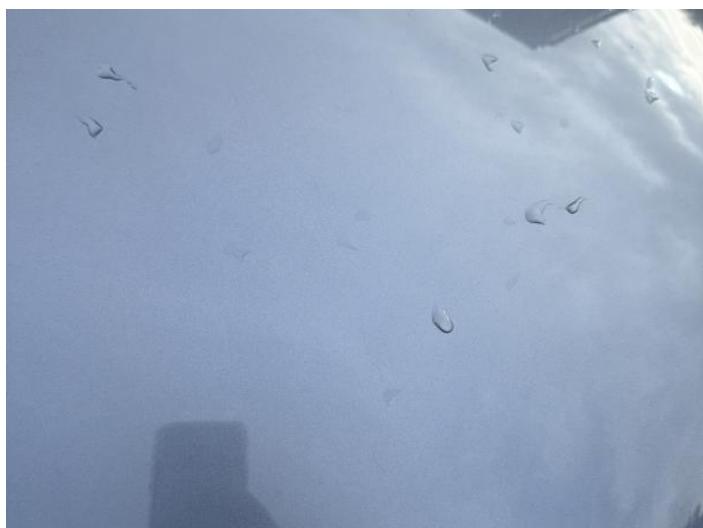
12: Bonnet
Chipped
1 To 5

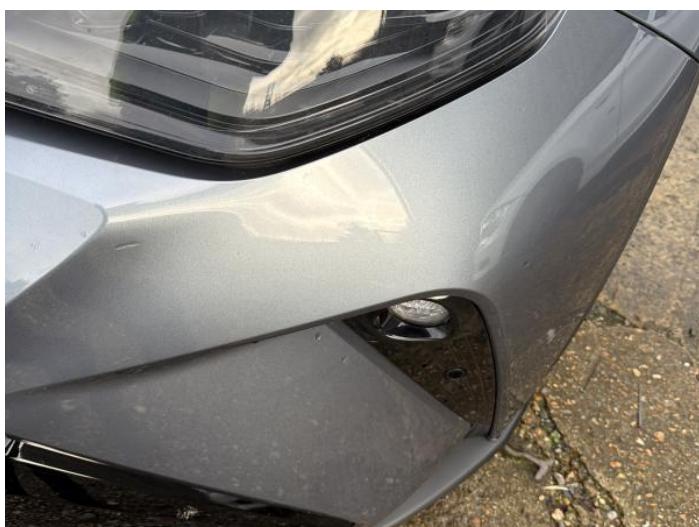
13: Bumper Front
Chipped
Multiple Chips

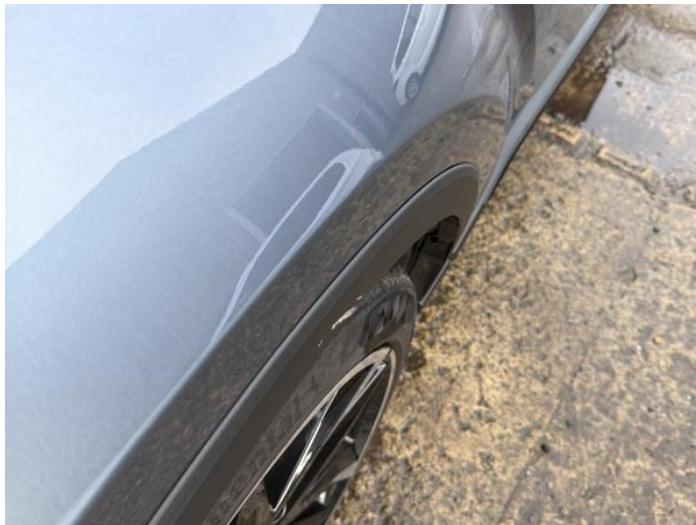
15: Wing nsf
Chipped
1 To 5

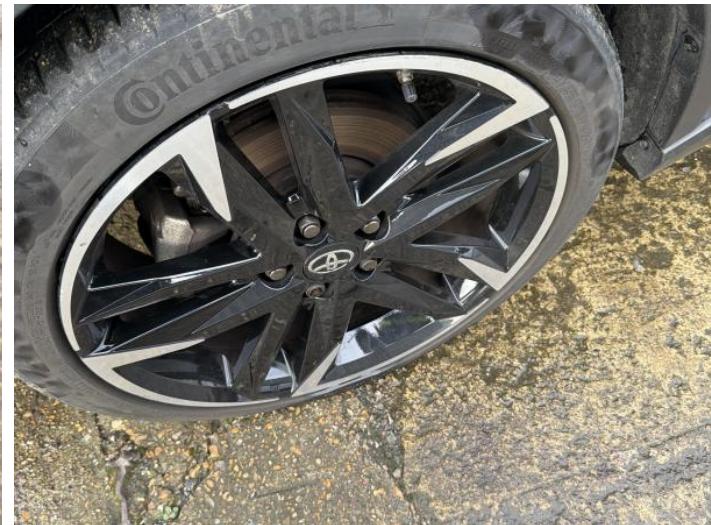
16: Wheel nsf
Scratched
Up To 50mm

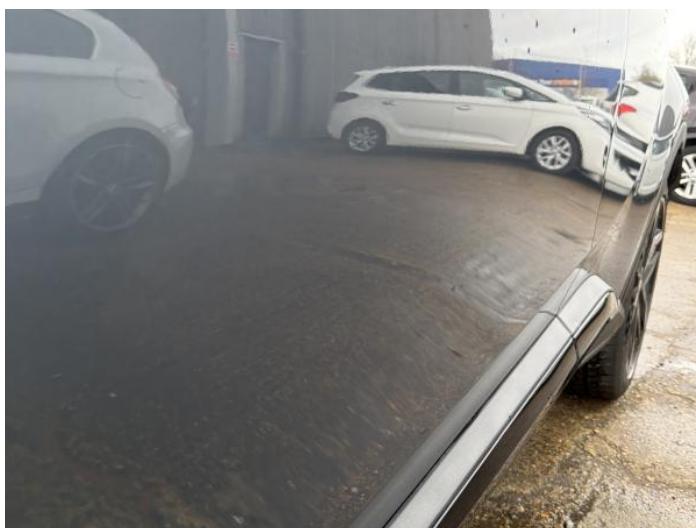
17: Door nsf
Dented
2 Or Less UpTo 10mm

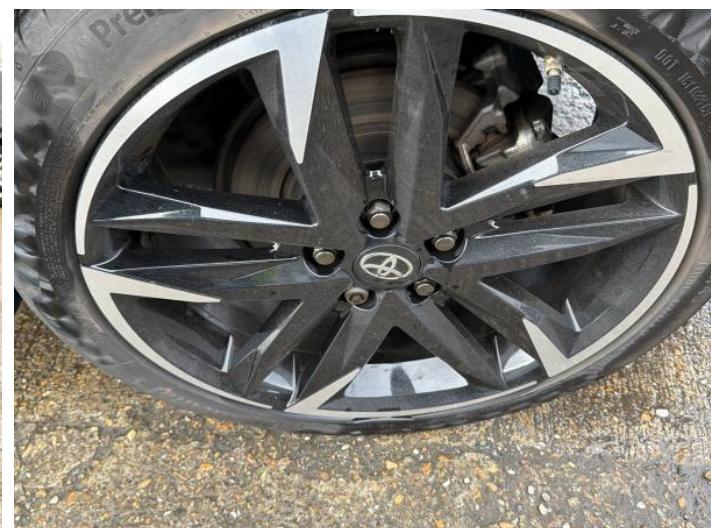
18: Wheel nsr
Scratched
Up To 50mm
