VEHICLE INSPECTION REPORT

GV17VBM

Ford Fiesta 1.1 Zetec 5dr

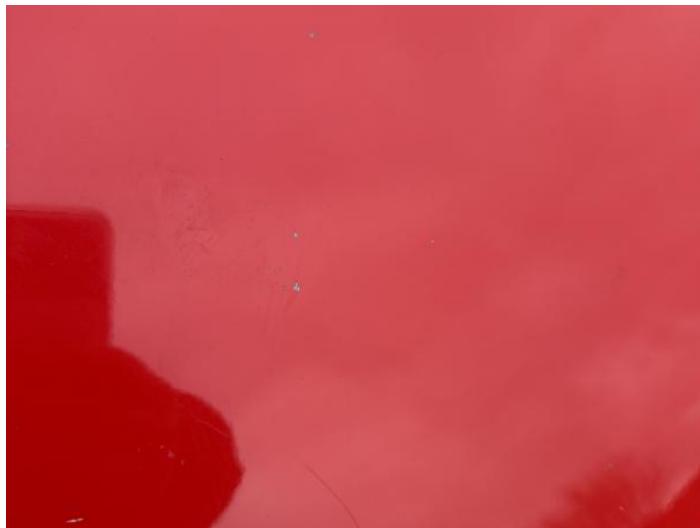
1: Bonnet
Chipped
Multiple Chips

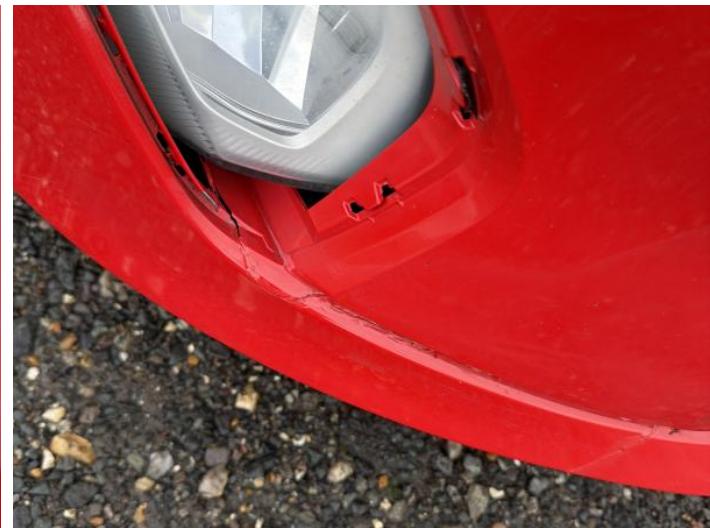
2: Bumper Front
Cracked
Over 25mm

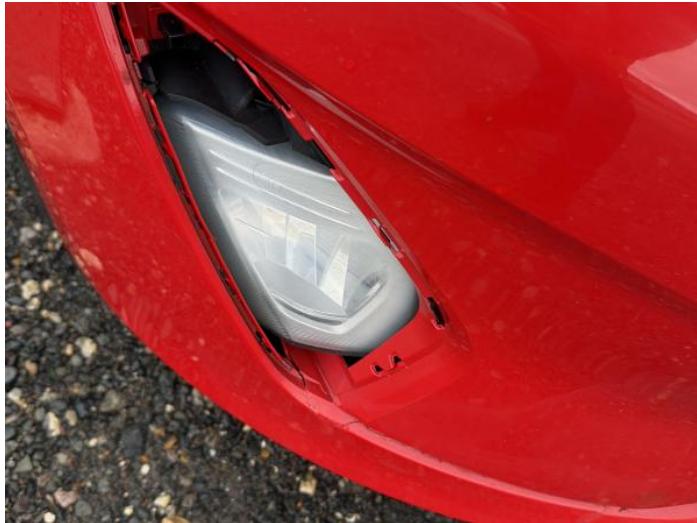
3: Fog Lamp Surround os
Missing
Replace

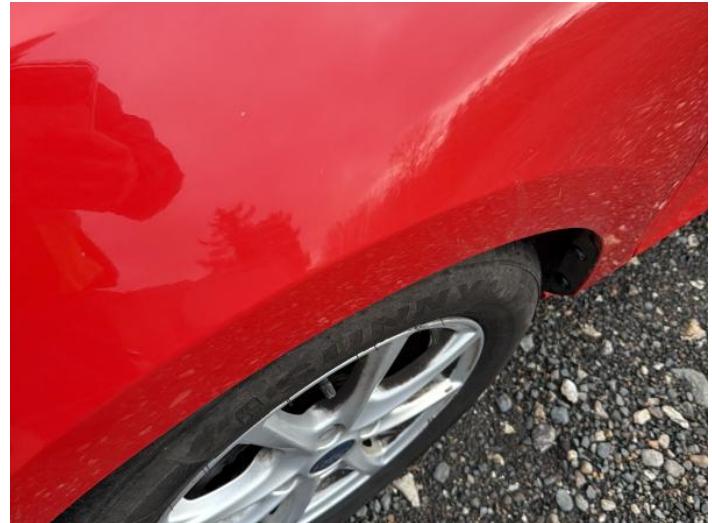
4: Wing nsf
Chipped
1 To 5

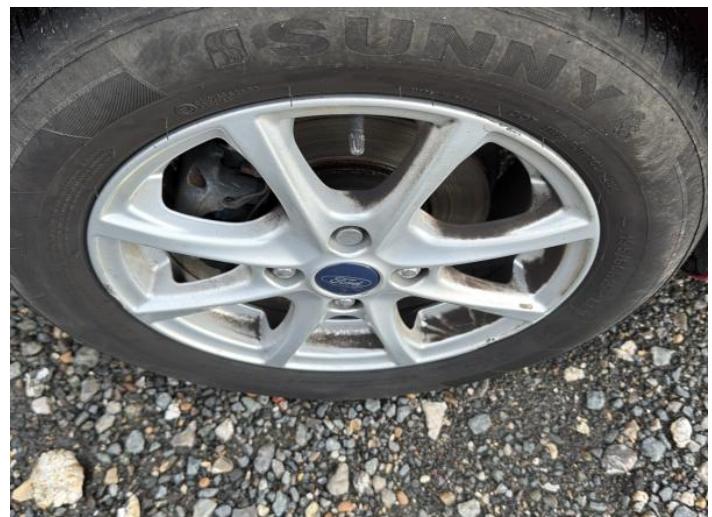
6: Wheel nsf
Scratched
Over 50mm

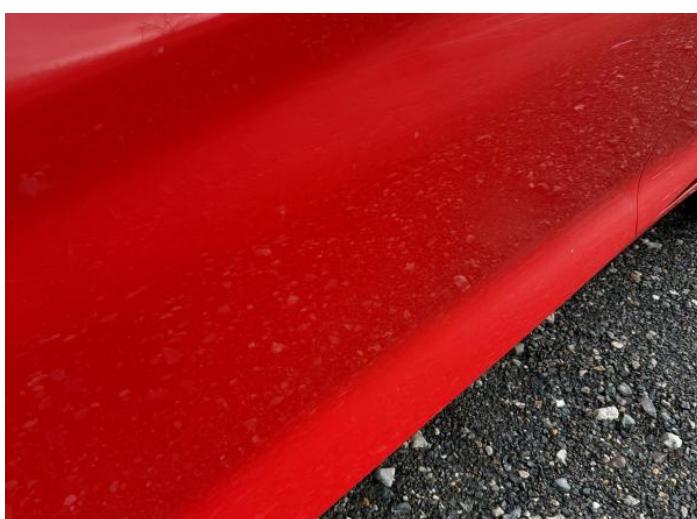
7: Door nsf
Chipped
1 To 5

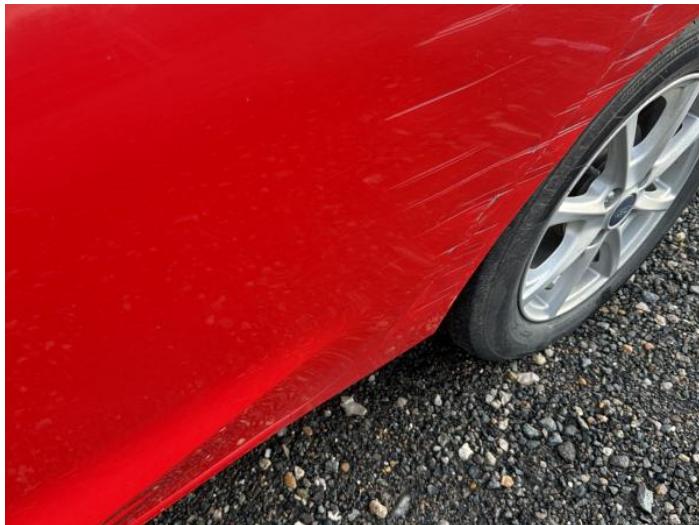
9: Door nsr
Dented
With Paint Damage

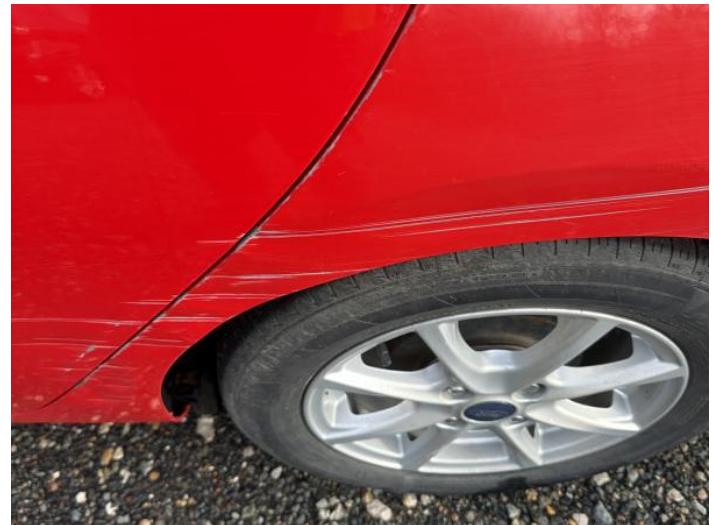
10: Qtr Panel nsr
Dented
With Paint Damage

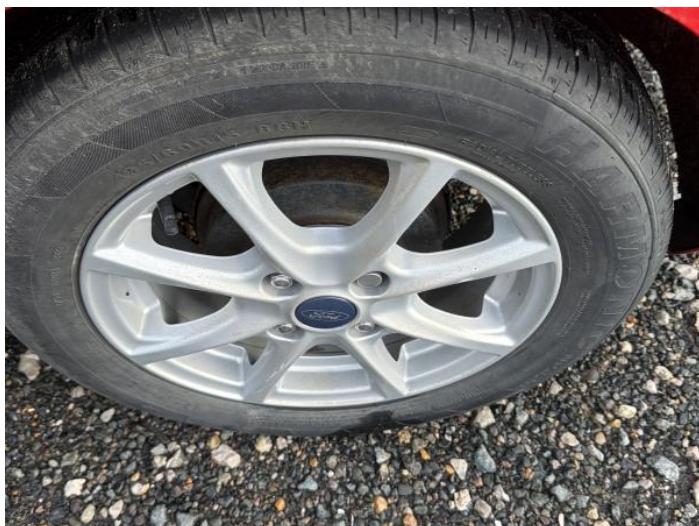
11: Wheel nsr
Scratched
Over 50mm

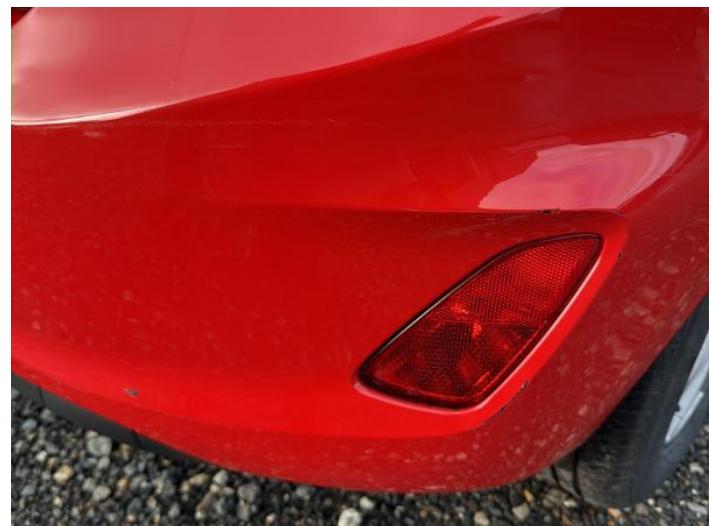
12: Bumper Rear
Scratched
Over 100mm Thru Paint

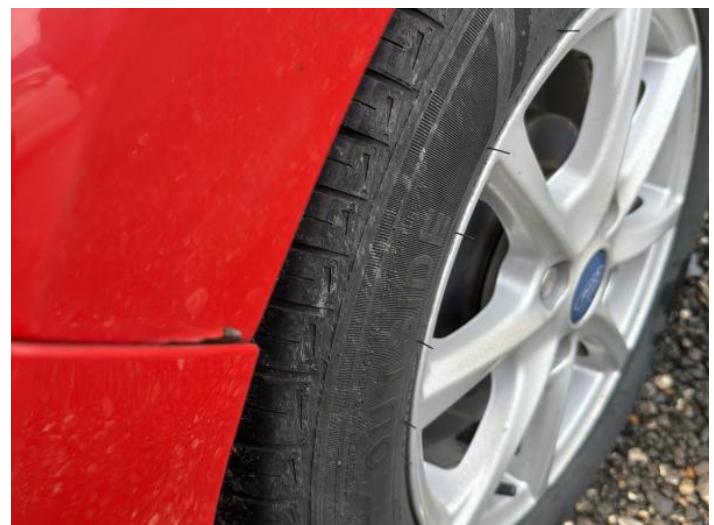
14: Qtr Panel osr
Poor Previous Repair
Paint Flake

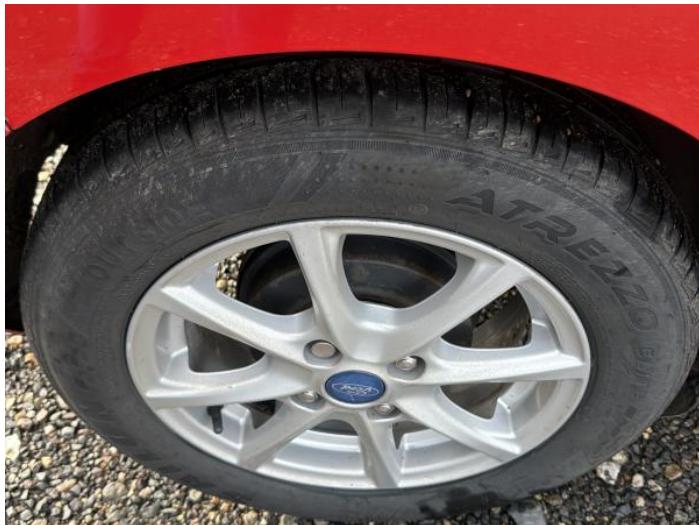
15: Wheel osr
Scratched
Over 50mm

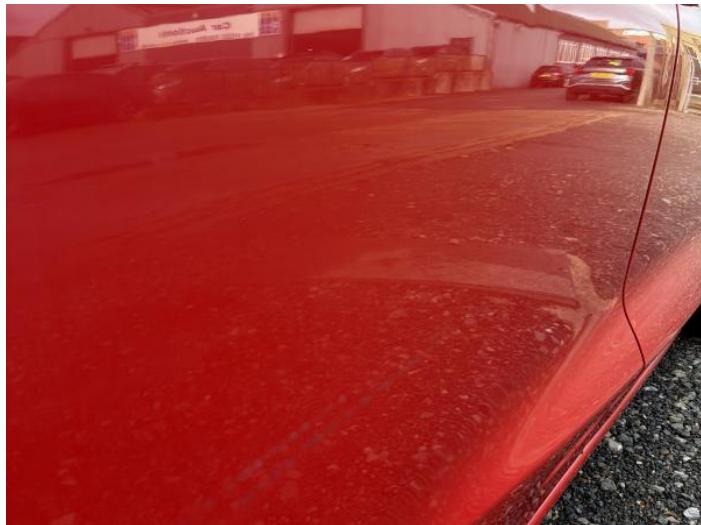
16: Door osr
Dented
With Paint Damage

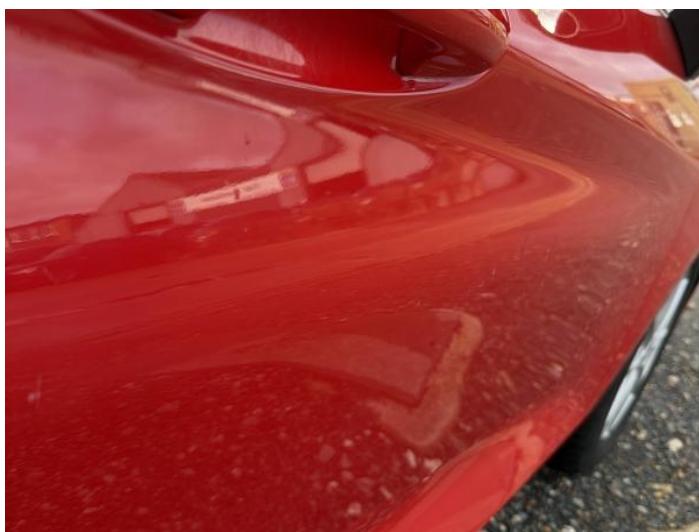
17: Door osf
Dented
Over 30mm

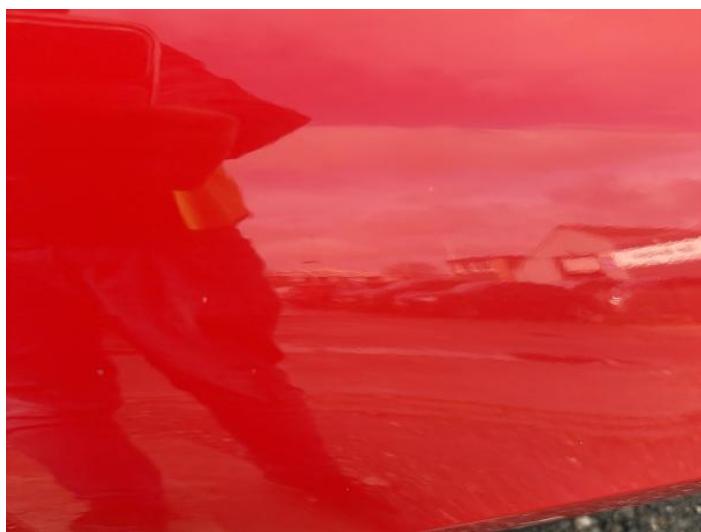
18: Wing osf
Chipped
1 To 5

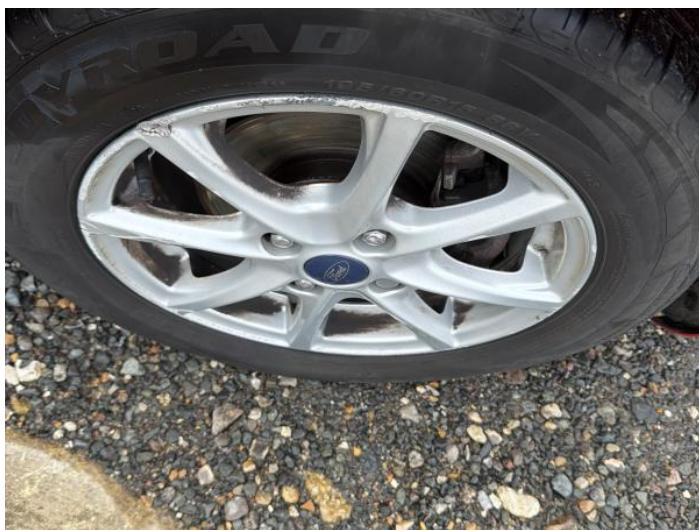
19: Wheel osf
Scratched
Over 50mm

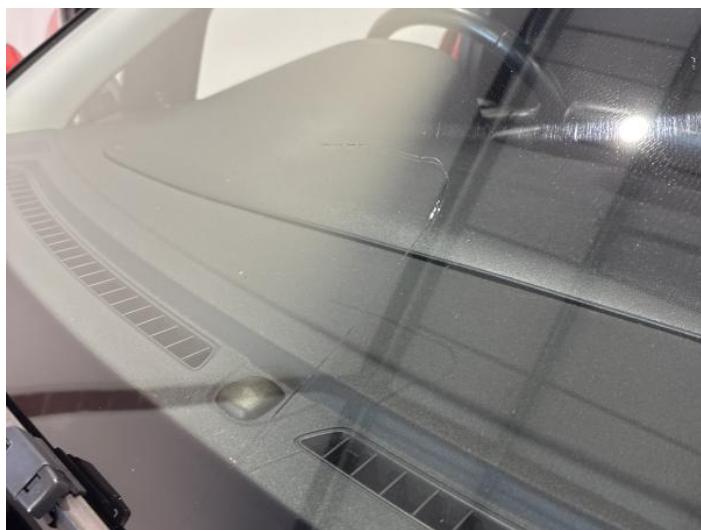
20: Screen Front
Cracked
Replace
