VEHICLE INSPECTION REPORT

GL67VHN

Volkswagen Polo 1.2 TSI Match Edition 5dr

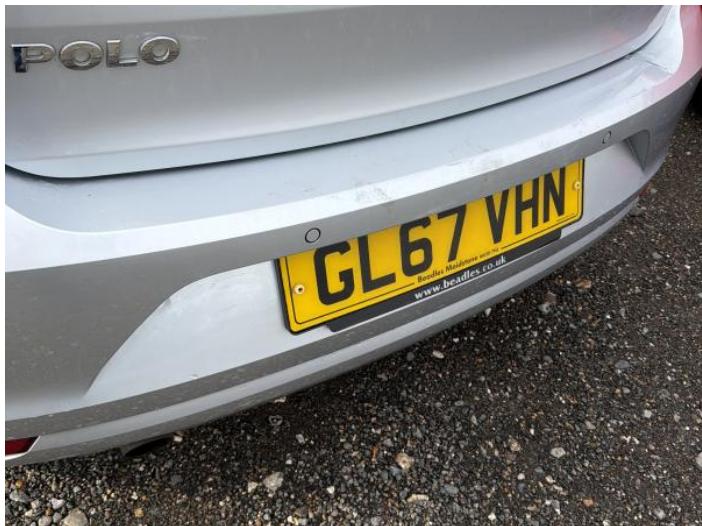
1: Bumper Rear
Scratched
Over 100mm Thru Paint

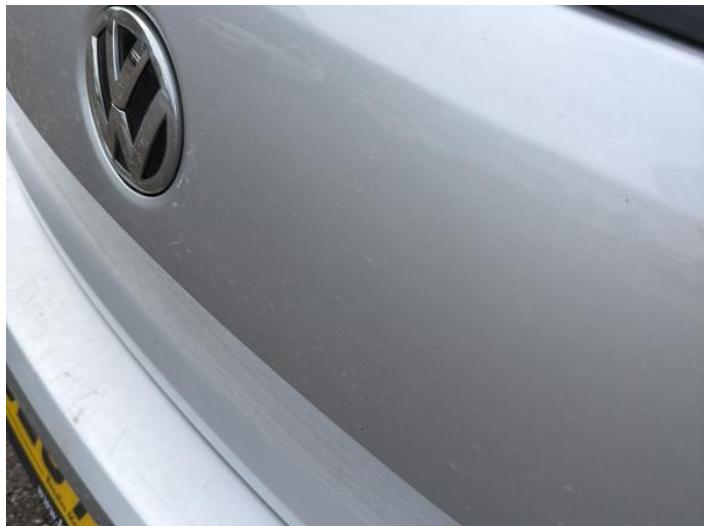
2: Boot Lid
Dented
With Paint Damage

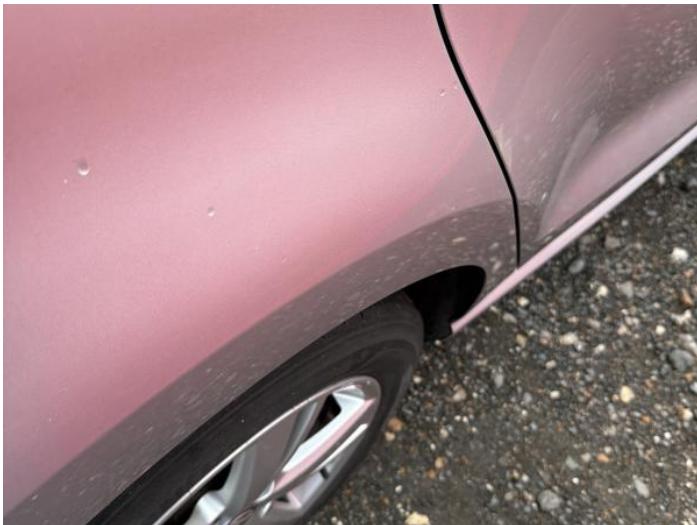
3: Qtr Panel osr
Dented
2 Or Less UpTo 10mm

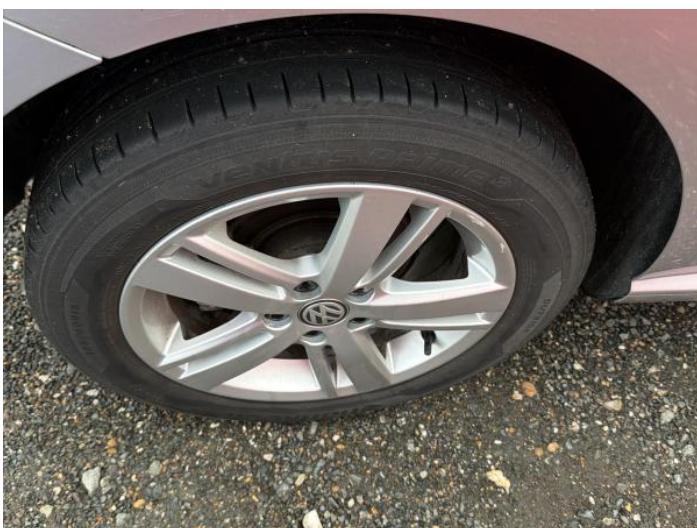
5: Wheel osr
Scratched
Over 50mm

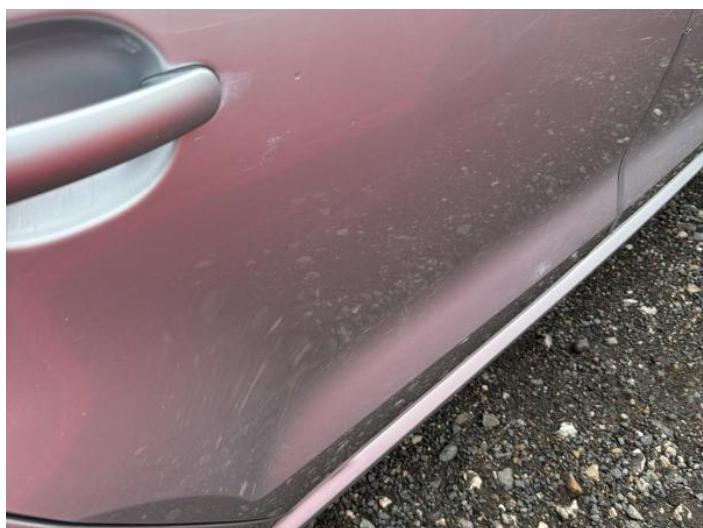
6: Door osr
Scratched
Over 25mm Thru Paint

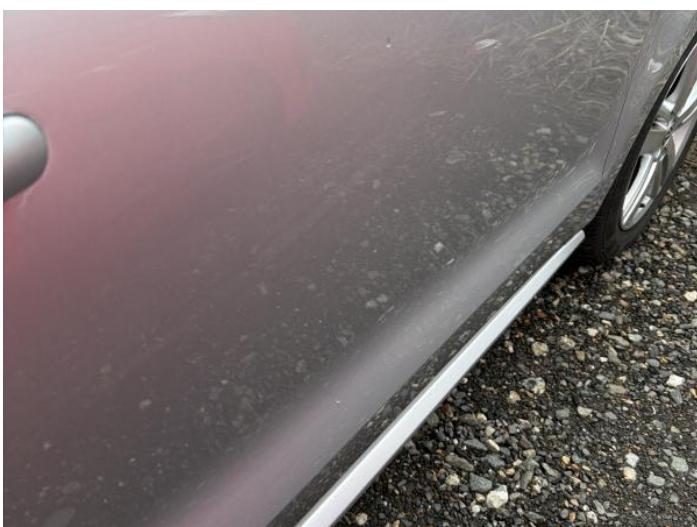
7: Door osf
Chipped
Multiple Chips

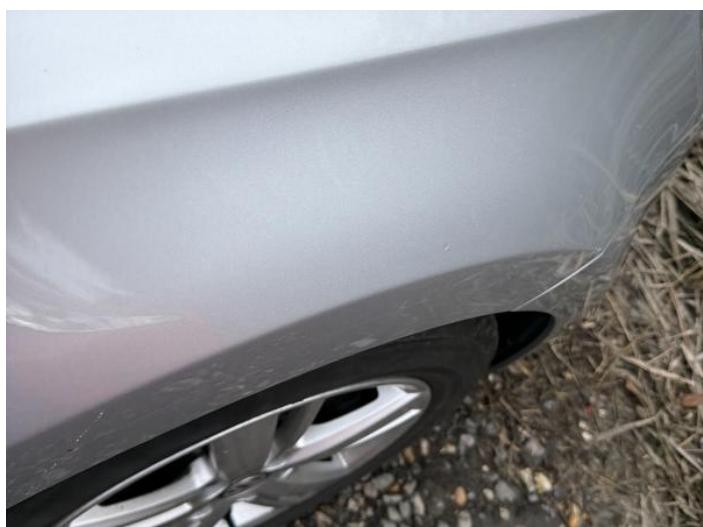
8: Wing osf
Chipped
1 To 5

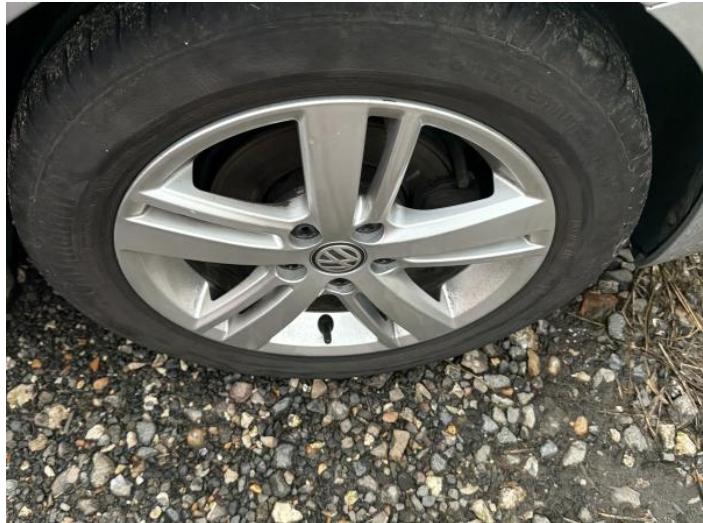
10: Wheel osf
Scratched
Over 50mm

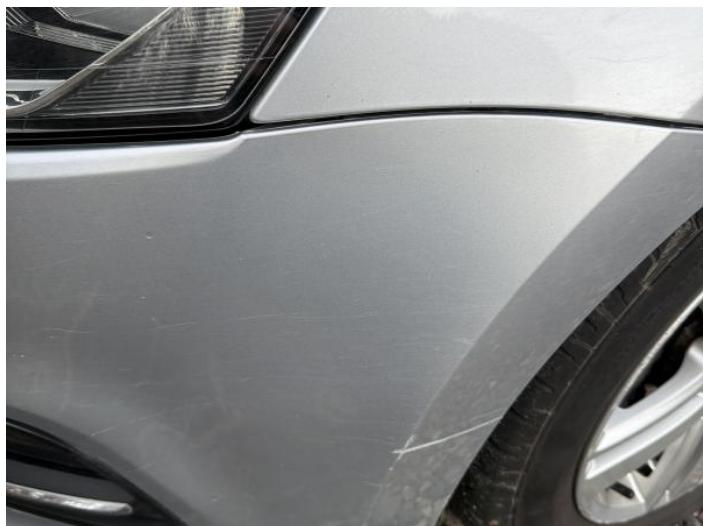
12: Bumper Front
Scratched
Over 100mm Thru Paint

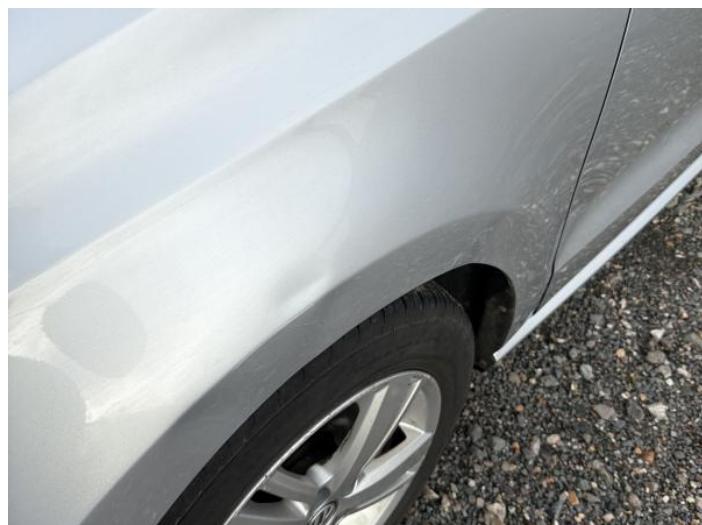
13: Wing nsf
Dented
With Paint Damage

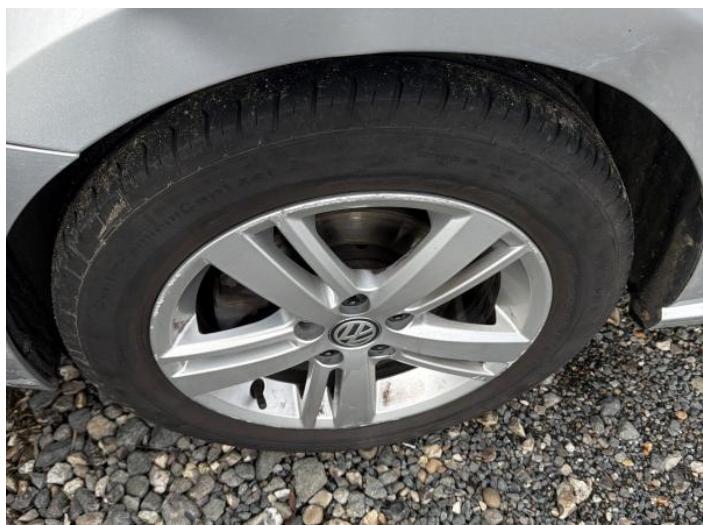
14: Wheel nsf
Scratched
Over 50mm

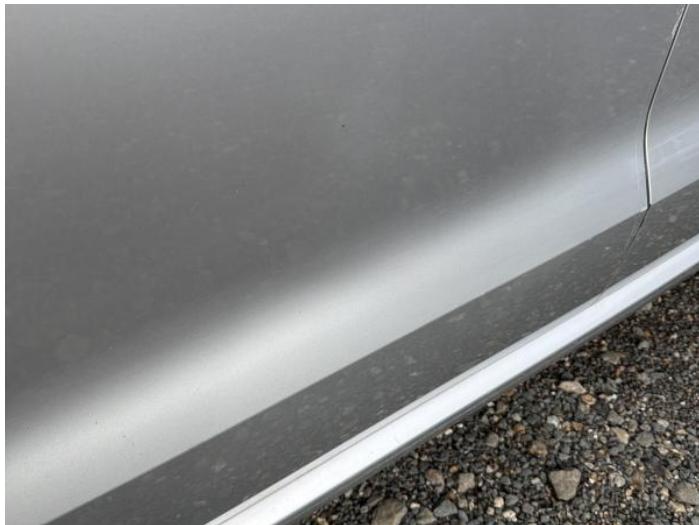
15: Door nsf
Chipped
Multiple Chips

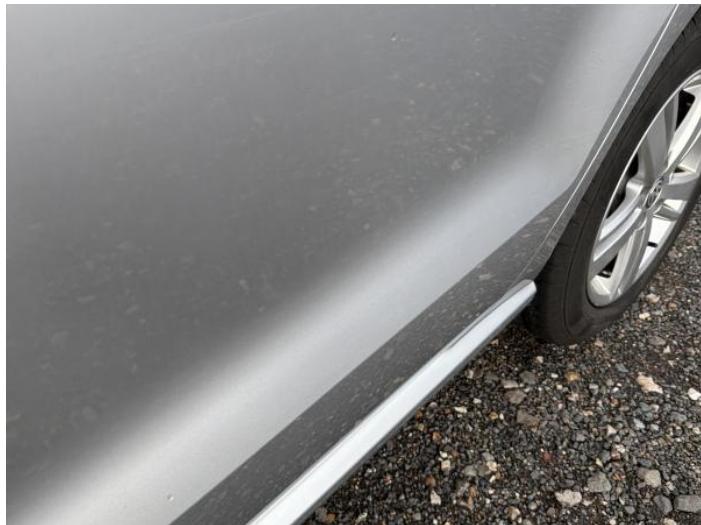
16: Door nsr
Chipped
1 To 5

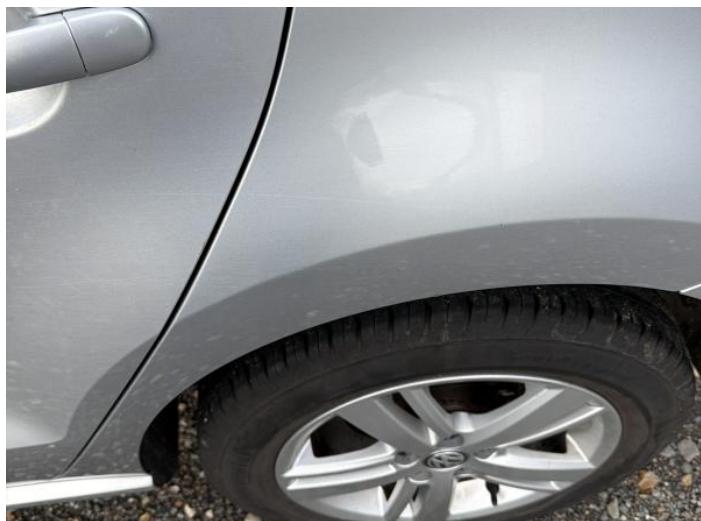
18: Qtr Panel nsr
Chipped
1 To 5

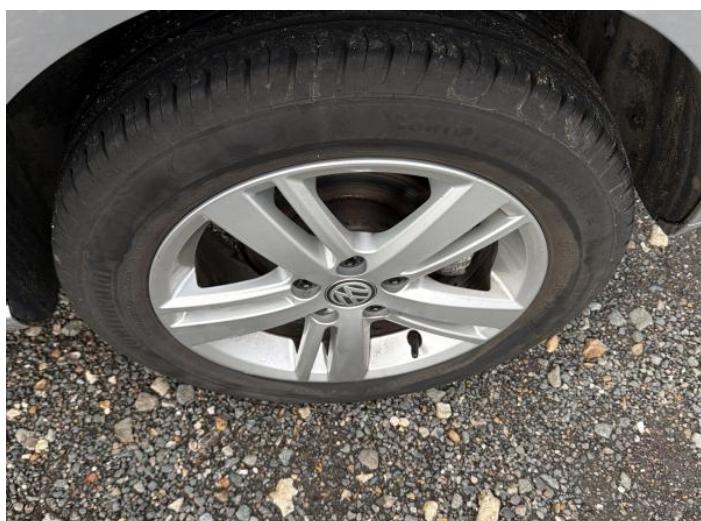
20: Wheel nsr
Scratched
Up To 50mm
