VEHICLE INSPECTION REPORT

KF21WZW

Ford Focus 1.5 EcoBlue 120 ST-Line 5dr Auto

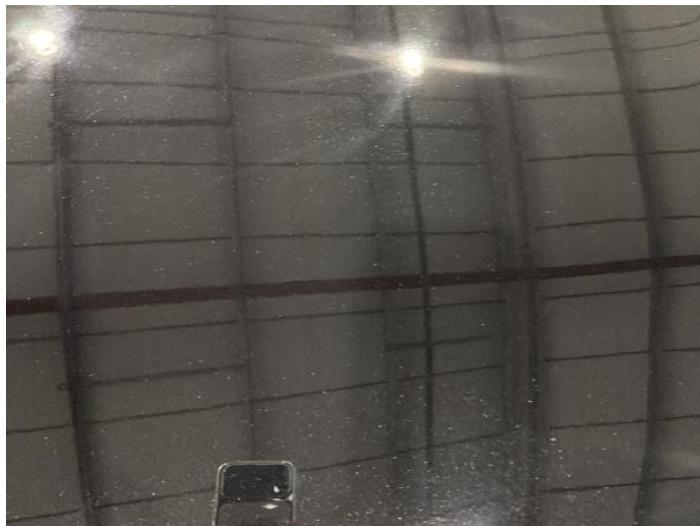
1: Bonnet
Chipped
1 To 5

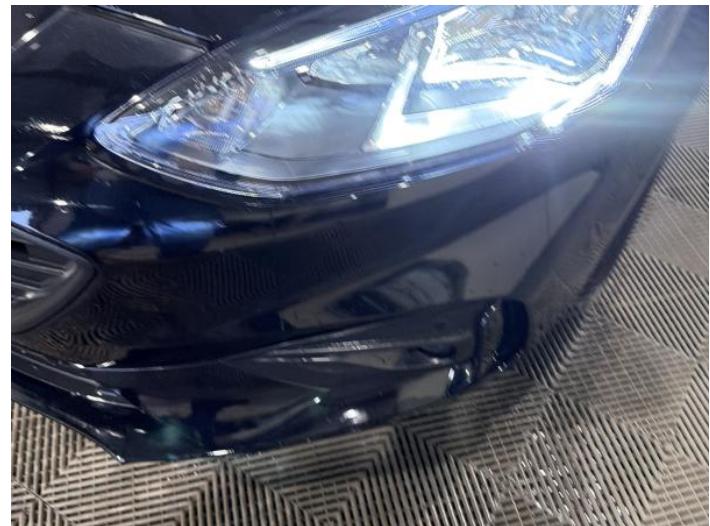
2: Bumper Front
Chipped
Multiple Chips

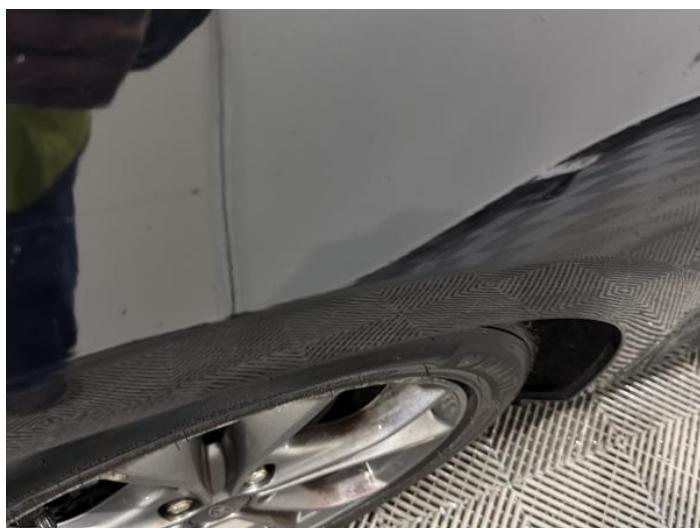
5: Wing nsf
Dented
Over 2 UpTo 10mm

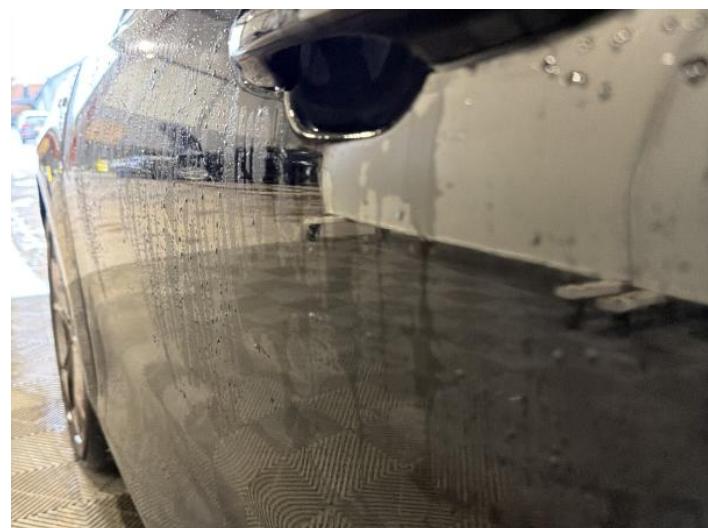
6: Door nsf
Chipped
1 To 5

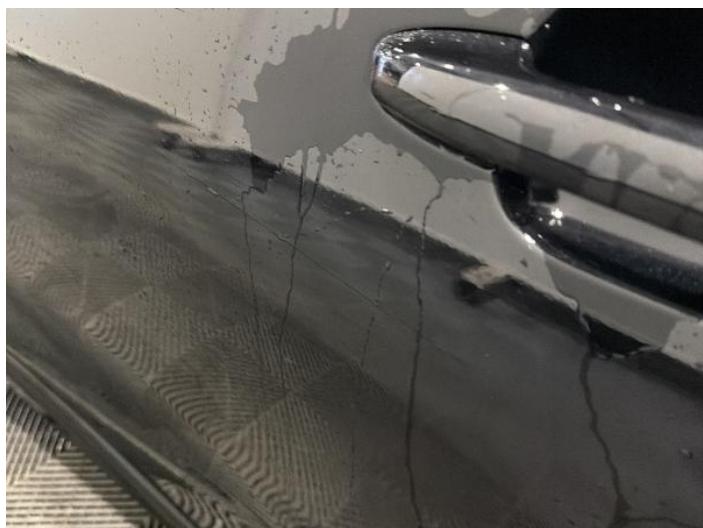
7: Door nsf
Scratched
Over 25mm Not Thru Paint

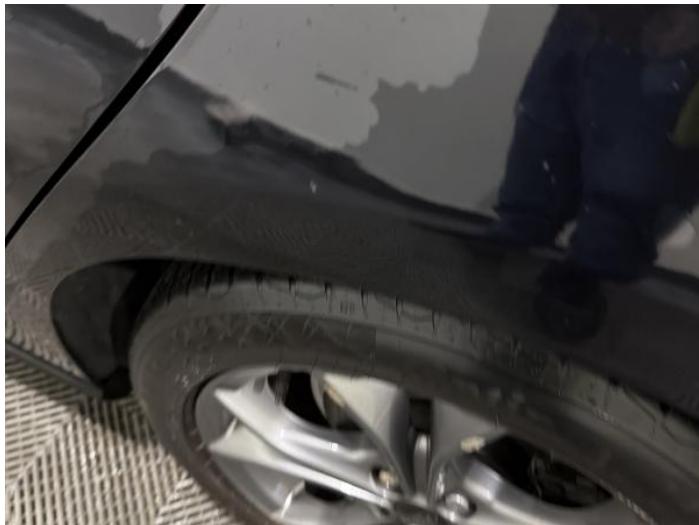
9: Qtr Panel nsr
Chipped
1 To 5

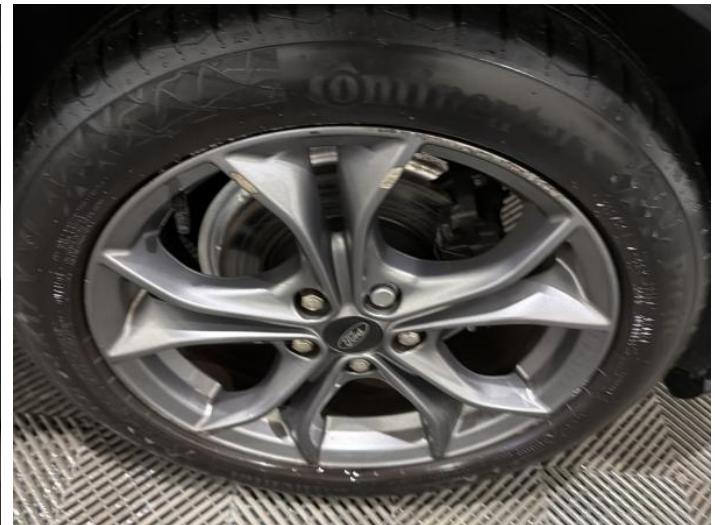
10: Wheel nsr
Scratched
Over 50mm

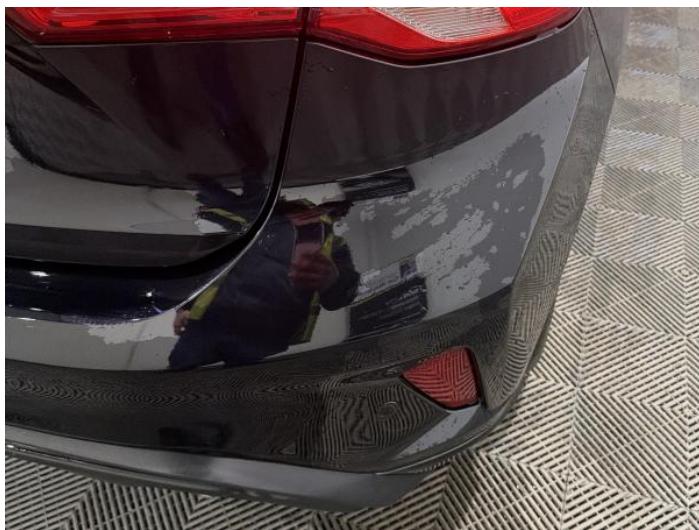
11: Bumper Rear
Chipped
Multiple Chips

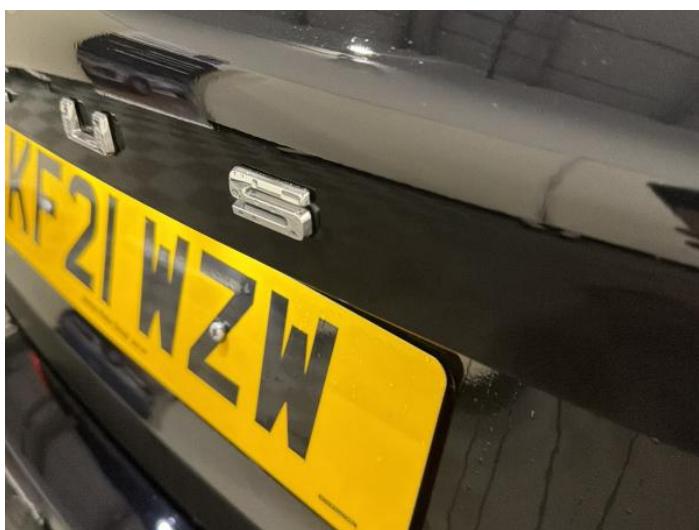
13: Boot Lid
Dented
Over 2 UpTo 10mm

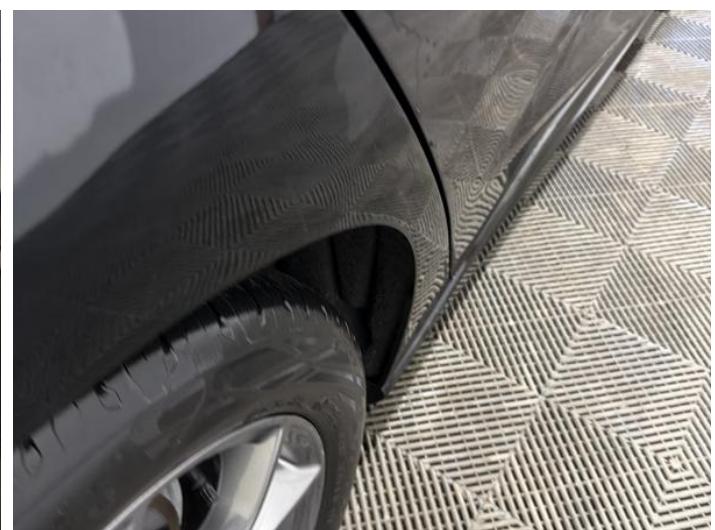
14: Qtr Panel osr
Dented
2 Or Less UpTo 10mm

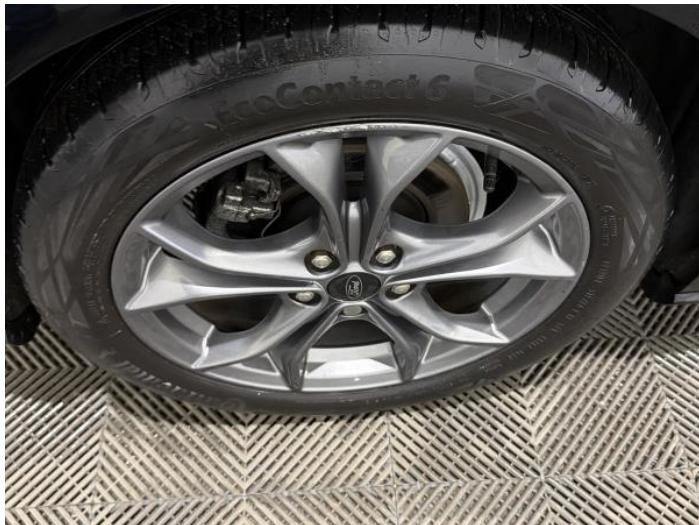
15: Wheel osr
Scratched
Over 50mm

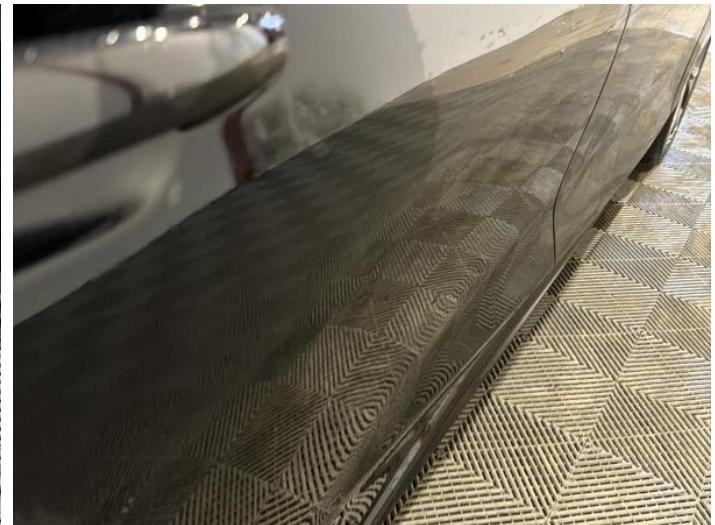
16: Door osr
Chipped
1 To 5

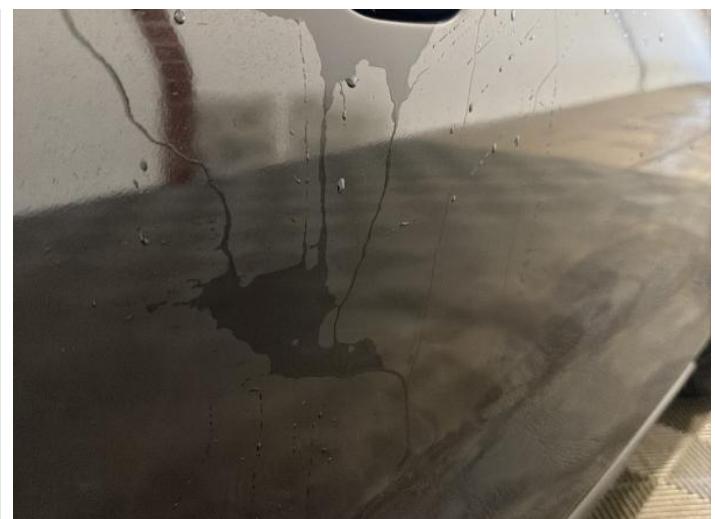
18: Door osf
Chipped
1 To 5

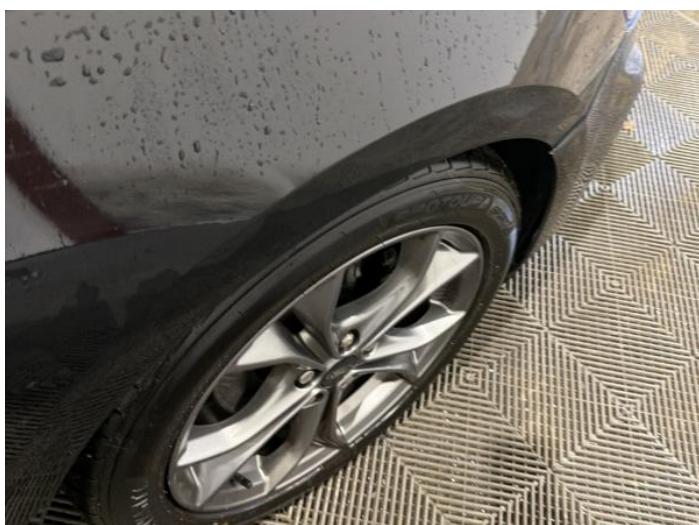
19: Wing osf
Dented
Over 2 UpTo 10mm

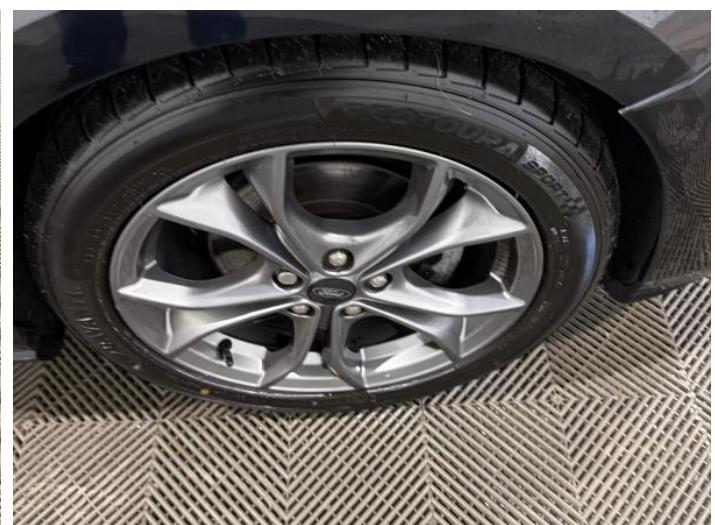
20: Wheel osf
Scratched
Up To 50mm
