VEHICLE INSPECTION REPORT

KM65JXF

Mini Clubman 1.5 Cooper 6dr

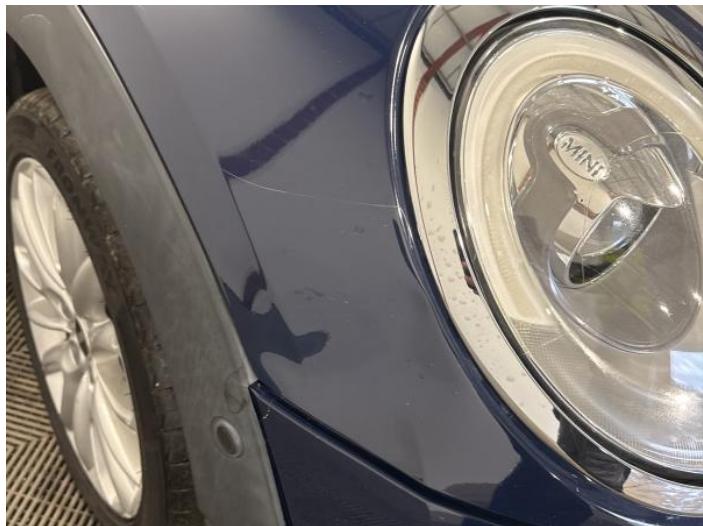
1: Bonnet
Dented
With Paint Damage

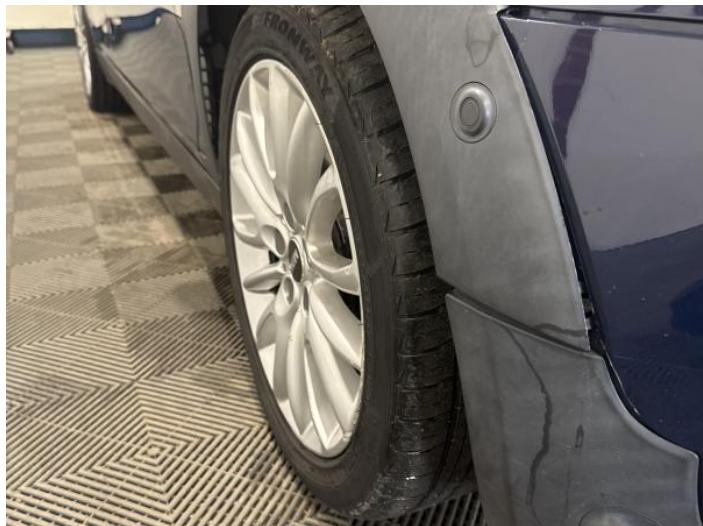
2: Wing Front Arch Extension os
Scuffed (Unpainted)
Over 100mm

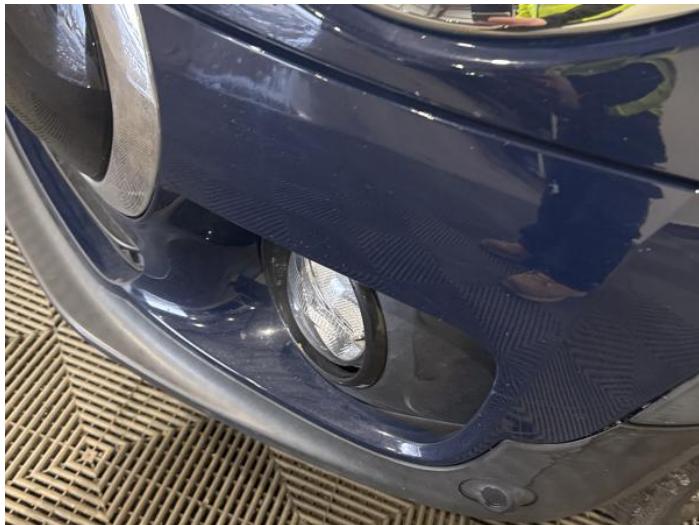
3: Bumper Front
Chipped
Multiple Chips

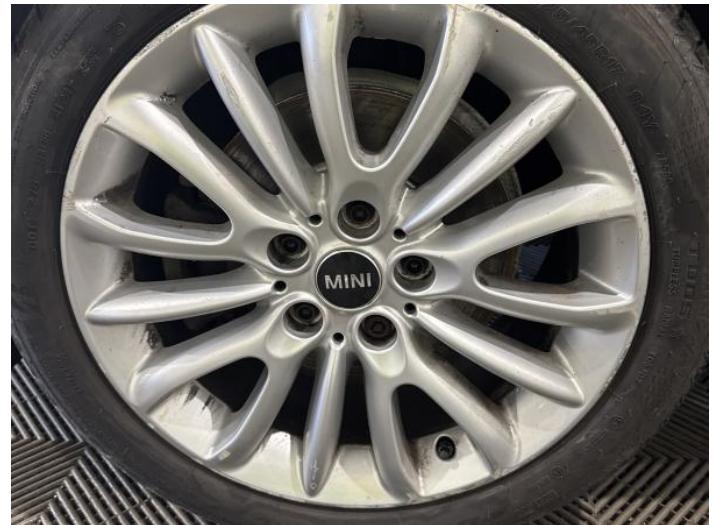
4: Wheel nsf
Scratched
Over 50mm

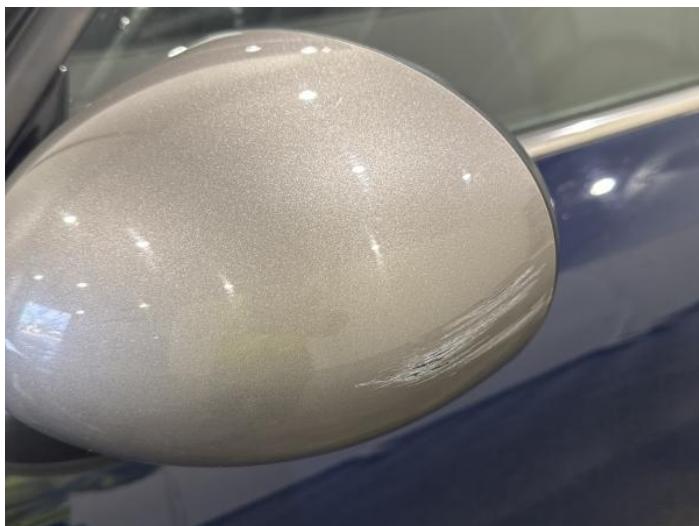
5: Door Mirror Assy nsf
Scratched (Painted)
Over 25mm Thru Paint

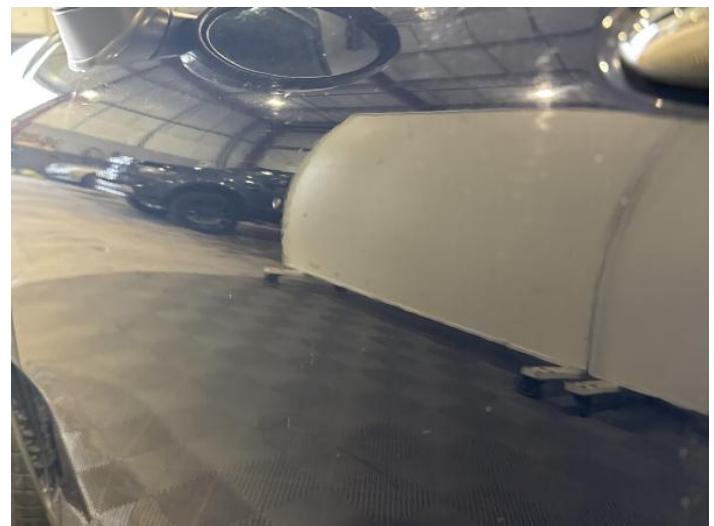
6: Door nsf
Dented
Between 10mm + 30mm

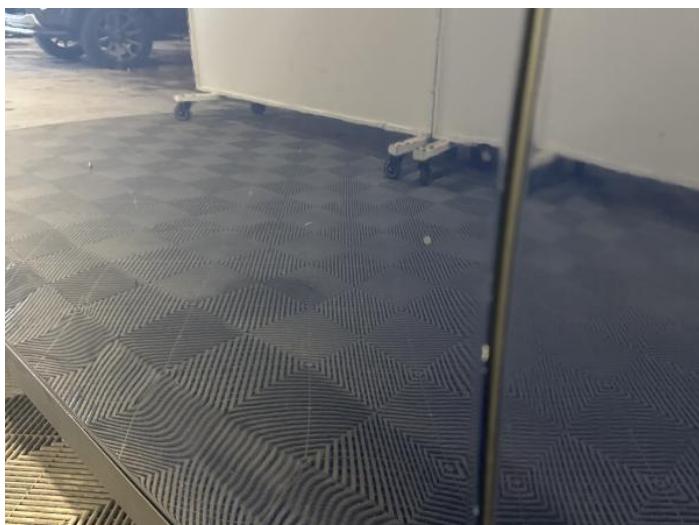
7: Door nsf
Chipped
1 To 5

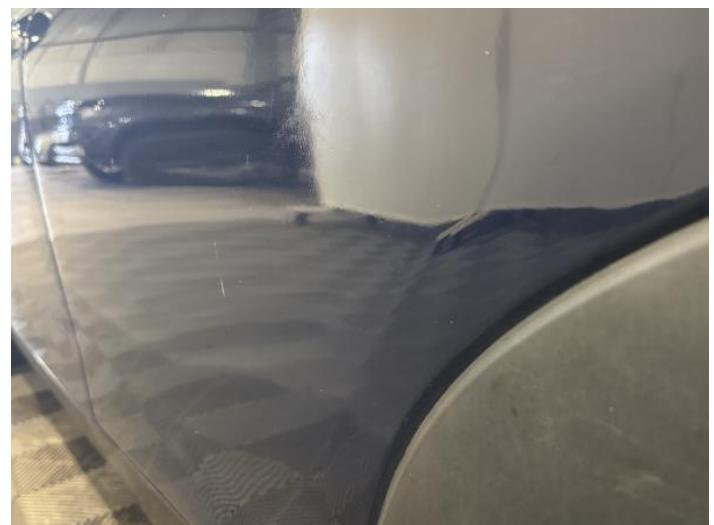
8: Door nsr
Poor Previous Repair
Rippled UpTo 30%

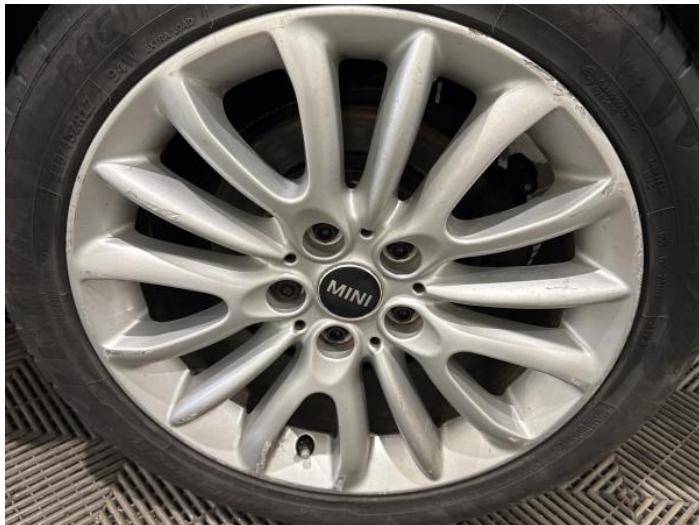
9: Wheel nsr
Scratched
Over 50mm

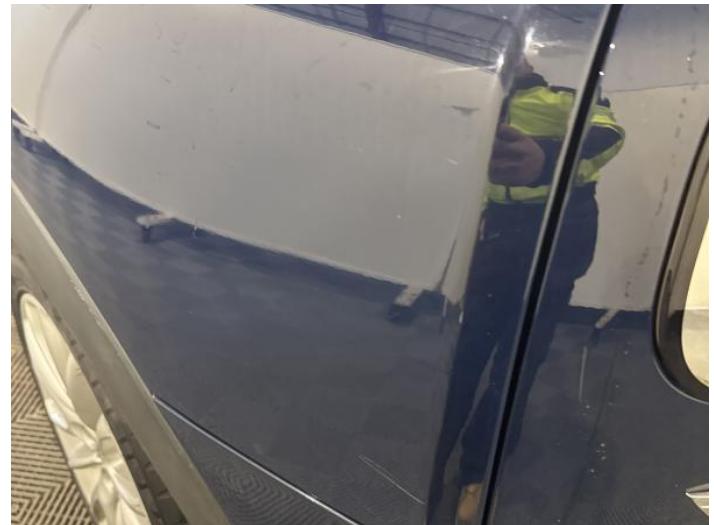
10: Qtr Panel nsr
Scratched
Over 25mm Thru Paint

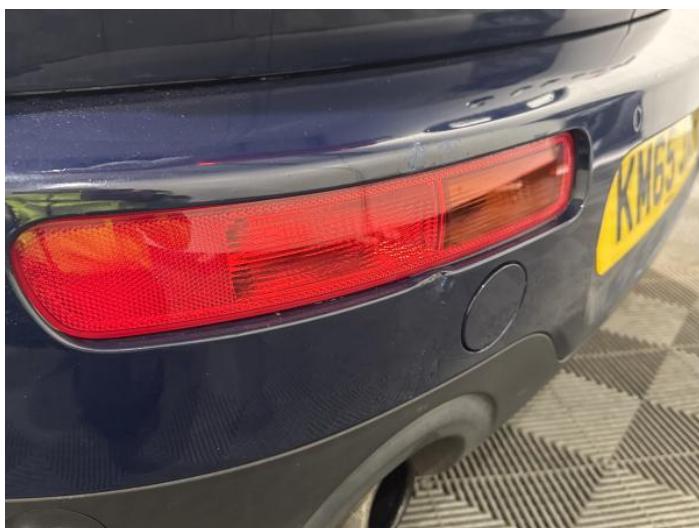
11: Bumper Rear
Dented
With Paint Damage

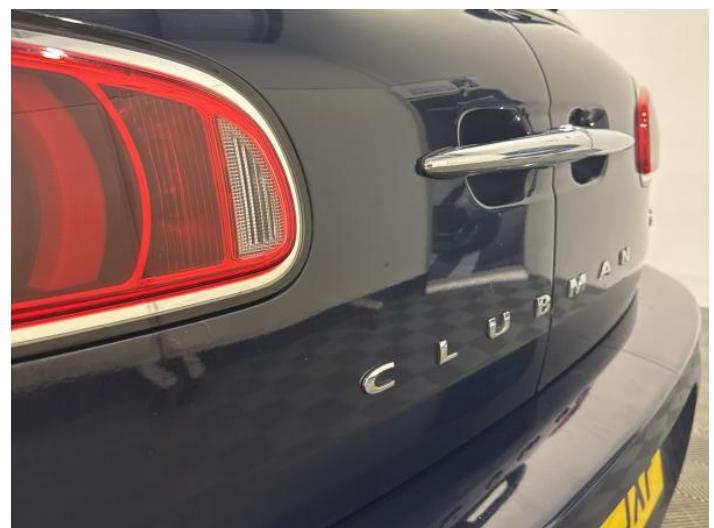
12: Tailgate
Dented
Over 30mm

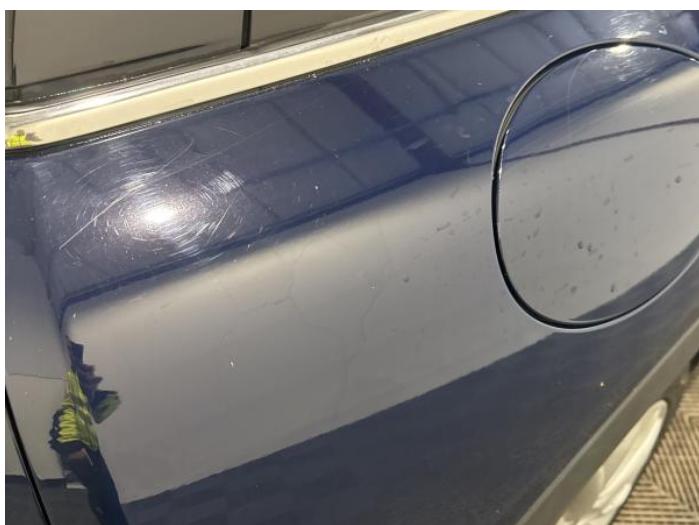
13: Qtr Panel osr
Scratched
Over 25mm Thru Paint

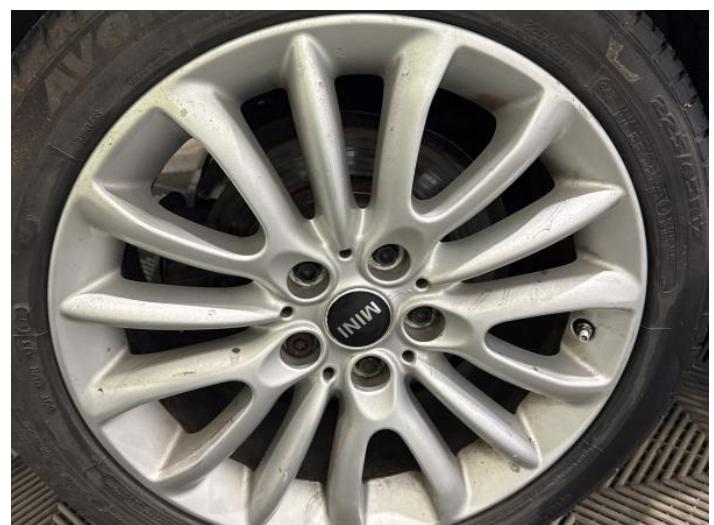
14: Wheel osr
Scratched
Over 50mm

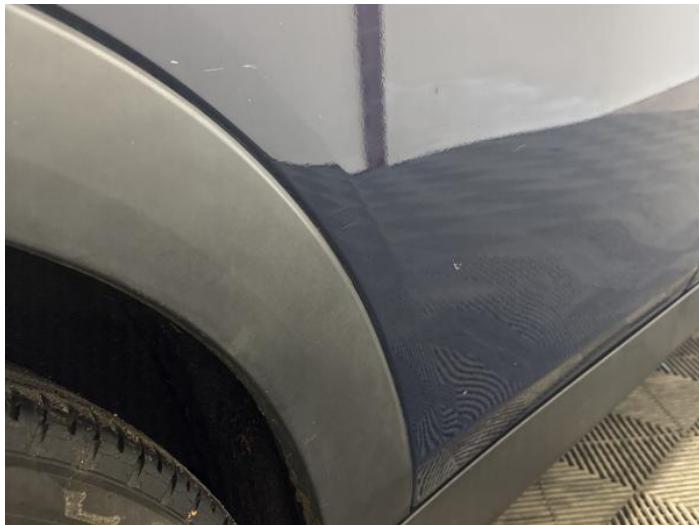
15: Door osr
Scratched
Over 25mm Thru Paint

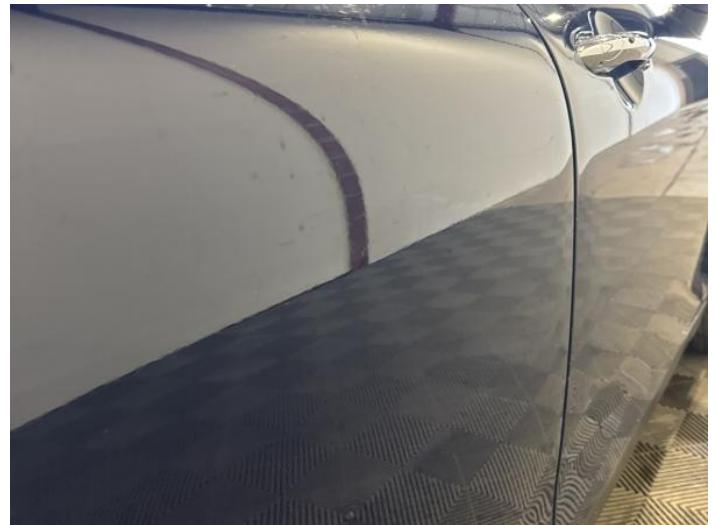
16: Door osr
Dented
Between 10mm + 30mm

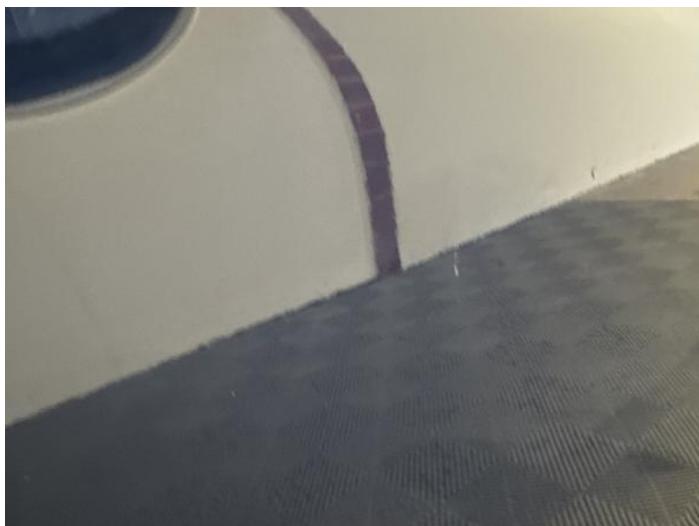
17: Door osf
Scratched
UpTo 25mm Thru Paint

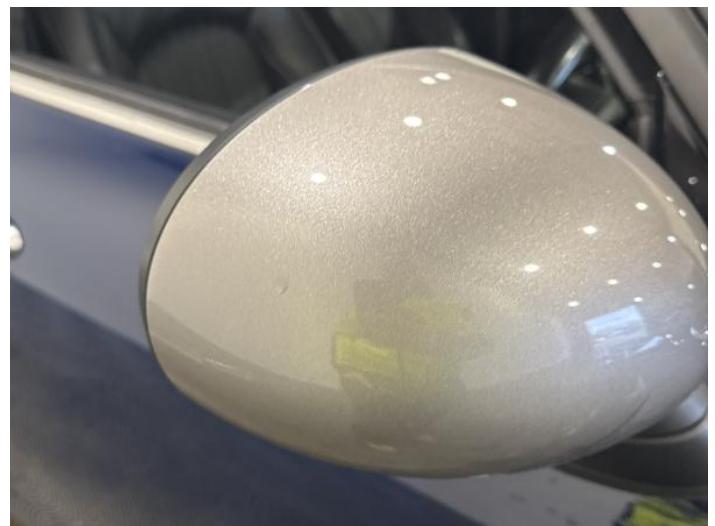
18: Door Mirror Assy osf
Scratched (Painted)
Over 25mm Thru Paint

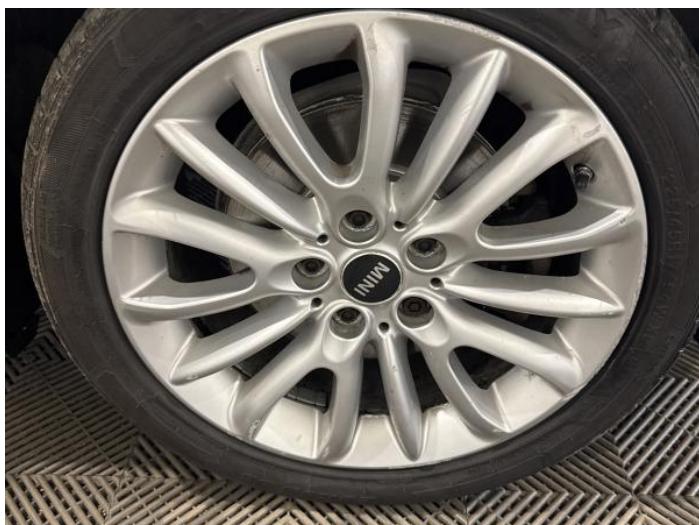
19: Wheel osf
Scratched
Over 50mm
