# VEHICLE INSPECTION REPORT

LL16YYM

## Seat Ibiza 1.4 EcoTSI 150 FR 3dr

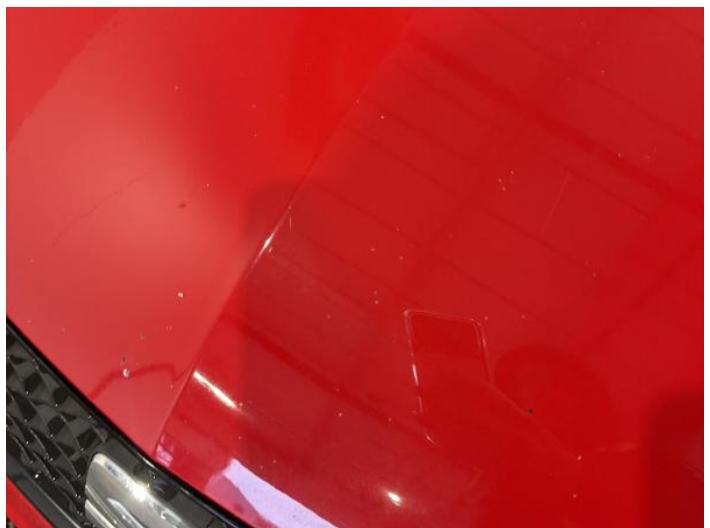
1: Bonnet  
Chipped  
Multiple Chips

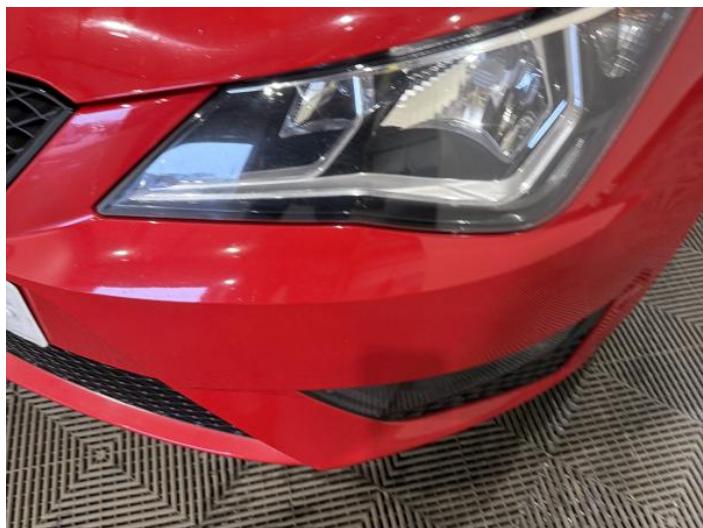
2: Bumper Front  
Poor Previous Repair  
Poor Paint

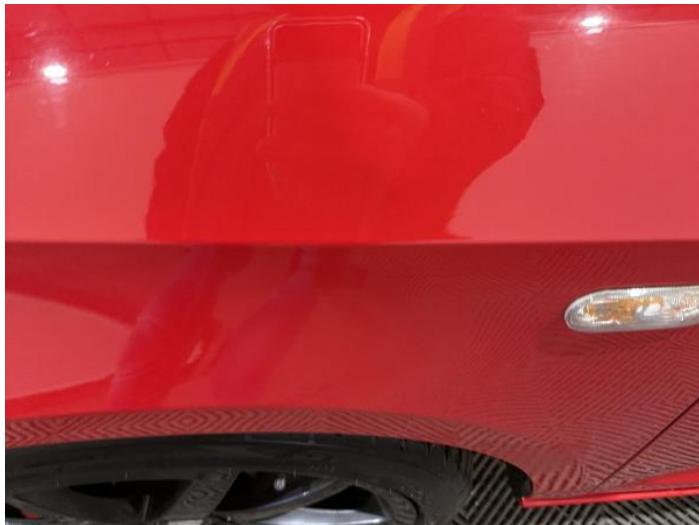
3: Wing nsf  
Chipped  
1 To 5

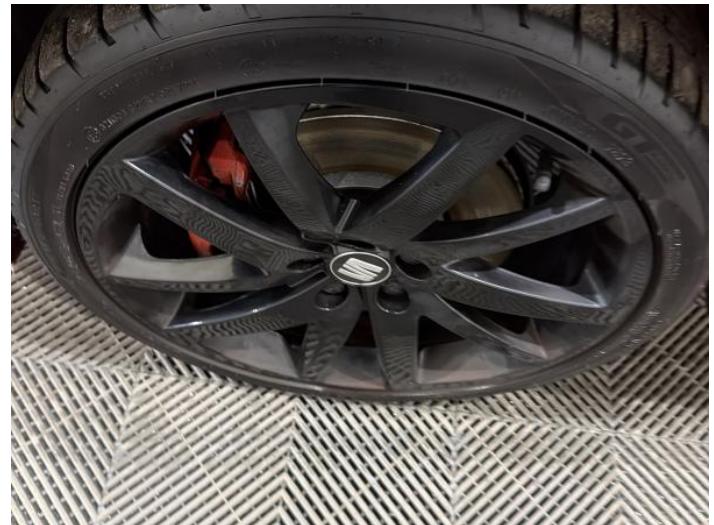
4: Wheel nsf  
Scratched  
Up To 50mm

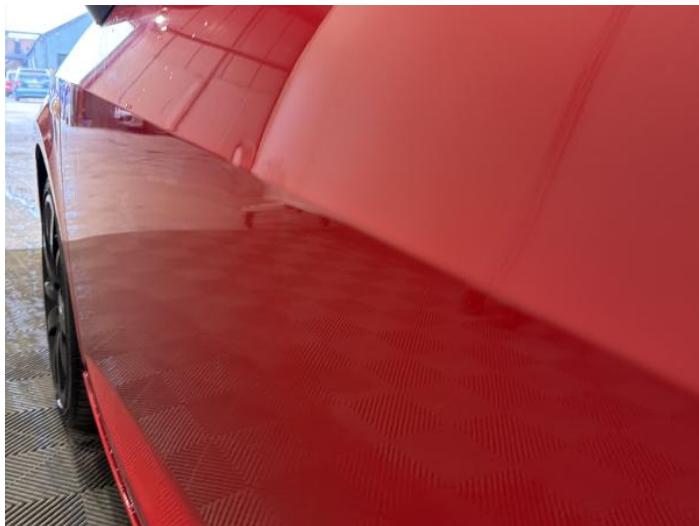
5: Door nsf  
Poor Previous Repair  
Poor Paint

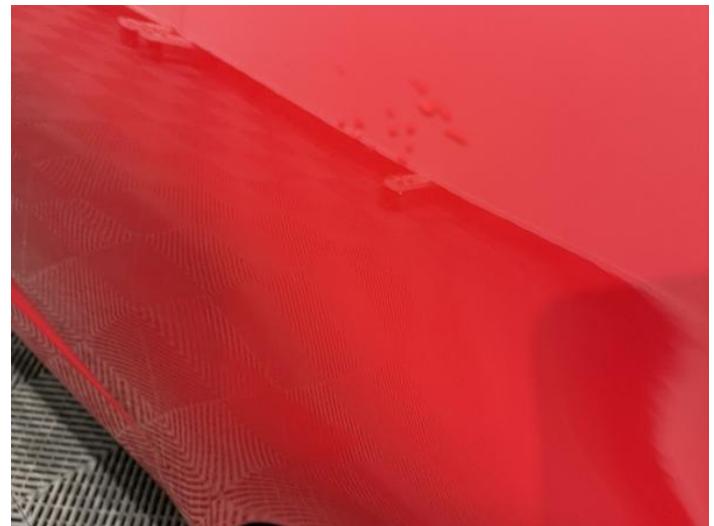
6: Qtr Panel nsr  
Poor Previous Repair  
Poor Paint

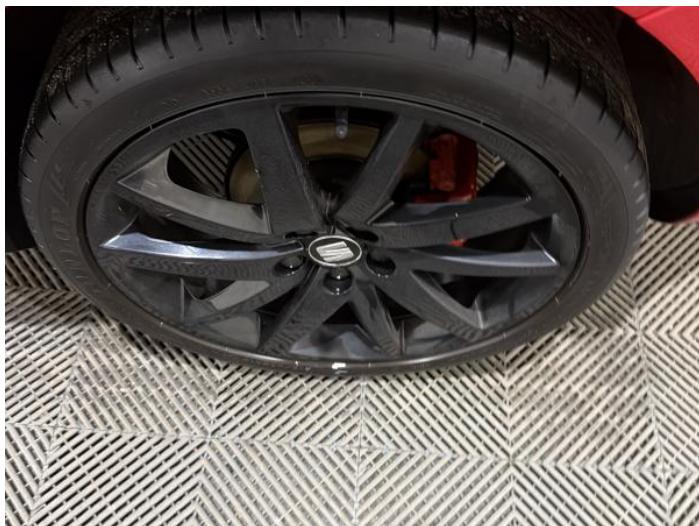
7: Wheel nsr  
Scratched  
Up To 50mm

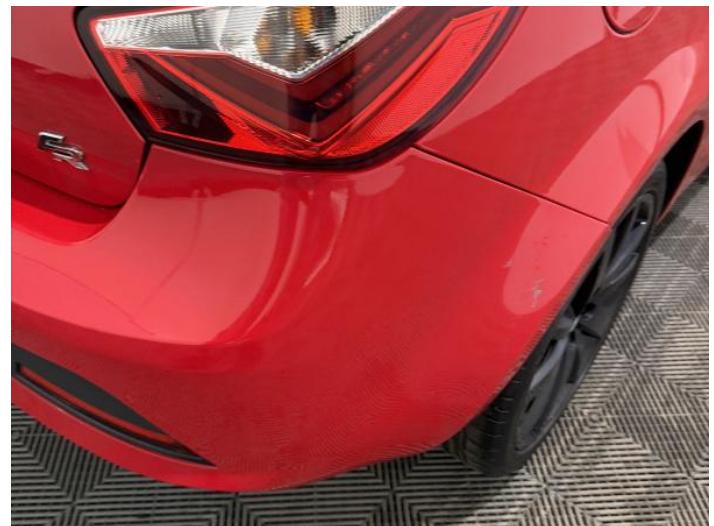
8: Bumper Rear  
Scratched  
25 to 100mm Thru Paint

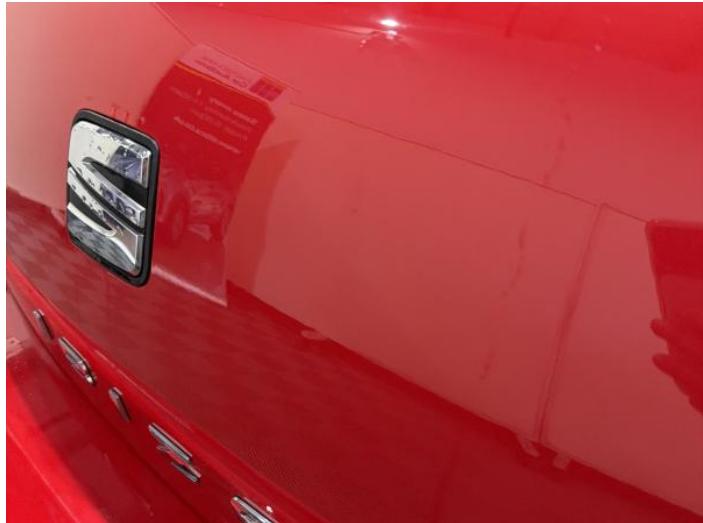
10: Boot Lid  
Dented  
2 Or Less UpTo 10mm

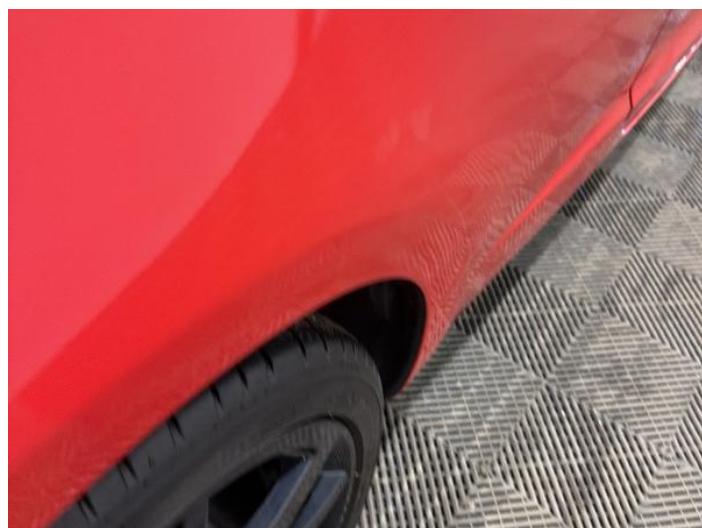
11: Qtr Panel osr  
Dented  
2 Or Less UpTo 10mm

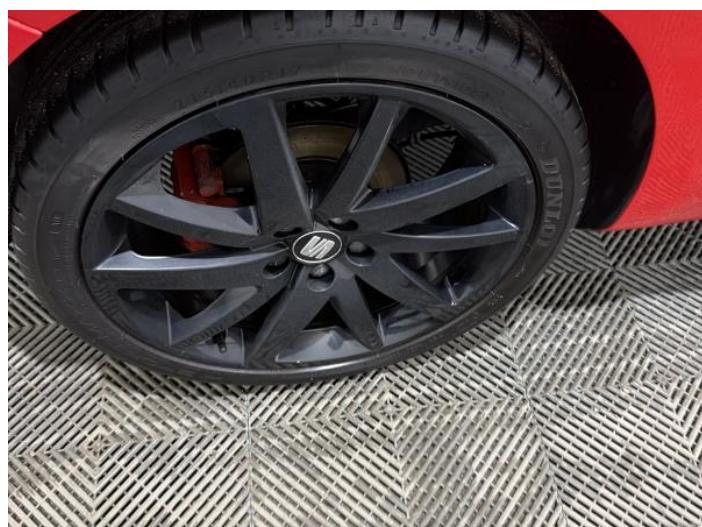
13: Wheel osr  
Scratched  
Up To 50mm

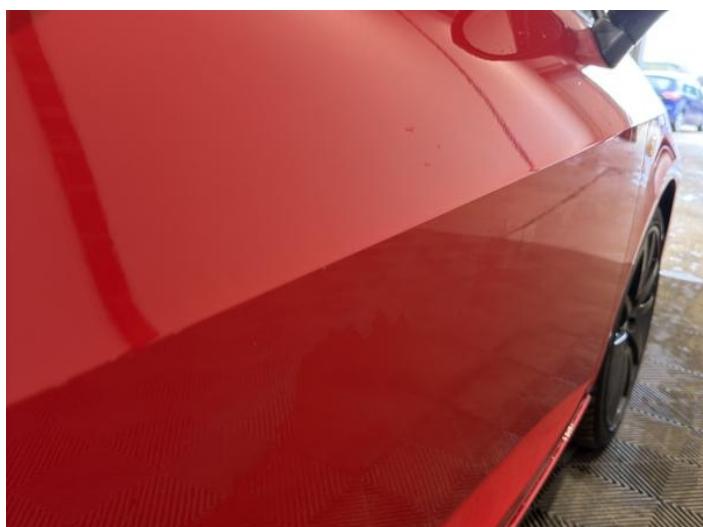
14: Door osf  
Dented  
Over 2 UpTo 10mm

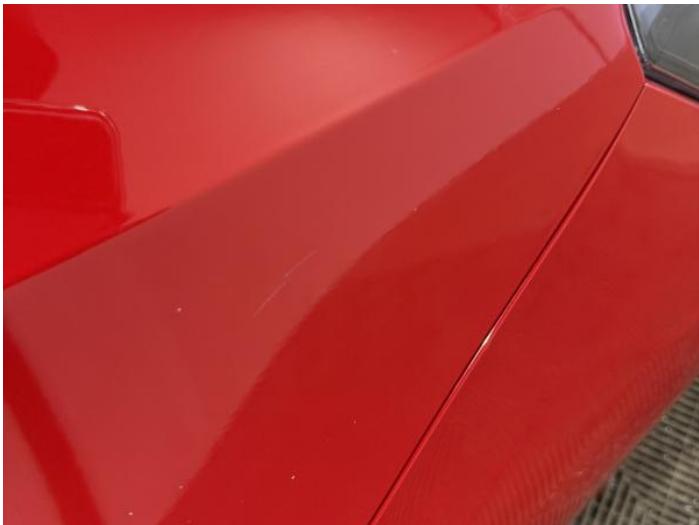
15: Wing osf  
Scratched  
UpTo 25mm Thru Paint

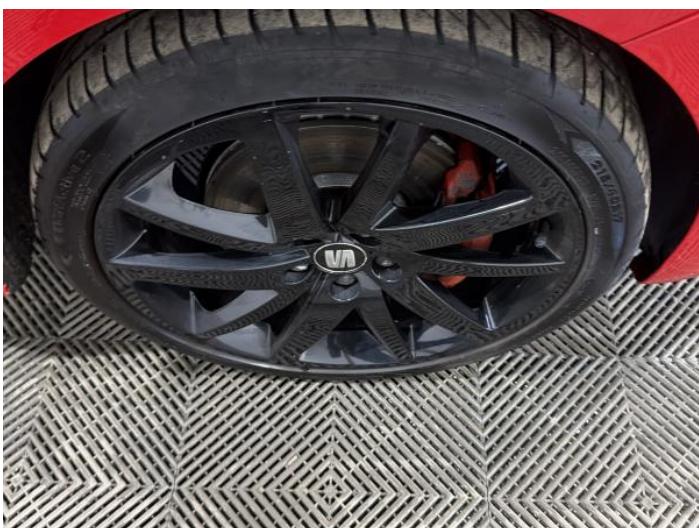
17: Wheel osf  
Scratched  
Up To 50mm

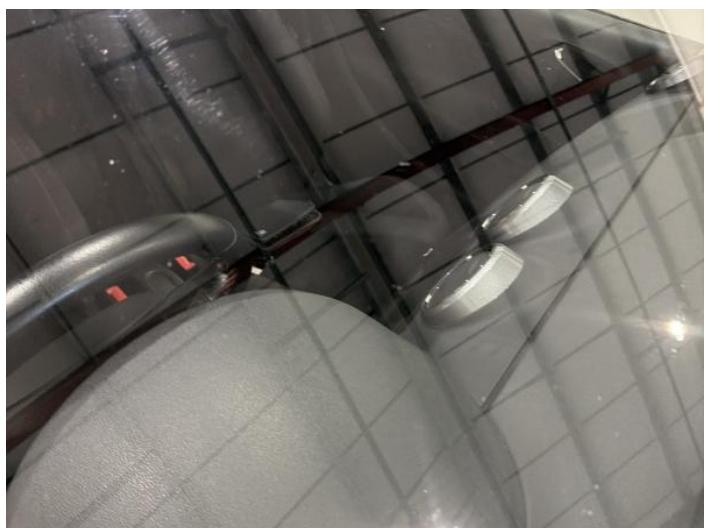
18: Screen Front  
Chipped  
UpTo 10mm

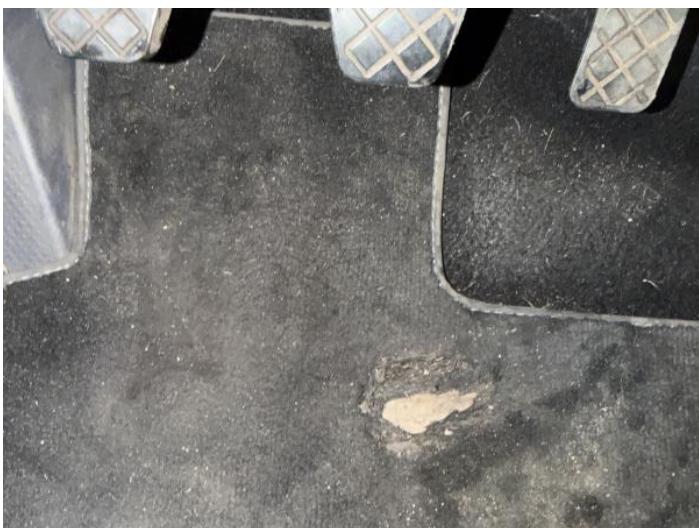
19: Carpets Front  
Torn  
Over 10mm
