VEHICLE INSPECTION REPORT

GX15UZW

Ford Fiesta 1.0 EcoBoost 140 Zetec S Red 3dr

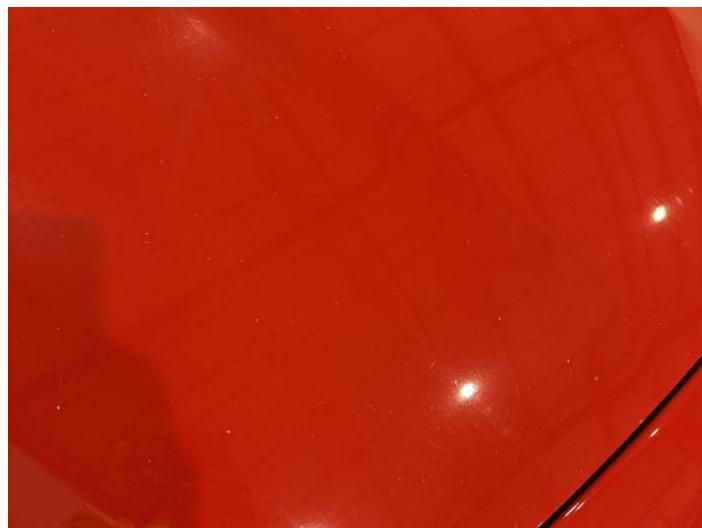
1: Bonnet
Chipped
Multiple Chips

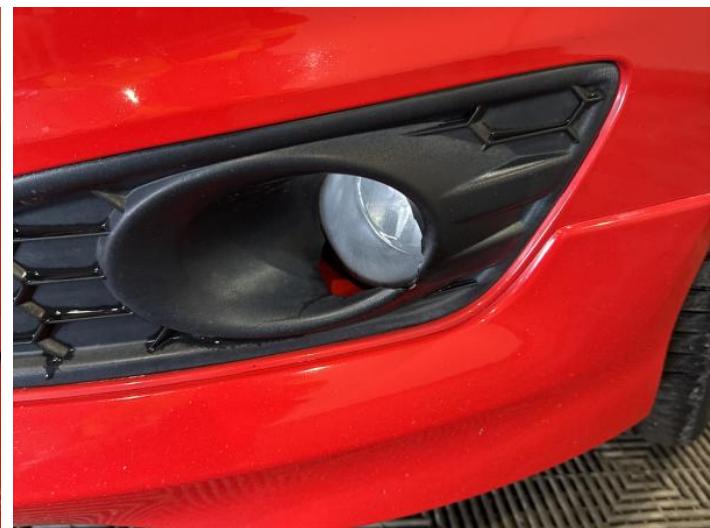
2: Fog Lamp Surround ns
Broken
Replace

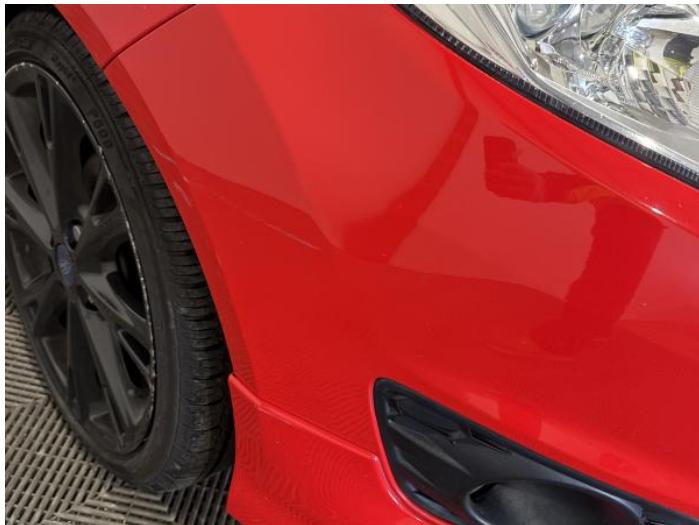
3: Bumper Front
Scratched
25 to 100mm Thru Paint

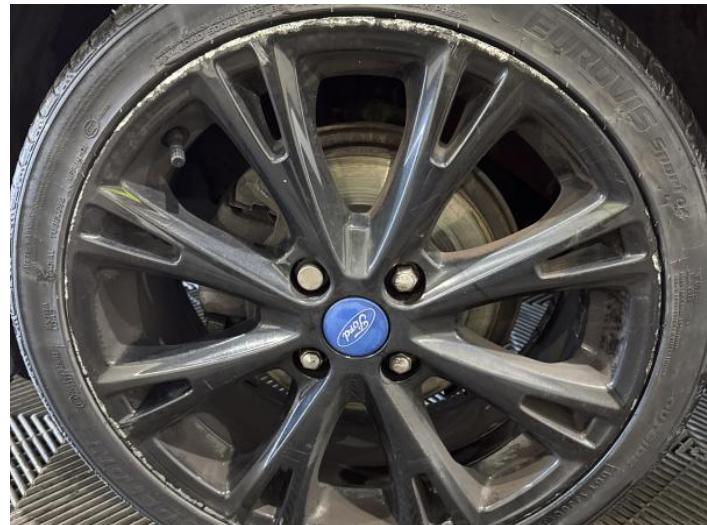
4: Wheel nsf
Scratched
Over 50mm

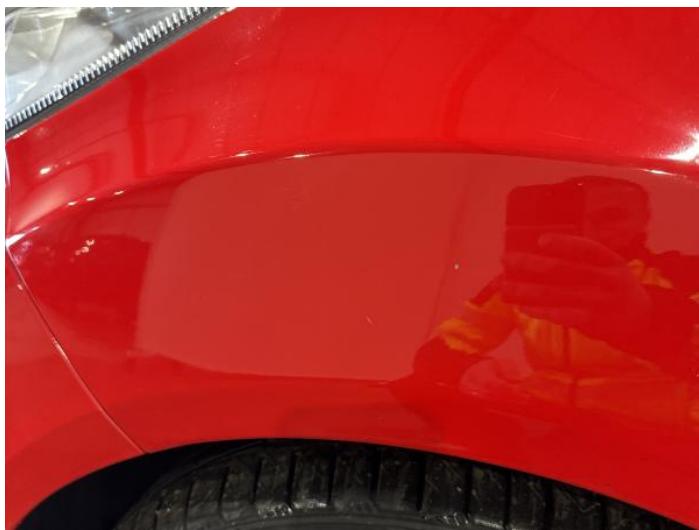
5: Wing nsf
Chipped
1 To 5

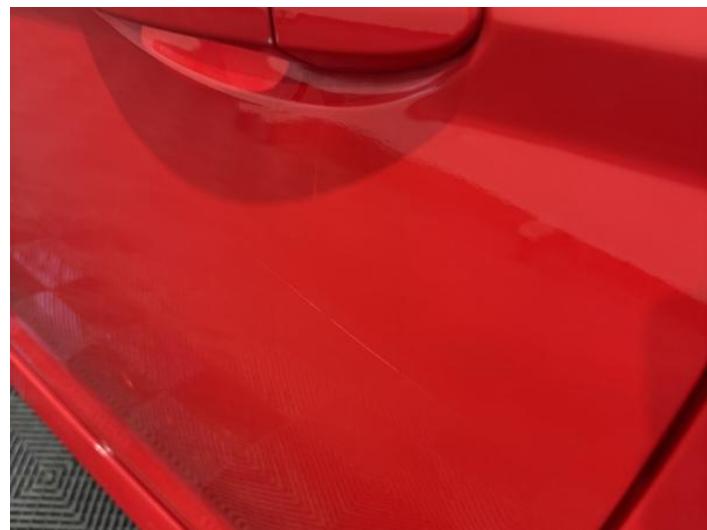
6: Door nsf
Scratched
Over 25mm Thru Paint

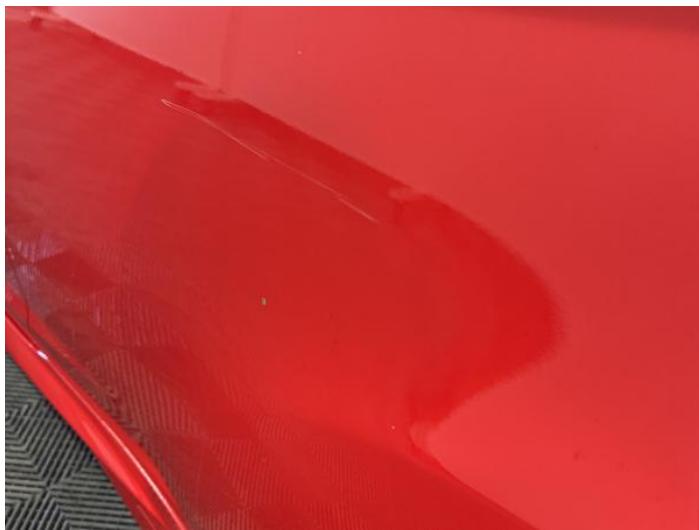
7: Qtr Panel nsr
Scratched
Over 25mm Thru Paint

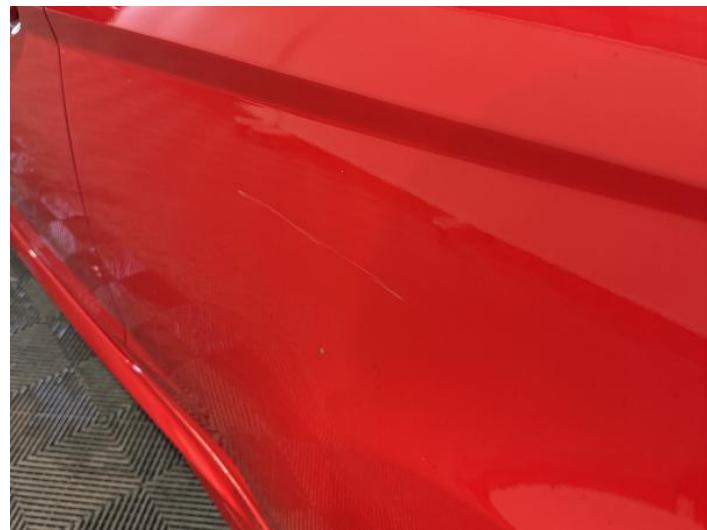
8: Qtr Panel nsr
Dented
Between 10mm + 30mm

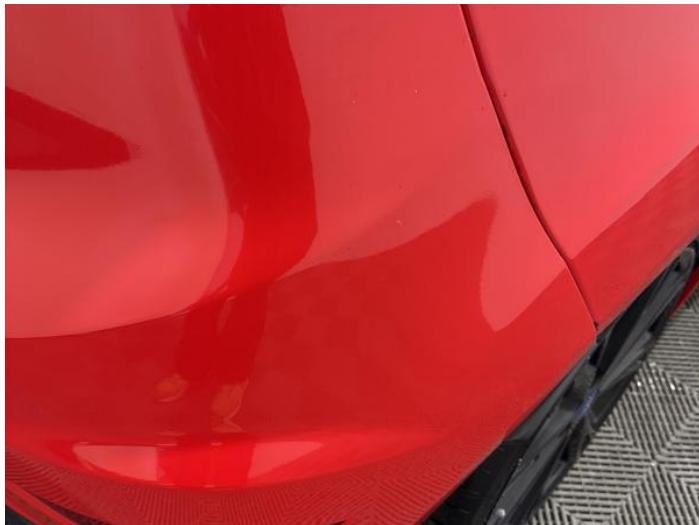
9: Bumper Rear
Chipped
1 To 5

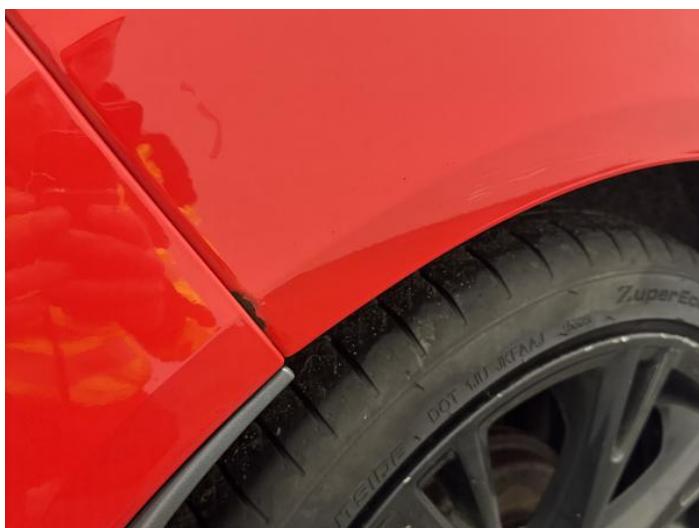
11: Qtr Panel osr
Scratched
Over 25mm Thru Paint

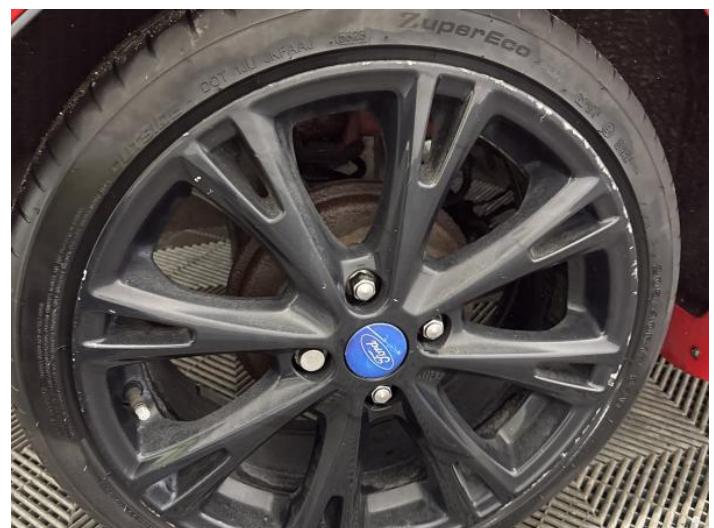
12: Wheel osr
Scratched
Over 50mm

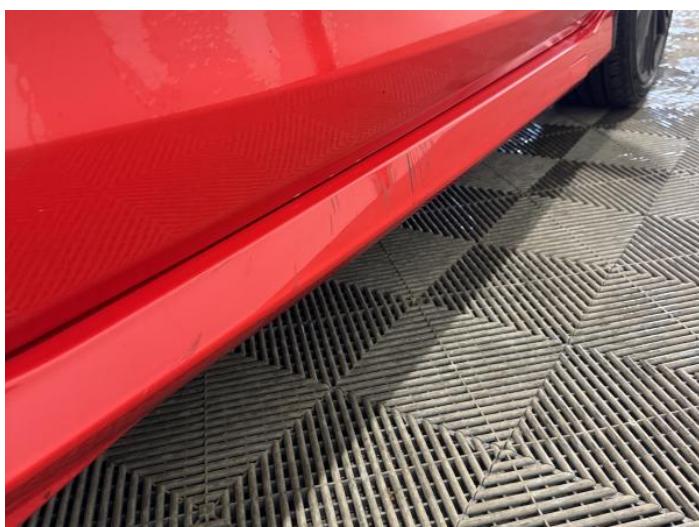
13: Sill Panel Trim os
Scratched (Painted)
Over 25mm Thru Paint

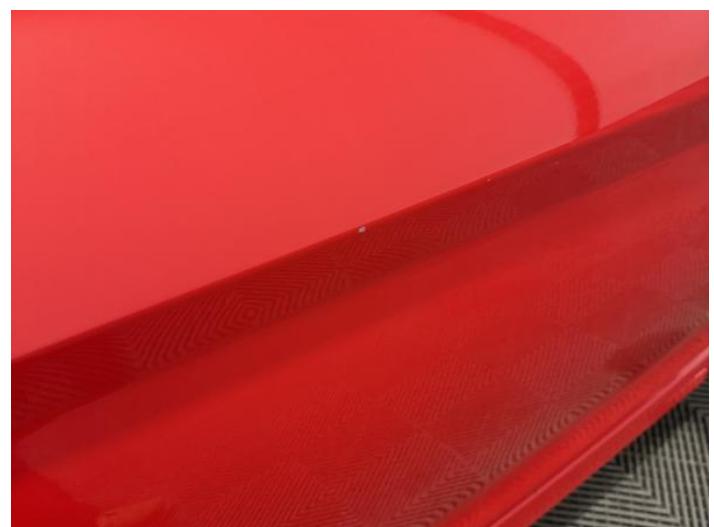
14: Door osf
Chipped
1 To 5

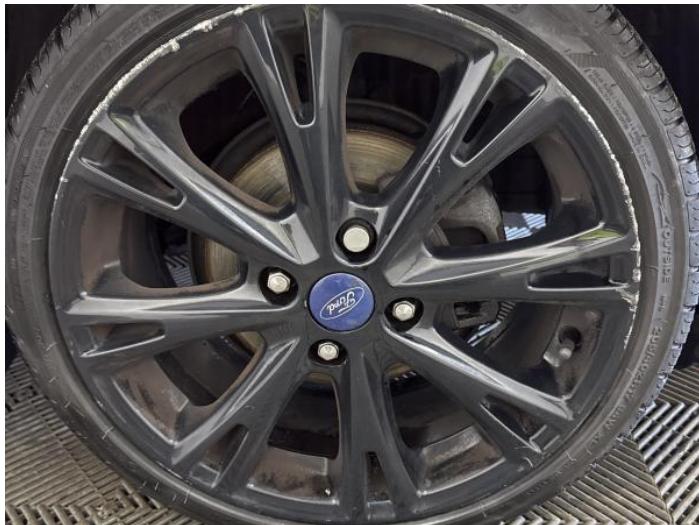
15: Wheel osf
Scratched
Over 50mm

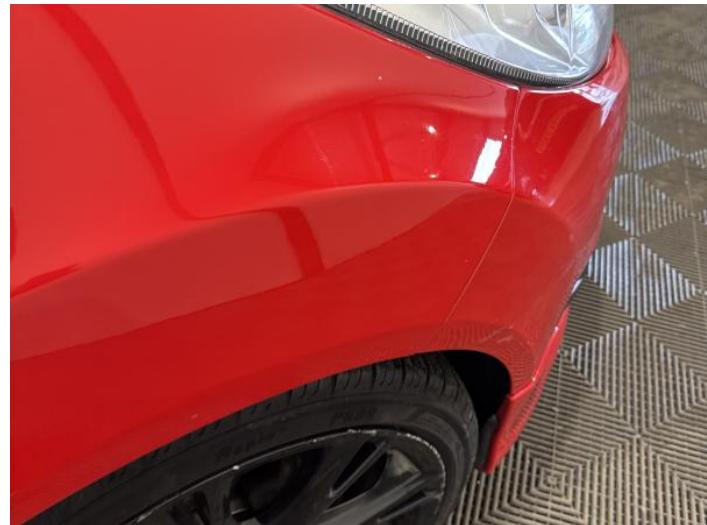
16: Wing osf
Chipped
Multiple Chips

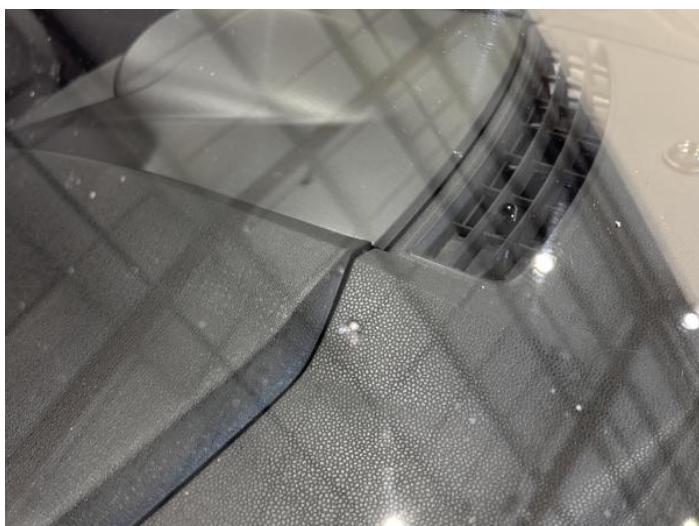
17: Screen Front
Chipped
Over 10mm

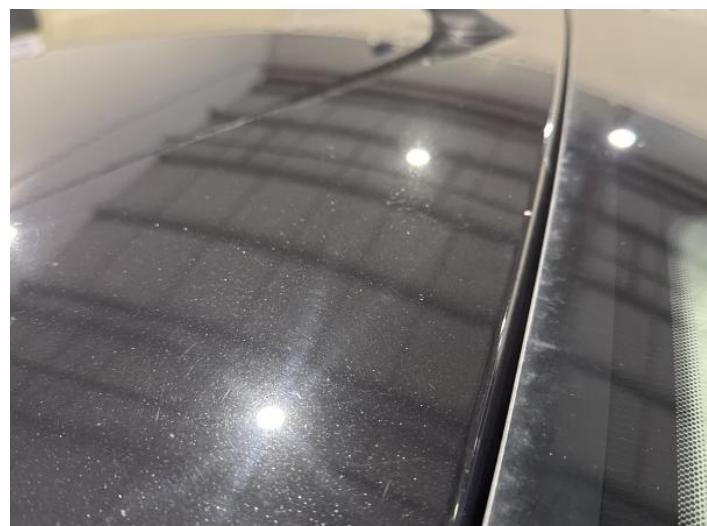
18: Roof
Chipped
Edge Chip
