VEHICLE INSPECTION REPORT

WR19LKF

Mitsubishi Eclipse Cross 1.5 4 5dr CVT 4WD

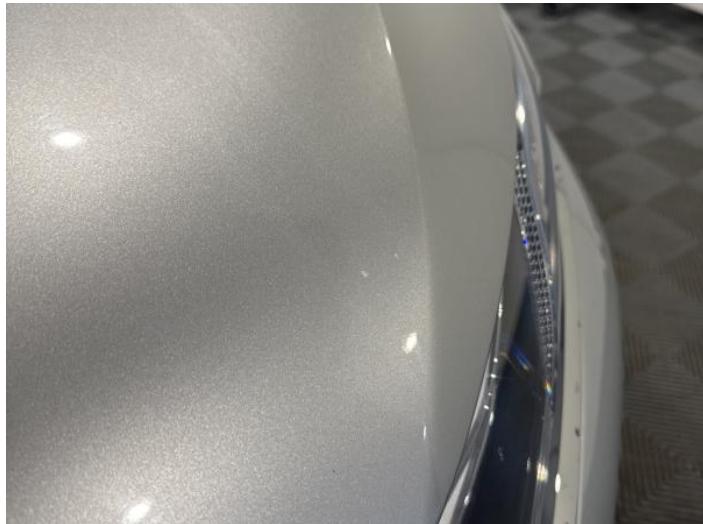
1: Bonnet
Chipped
1 To 5

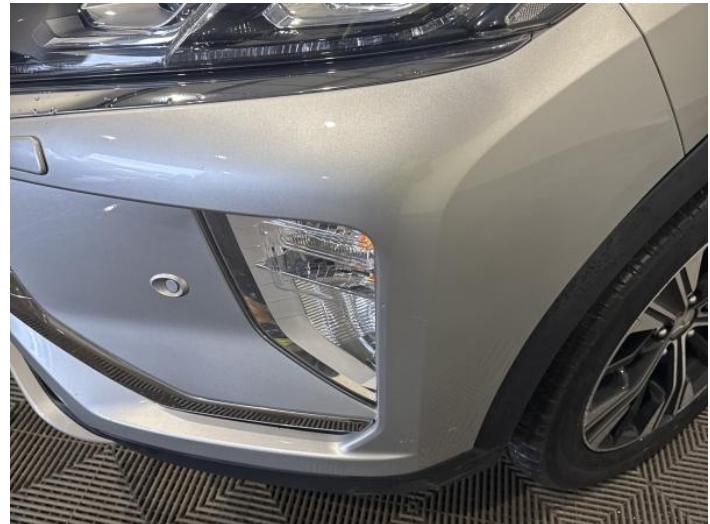
2: Bumper Front
Scratched
Over 100mm Thru Paint

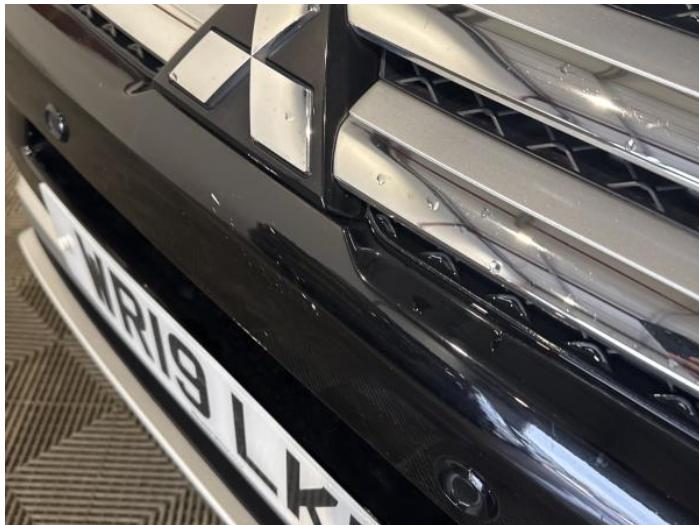
3: Bumper Front Moulding
Scratched (Painted)
Over 25mm Thru Paint

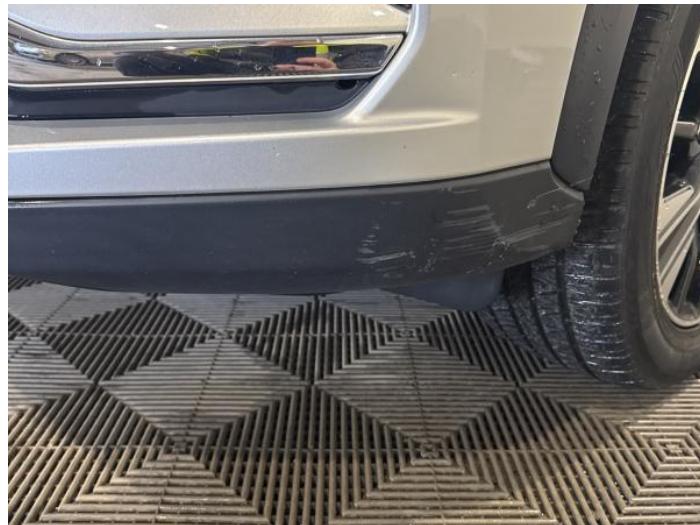
4: Bumper Front Moulding
Scuffed (Unpainted)
Over 100mm

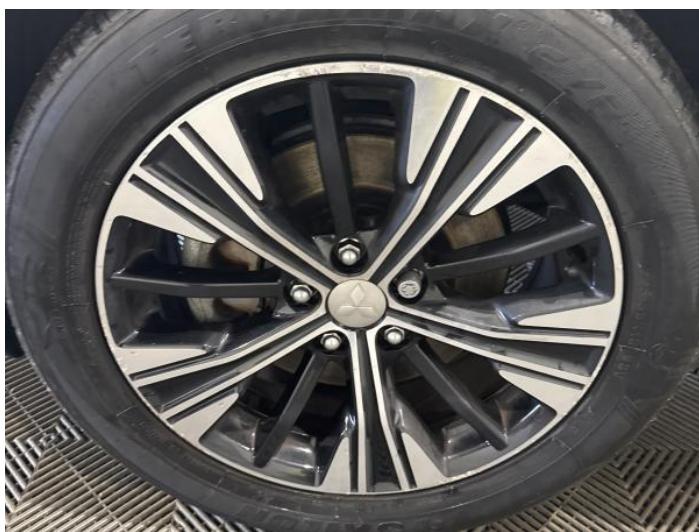
5: Wheel nsf
Scratched
Over 50mm

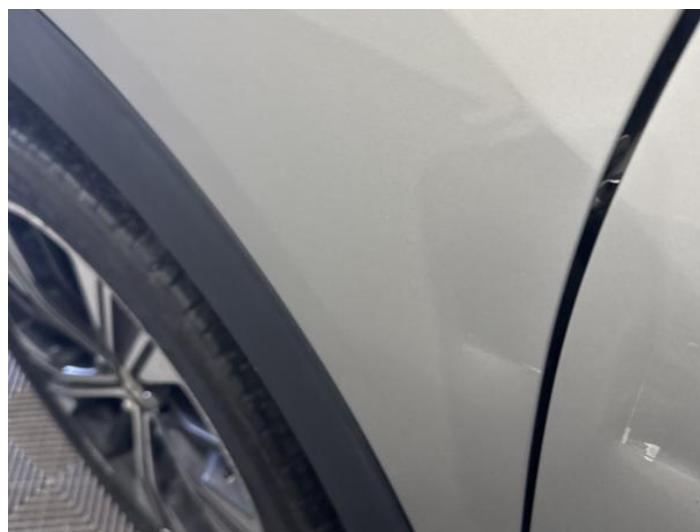
6: Wing nsf
Dented
Between 10mm + 30mm

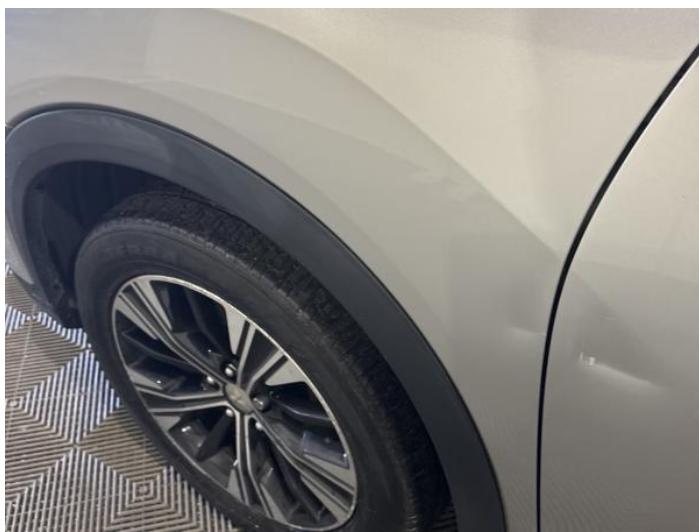
7: Wing nsf
Scratched
Over 25mm Thru Paint

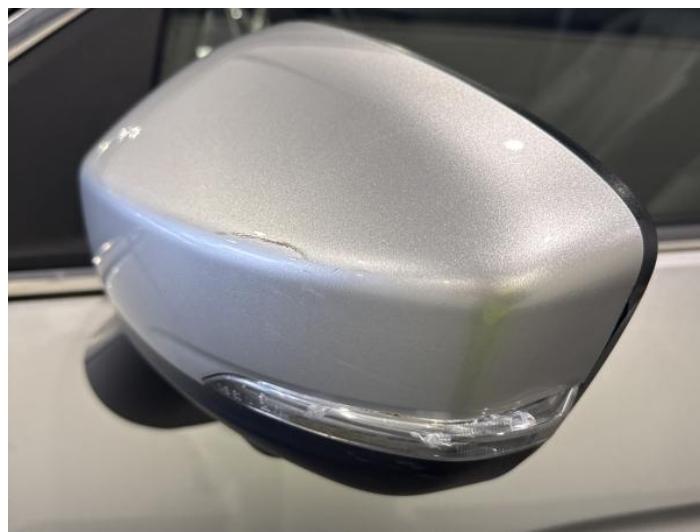
8: Door Mirror Assy nsf
Scratched (Painted)
UpTo 25mm Thru Paint

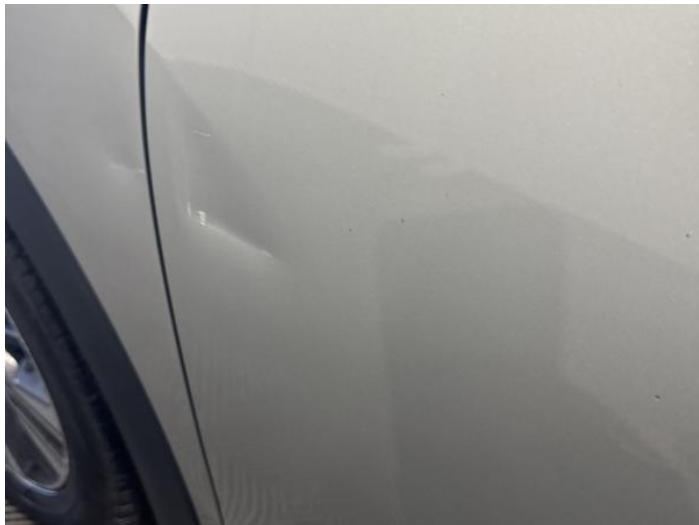
9: Door nsf
Dented
With Paint Damage

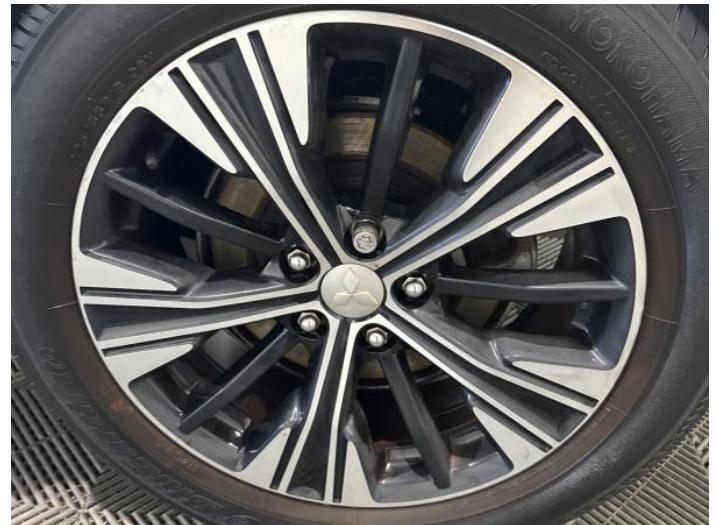
10: Wheel osr
Scratched
Over 50mm

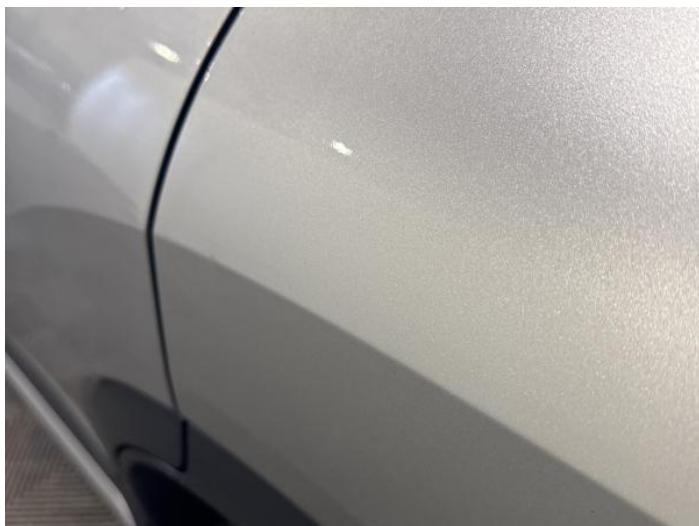
11: Qtr Panel nsr
Dented
Between 10mm + 30mm

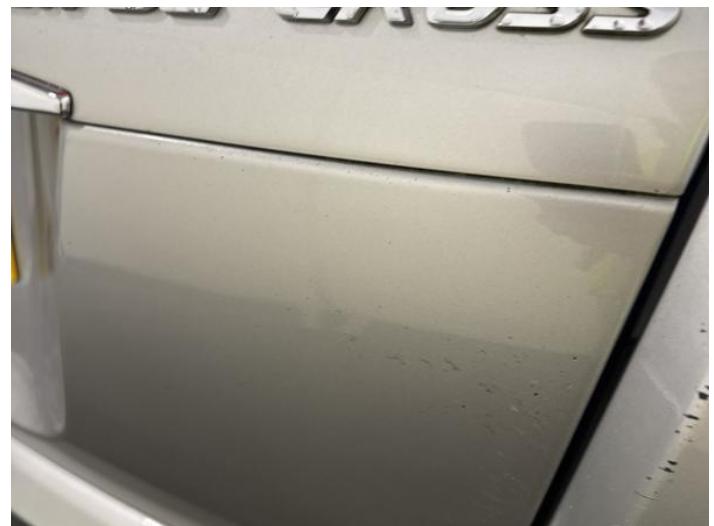
12: Tailgate
Scratched
Over 25mm Thru Paint

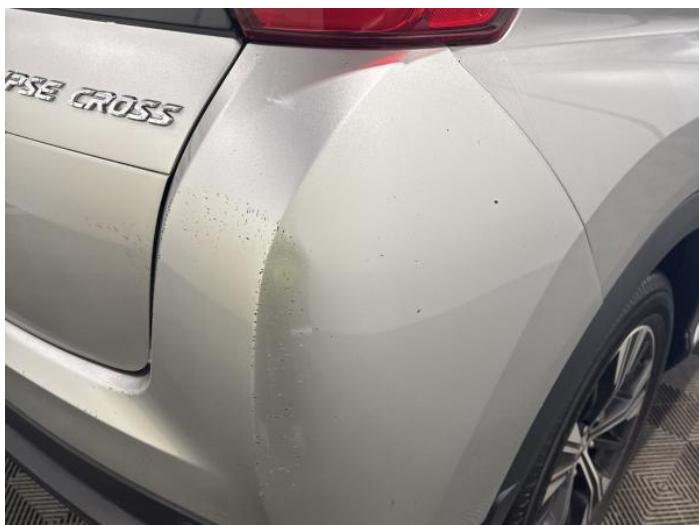
13: Bumper Rear
Scratched
25 to 100mm Thru Paint

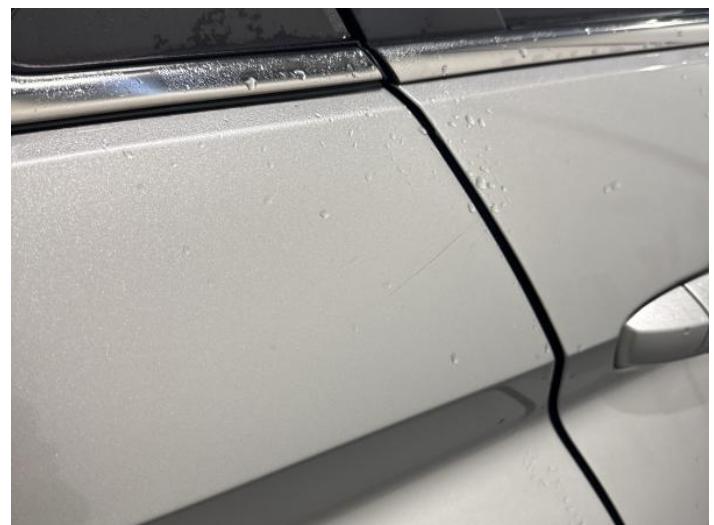
14: Qtr Panel osr
Scratched
Over 25mm Thru Paint

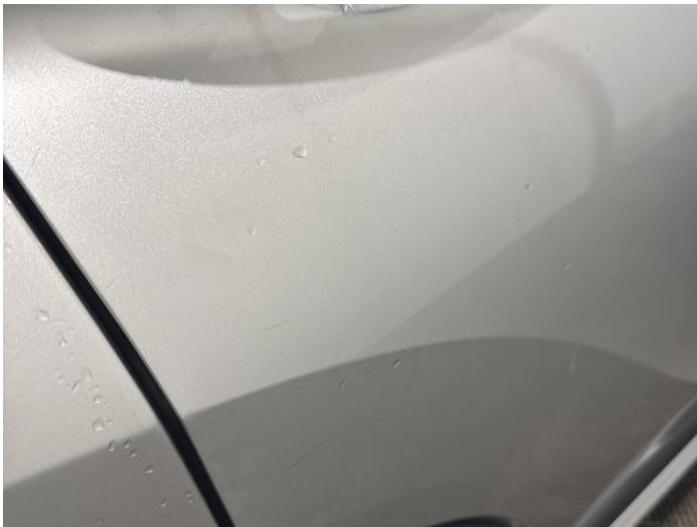
15: Door osr
Scratched
UpTo 25mm Thru Paint

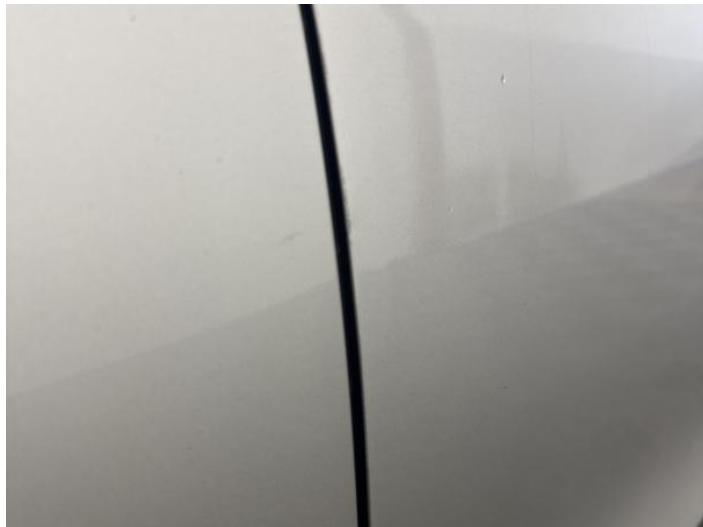
16: Door osf
Dented
Between 10mm + 30mm

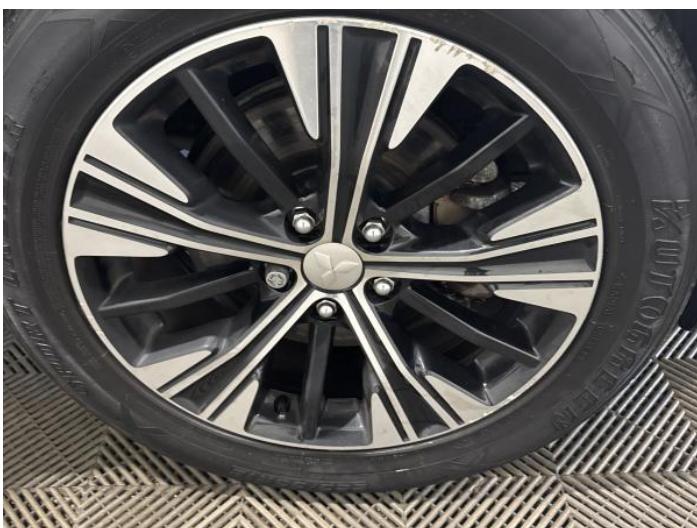
17: Wheel osf
Scratched
Over 50mm

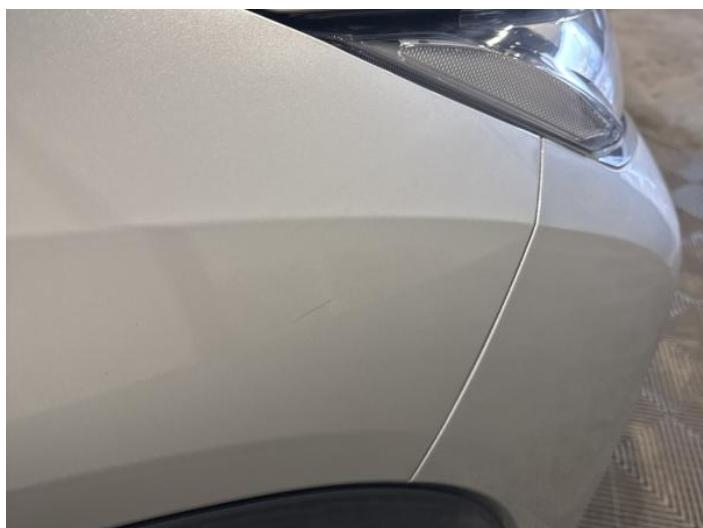
18: Wing osf
Scratched
UpTo 25mm Thru Paint
