## VEHICLE INSPECTION REPORT

**GX71WRA**

### Volkswagen Polo 1.0 EVO 80 Match 5dr

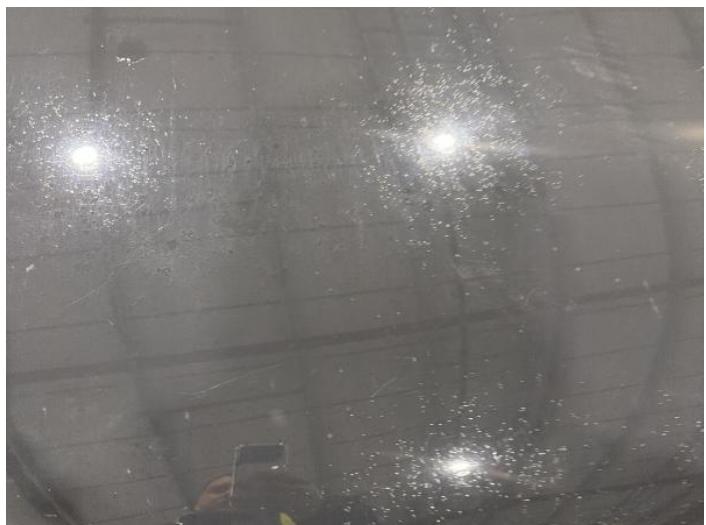
1: Bonnet  
Chipped  
Multiple Chips

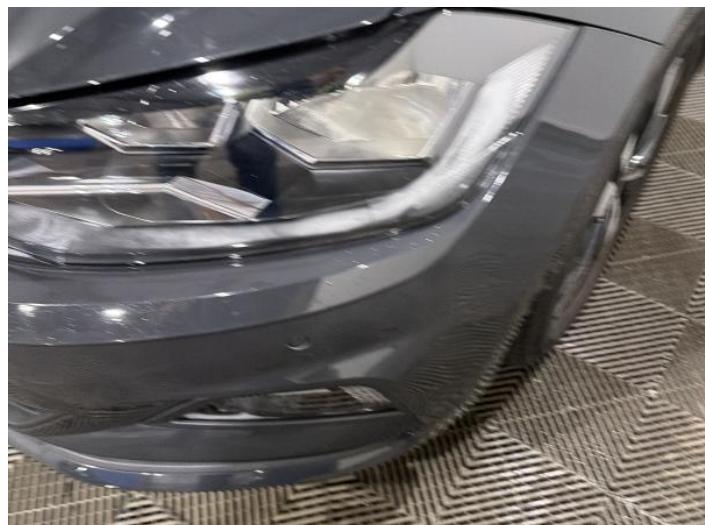
2: Bumper Front  
Chipped  
Multiple Chips

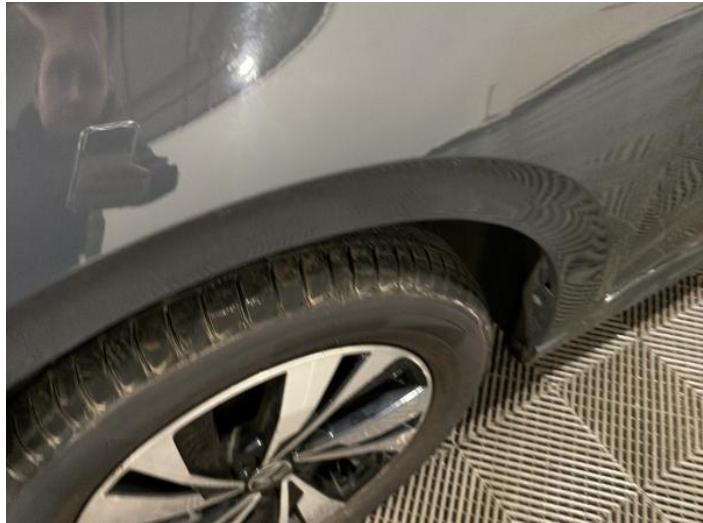
4: Wing nsf  
Chipped  
1 To 5

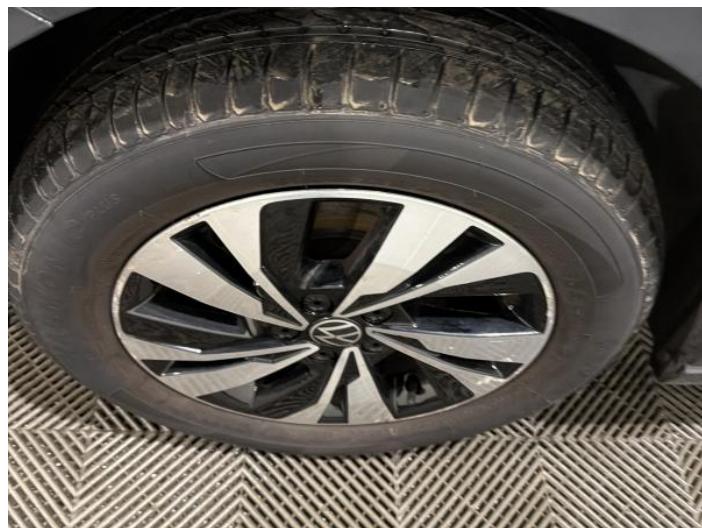
5: Wheel nsf  
Scratched  
Up To 50mm

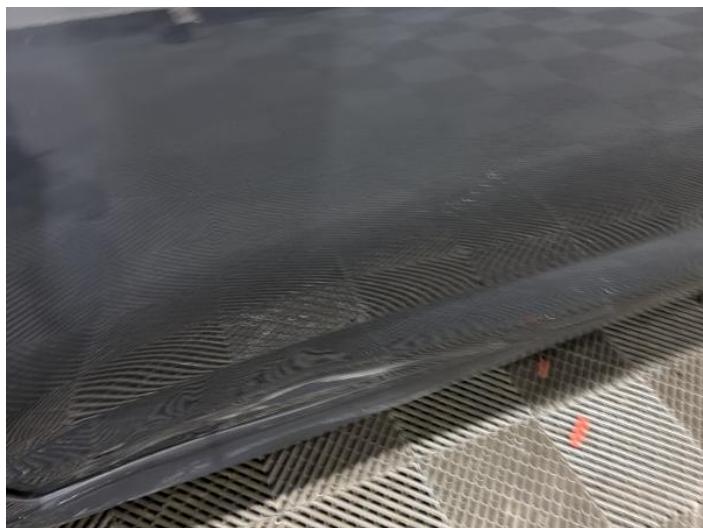
6: Door nsf  
Dented  
With Paint Damage

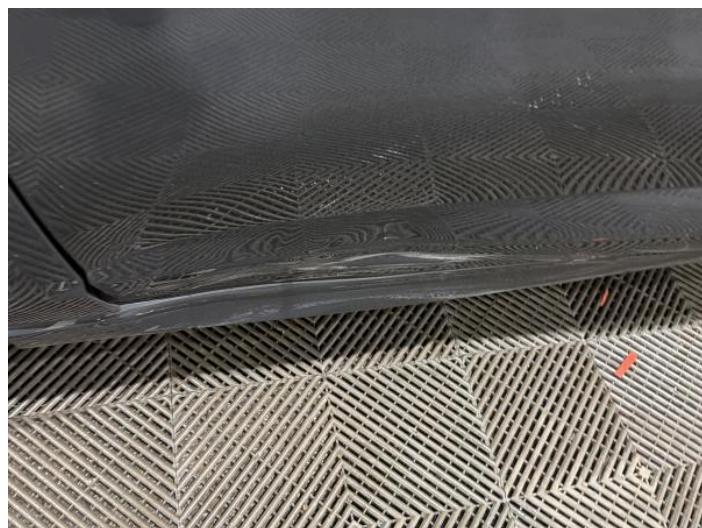
7: Sill ns  
Dented  
With Paint Damage

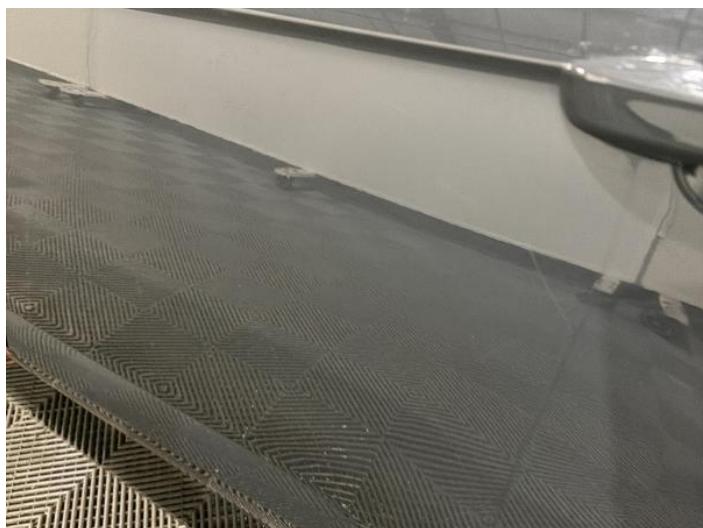
8: Door nsr  
Scratched  
UpTo 25mm Thru Paint

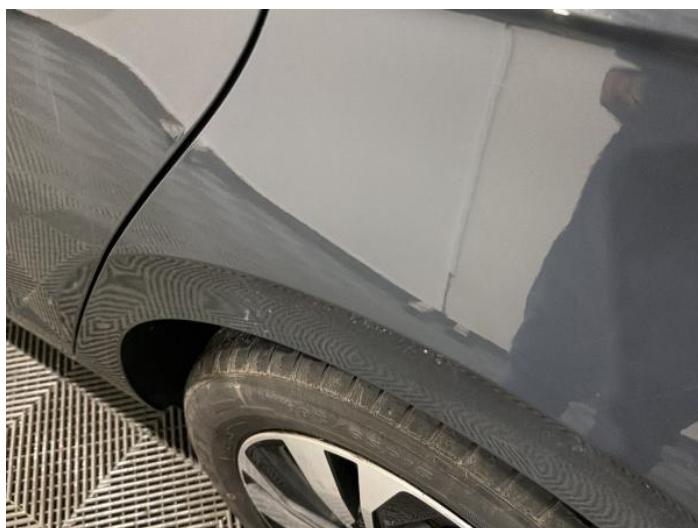
11: Qtr Panel nsr  
Dented  
Over 2 UpTo 10mm

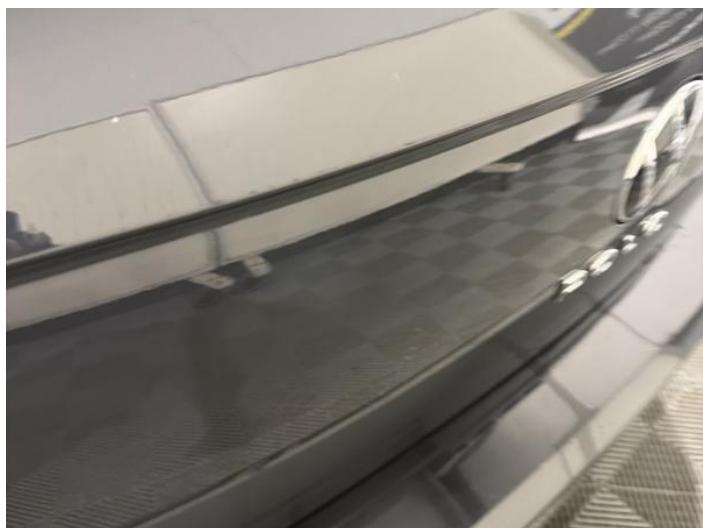
13: Bumper Rear  
Scratched  
Over 100mm Thru Paint

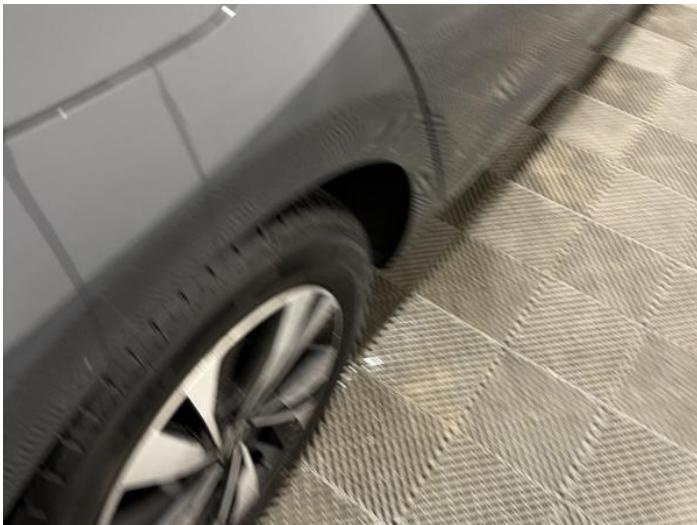
15: Qtr Panel osr  
Chipped  
1 To 5

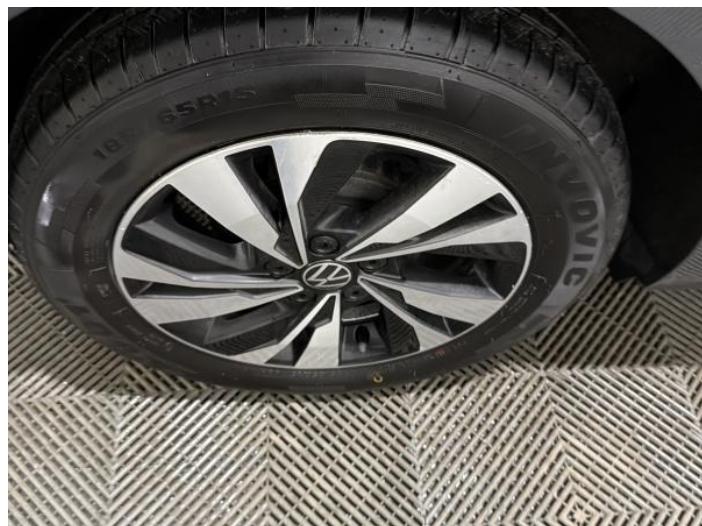
17: Wheel osr  
Scratched  
Up To 50mm

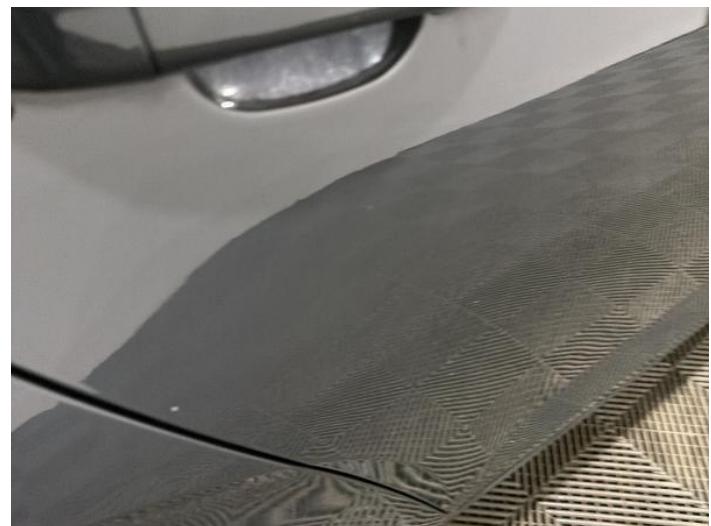
18: Door osr  
Chipped  
1 To 5

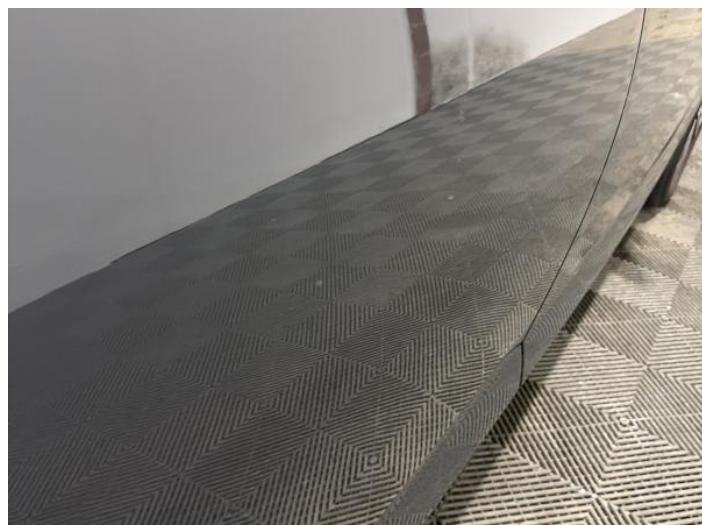
19: Door osr  
Dented  
Over 2 UpTo 10mm

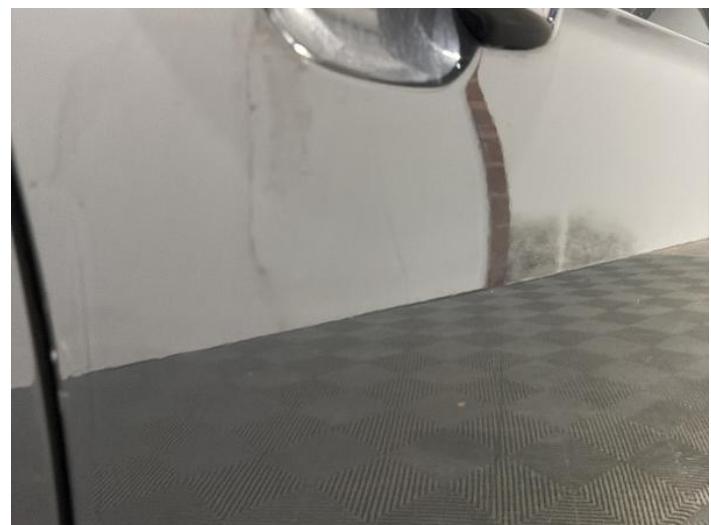
20: Door osf  
Chipped  
1 To 5

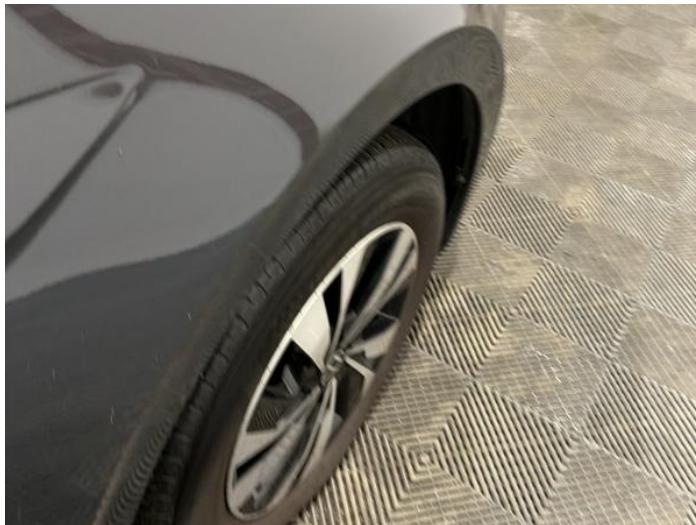
21: Wing osf  
Chipped  
1 To 5

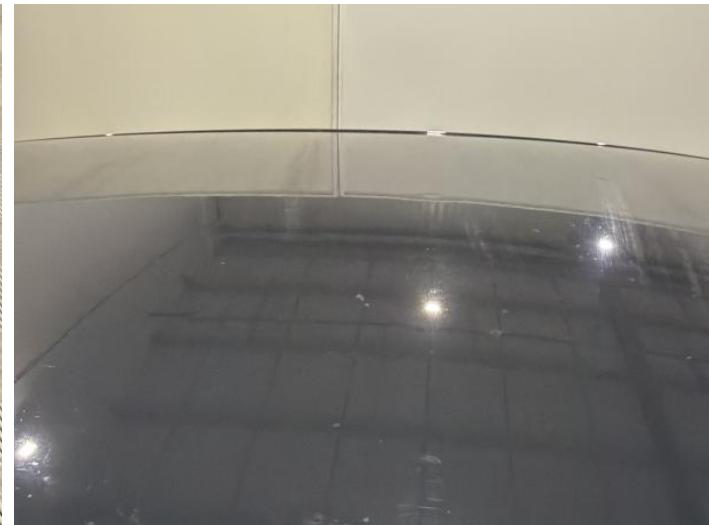
22: Roof  
Dented  
Hail - Moderate

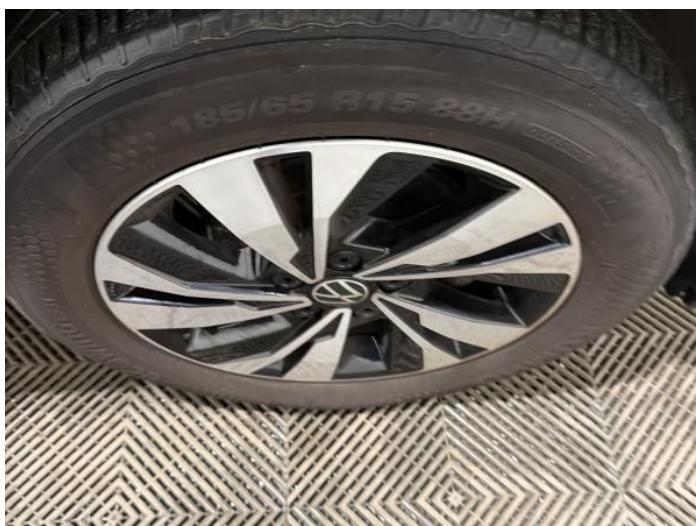
23: Wheel osf  
Scratched  
Up To 50mm

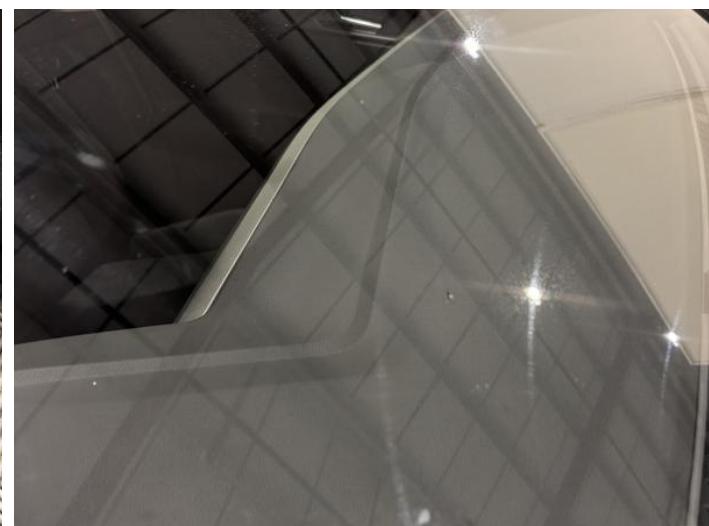
24: Screen Front  
Chipped  
UpTo 10mm
