VEHICLE INSPECTION REPORT

GX16EOJ

Volkswagen Touran 1.6 TDI SE Family 5dr DSG

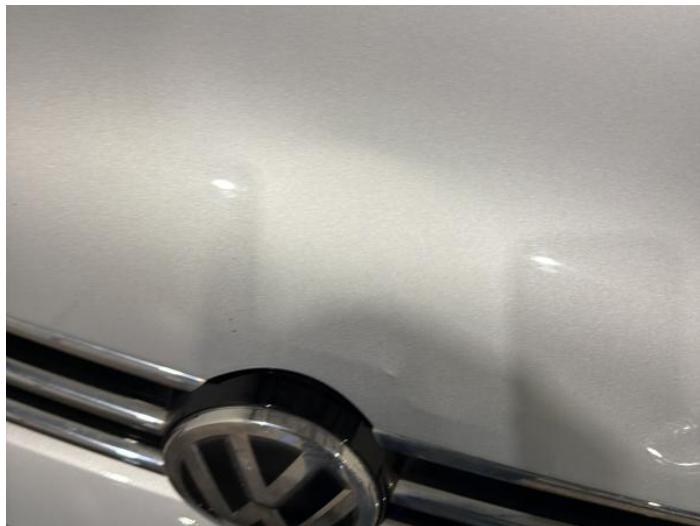
1: Bonnet
Dented
With Paint Damage

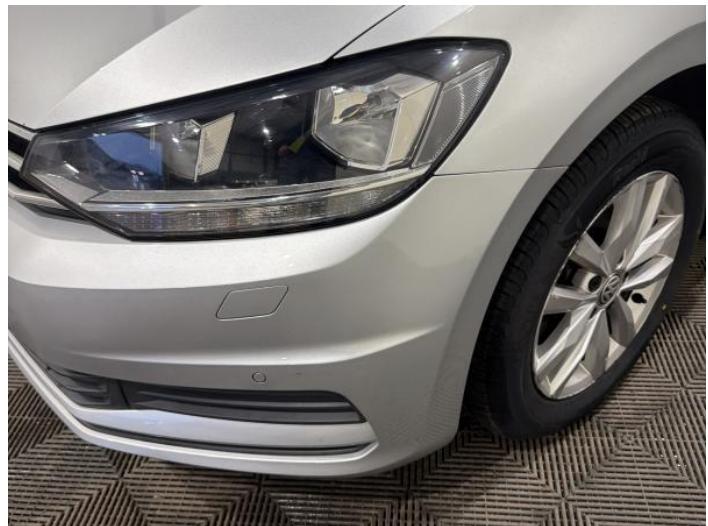
2: Bumper Front
Chipped
Multiple Chips

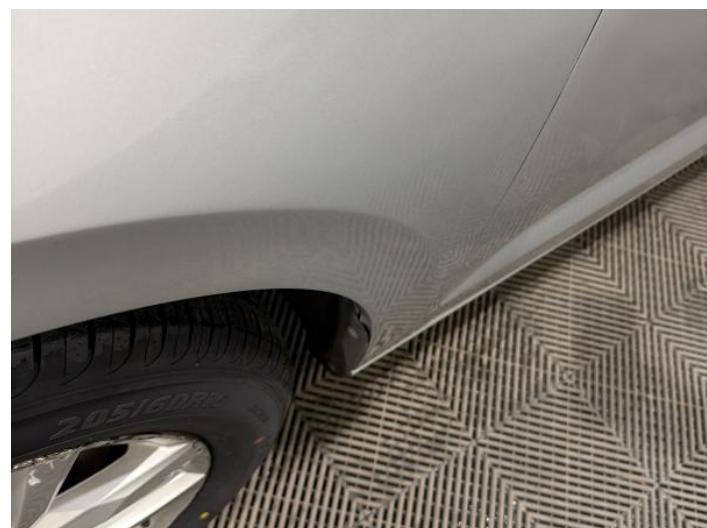
5: Wing nsf
Dented
Over 2 UpTo 10mm

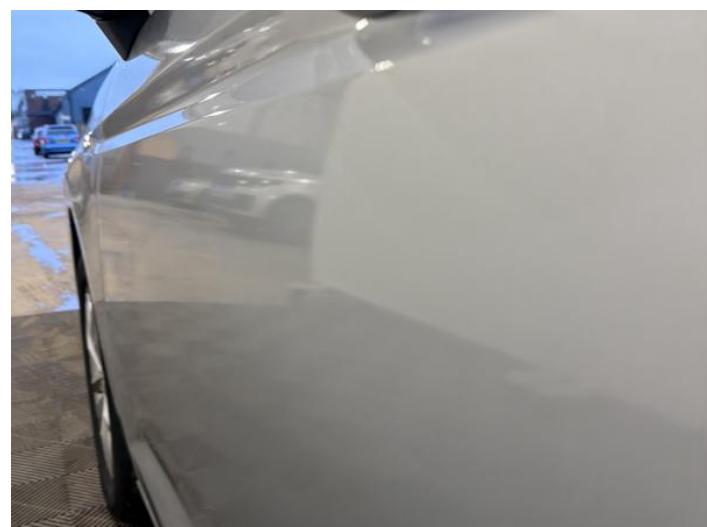
7: Door nsf
Poor Previous Repair
Poor Paint

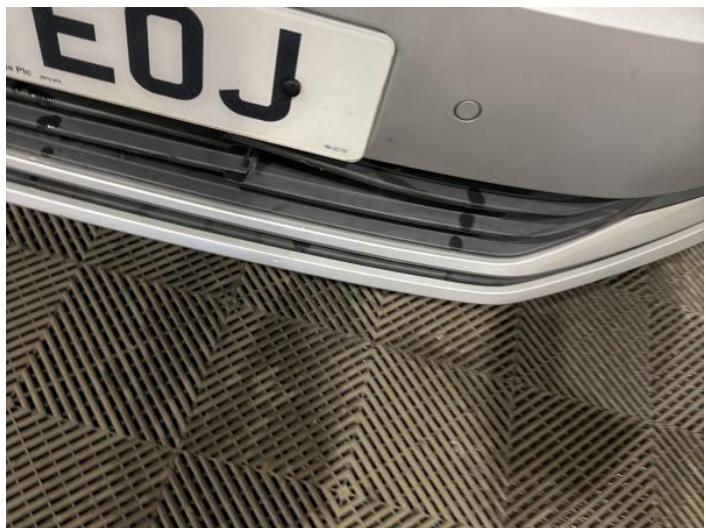
4: Bumper Front Moulding
Broken
Replace

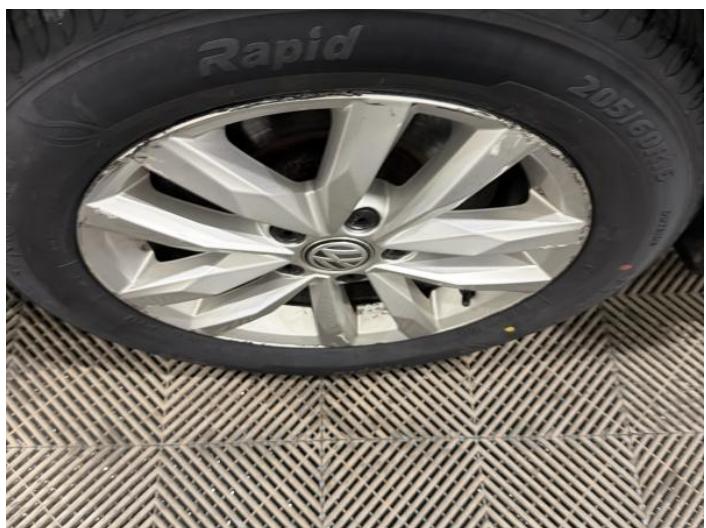
6: Wheel nsf
Scratched
Over 50mm

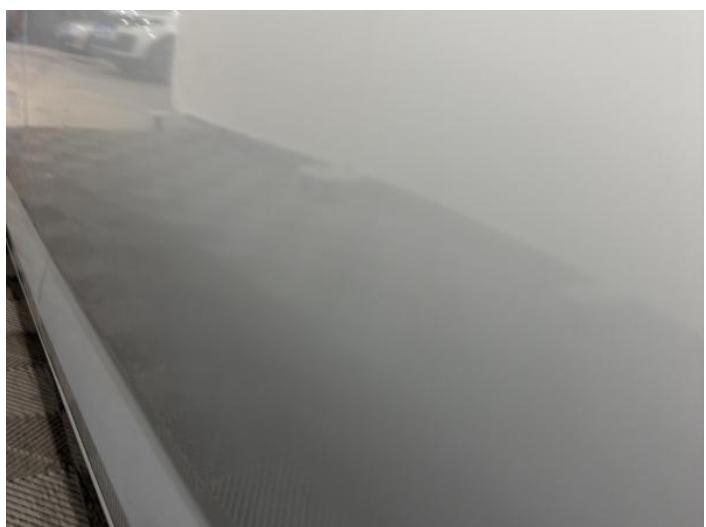
8: Door nsf
Poor Previous Repair
Poor Paint

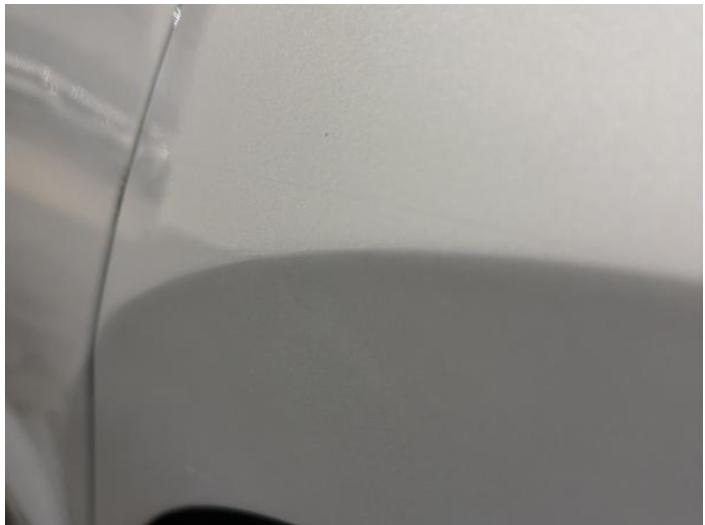
9: Qtr Panel nsr
Poor Previous Repair
Poor Paint

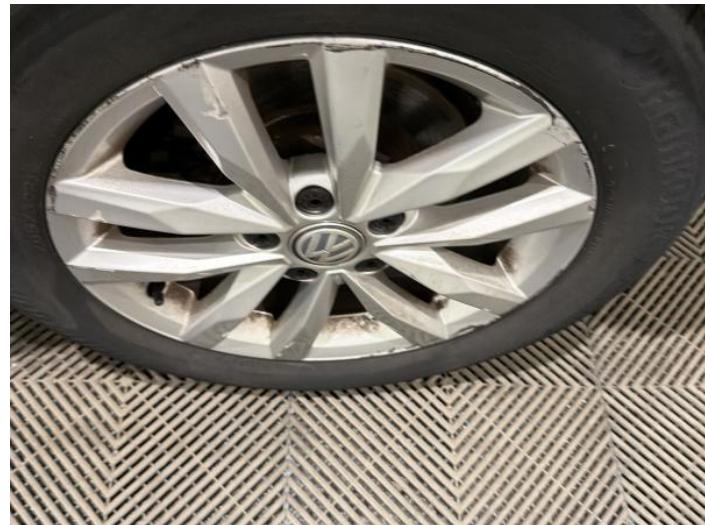
10: Wheel nsr
Scratched
Over 50mm

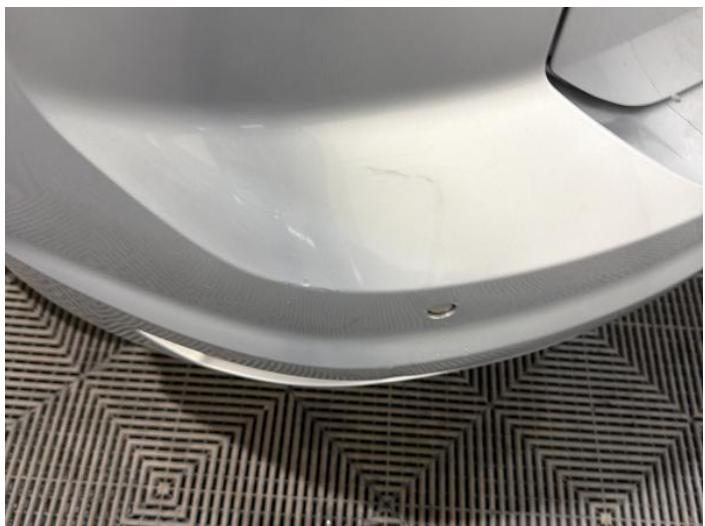
11: Bumper Rear
Poor Previous Repair
Poor Paint

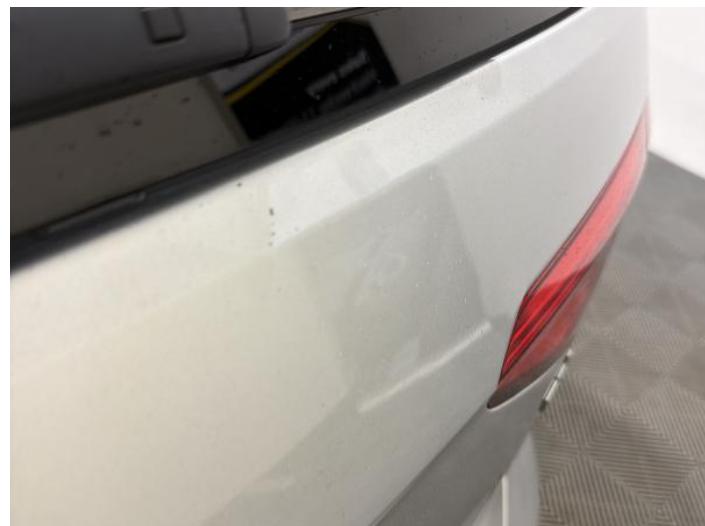
12: Boot Lid
Dented
Between 10mm + 30mm

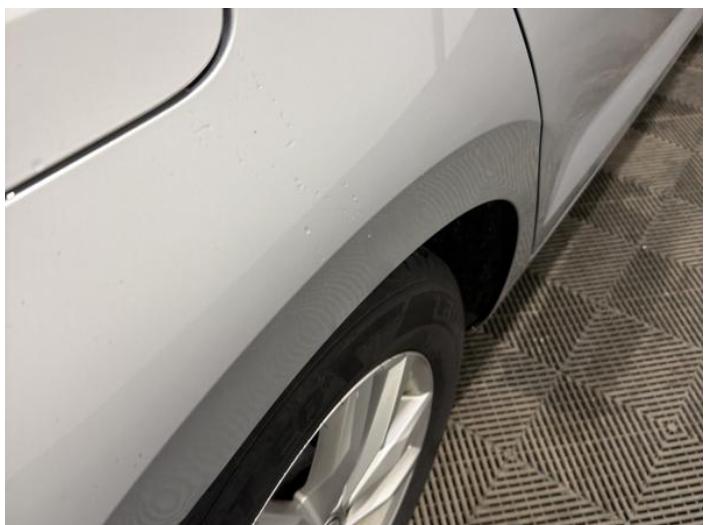
13: Qtr Panel osr
Dented
Between 10mm + 30mm

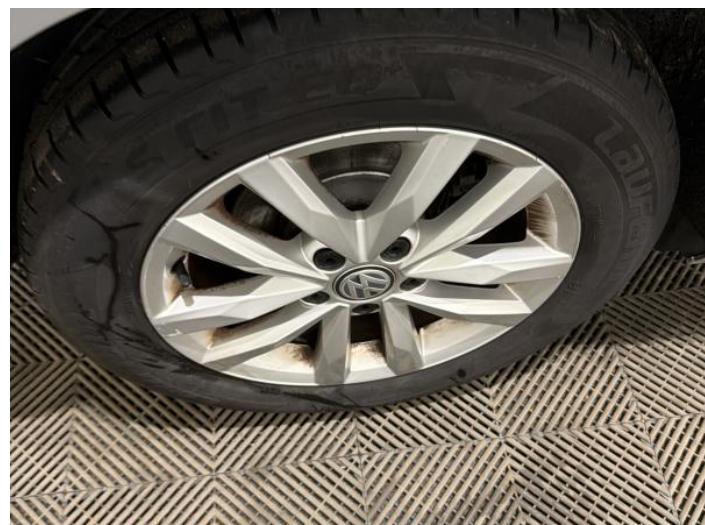
14: Wheel osr
Scratched
Over 50mm

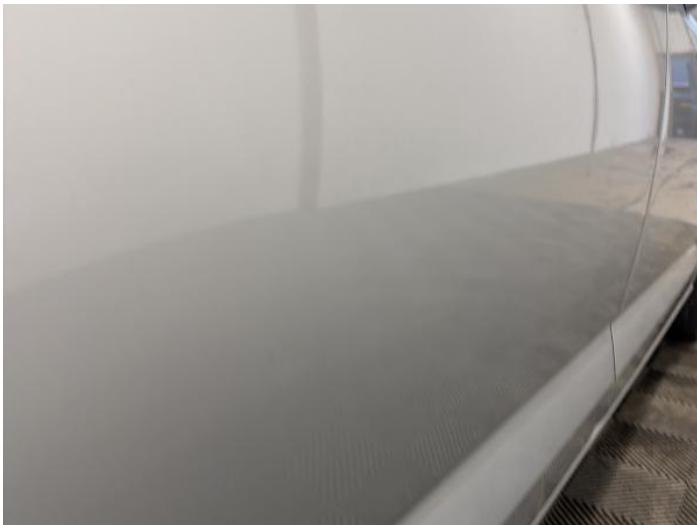
15: Door osr
Chipped
1 To 5

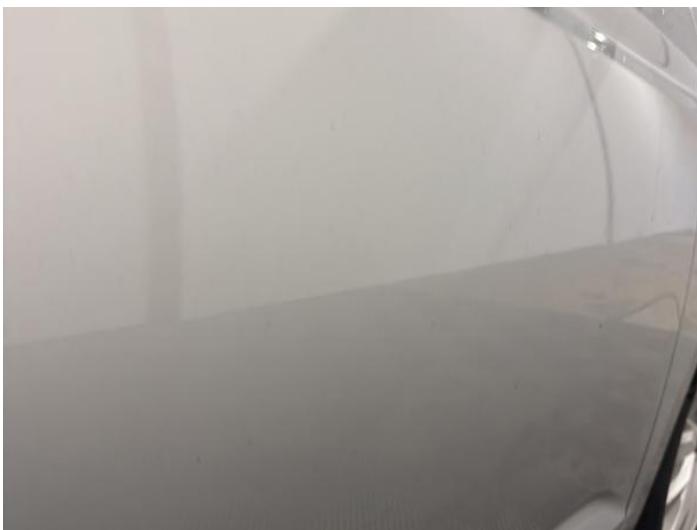
17: Door osf
Poor Previous Repair
Poor Paint

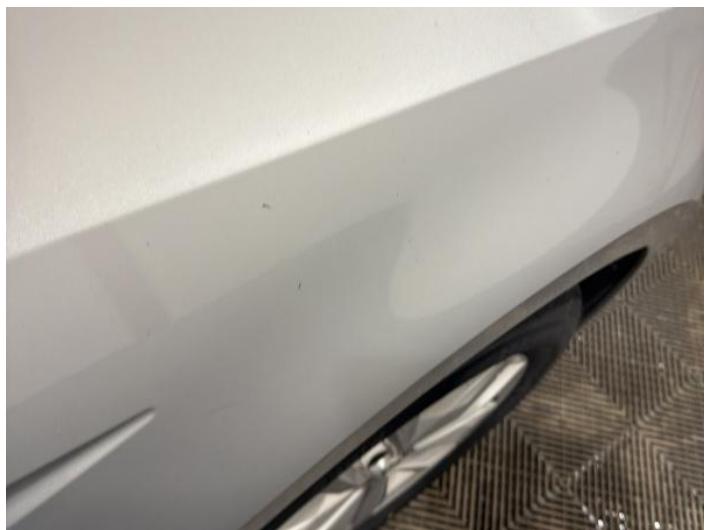
18: Wing osf
Chipped
1 To 5

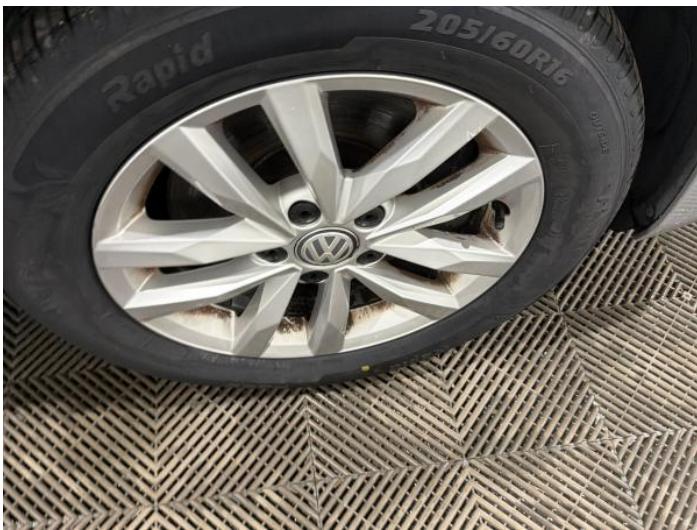
19: Wheel osf
Scratched
Over 50mm
