## VEHICLE INSPECTION REPORT

DV63PZK

### Seat Leon 1.4 TSI FR 5dr [Technology Pack]

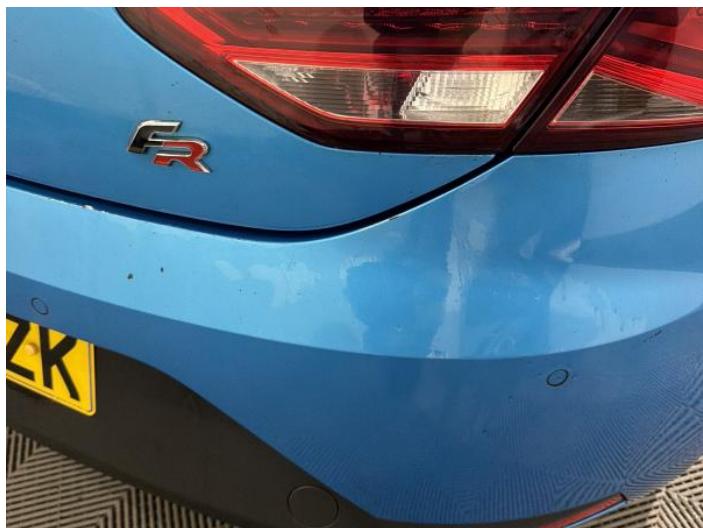
1: Bumper Rear  
Scratched  
Over 100mm Thru Paint

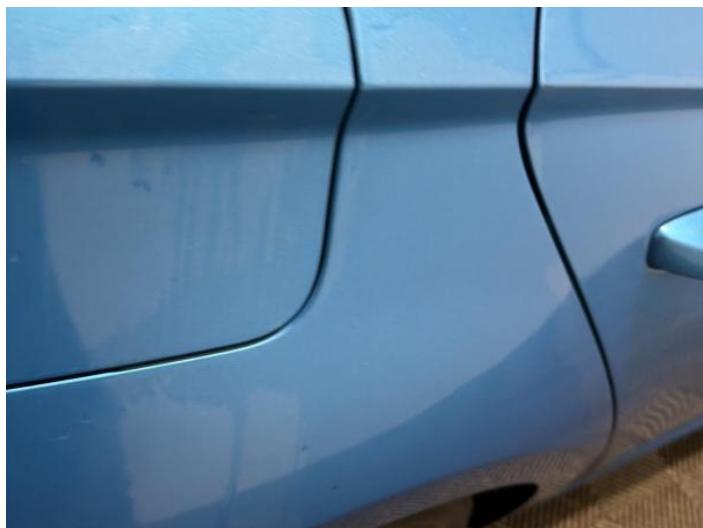
2: Qtr Panel osr  
Poor Previous Repair  
Poor Paint

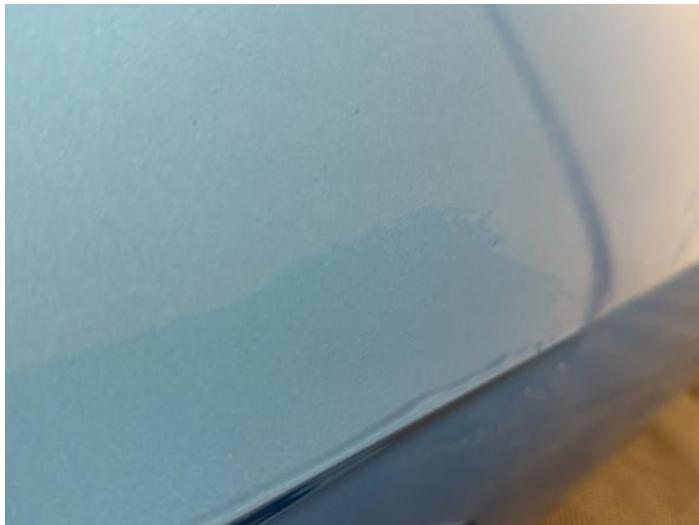
3: Door osr  
Poor Previous Repair  
Poor Paint

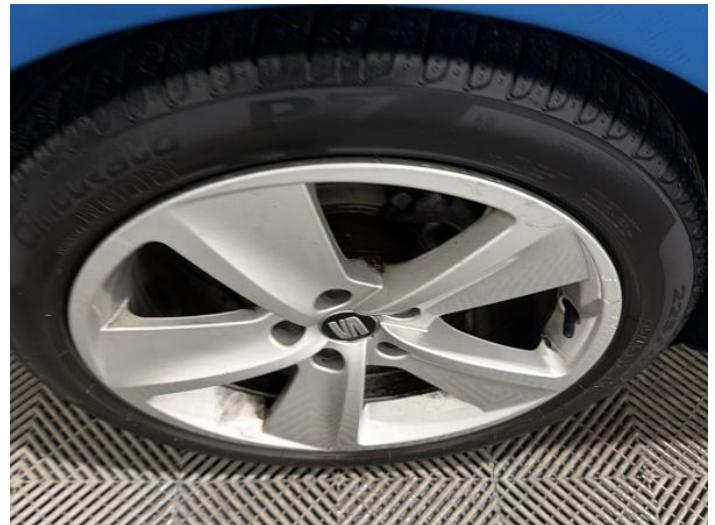
4: Wheel osr  
Scratched  
Over 50mm

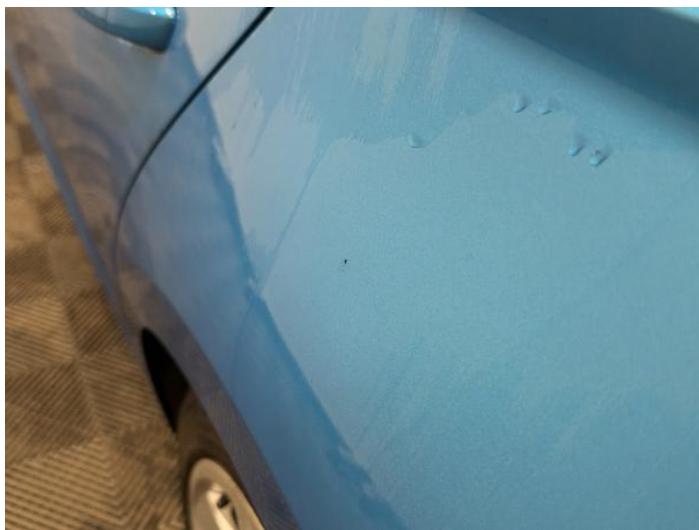
5: Qtr Panel nsr  
Dented  
Over 2 UpTo 10mm

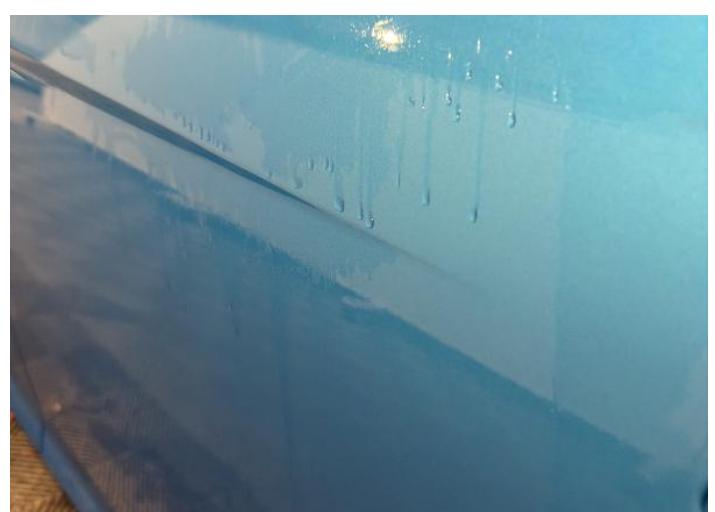
8: Door nsr  
Chipped  
1 To 5

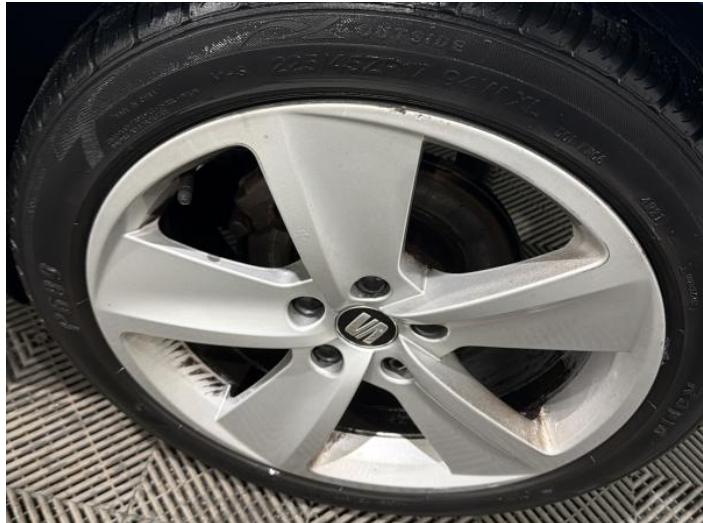
10: Wheel nsr  
Scratched  
Over 50mm

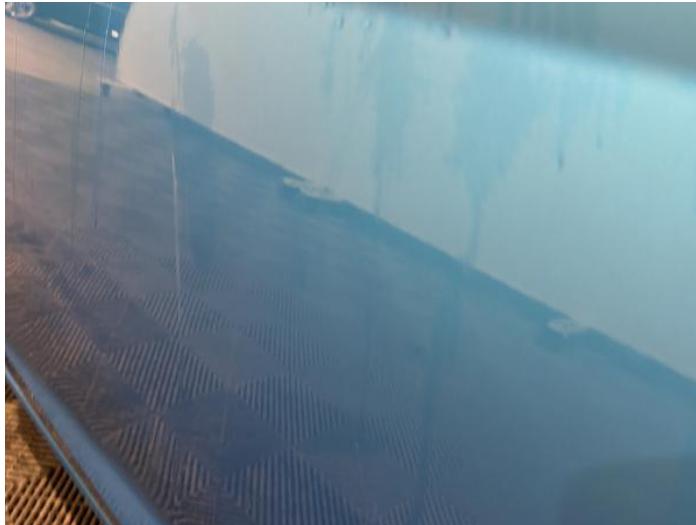
11: Door nsf  
Scratched  
Over 25mm Not Thru Paint

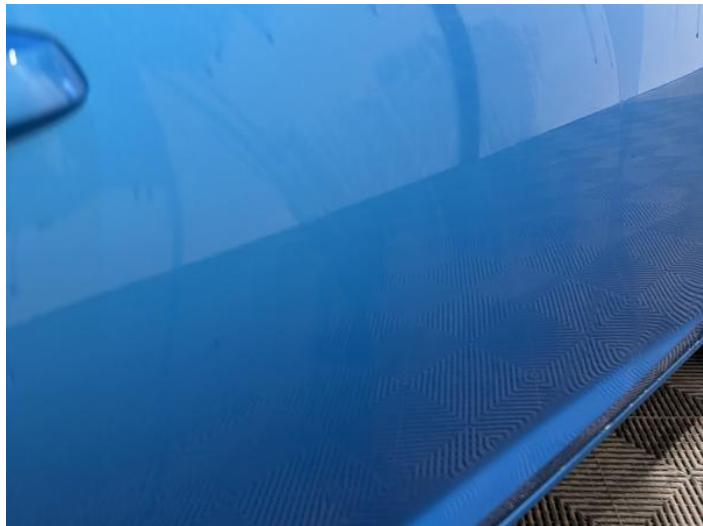
12: Door nsf  
Scratched  
Over 25mm Not Thru Paint

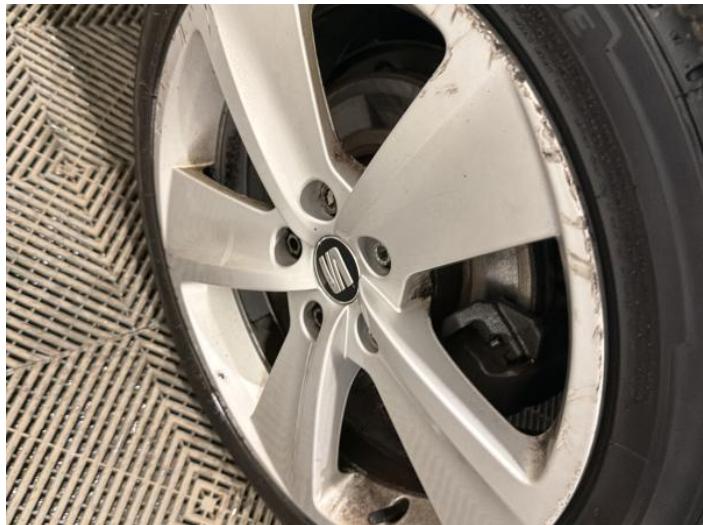
16: Wheel osf  
Scratched  
Over 50mm

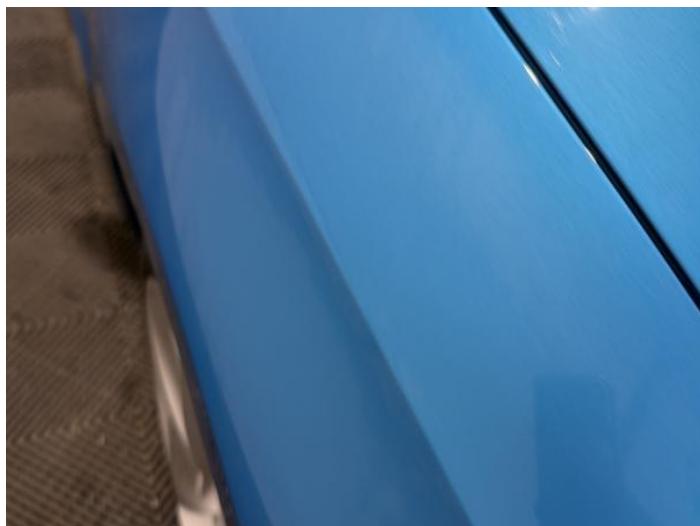
17: Wing osf  
Chipped  
1 To 5

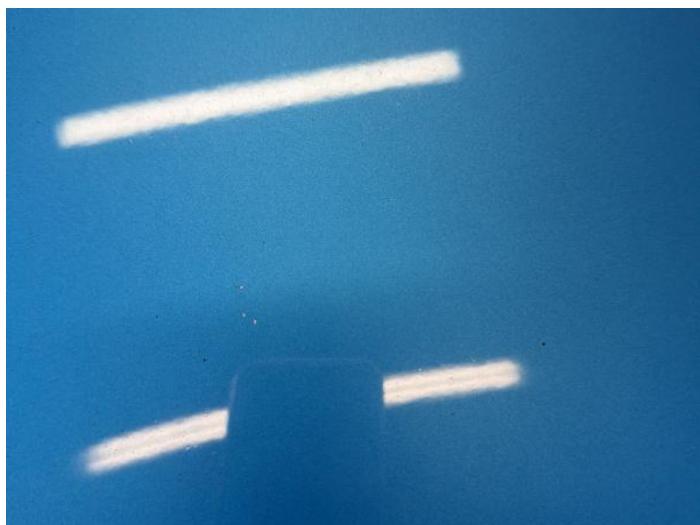
19: Bonnet  
Chipped  
Multiple Chips

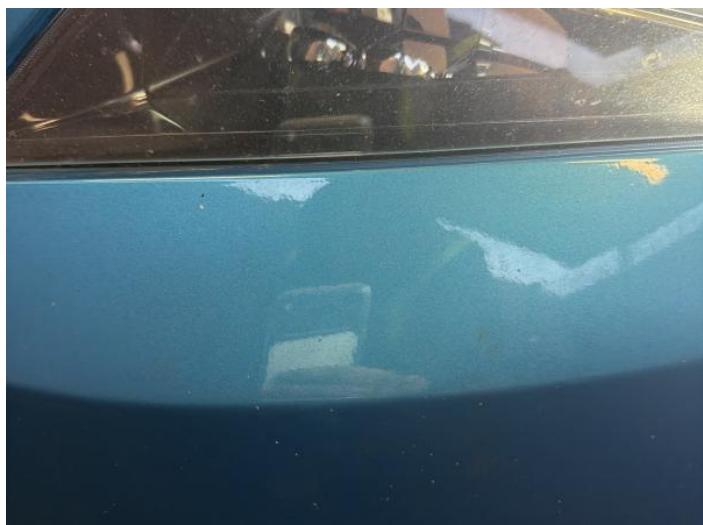
20: Bumper Front  
Scratched  
Over 100mm Thru Paint

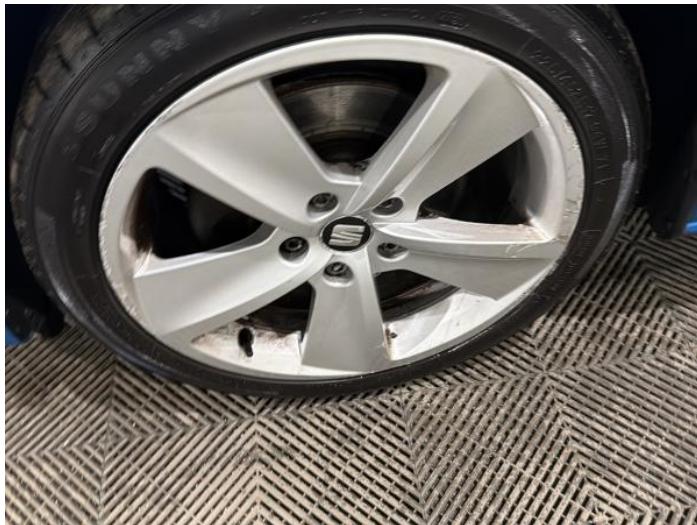
21: Wheel nsf  
Scratched  
Over 50mm
