VEHICLE INSPECTION REPORT

GL22KFV

Kia E-Niro 150kW 2 Long Range 64kWh 5dr Auto

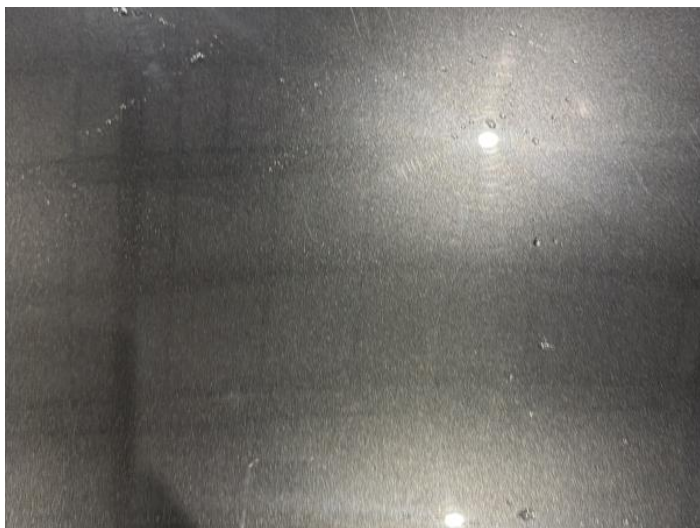
1: Bonnet
Chipped
1 To 5

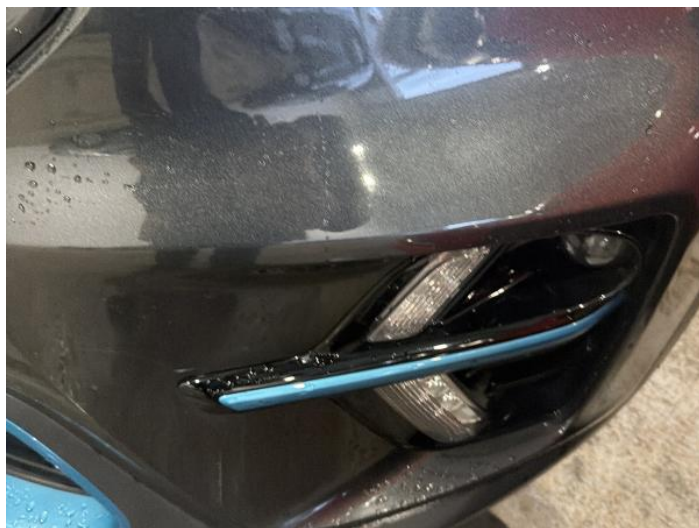
2: Bumper Front
Chipped
Multiple Chips

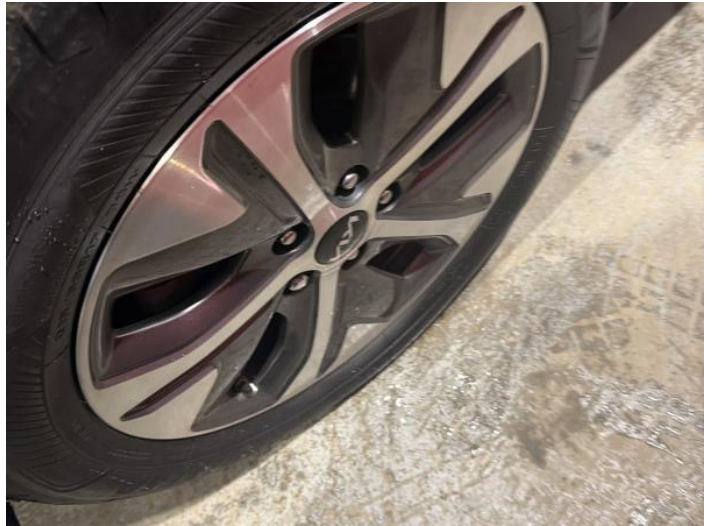
4: Wheel nsf
Scratched
Up To 50mm

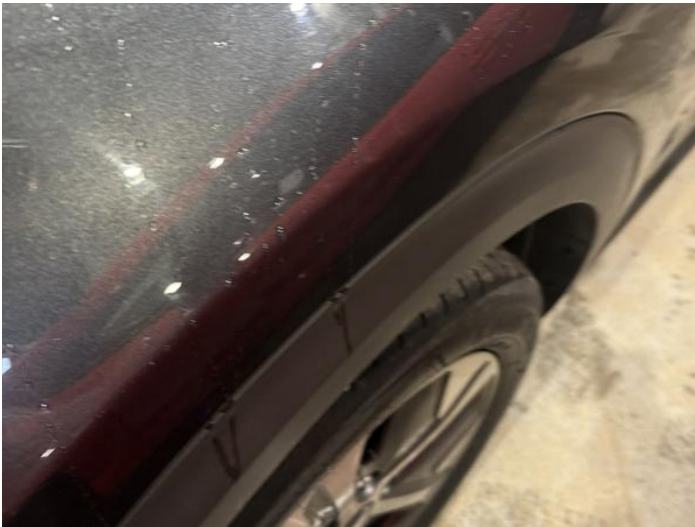
5: Wing nsf
Dented
Over 2 UpTo 10mm

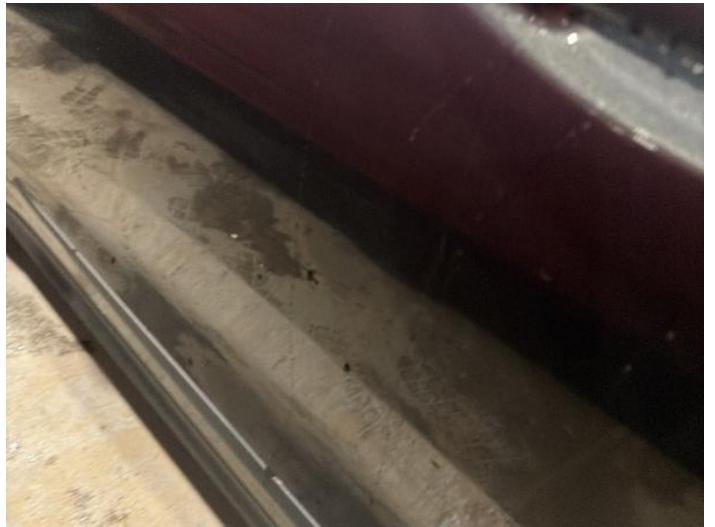
6: Door nsf
Dented
Over 2 UpTo 10mm

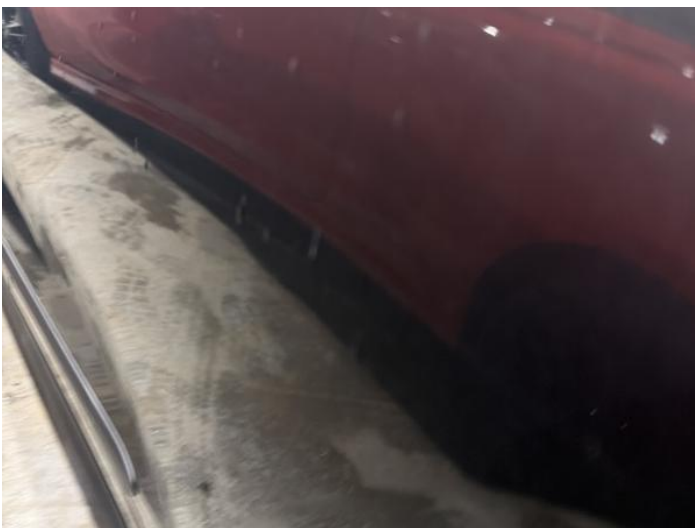
7: Door nsr
Chipped
1 To 5

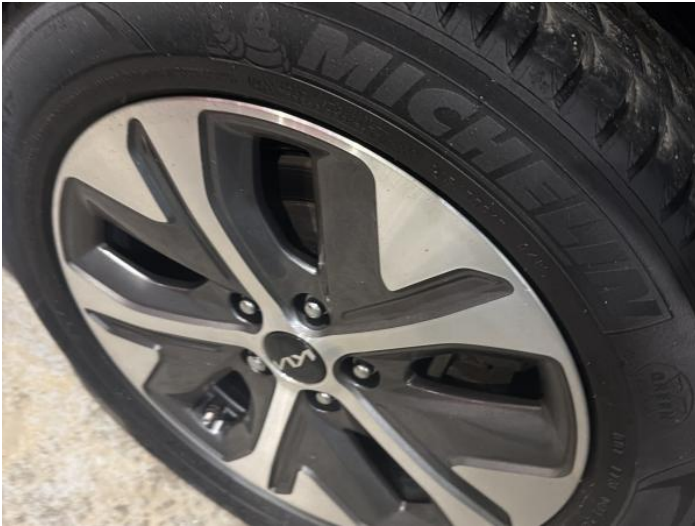
9: Wheel nsr
Scratched
Up To 50mm

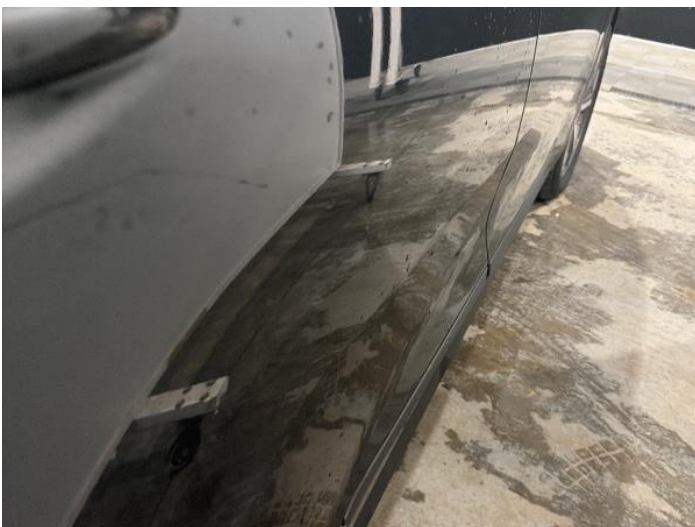
13: Door osr
Dented
2 Or Less UpTo 10mm

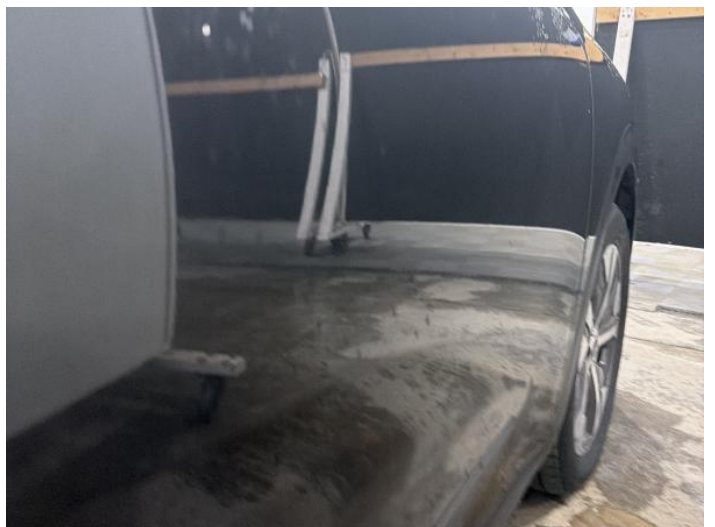
14: Door osf
Dented
2 Or Less UpTo 10mm
