VEHICLE INSPECTION REPORT

TGZ9462

Toyota Yaris 1.5 Hybrid Excel 5dr CVT

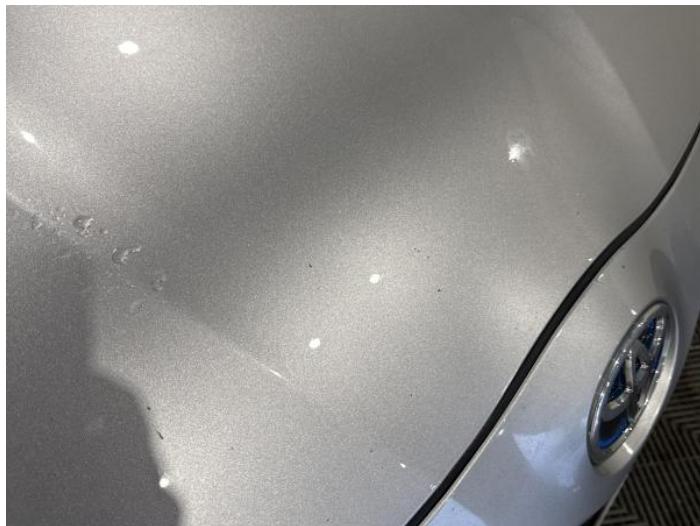
1: Bonnet
Chipped
Multiple Chips

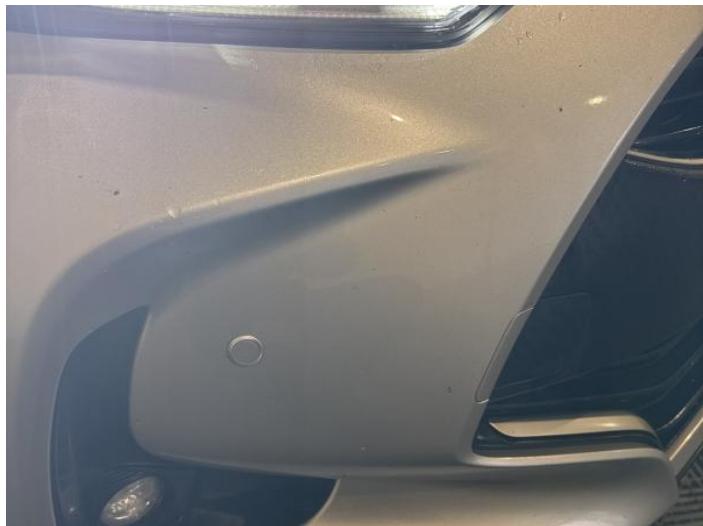
2: Bumper Front
Chipped
Multiple Chips

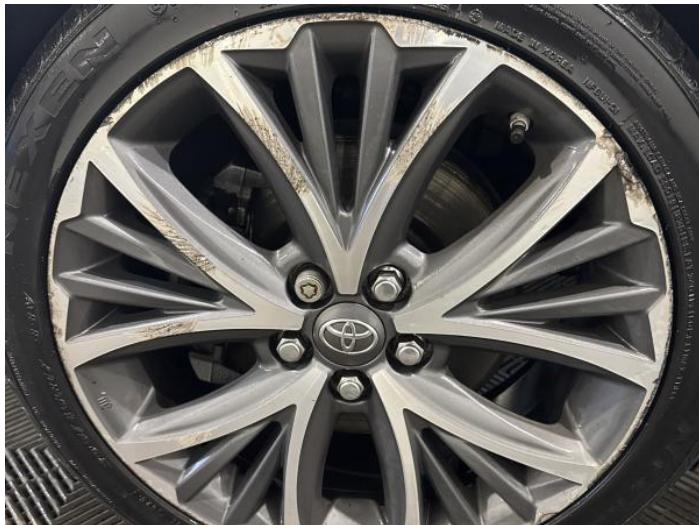
3: Wheel nsf
Scratched
Over 50mm

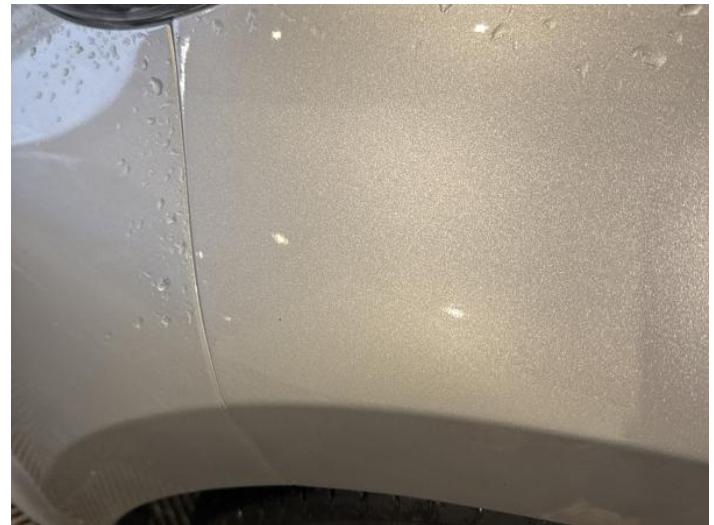
4: Wing nsf
Chipped
1 To 5

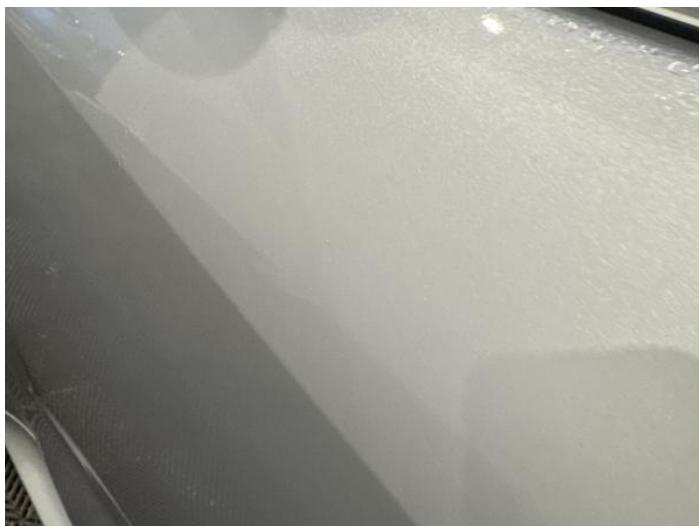
5: Door nsf
Dented
Between 10mm + 30mm

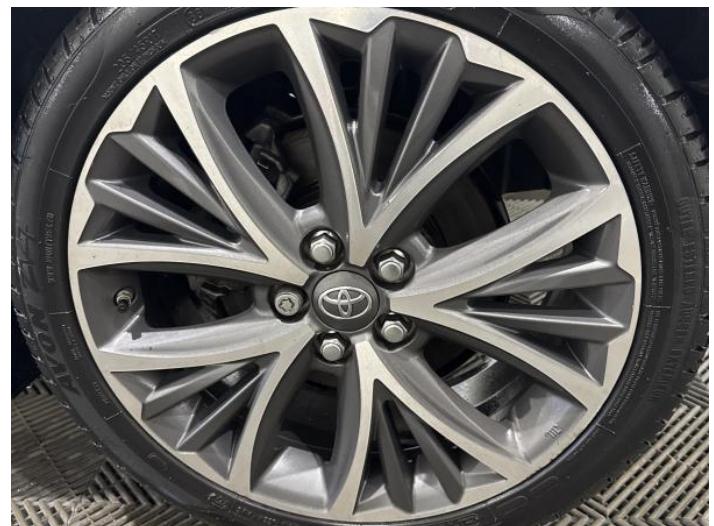
6: Wheel nsr
Scratched
Over 50mm

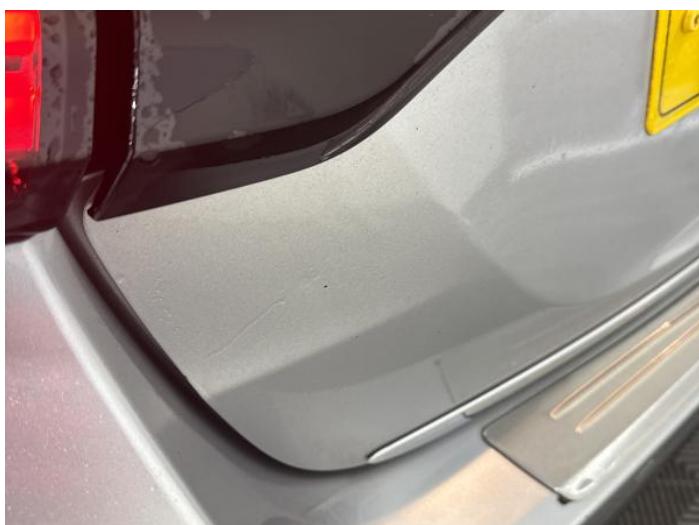
7: Tailgate
Dented
Between 10mm + 30mm

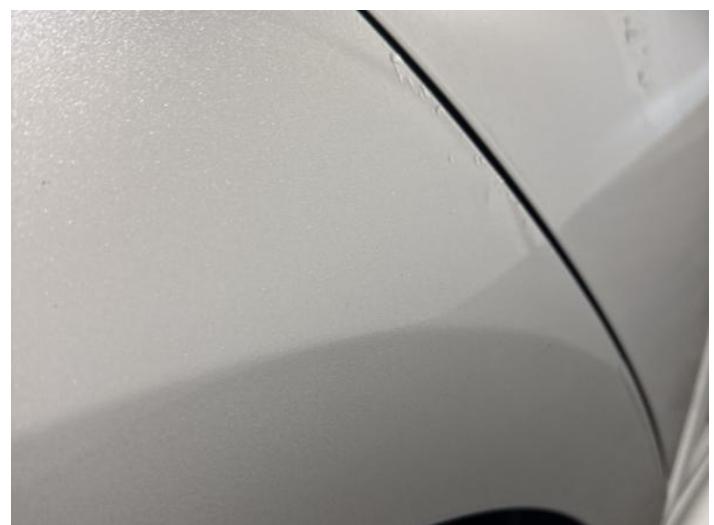
8: Qtr Panel osr
Dented
Between 10mm + 30mm

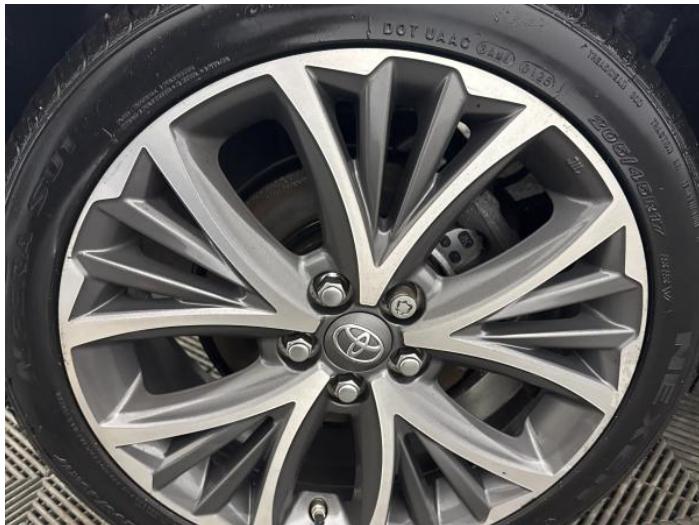
9: Wheel osf
Scratched
Up To 50mm

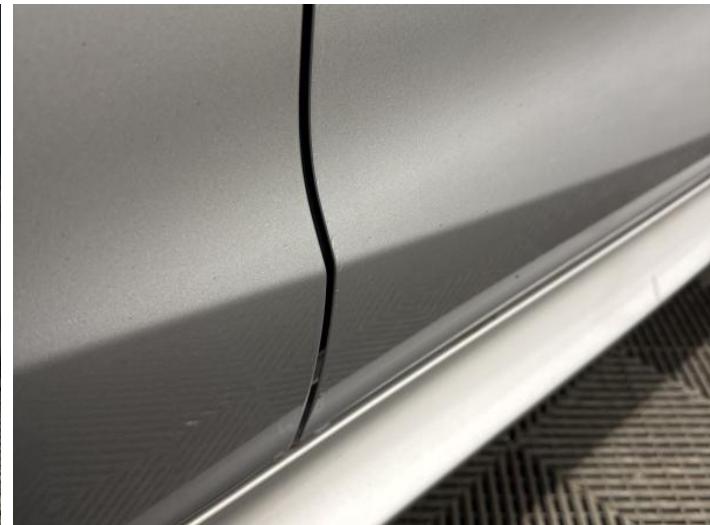
10: Door osf
Chipped
Edge Chip

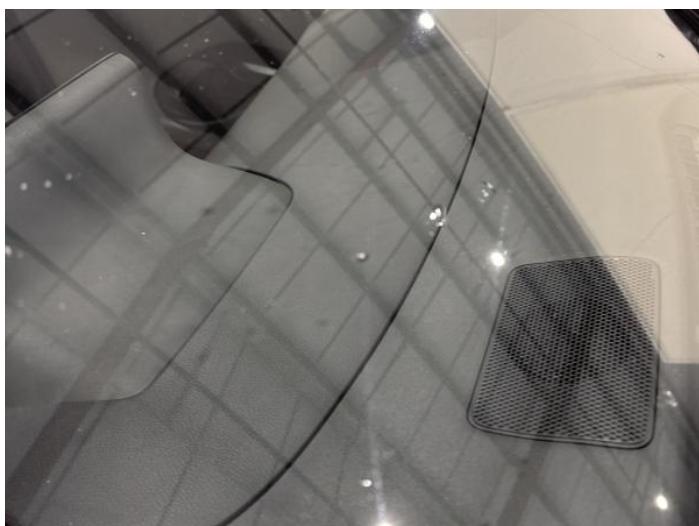
11: Screen Front
Chipped
UpTo 10mm

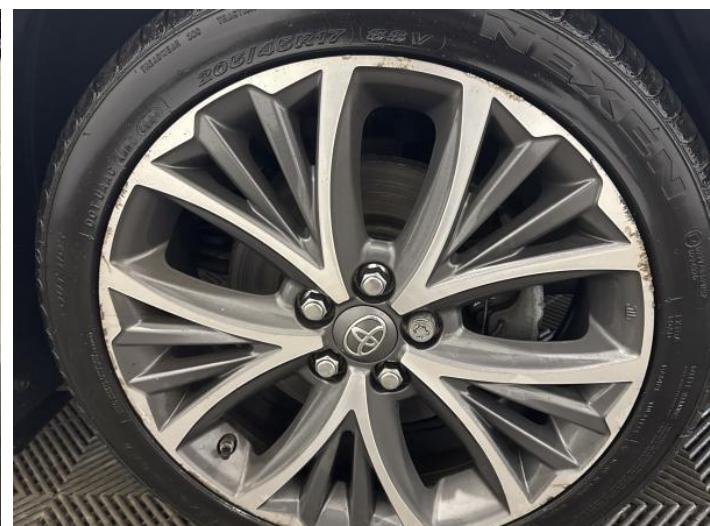
12: Wheel osf
Scratched
Over 50mm
