VEHICLE INSPECTION REPORT

GP18NNM

Volkswagen Tiguan 2.0 TSi 180 4Motion SEL 5dr DSG

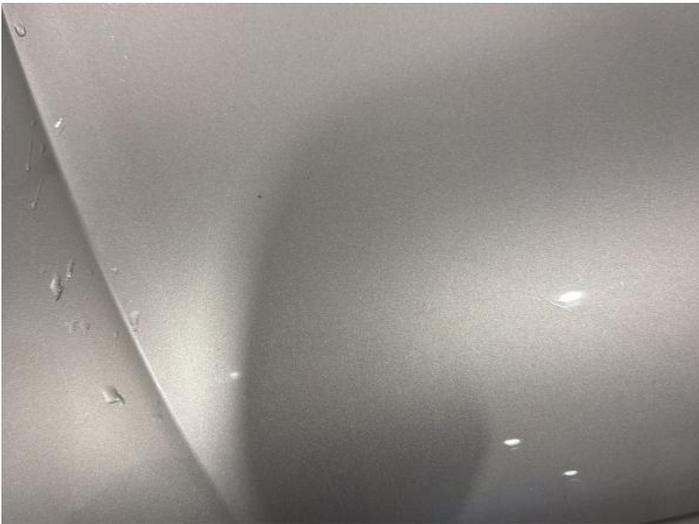
1: Bonnet
Chipped
Multiple Chips

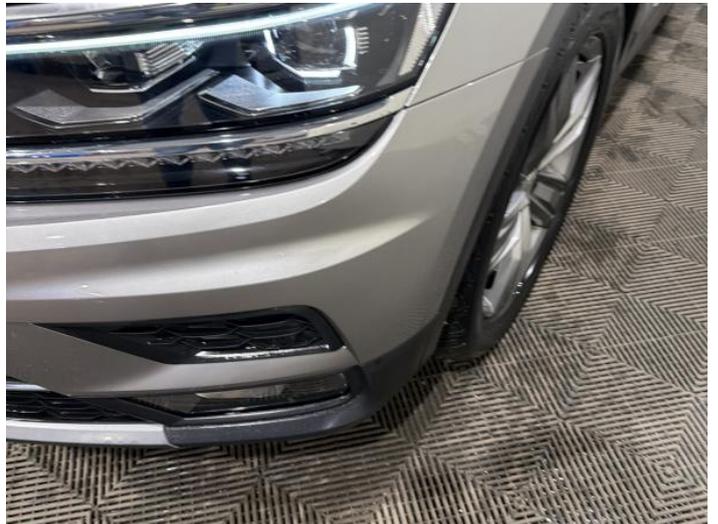
2: Bumper Front
Chipped
Multiple Chips

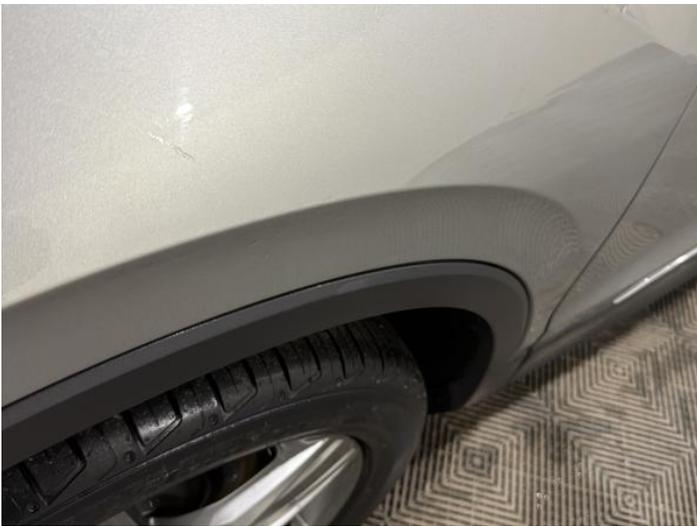
5: Wing nsf
Chipped
1 To 5

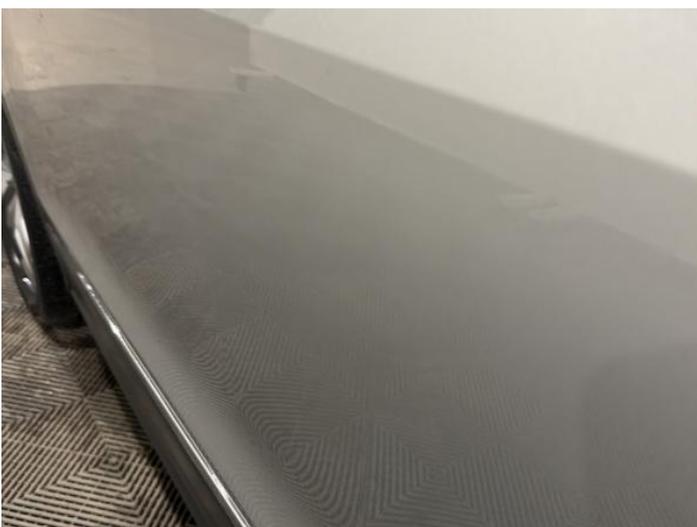
7: Door nsf
Dented
Over 2 Up To 10mm

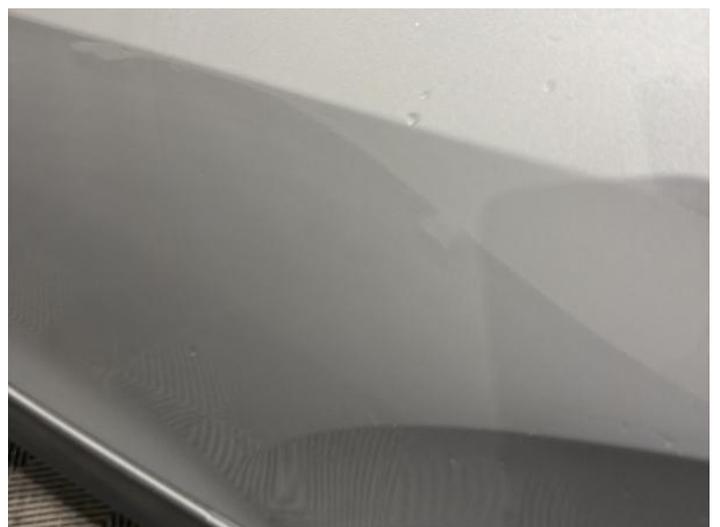
8: Door nsr
Dented
2 Or Less Up To 10mm

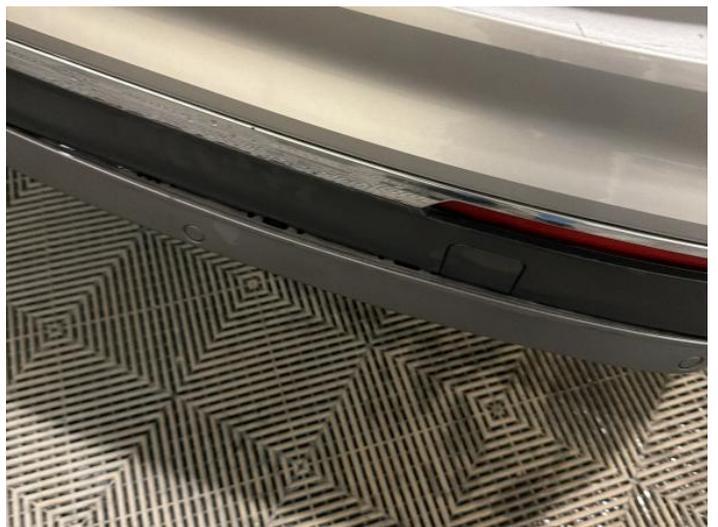
13: Bumper Rear
Scratched
Over 25mm Not Thru Paint

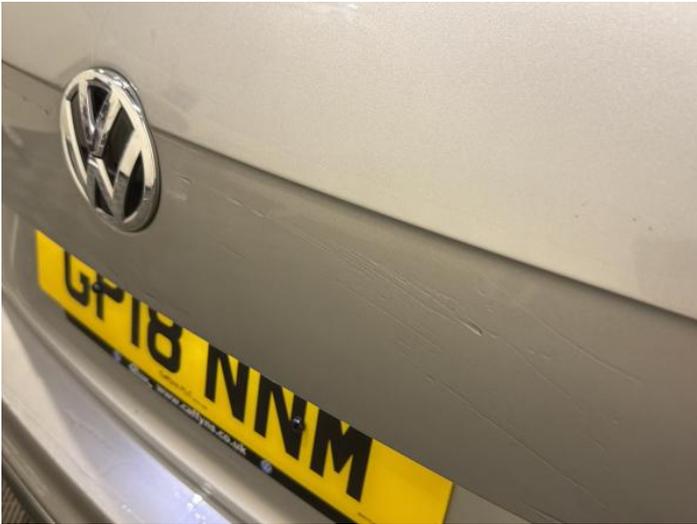
15: Boot Lid
Dented
2 Or Less Up To 10mm

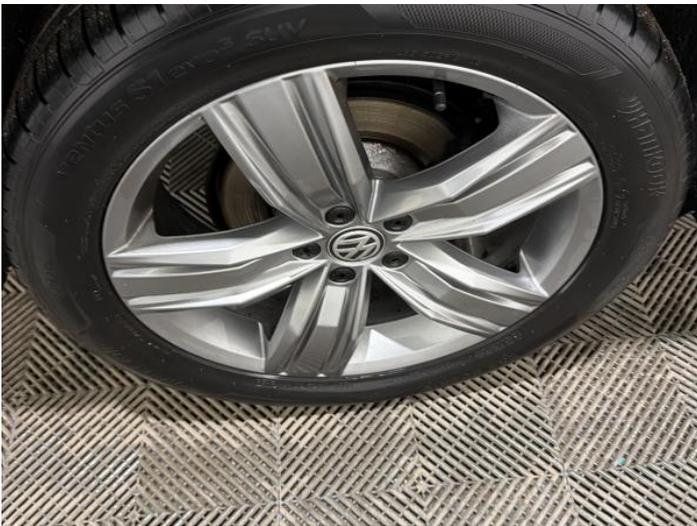
17: Wheel osr
Scratched
Up To 50mm

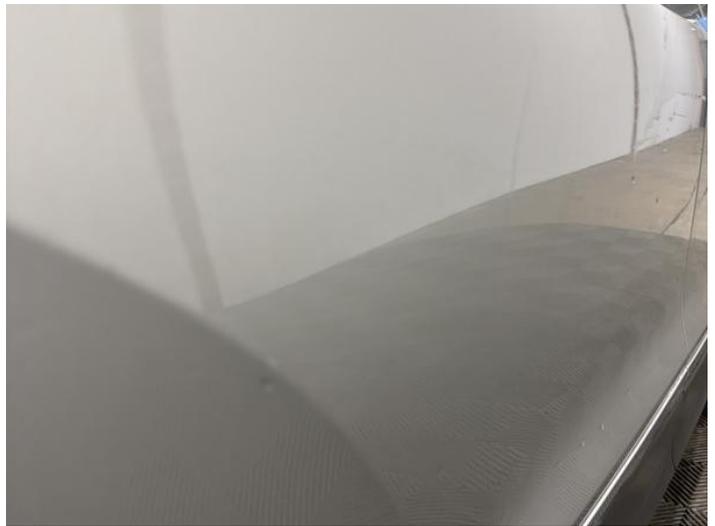
18: Door osr
Chipped
1 To 5

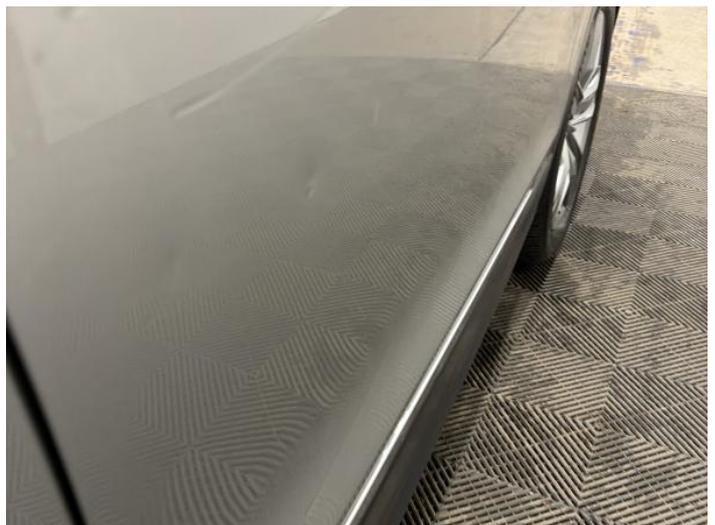
20: Door osf
Dented
Between 10mm + 30mm
