VEHICLE INSPECTION REPORT

GN63YDZ

Vauxhall Astra Gtc 1.4T 16V SRi 3dr

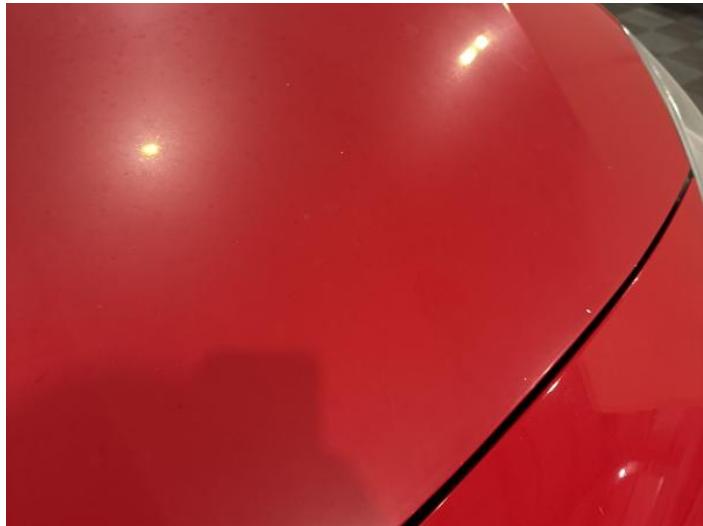
1: Bonnet
Chipped
Multiple Chips

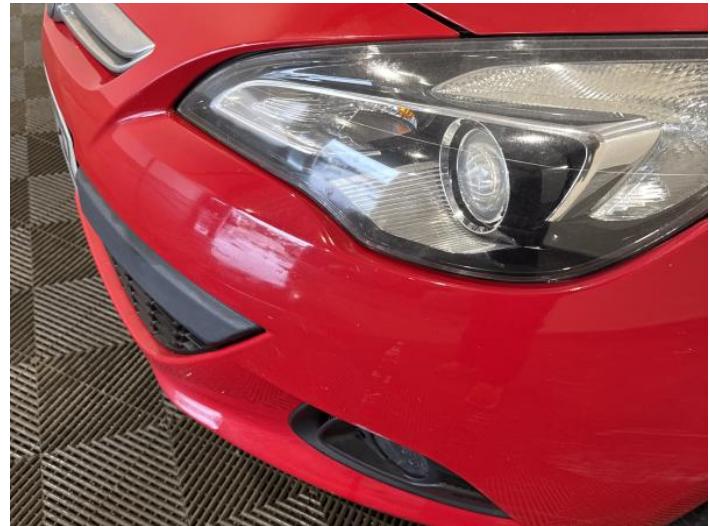
2: Bumper Front
Scratched
Over 100mm Thru Paint

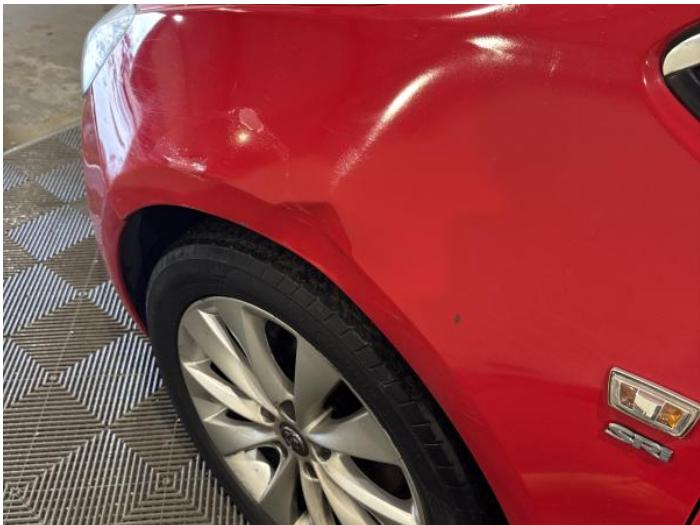
3: Wing nsf
Dented
With Paint Damage

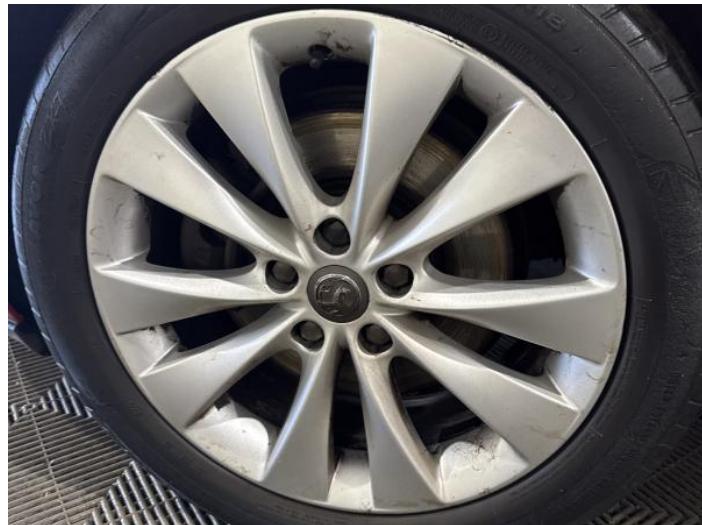
4: Wheel nsf
Scratched
Up To 50mm

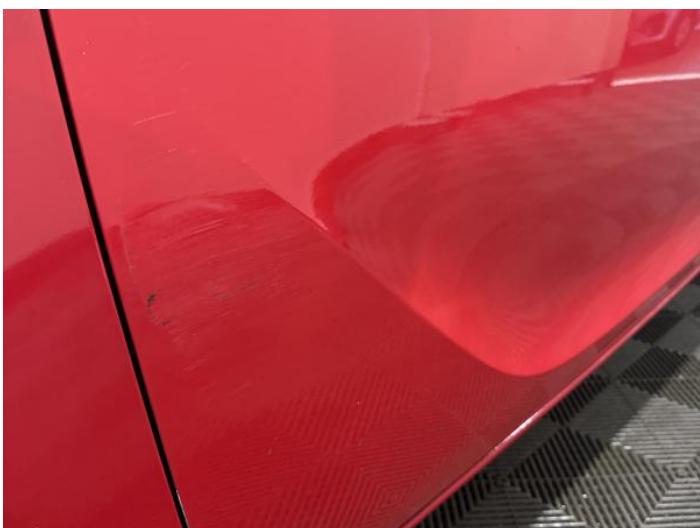
5: Door nsf
Dented
With Paint Damage

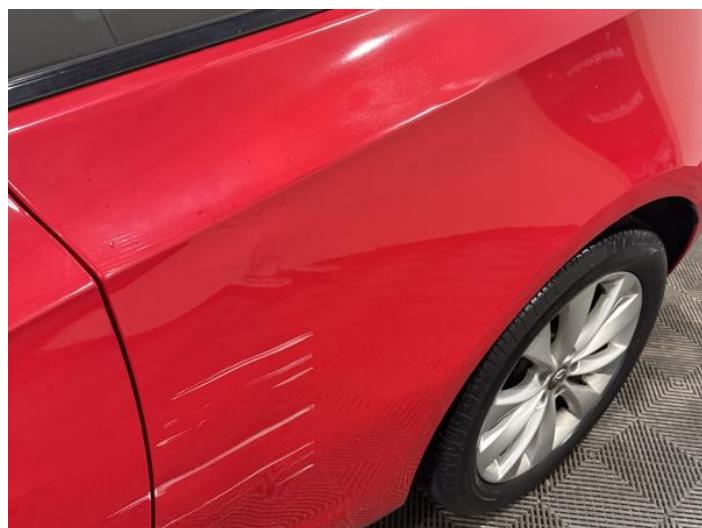
6: Qtr Panel nsr
Dented
With Paint Damage

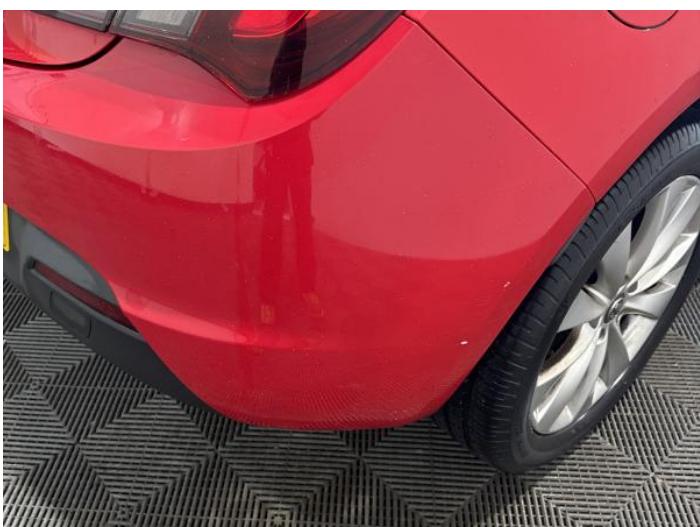
7: Bumper Rear
Scratched
Over 100mm Thru Paint

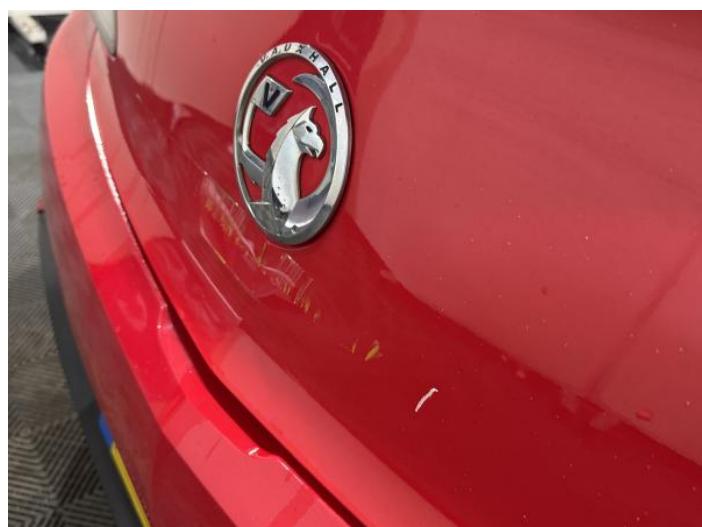
8: Tailgate
Dented
With Paint Damage

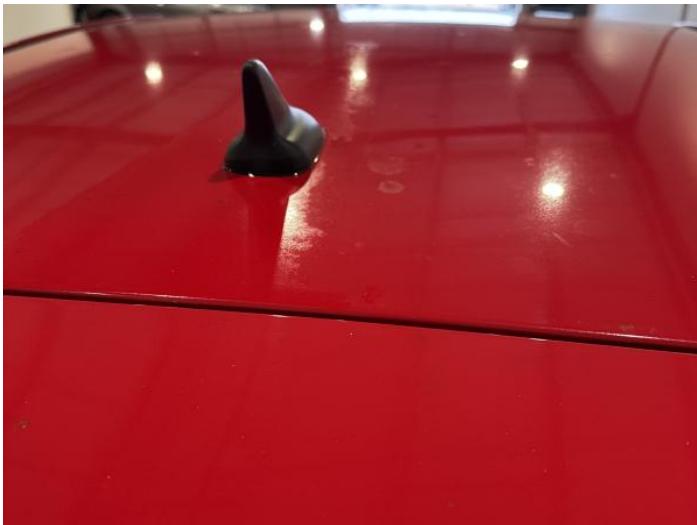
9: Roof
Dented
Between 10mm + 30mm

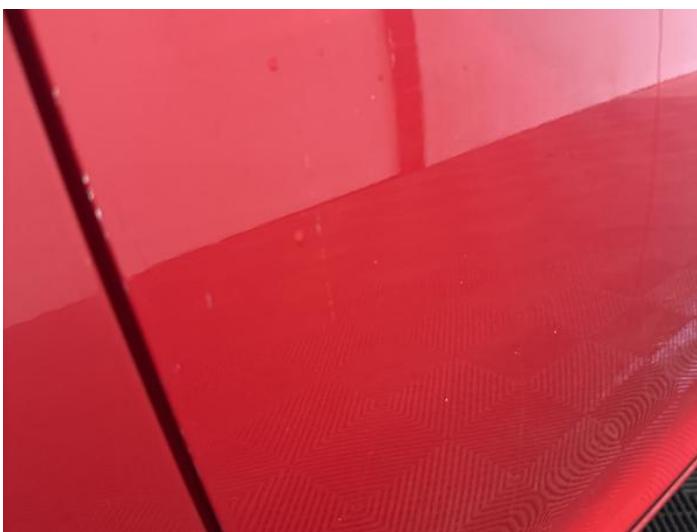
11: Door osf
Scratched
Over 25mm Thru Paint

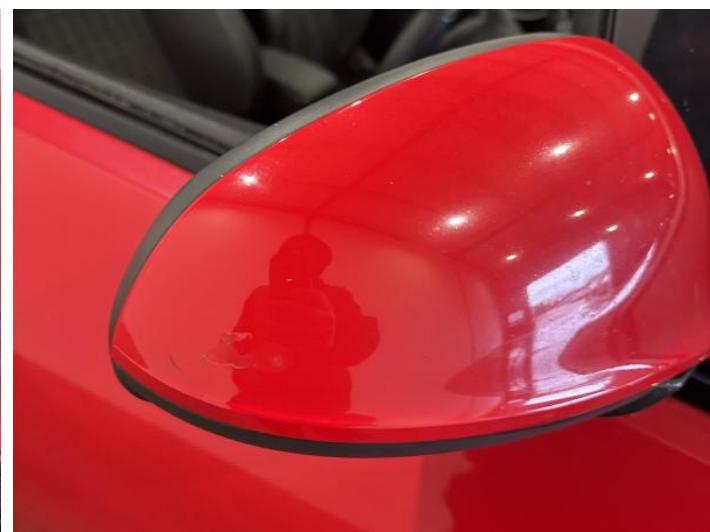
12: Door Mirror Assy nsf
Scratched (Painted)
UpTo 25mm Thru Paint

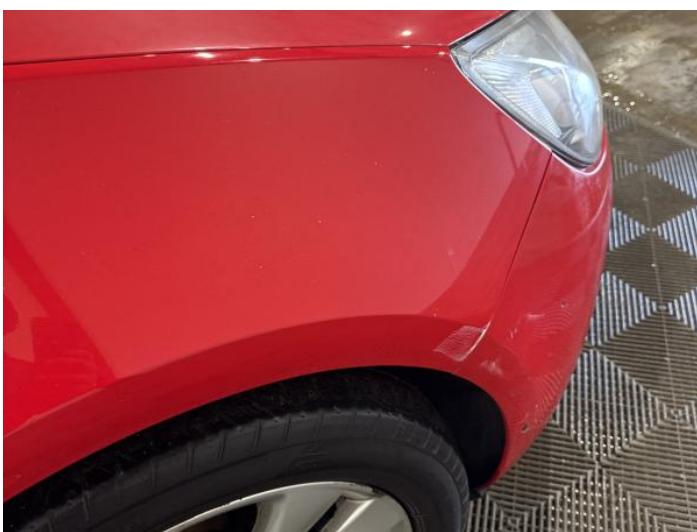
13: Wing osf
Scratched
Over 25mm Thru Paint

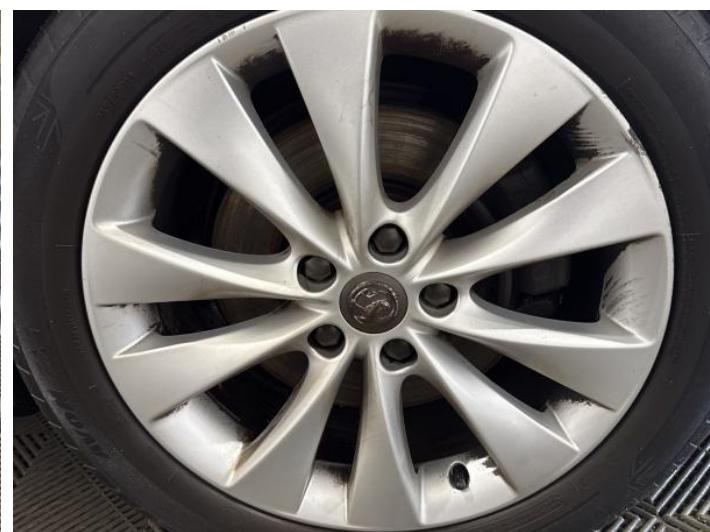
14: Wheel osf
Scratched
Up To 50mm

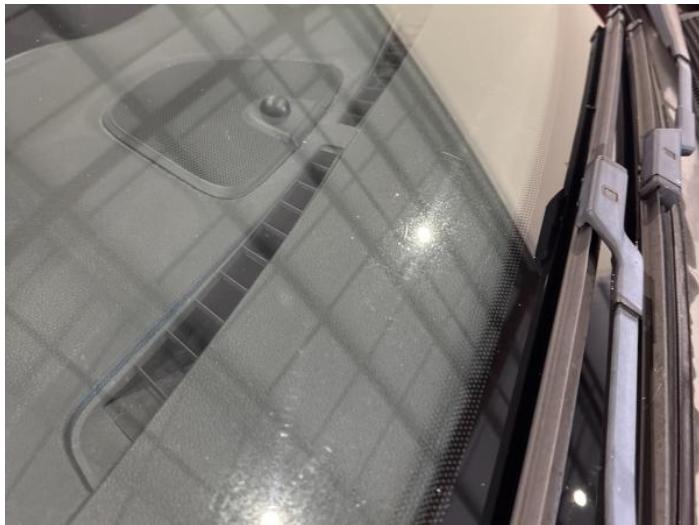
15: Screen Front
Chipped
UpTo 10mm
