## VEHICLE INSPECTION REPORT

RV15WBF

### Mercedes-Benz A Class A200 AMG Sport 5dr Auto

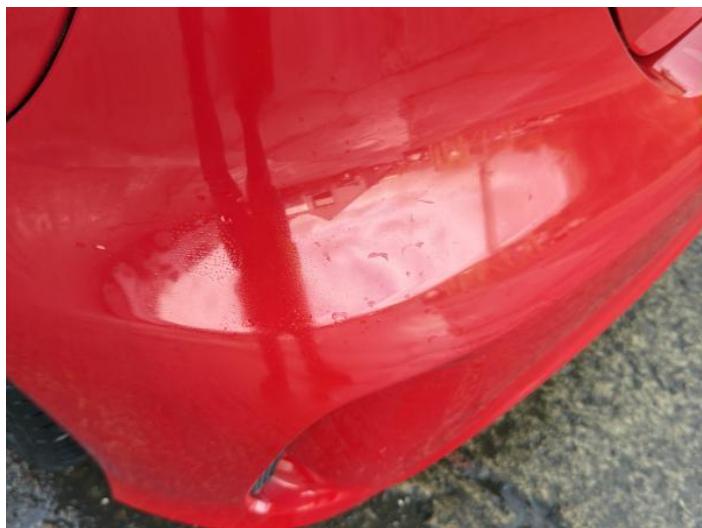
1: Bumper Rear  
Poor Previous Repair  
Poor Paint

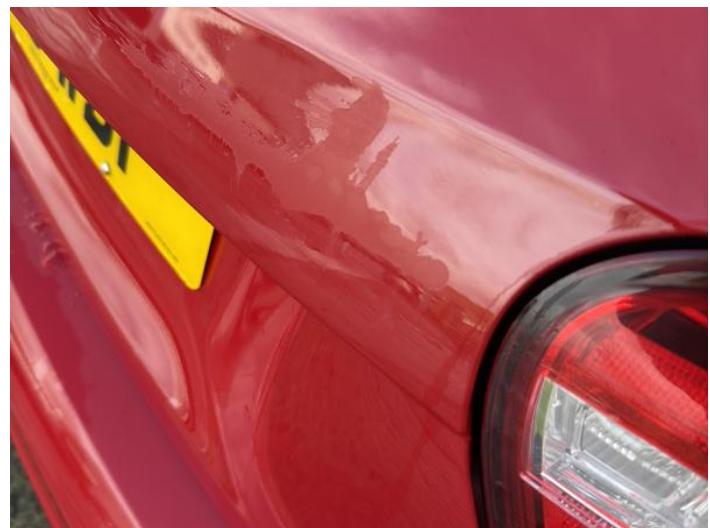
2: Boot Lid  
Dented  
With Paint Damage

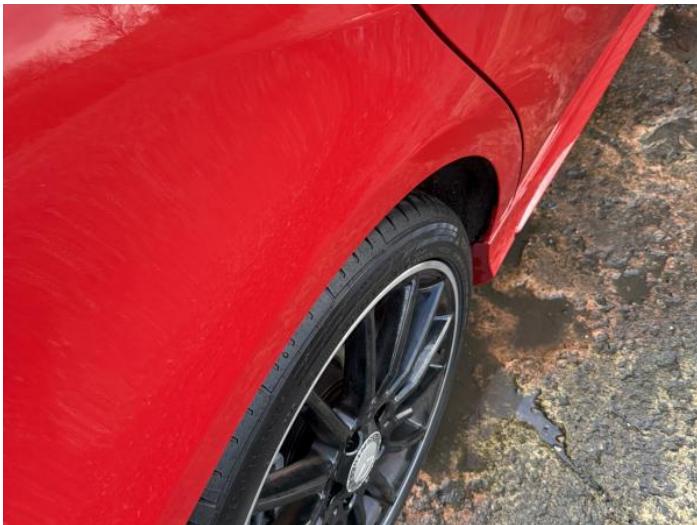
3: Qtr Panel osr  
Dented  
2 Or Less UpTo 10mm

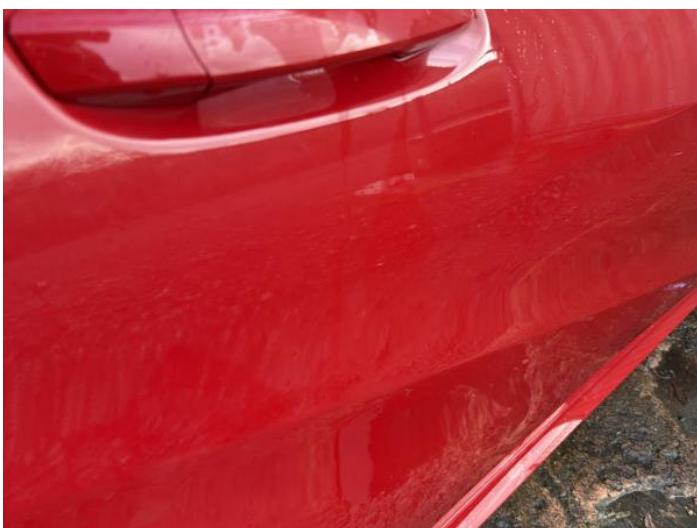
5: Door osr  
Poor Previous Repair  
Poor Paint

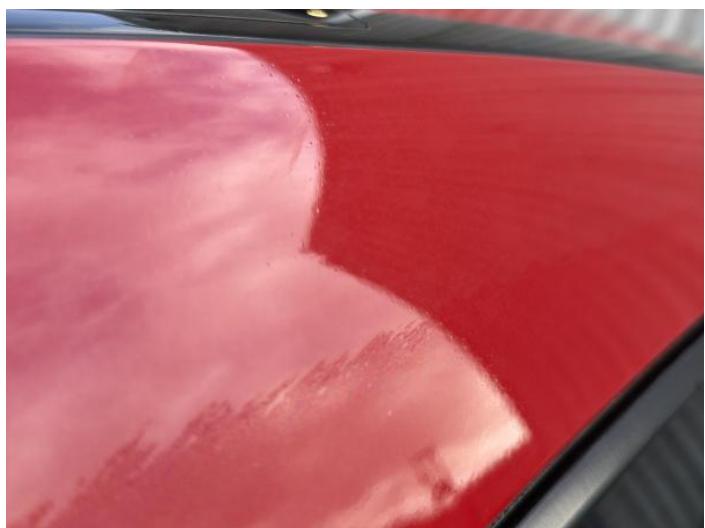
6: C Post os  
Poor Previous Repair  
Poor Paint

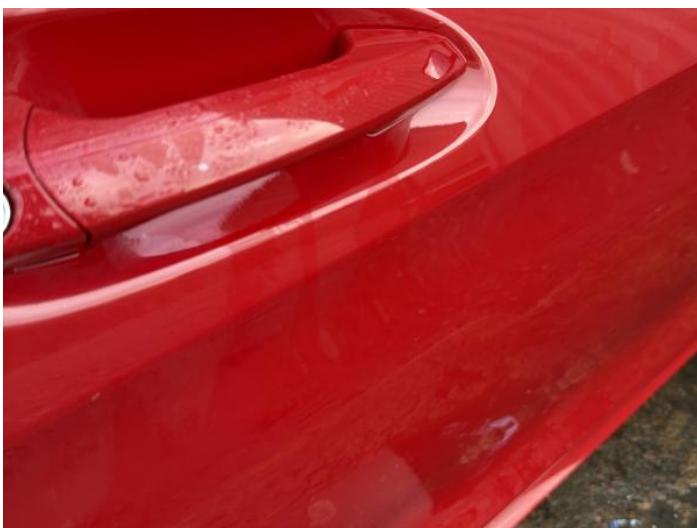
7: Door osf  
Poor Previous Repair  
Poor Paint

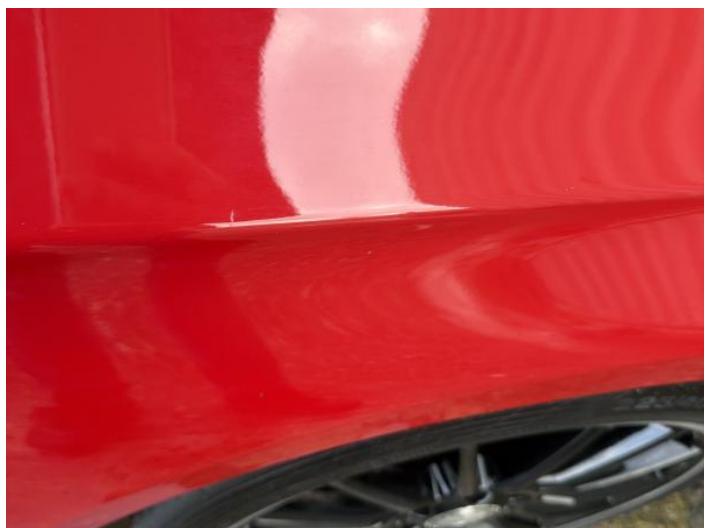
8: Wing osf  
Poor Previous Repair  
Poor Paint

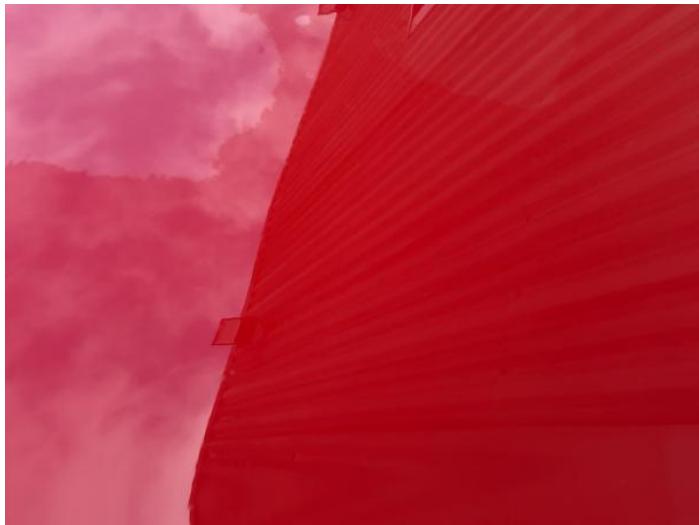
9: Bonnet  
Chipped  
1 To 5

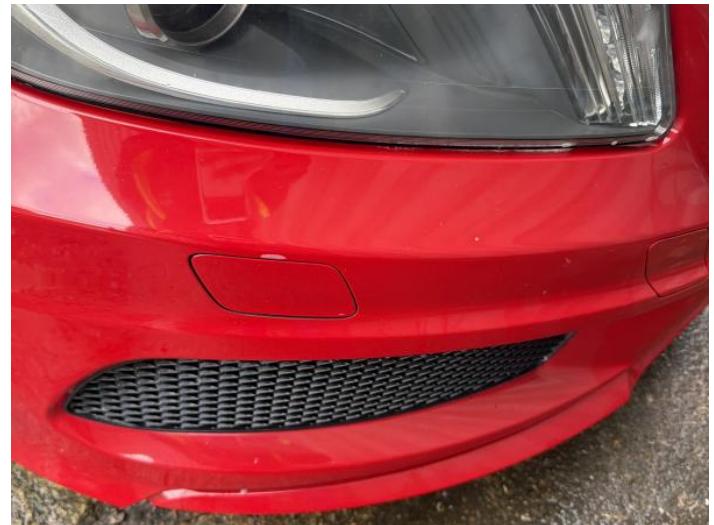
10: Bumper Front  
Poor Previous Repair  
Poor Paint

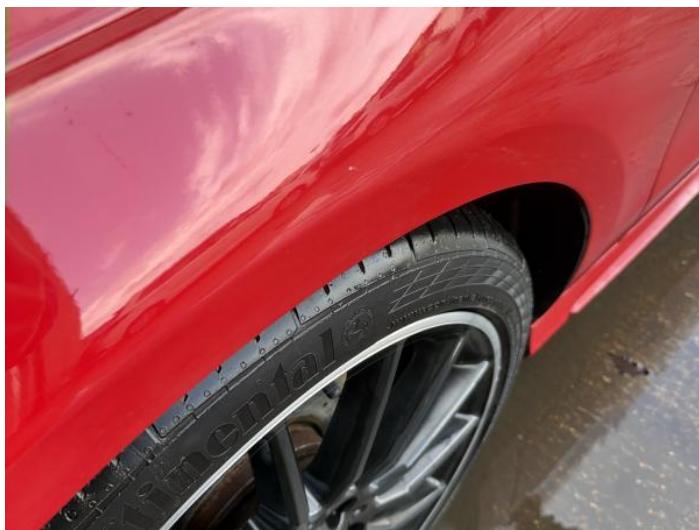
11: Wing nsf  
Chipped  
1 To 5

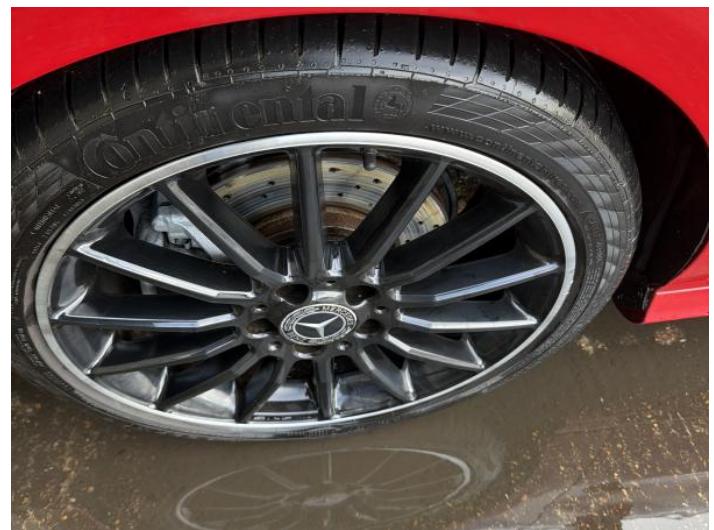
12: Wheel nsf  
Scratched  
Over 50mm

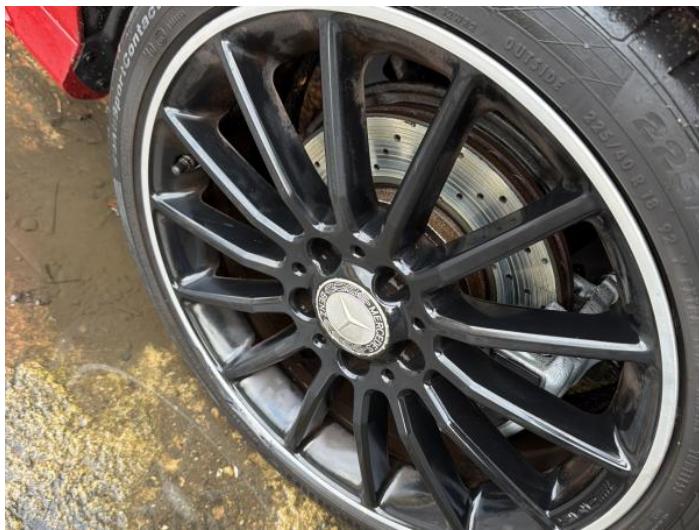
13: Wheel osf  
Scratched  
Over 50mm

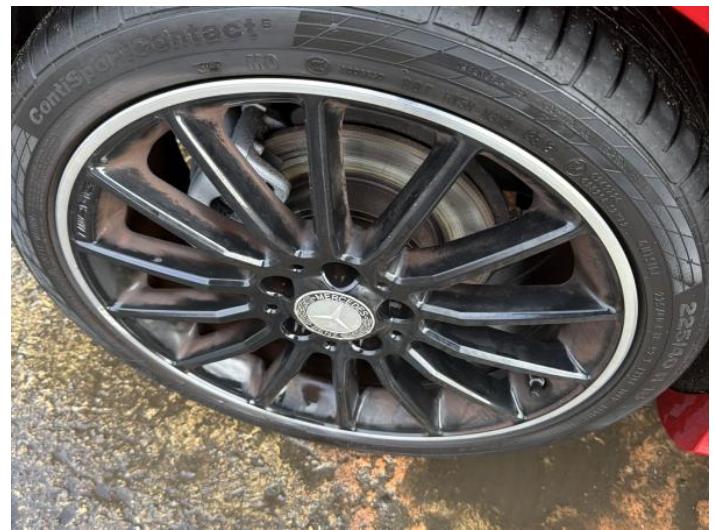
14: Wheel osr  
Scratched  
Over 50mm

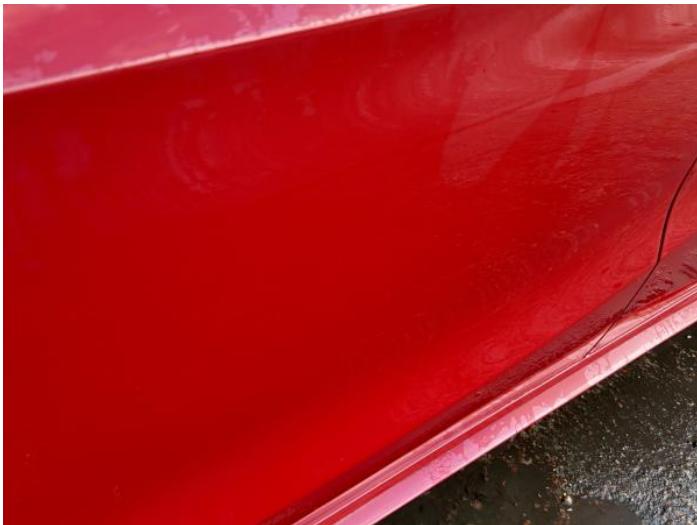
15: Door nsf  
Chipped  
1 To 5

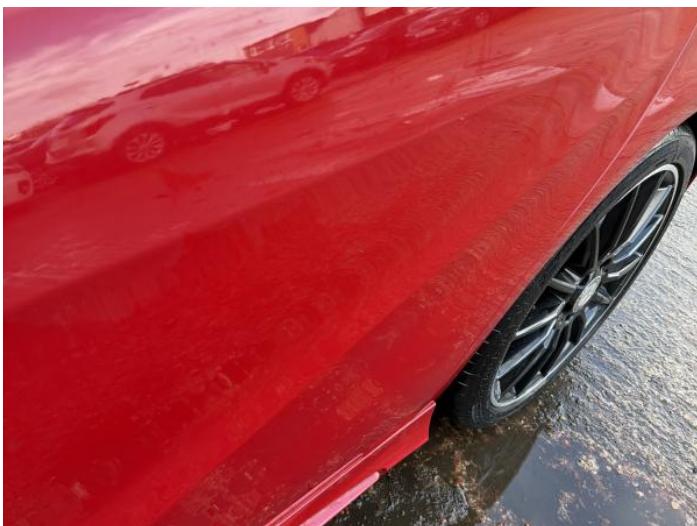
17: Door nsr  
Chipped  
1 To 5

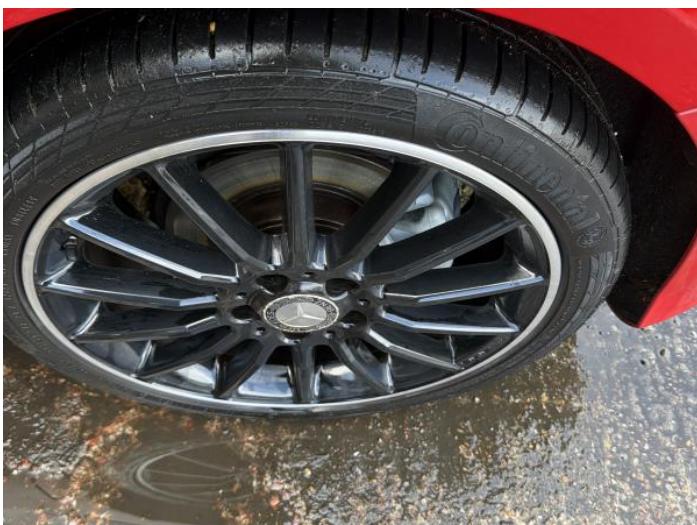
19: Wheel nsr  
Scratched  
Up To 50mm

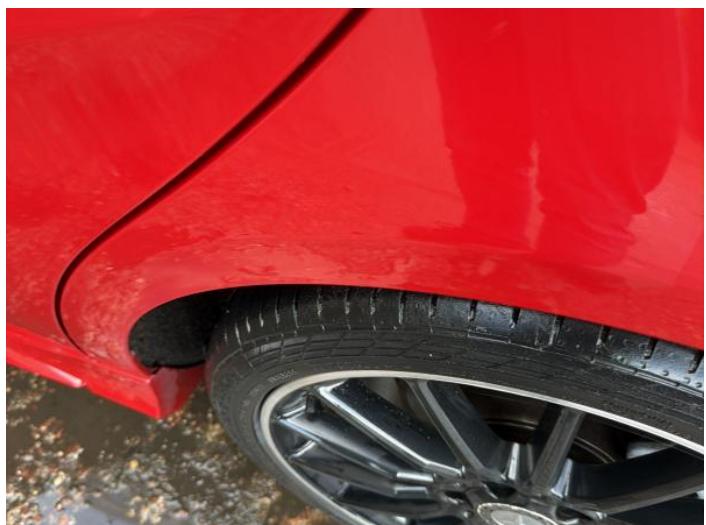
20: Qtr Panel nsr  
Dented  
Over 2 UpTo 10mm
