VEHICLE INSPECTION REPORT

LY08WUV

Volkswagen Polo 1.4 Match 80 5dr Auto

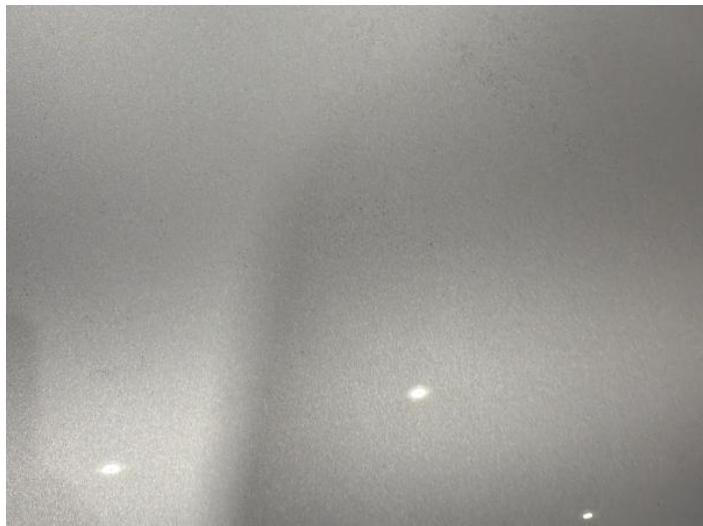
1: Bonnet
Chipped
1 To 5

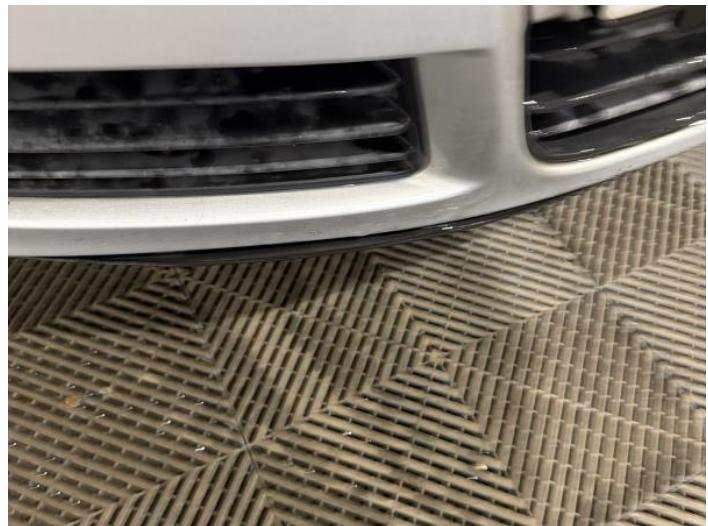
2: Bumper Front Moulding
Broken
Replace

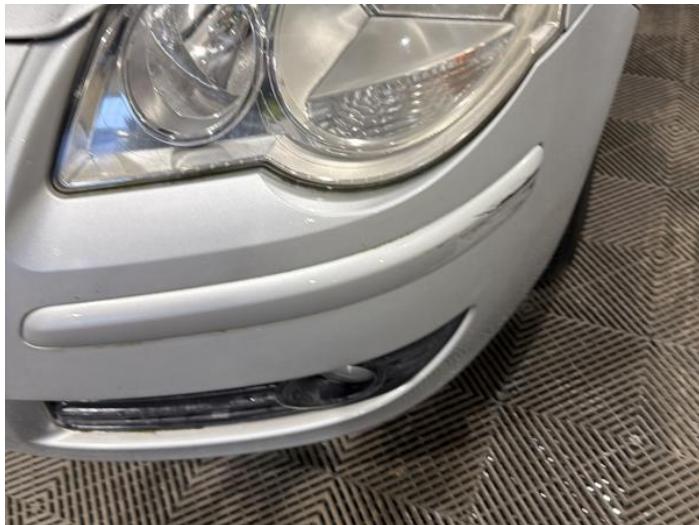
3: Bumper Front
Scratched
Over 100mm Thru Paint

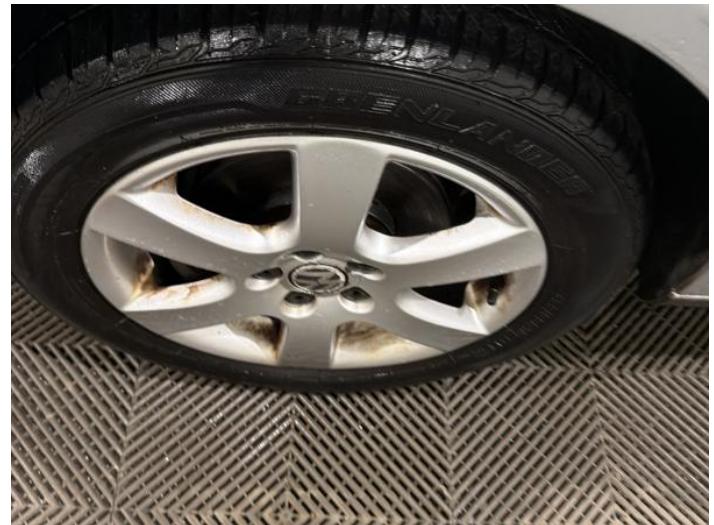
4: Wheel nsf
Scratched
Over 50mm

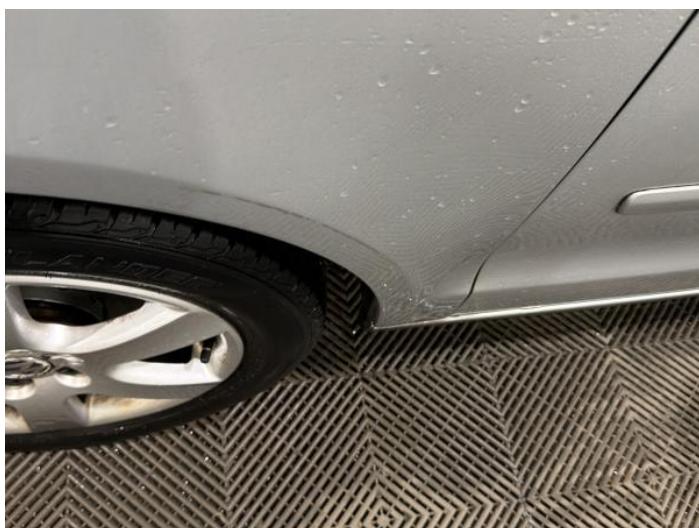
5: Wing nsf
Scratched
Over 25mm Thru Paint

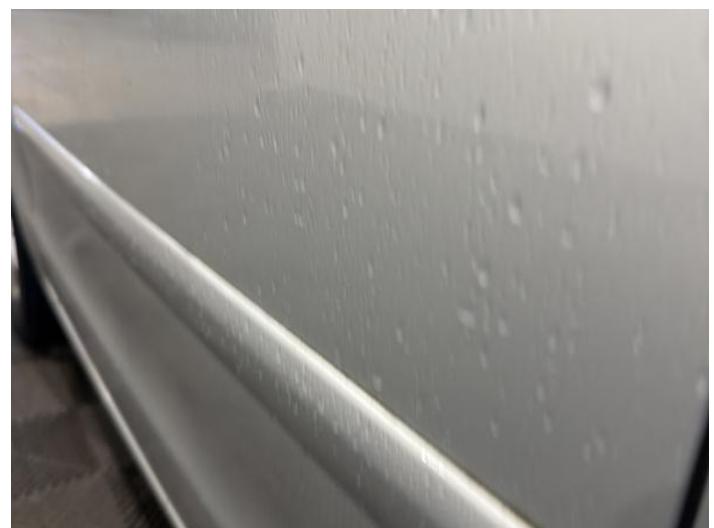
6: Door nsf
Dented
Over 2 UpTo 10mm

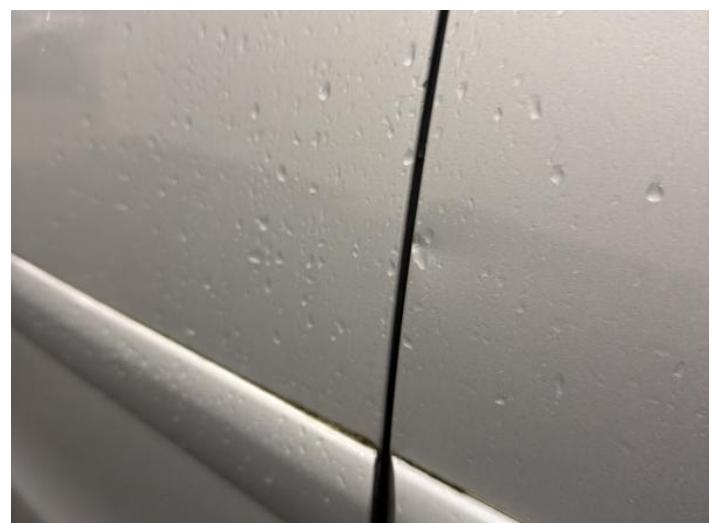
8: Door nsr
Dented
2 Or Less UpTo 10mm

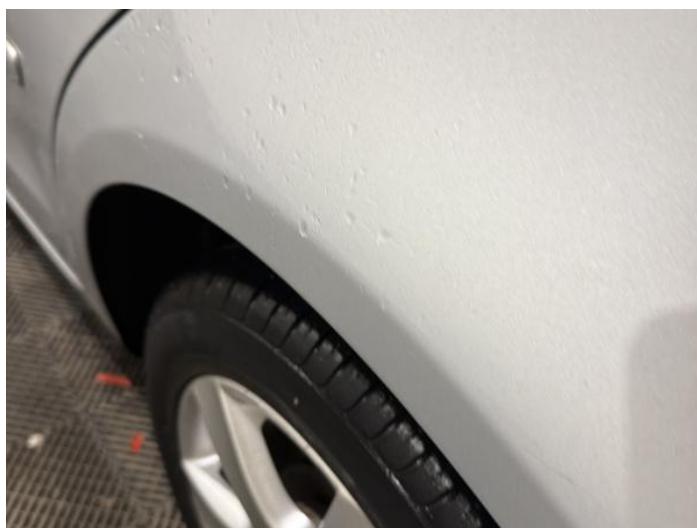
11: Qtr Panel nsr
Poor Previous Repair
Poor Paint

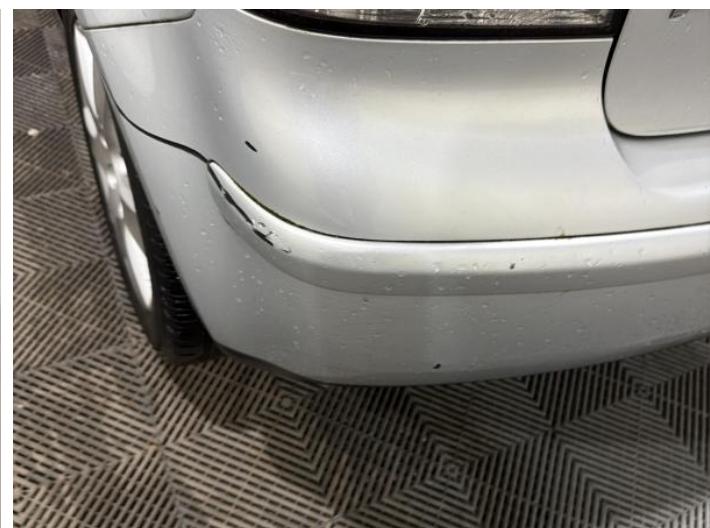
12: Bumper Rear
Scratched
Over 100mm Thru Paint

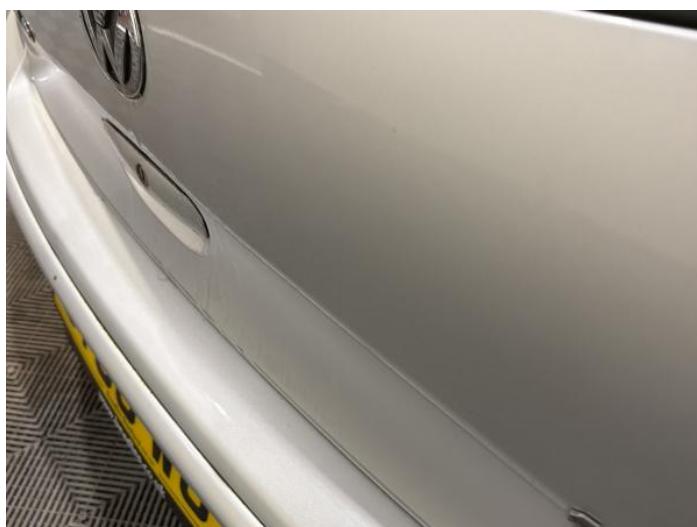
13: Boot Lid
Dented
Over 2 UpTo 10mm

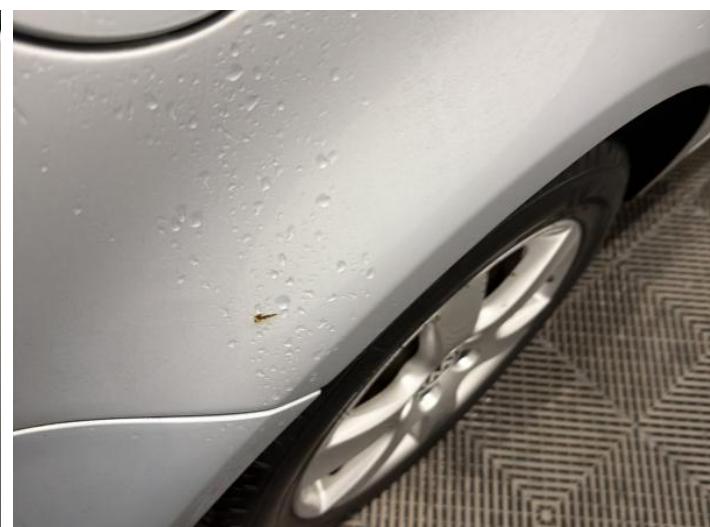
14: Qtr Panel osr
Rusted
UpTo 5mm

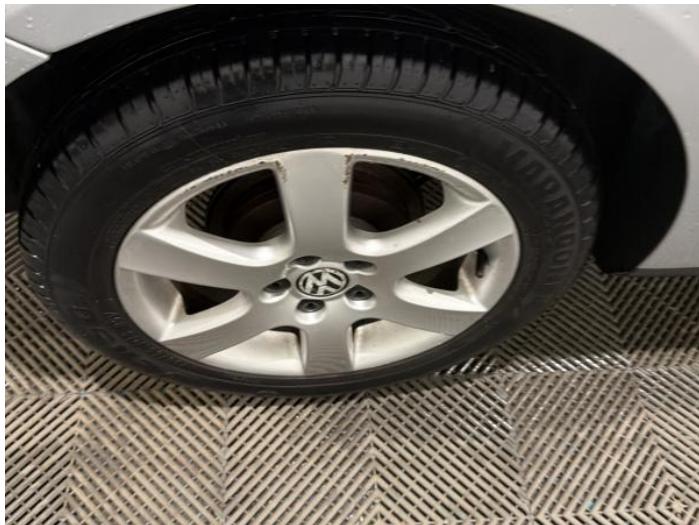
15: Wheel osr
Scratched
Over 50mm

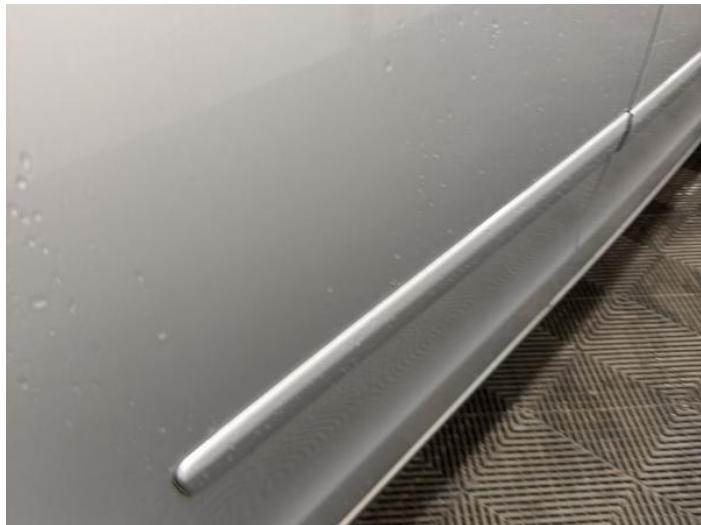
16: Door osr
Dented
Over 2 UpTo 10mm

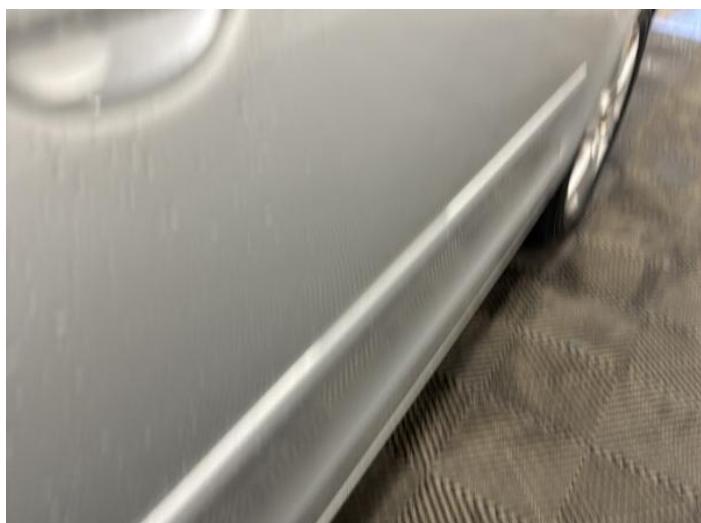
18: Door osf
Poor Previous Repair
Poor Paint

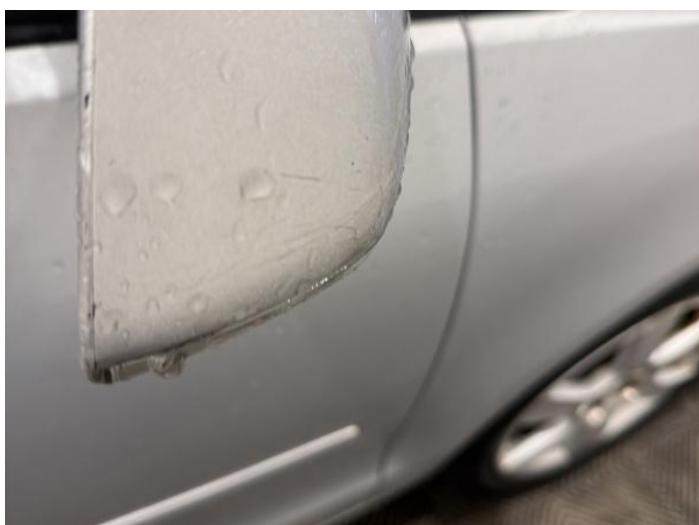
19: Door Mirror Assy osf
Scratched (Painted)
UpTo 25mm Thru Paint

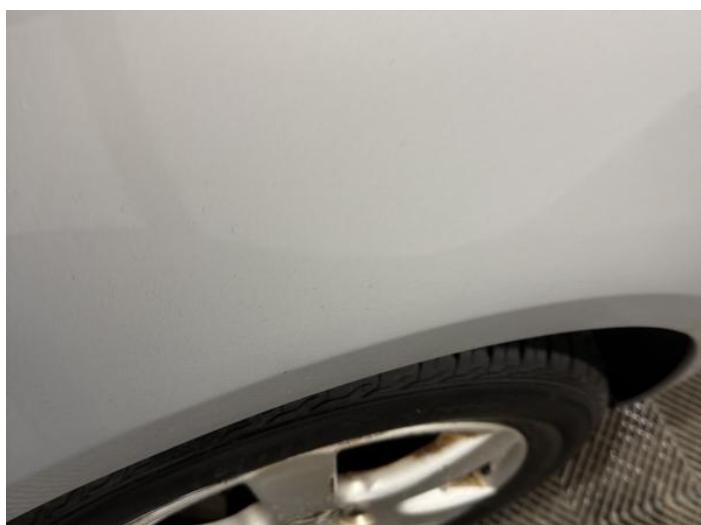
20: Wing osf
Chipped
1 To 5

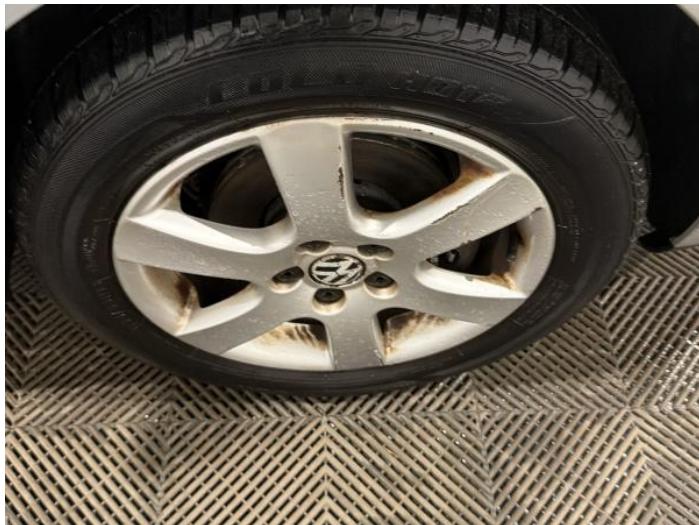
21: Wheel osf
Scratched
Over 50mm

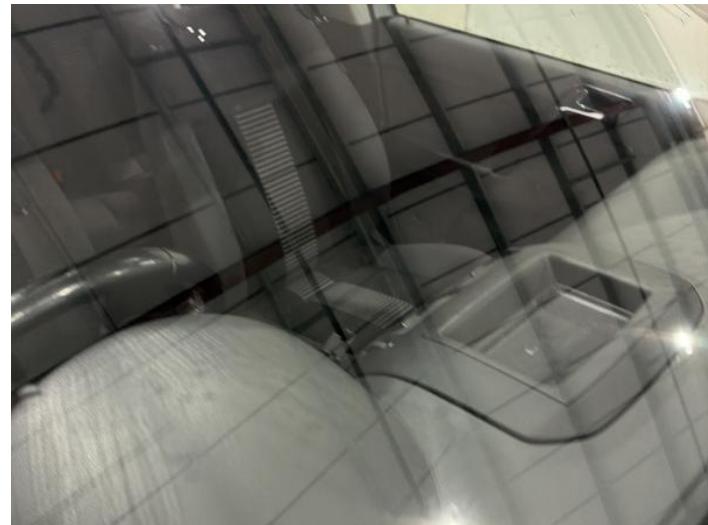
22: Screen Front
Chipped
UpTo 10mm
