VEHICLE INSPECTION REPORT

GJ68HSK

Volkswagen Transporter 2.0 TDI BMT 102 Trendline Van Euro 6

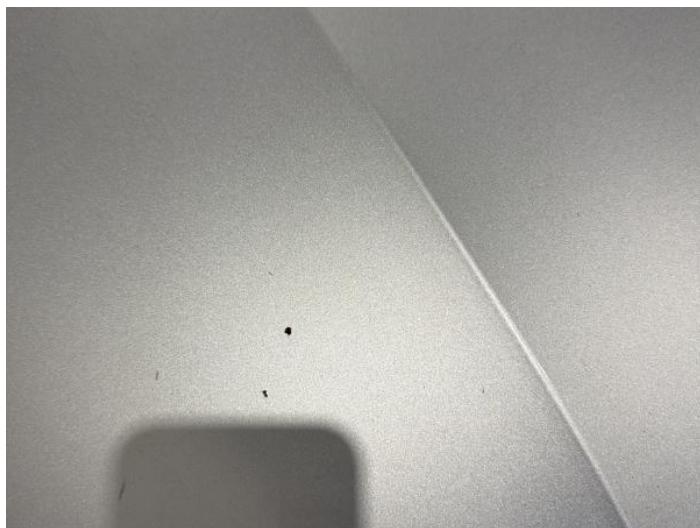
1: Bonnet
Chipped
Multiple Chips

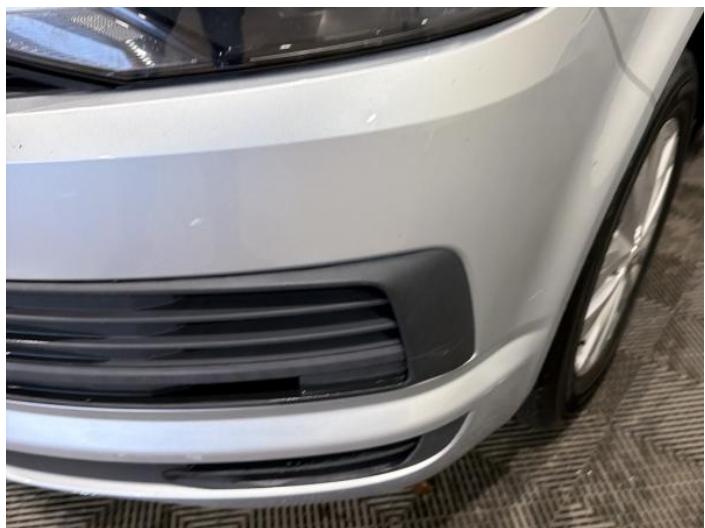
2: Bumper Front
Scratched
Over 100mm Thru Paint

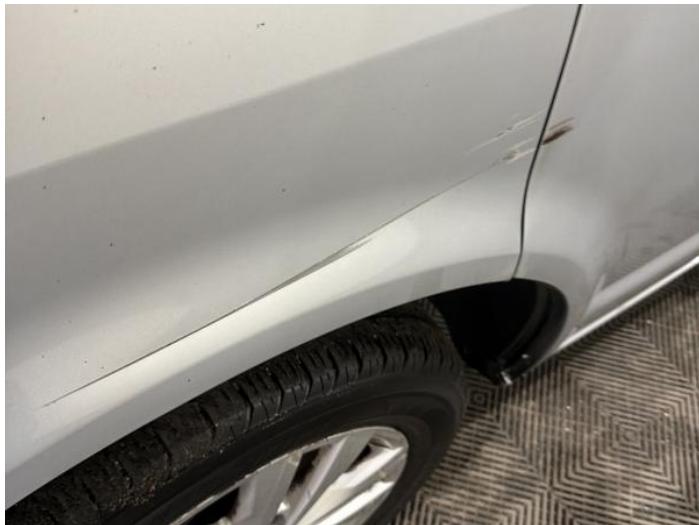
3: Wing nsf
Dented
With Paint Damage

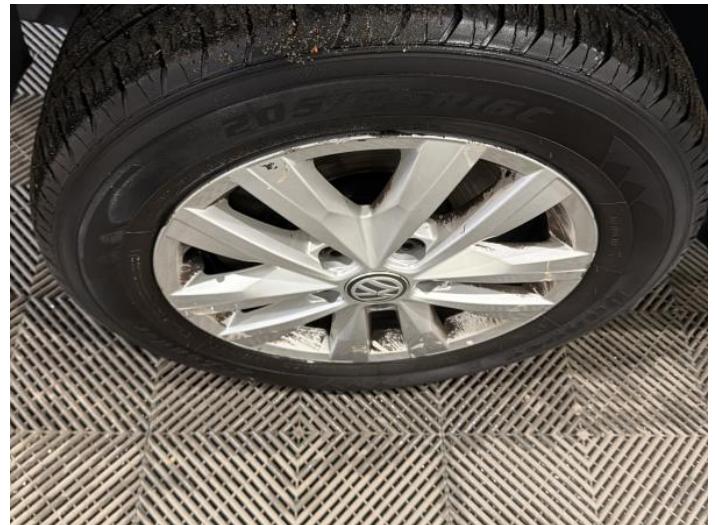
4: Wheel nsf
Scratched
Over 50mm

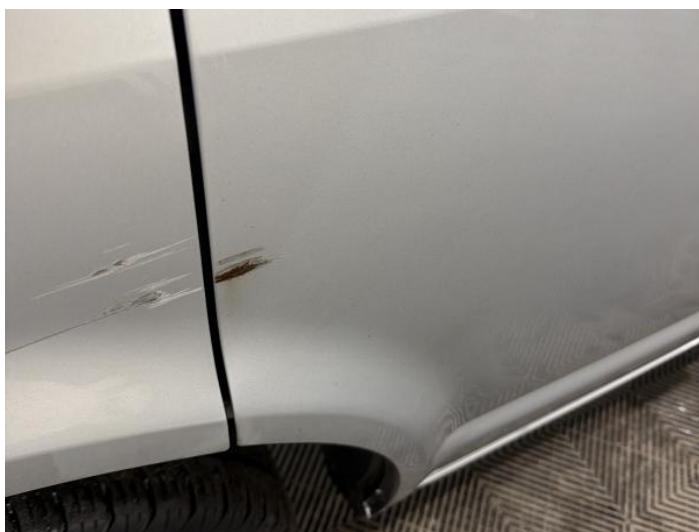
5: Door nsf
Dented
With Paint Damage

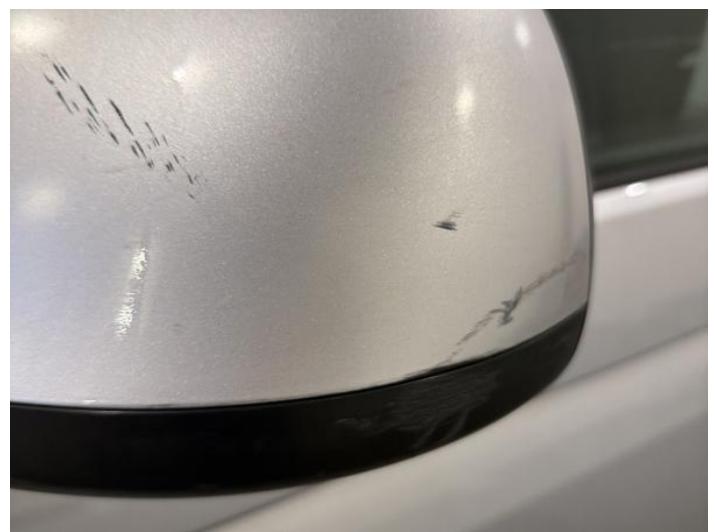
6: Door Mirror Assy nsf
Scratched (Painted)
Over 25mm Thru Paint

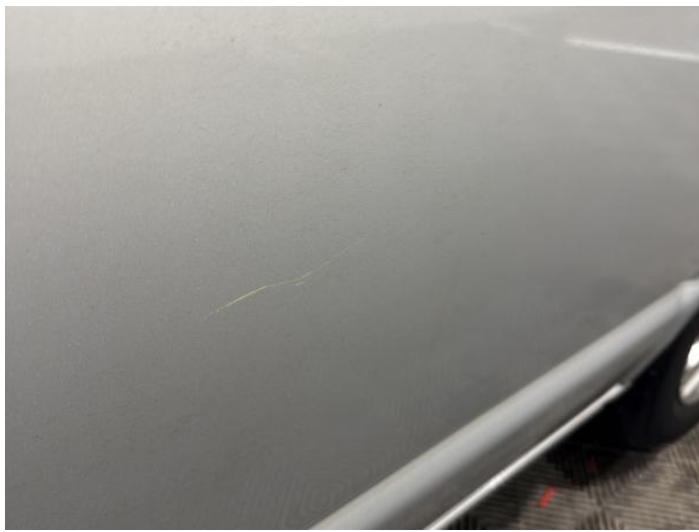
7: Door nsr
Scratched
Over 25mm Thru Paint

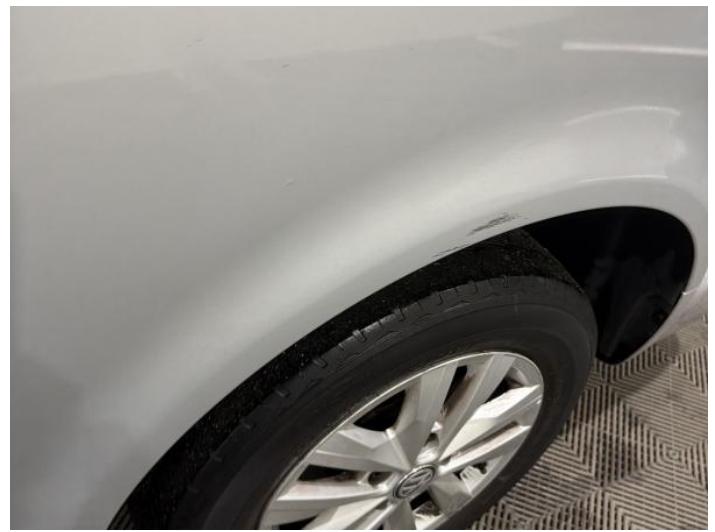
8: Qtr Panel nsr
Scratched
Over 25mm Thru Paint

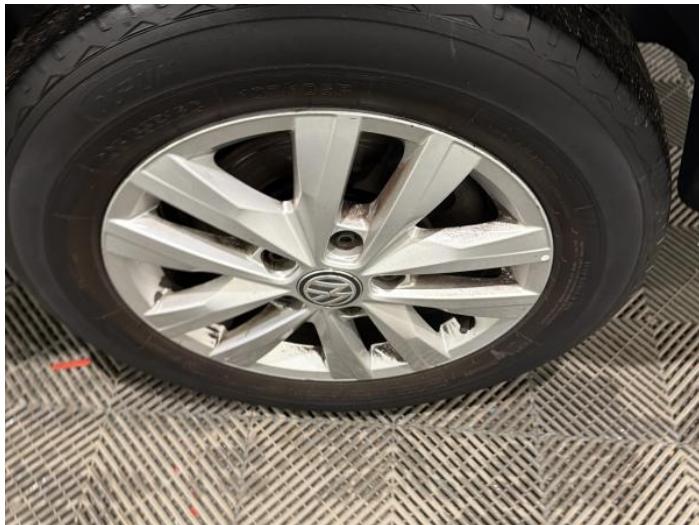
9: Wheel nsr
Scratched
Over 50mm

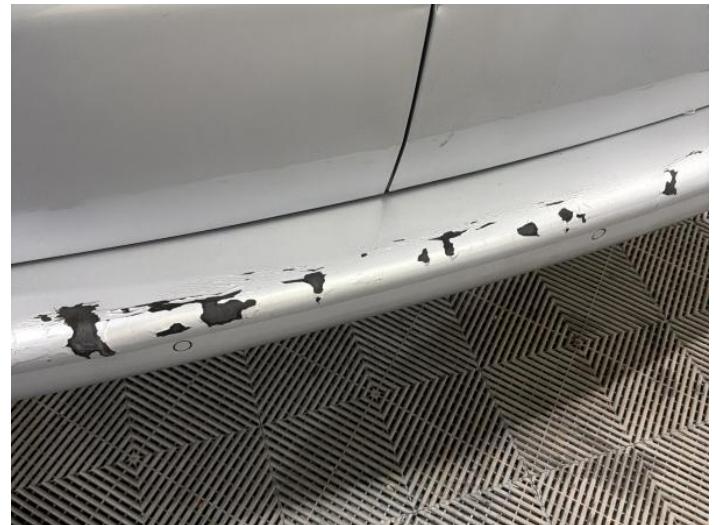
10: Bumper Rear
Poor Previous Repair
Rippled UpTo 30%

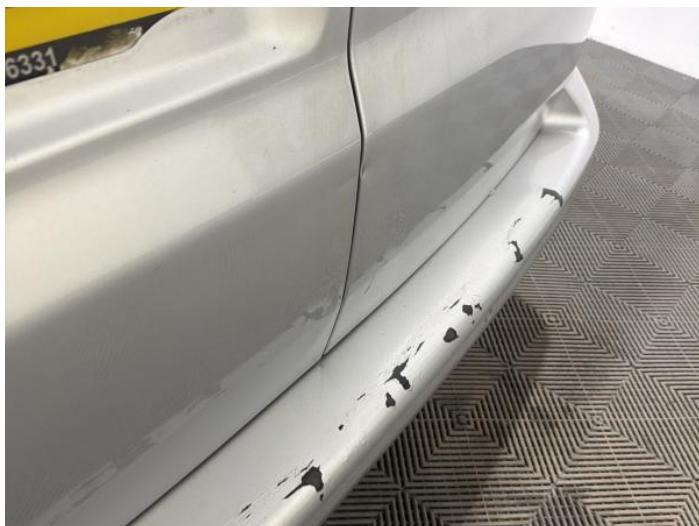
11: Boot Lid
Dented
With Paint Damage

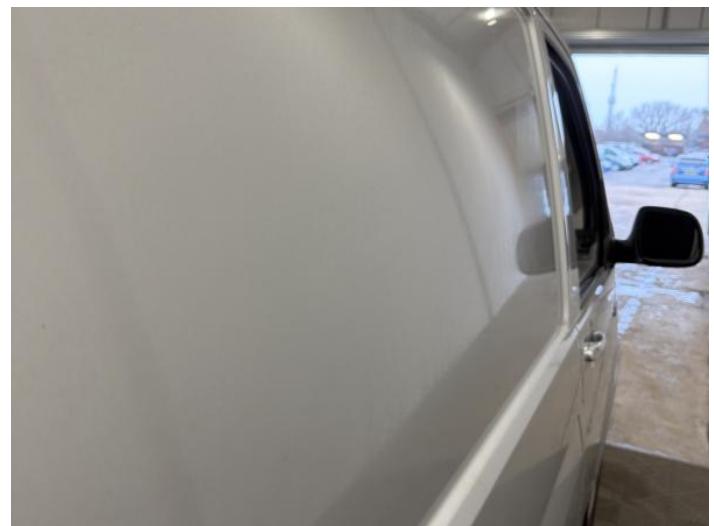
12: Qtr Panel osr
Dented
Over 30mm

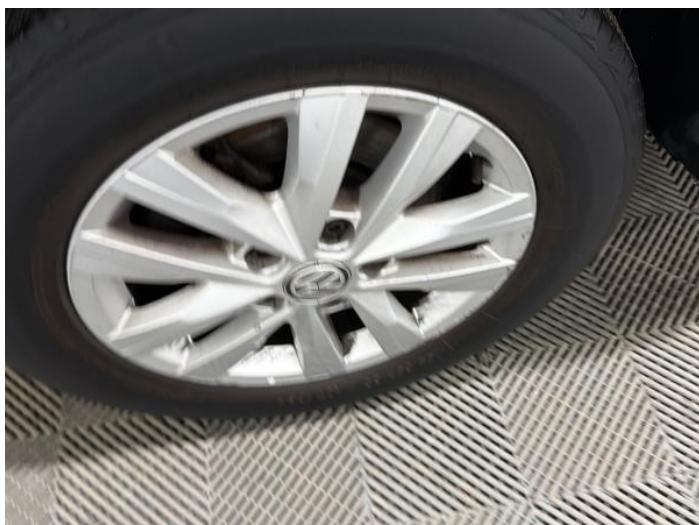
13: Wheel osr
Scratched
Over 50mm

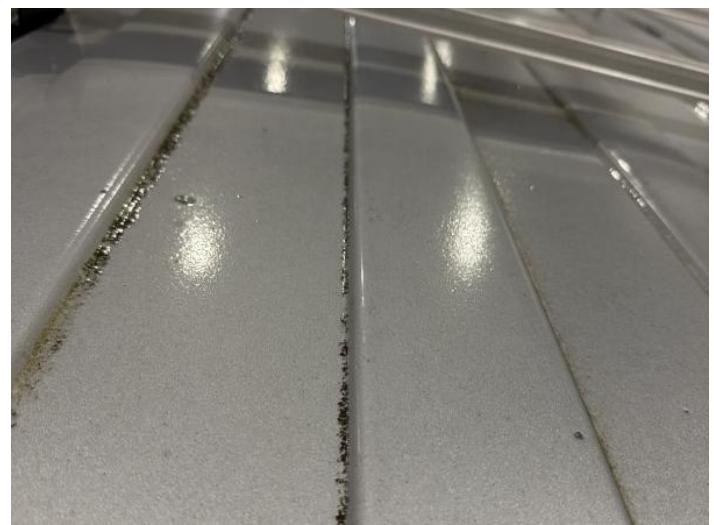
14: Roof
Dented
Between 10mm + 30mm

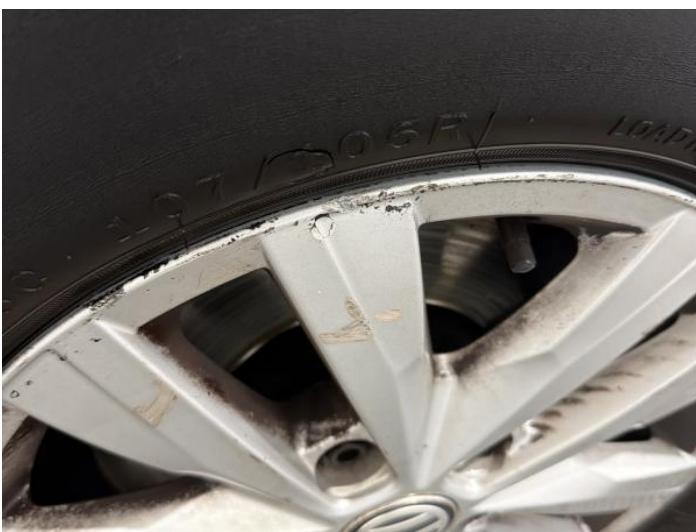
NSF	BUDGET	4.0mm
NSR	BUDGET	4.0mm
OSF	BUDGET	Damaged
OSR	BUDGET	3.0mm
Spare

17: Tyre osf
Damaged
Replace

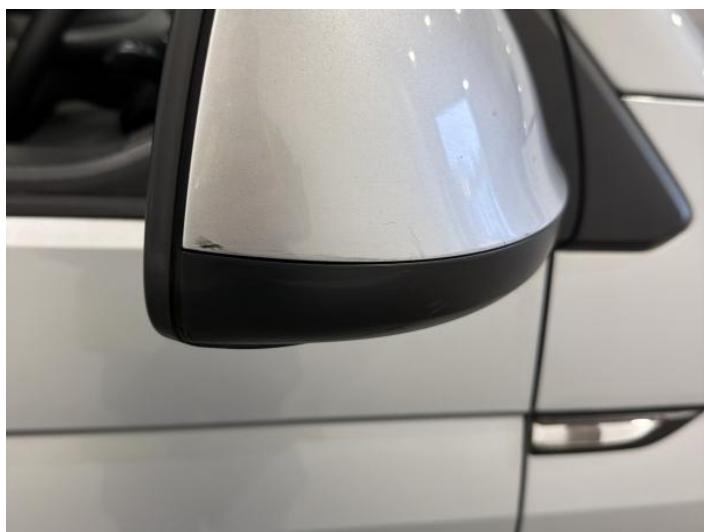
18: Door Mirror Assy osf
Scratched (Painted)
UpTo 25mm Thru Paint

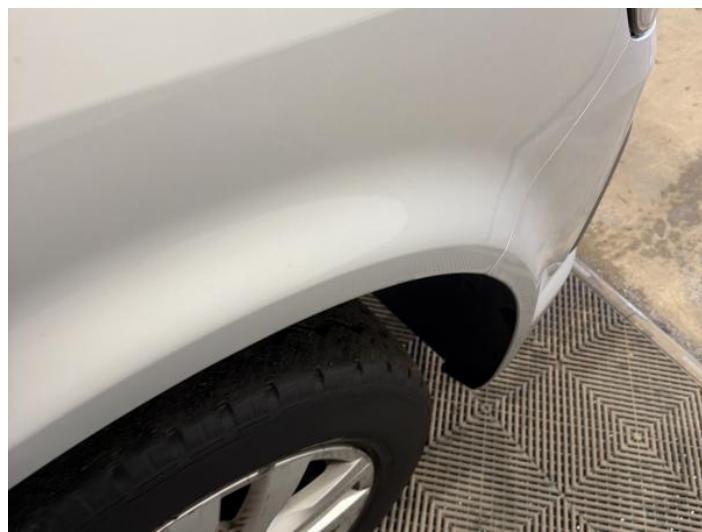
19: Wing osf
Chipped
1 To 5

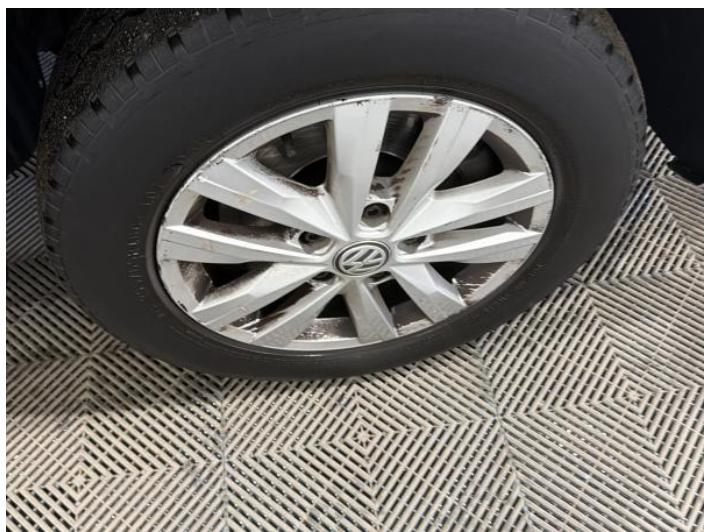
20: Wheel osf
Scratched
Over 50mm

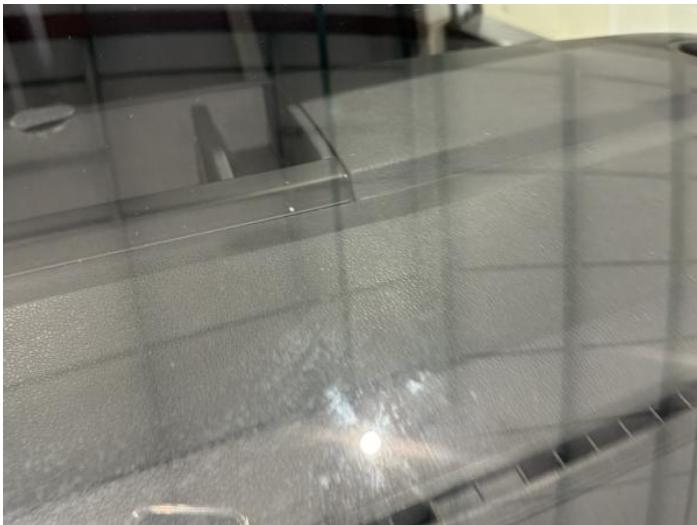
21: Screen Front
Chipped
UpTo 10mm
