# VEHICLE INSPECTION REPORT

FY08UZE

## BMW 1 Series 116i M Sport 3dr [122]

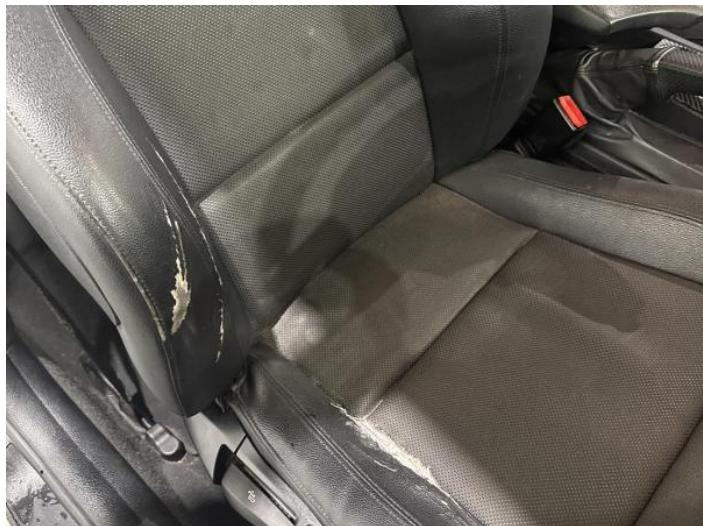
1: Seat Base Cover off  
Torn  
Over 3mm

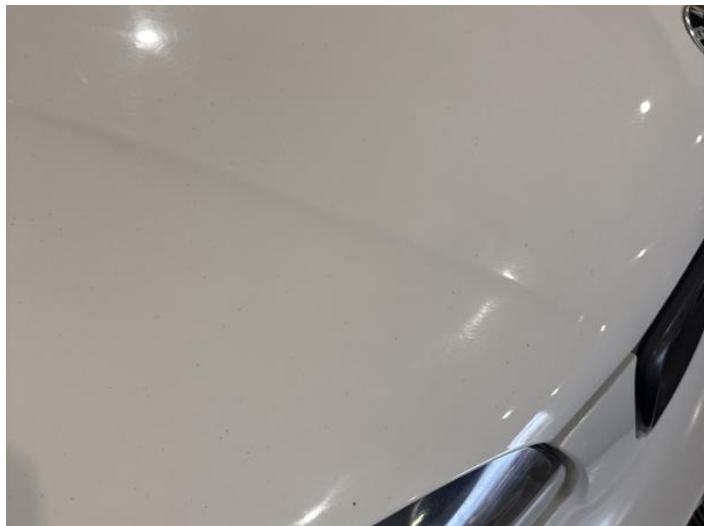
2: Bonnet  
Chipped  
Multiple Chips

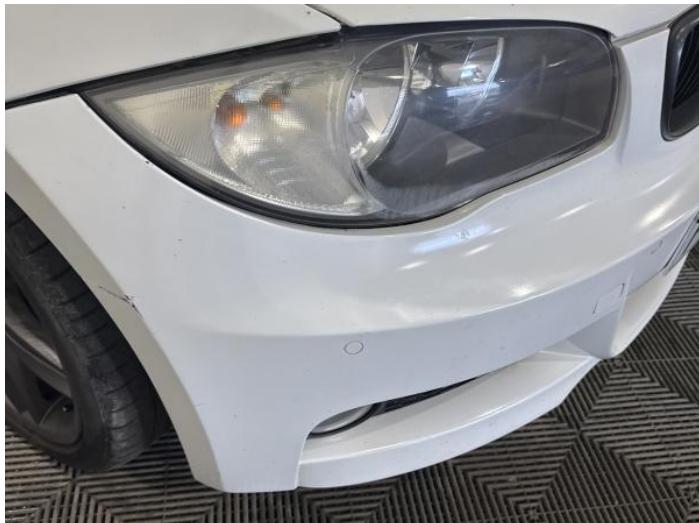
3: Bumper Front  
Poor Previous Repair  
Poor Paint

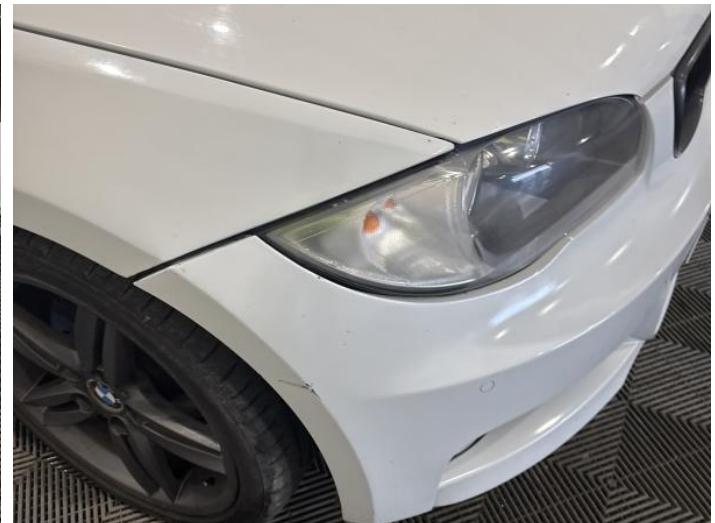
4: Bumper Front  
Insecure  
Action Required

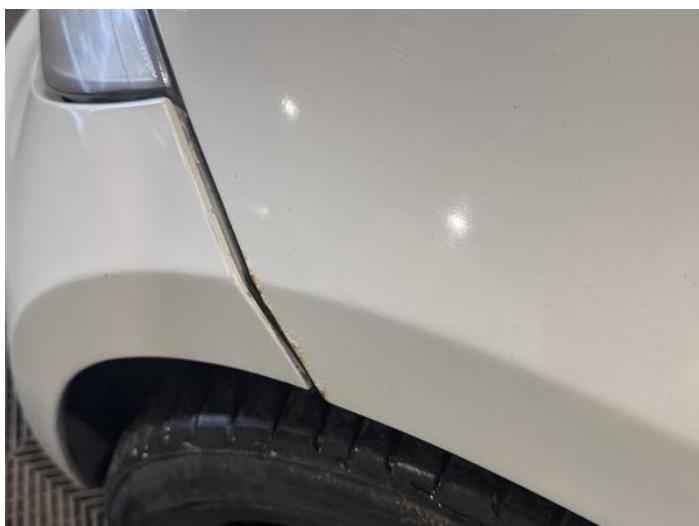
5: Wing nsf  
Poor Previous Repair  
Rippled UpTo 30%

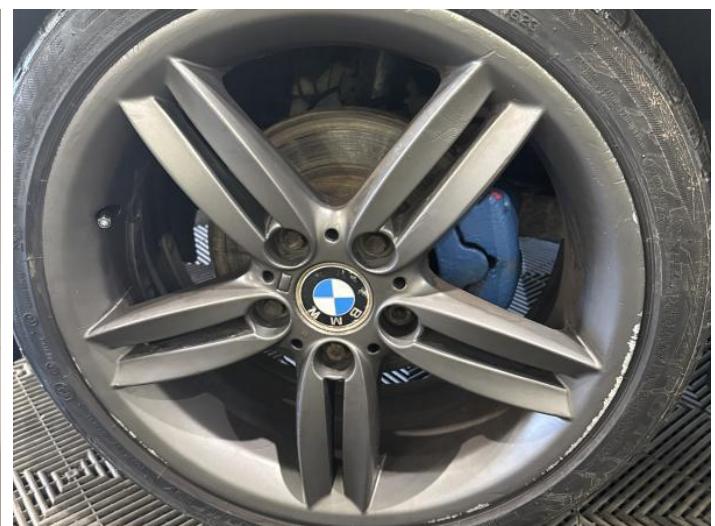
6: Wheel nsf  
Scratched  
Over 50mm

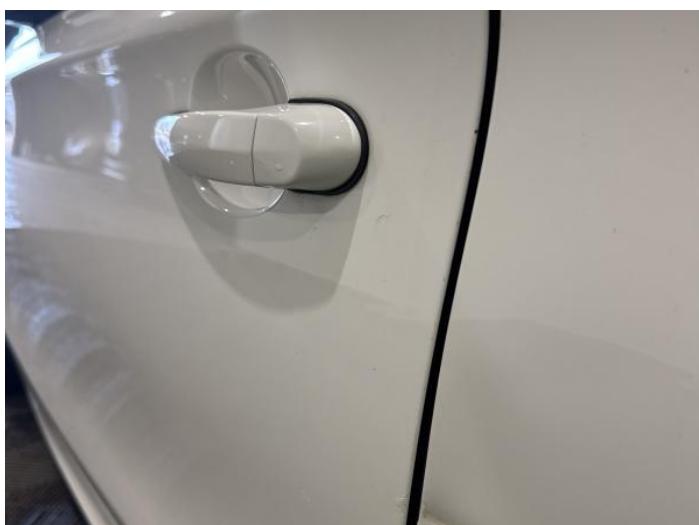
7: Door nsf  
Scratched  
Over 25mm Thru Paint

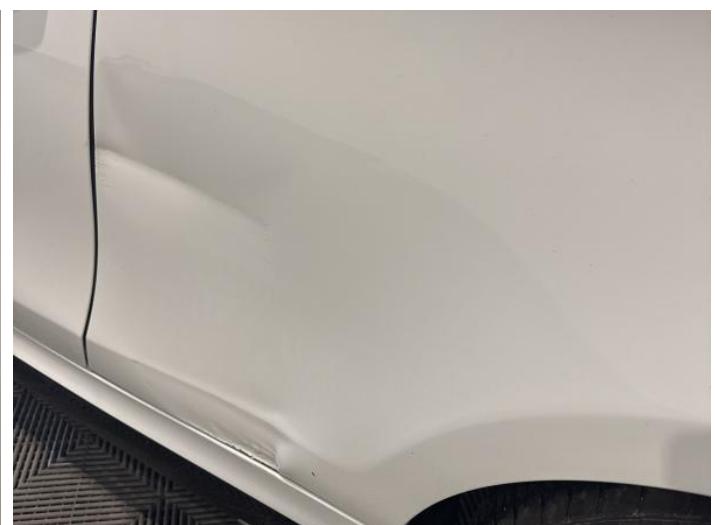
8: Qtr Panel nsf  
Dented  
With Paint Damage

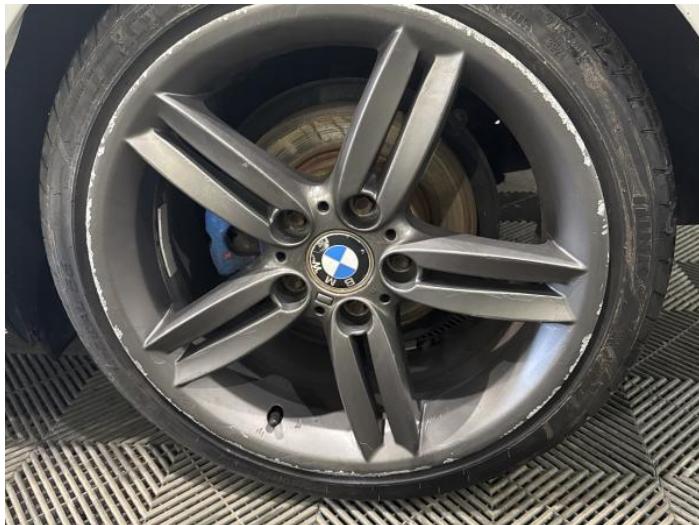
9: Wheel nsr  
Scratched  
Over 50mm

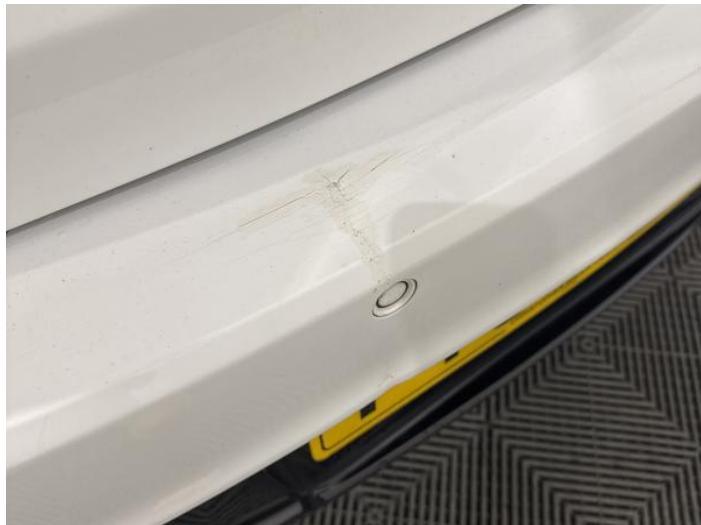
10: Bumper Rear  
Dented  
With Paint Damage

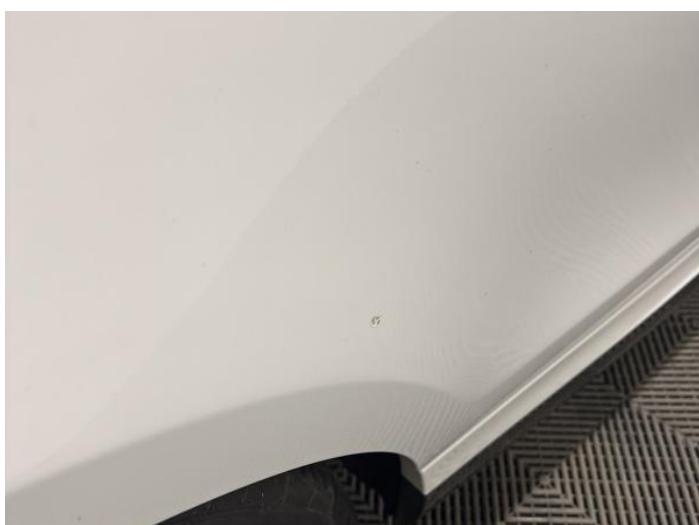
11: Qtr Panel osr  
Chipped  
Over 5mm

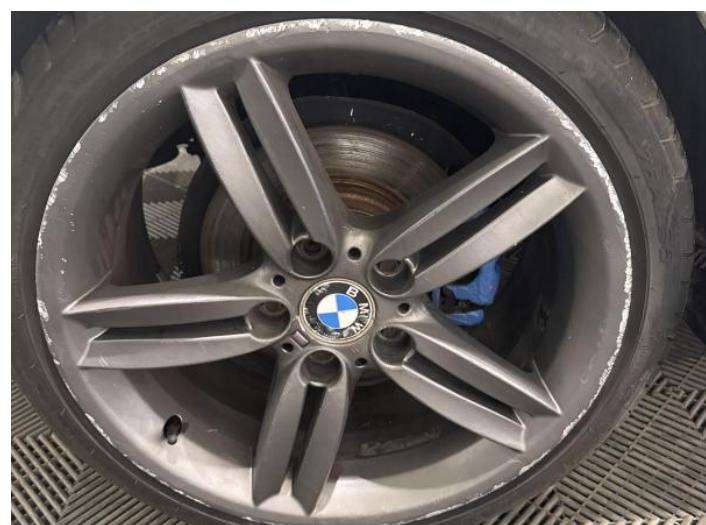
12: Wheel osr  
Scratched  
Over 50mm

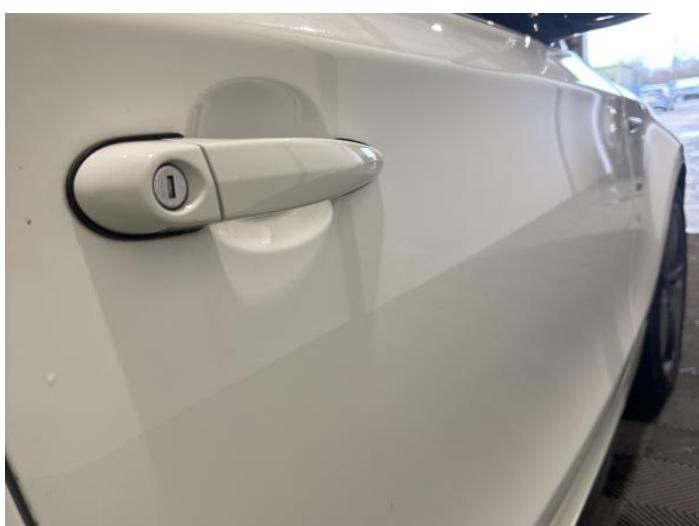
13: Door osf  
Poor Previous Repair  
Rippled UpTo 30%

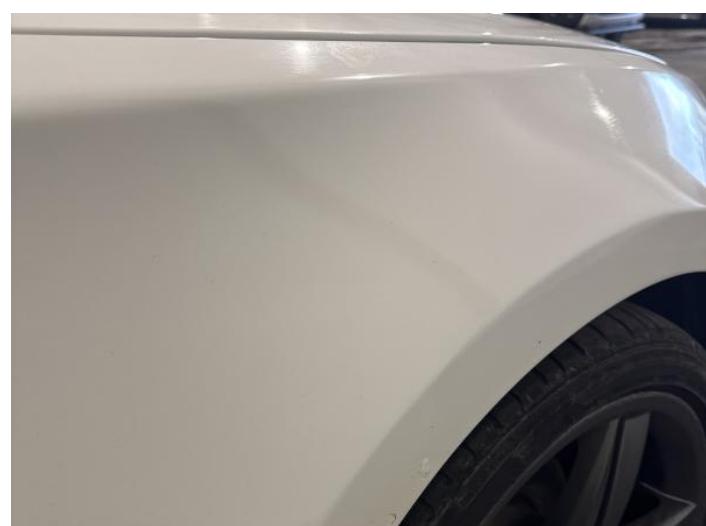
14: Wing osf  
Poor Previous Repair  
Rippled UpTo 30%

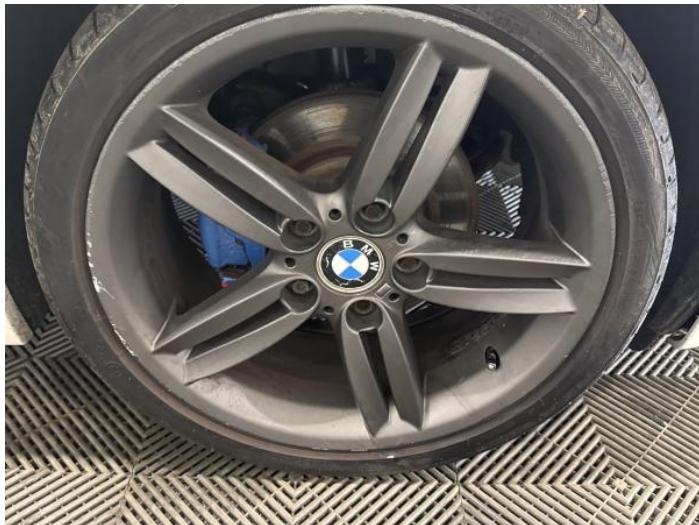
15: Wheel osf  
Scratched  
Over 50mm

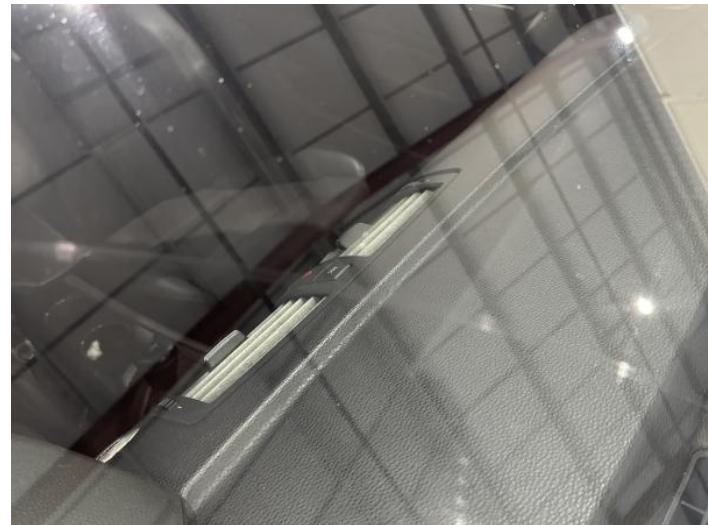
16: Screen Front  
Chipped  
UpTo 10mm
