## VEHICLE INSPECTION REPORT

GU69WUK

### Citroen Grand C4 Spacetourer 1.2 PureTech 130 Feel Plus 5dr

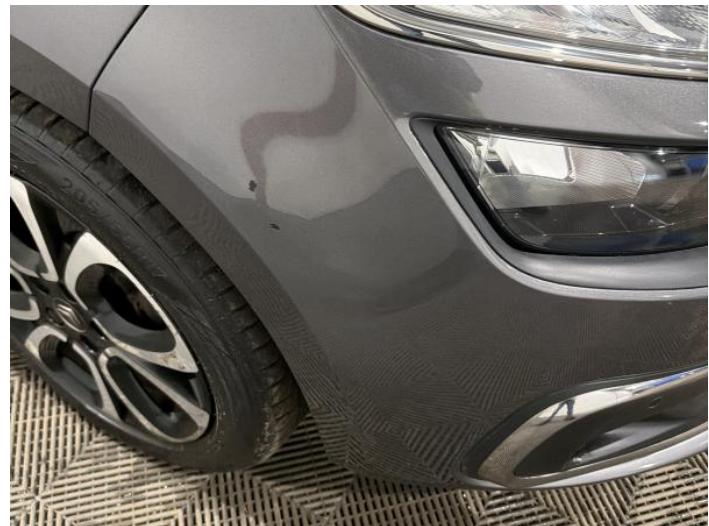
2: Bumper Front  
Scratched  
25 to 100mm Thru Paint

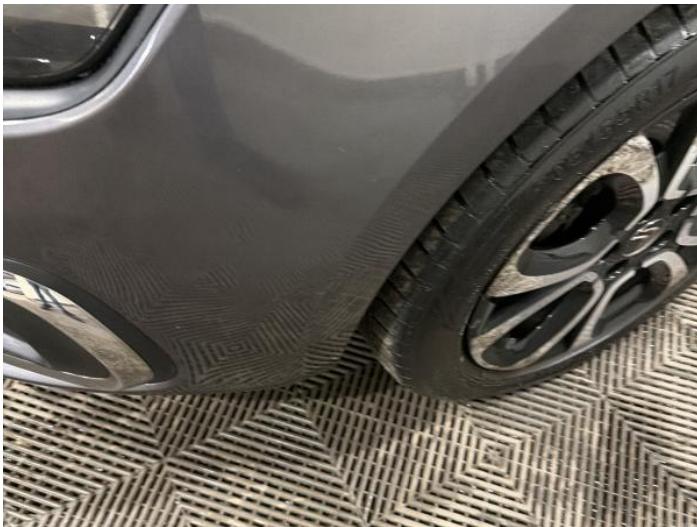
3: Bumper Front  
Scratched  
UpTo 25mm Thru Paint

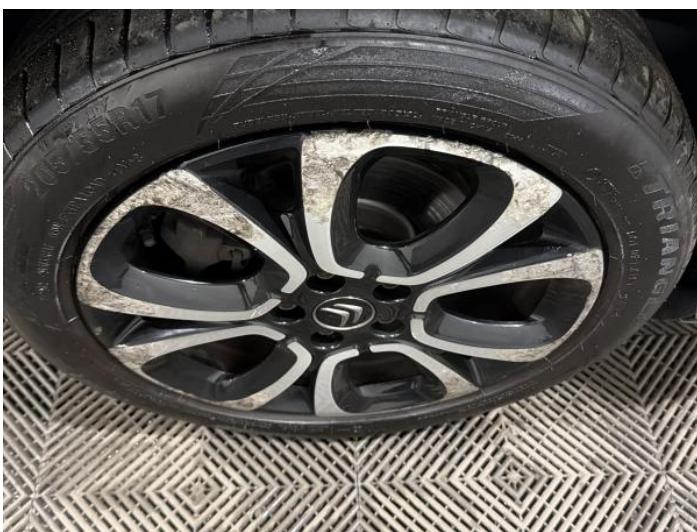
5: Wheel nsf  
Scratched  
Over 50mm

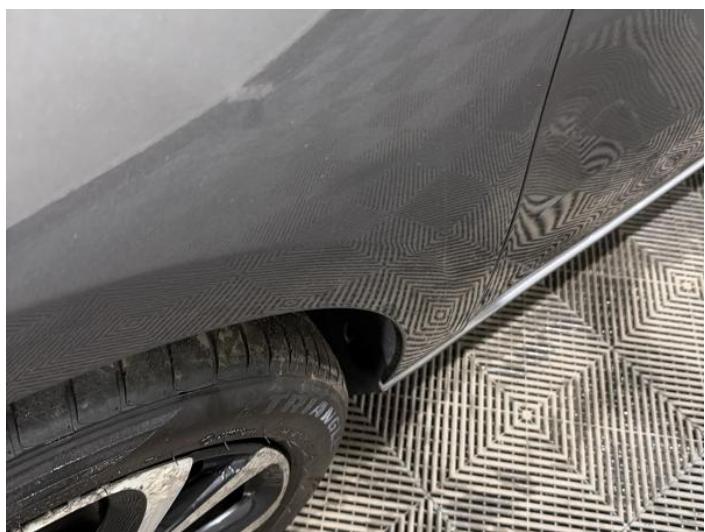
6: Wing nsf  
Chipped  
1 To 5

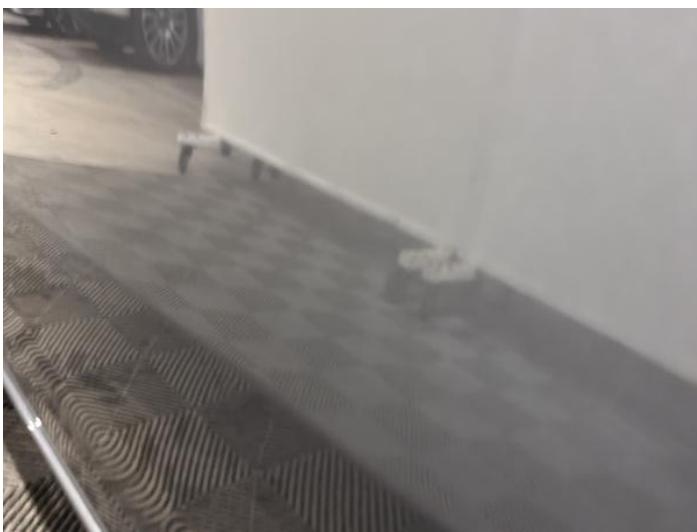
7: Door nsf  
Chipped  
1 To 5

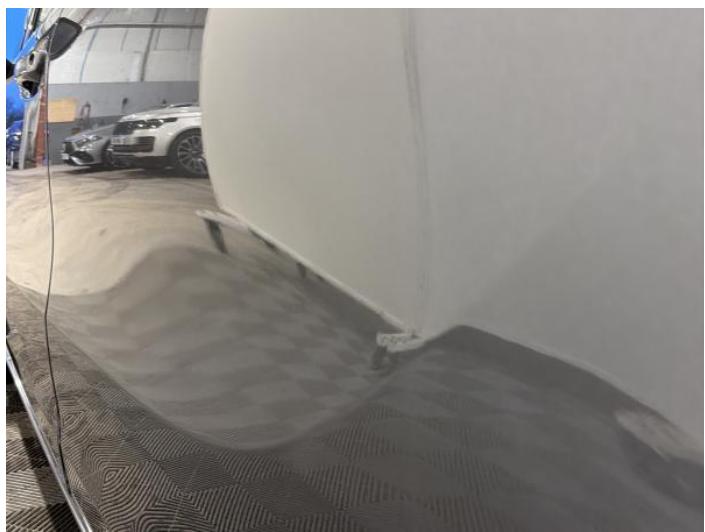
8: Door nsr  
Chipped  
1 To 5

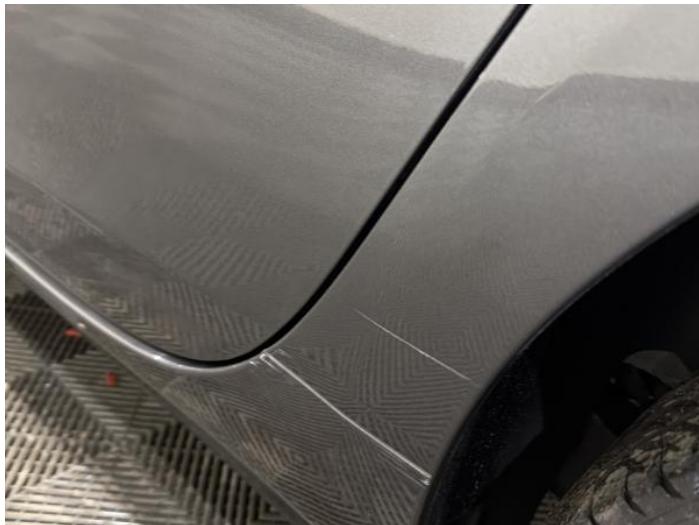
9: Qtr Panel nsr  
Dented  
With Paint Damage

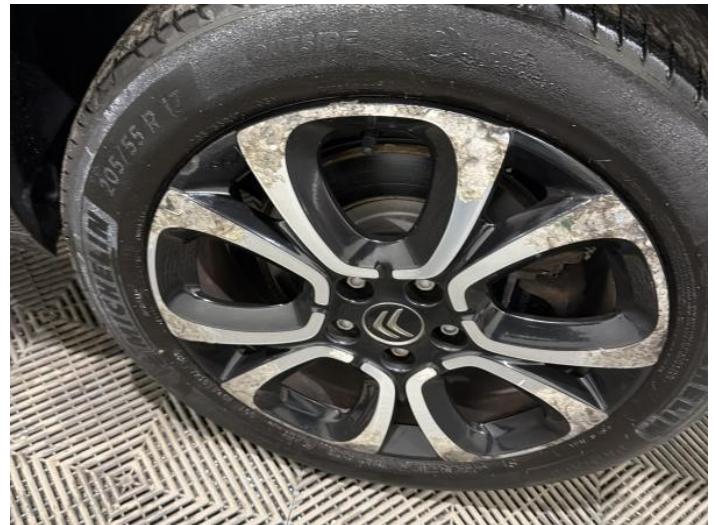
10: Wheel nsr  
Scratched  
Over 50mm

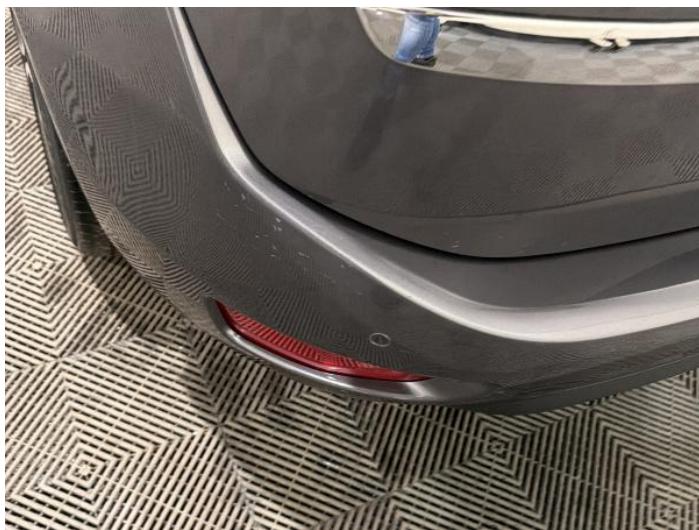
11: Bumper Rear  
Scratched  
25 to 100mm Thru Paint

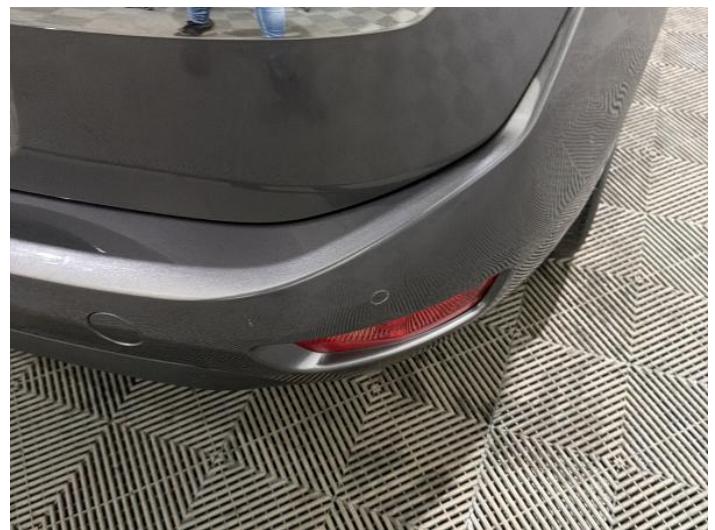
12: Bumper Rear  
Chipped  
Multiple Chips

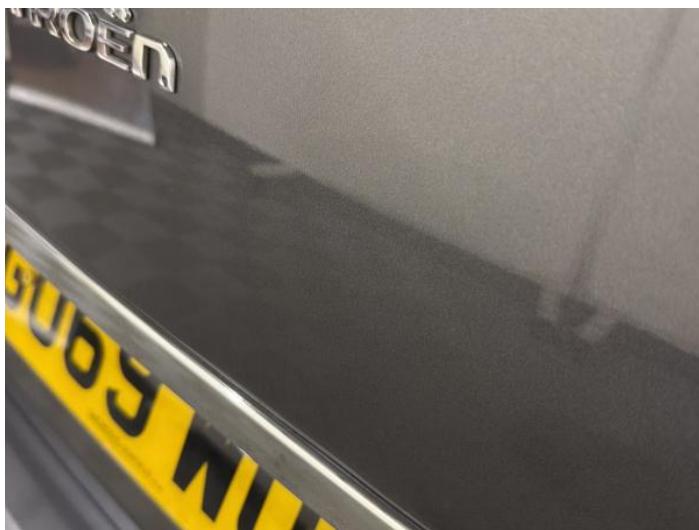
13: Boot Lid  
Dented  
2 Or Less UpTo 10mm

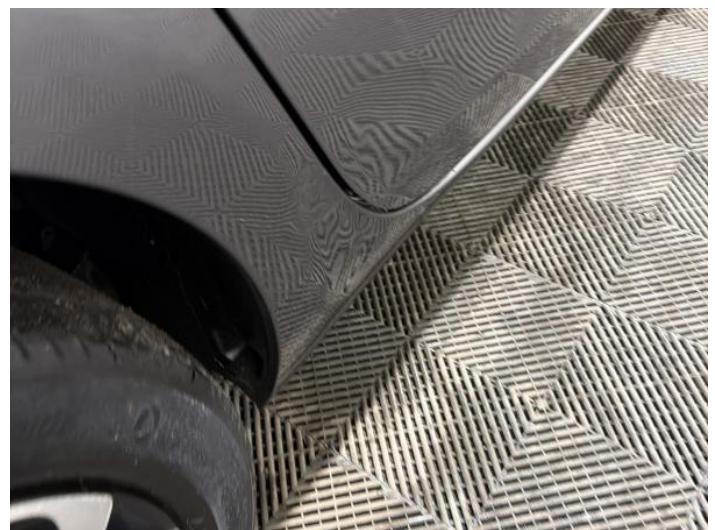
14: Qtr Panel osr  
Dented  
Over 30mm

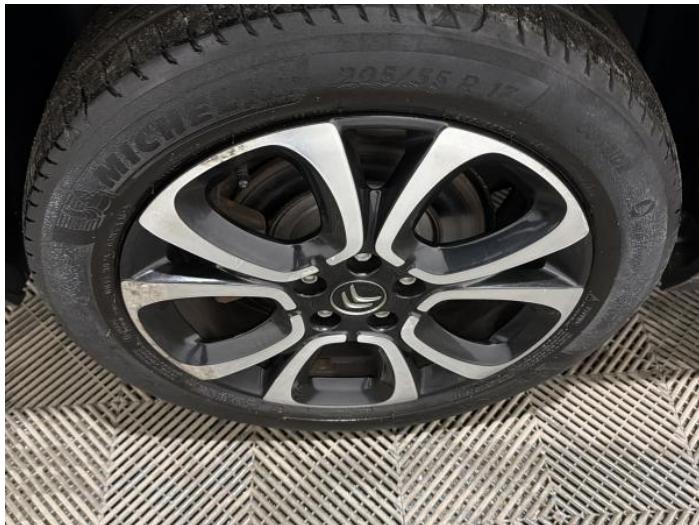
15: Wheel osr  
Scratched  
Over 50mm

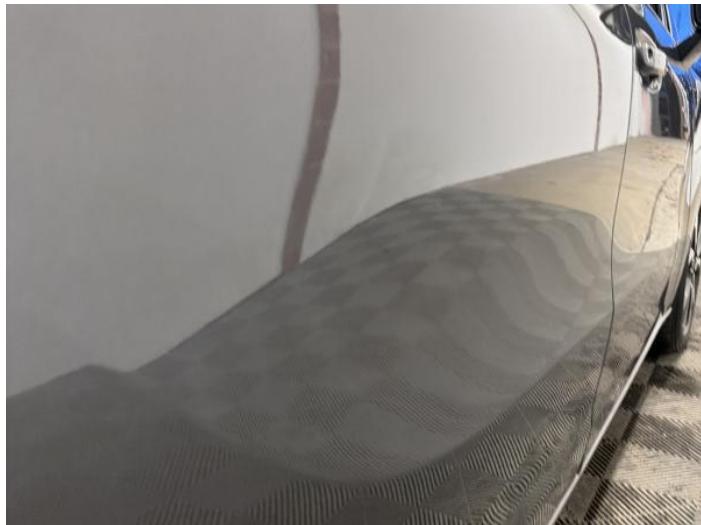
16: Door osr  
Poor Previous Repair  
Poor Paint

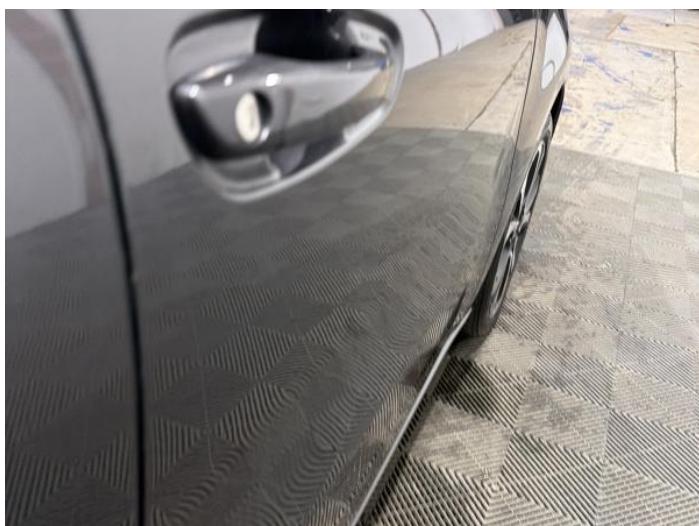
17: Door osf  
Dented  
Over 2 UpTo 10mm

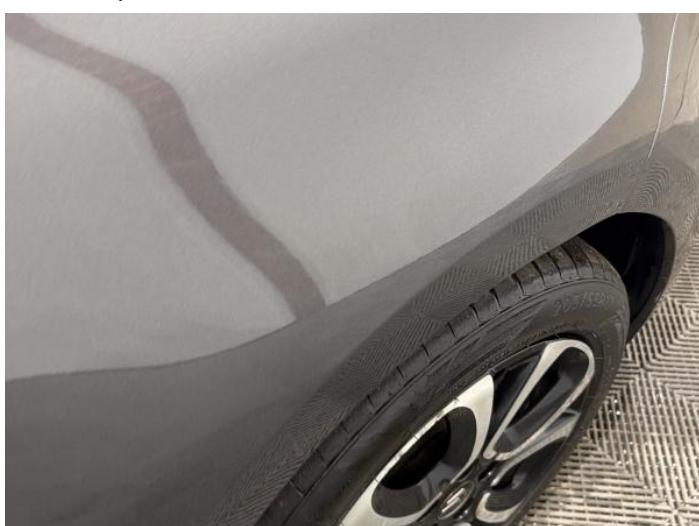
19: Wing osf  
Dented  
Between 10mm + 30mm

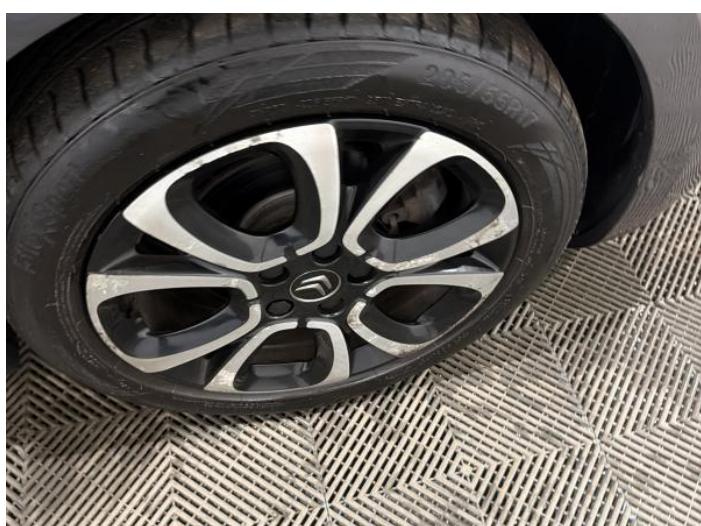
20: Wheel osf  
Scratched  
Over 50mm

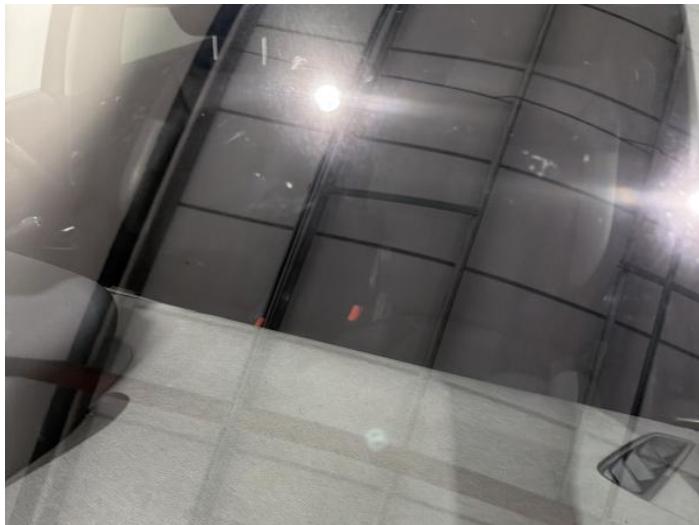
21: Screen Front  
Chipped  
UpTo 10mm
