## VEHICLE INSPECTION REPORT

EN19NAE

### VAUXHALL INSIGNIA 1.5T Tech Line Nav 5dr

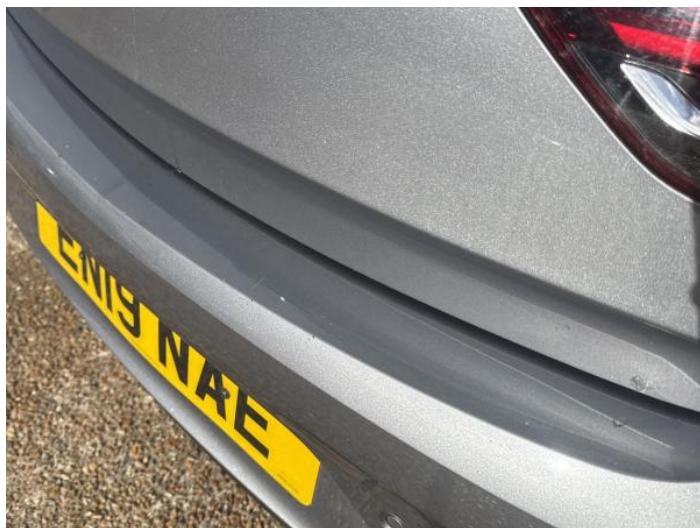
1: Bumper Rear  
Scratched  
25 to 100mm Thru Paint

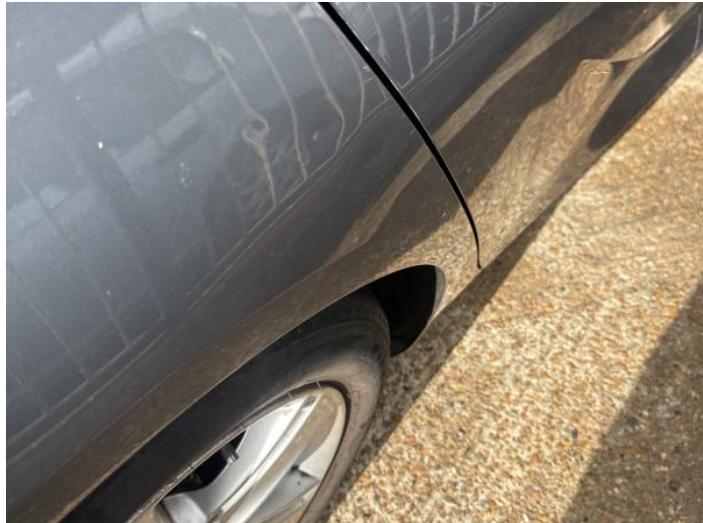
4: Qtr Panel osr  
Dented  
Over 30mm

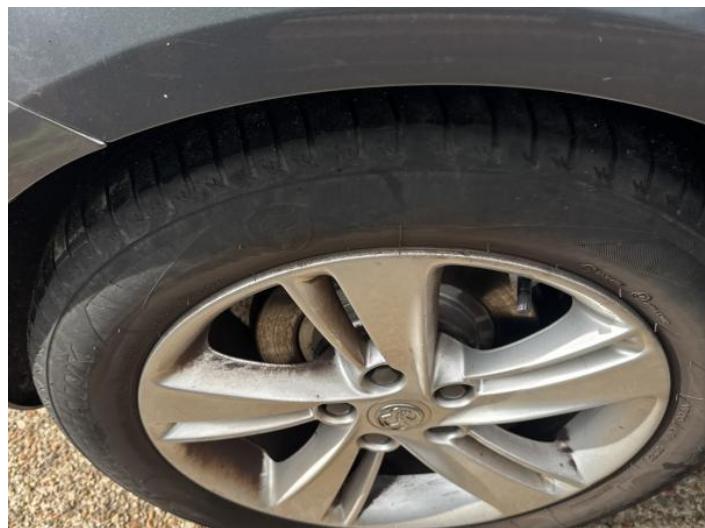
5: Wheel osr  
Scratched  
Over 50mm

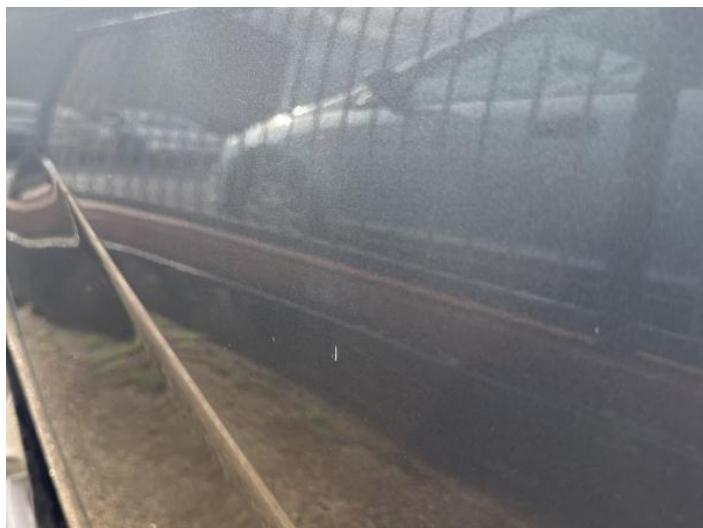
6: Door osr  
Chipped  
1 To 5

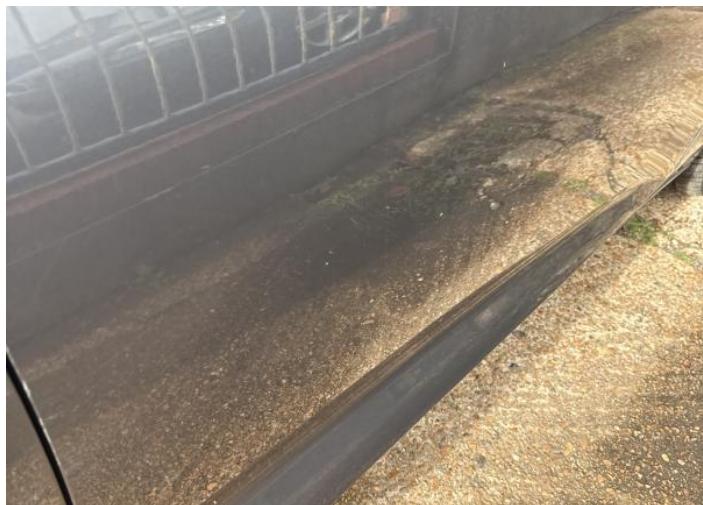
8: Door osf  
Chipped  
Multiple Chips

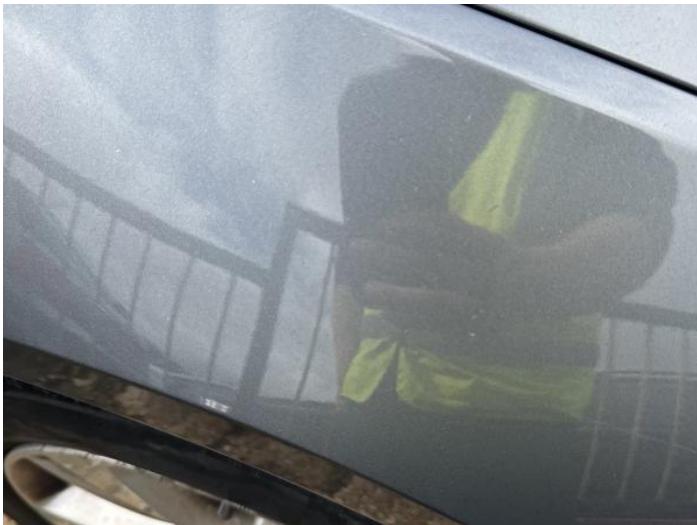
9: Wing osf  
Chipped  
1 To 5

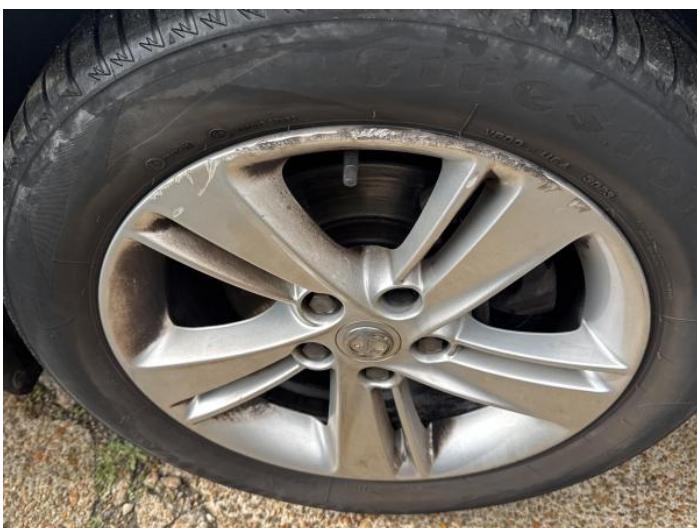
11: Wheel osf  
Scratched  
Over 50mm

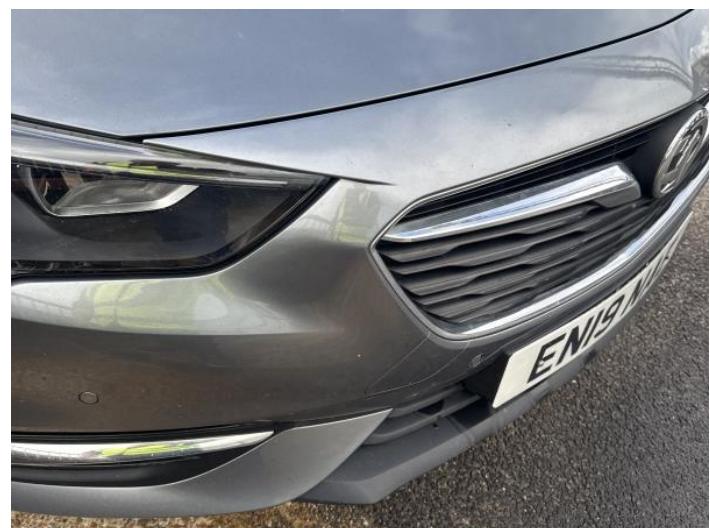
12: Bumper Front  
Chipped  
Multiple Chips

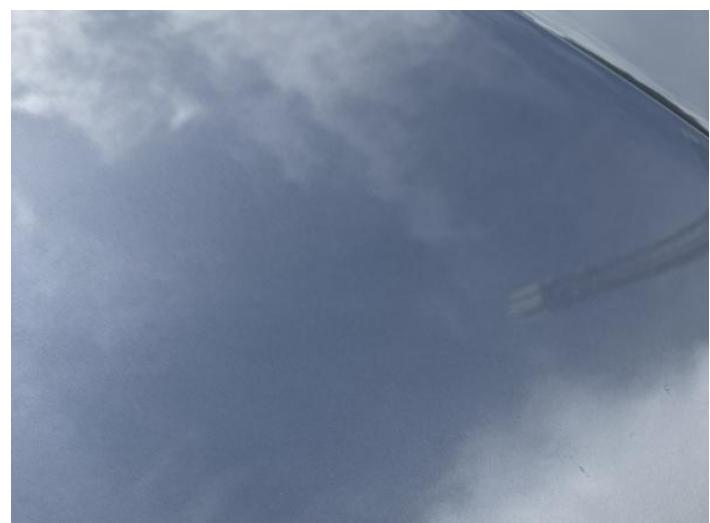
14: Bonnet  
Chipped  
1 To 5

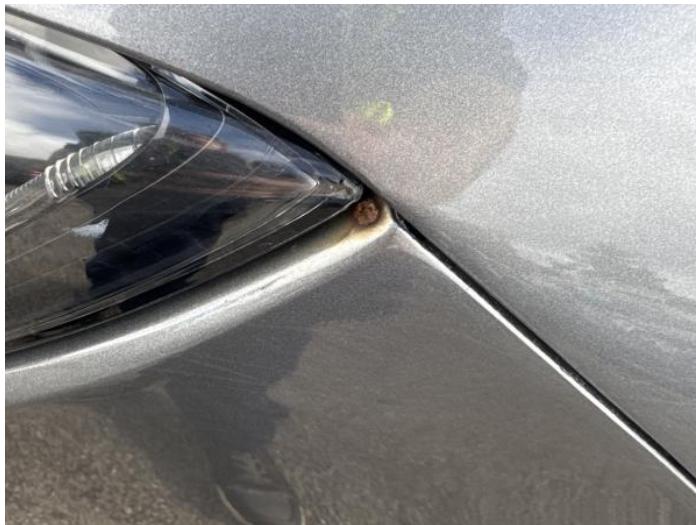
15: Bumper Front  
Hole  
UpTo 25mm

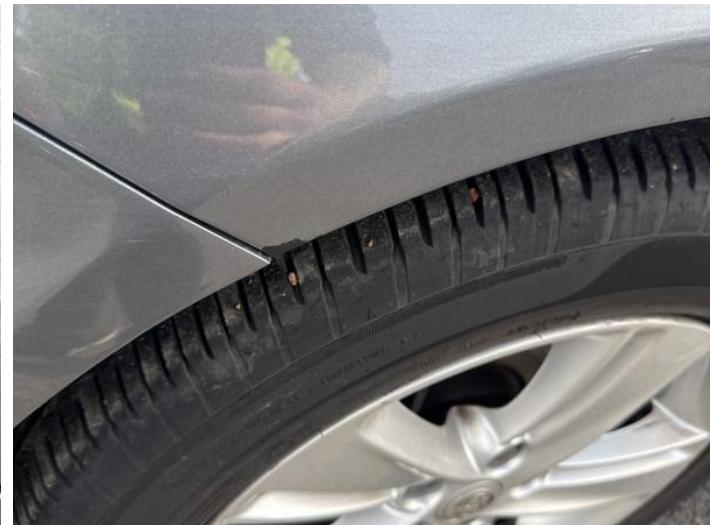
16: Wing nsf  
Poor Previous Repair  
Poor Paint

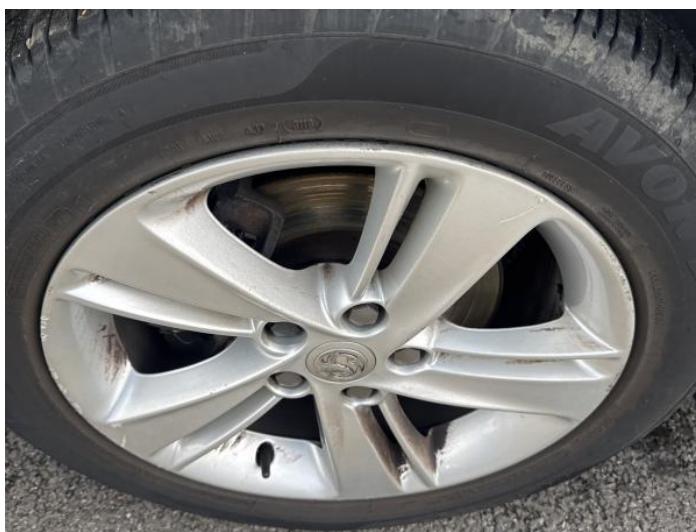
17: Wheel nsf  
Scratched  
Over 50mm

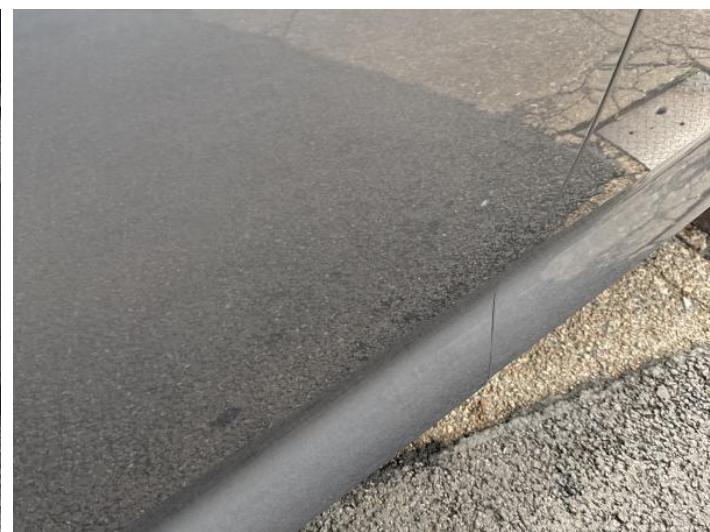
18: Door nsr  
Scratched  
UpTo 25mm Thru Paint

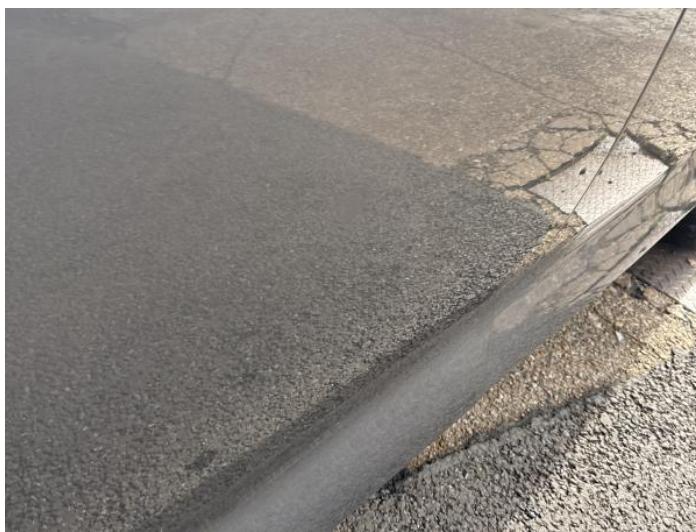
19: Door nsf  
Dented  
Over 2 UpTo 10mm

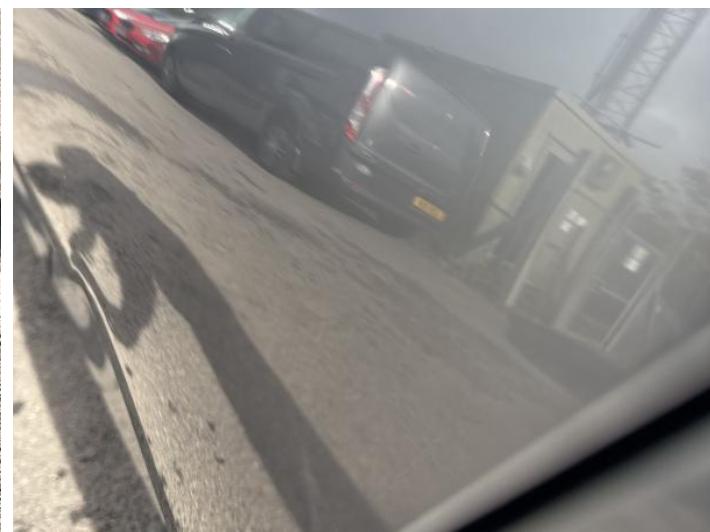
20: Door nsr  
Dented  
2 Or Less UpTo 10mm

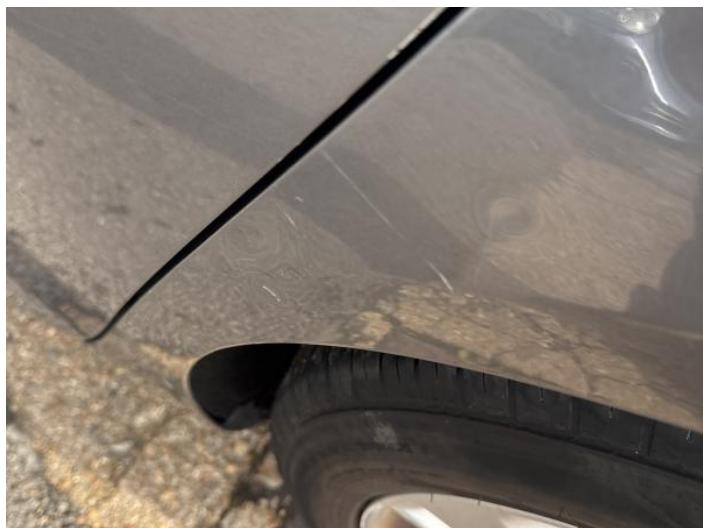
22: Qtr Panel nsr  
Dented  
Over 30mm

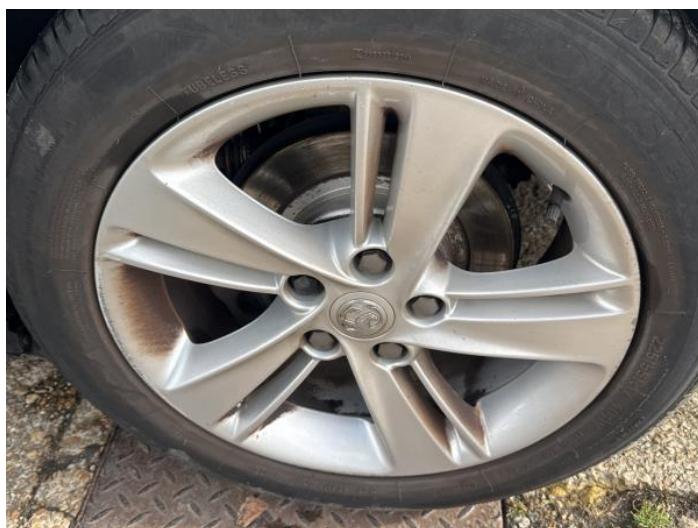
23: Wheel nsr  
Scratched  
Over 50mm
