# VEHICLE INSPECTION REPORT

LX06VEA

## Peugeot 1007 1.6 Sport 3dr 2-Tronic

Inspection	Vehicle		GRADE 3
Serious Damage?	VAT	Margin	
No	V5	Present

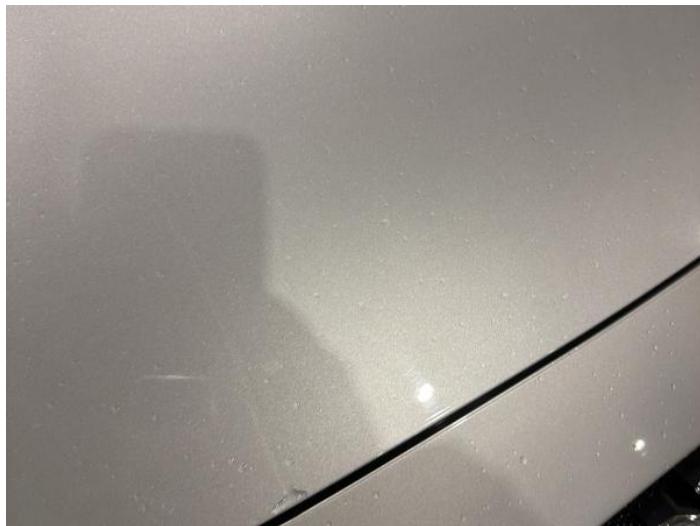
1: Bonnet  
Chipped  
1 To 5

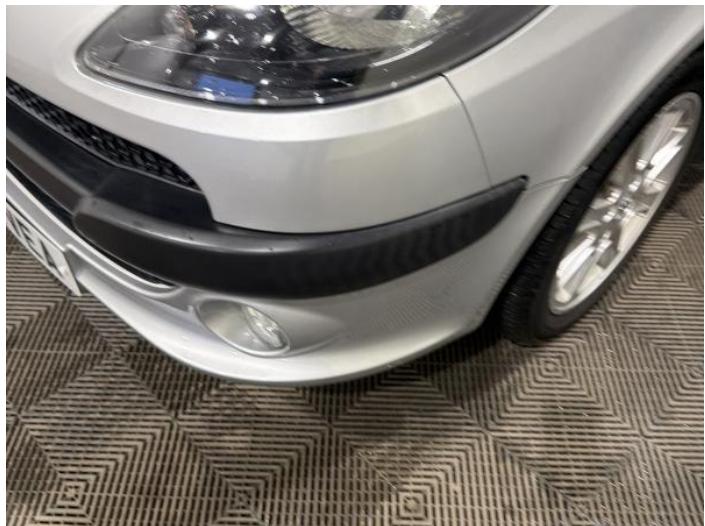
2: Bumper Front  
Chipped  
Multiple Chips

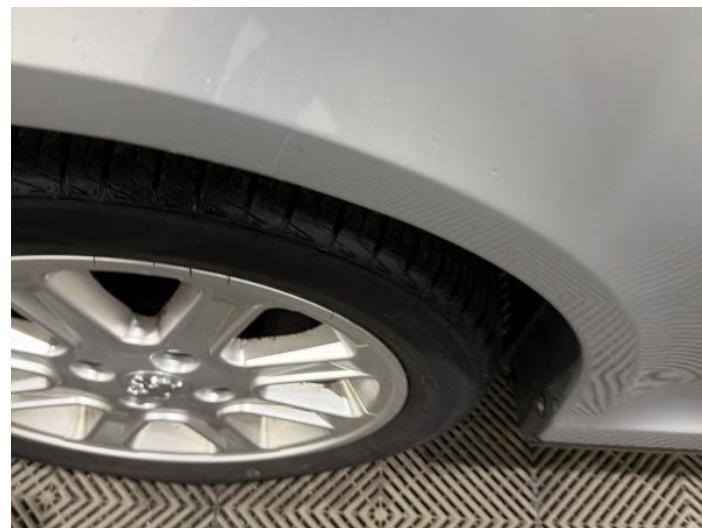
5: Wing nsf  
Scratched  
UpTo 25mm Thru Paint

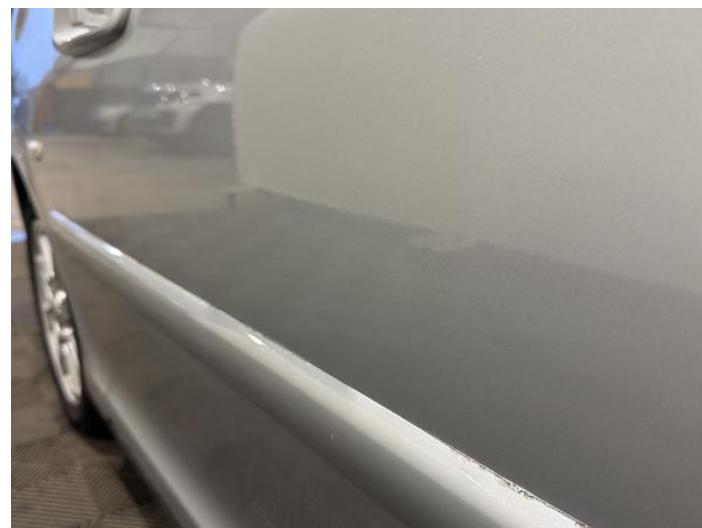
7: Door nsf  
Poor Previous Repair  
Poor Paint

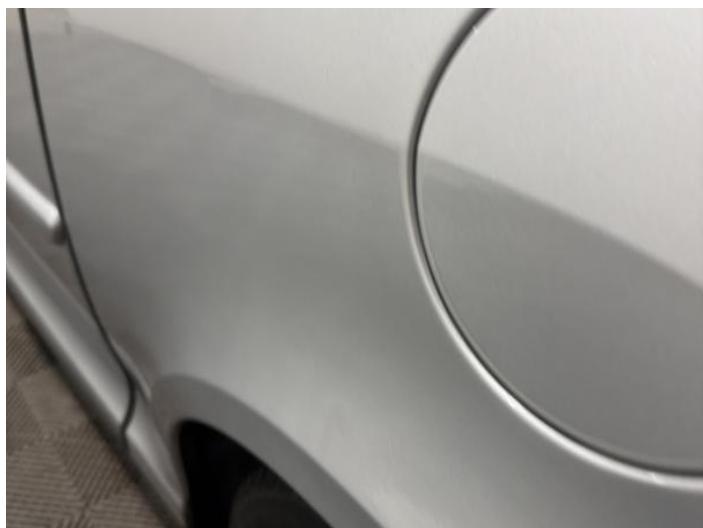
8: Qtr Panel nsf  
Poor Previous Repair  
Poor Paint

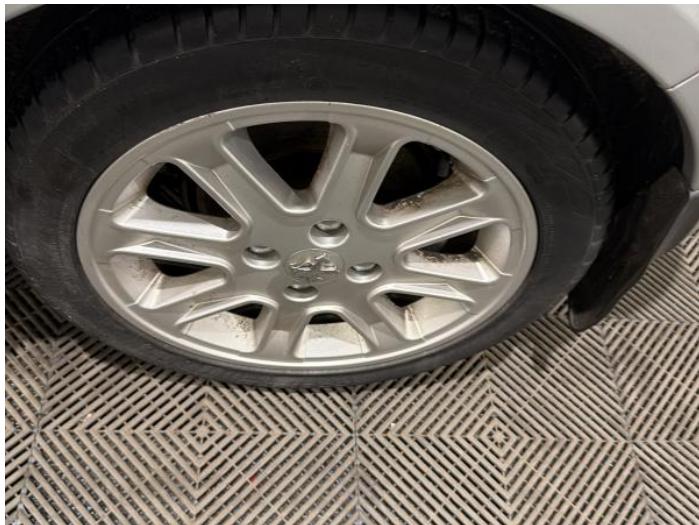
9: Wheel nsr  
Scratched  
Up To 50mm

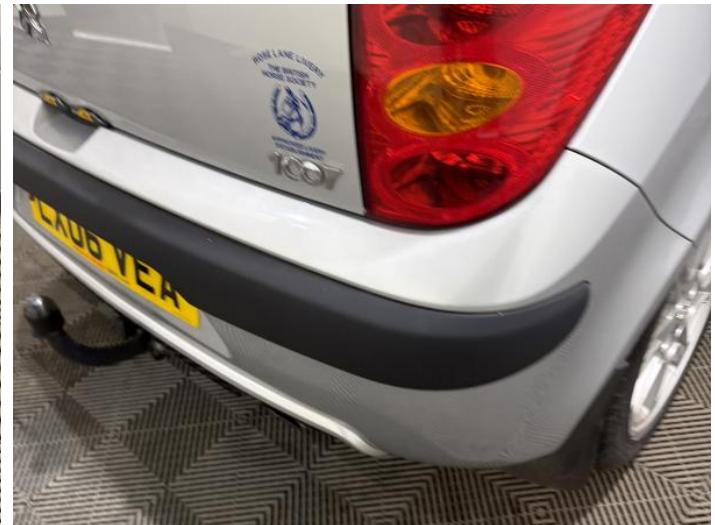
10: Bumper Rear  
Chipped  
Multiple Chips

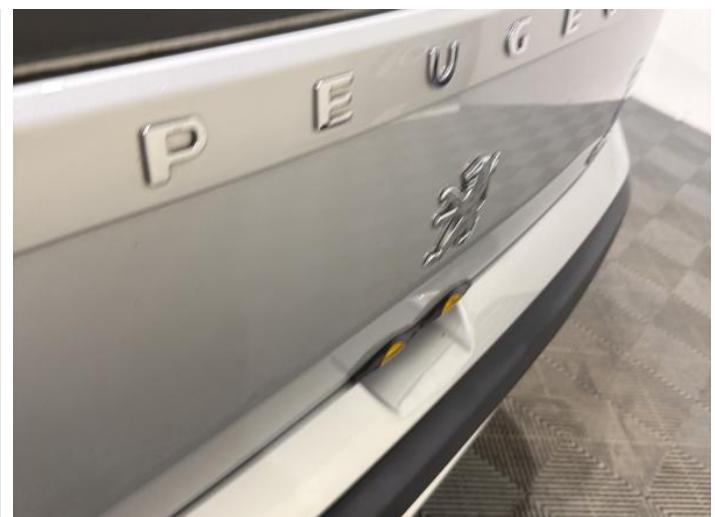
12: Boot Lid  
Chipped  
1 To 5

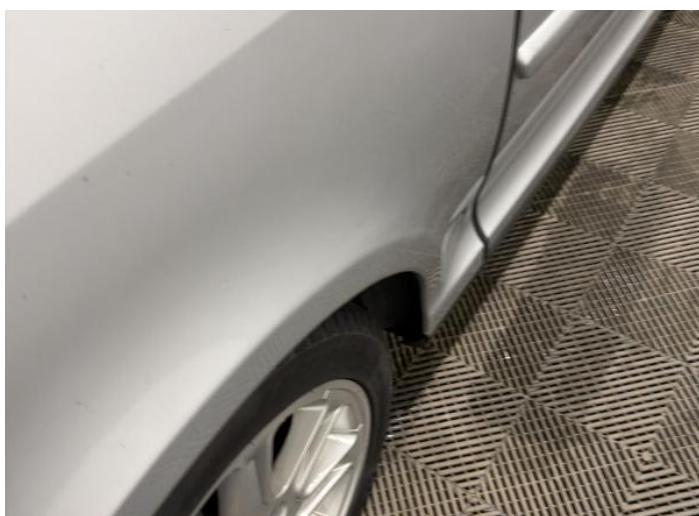
13: Qtr Panel osr  
Dented  
Over 30mm

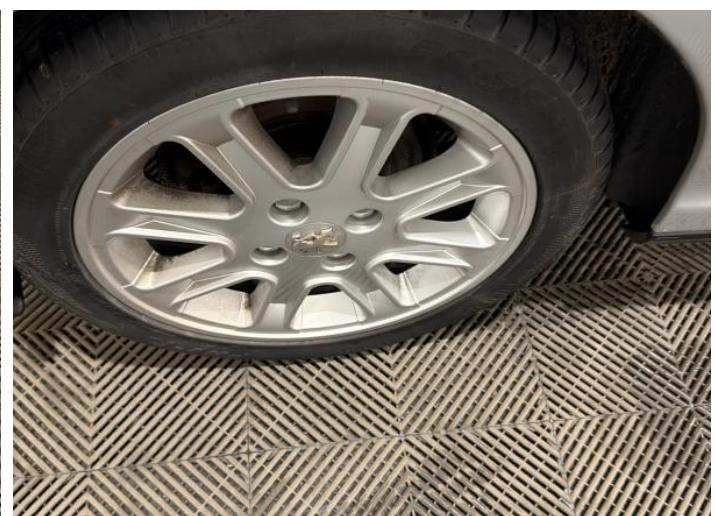
14: Wheel osr  
Scratched  
Up To 50mm

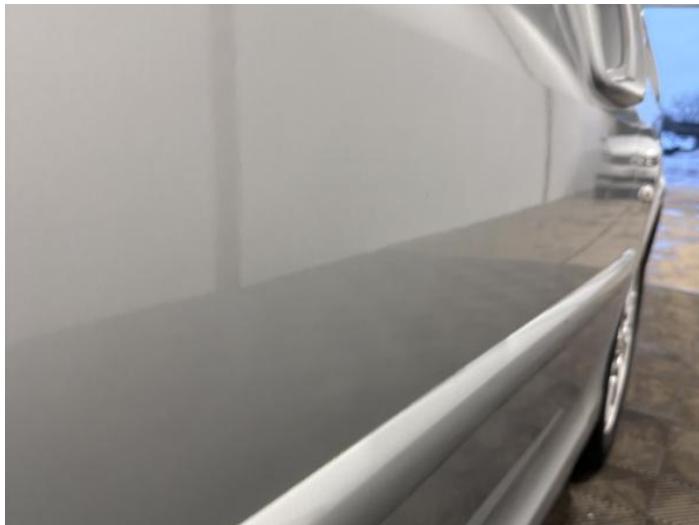
15: Door osf  
Poor Previous Repair  
Poor Paint

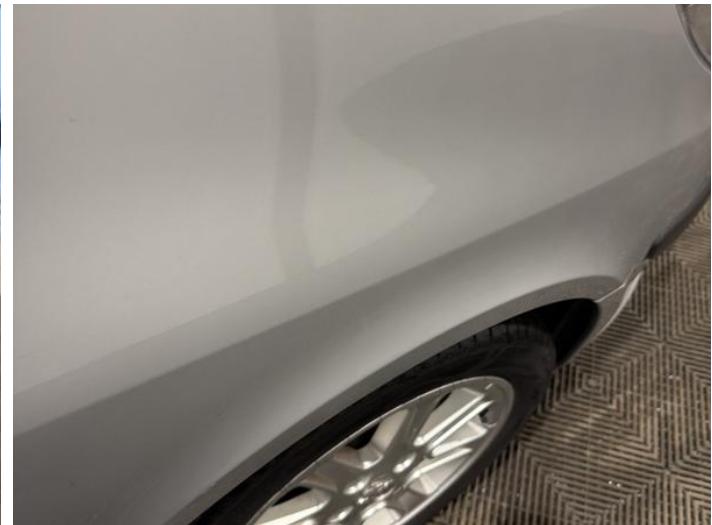
16: Wing osf  
Chipped  
1 To 5

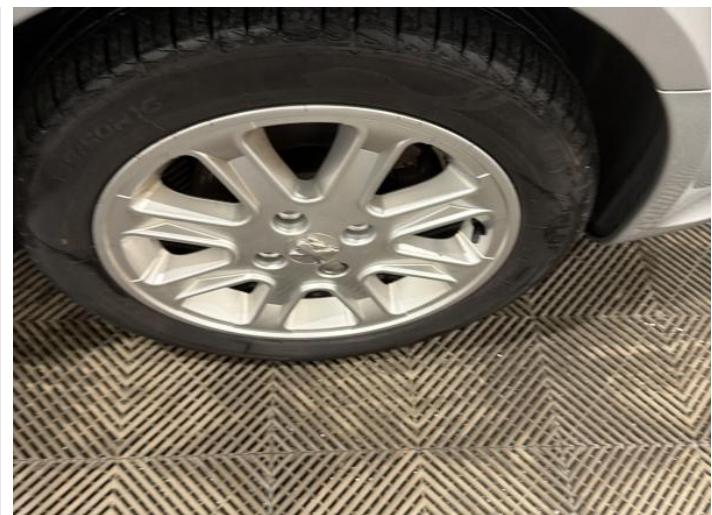
18: Wheel osf  
Scratched  
Up To 50mm
