VEHICLE INSPECTION REPORT

VO18MHZ

Volkswagen Golf 1.6 TDI GT 5dr

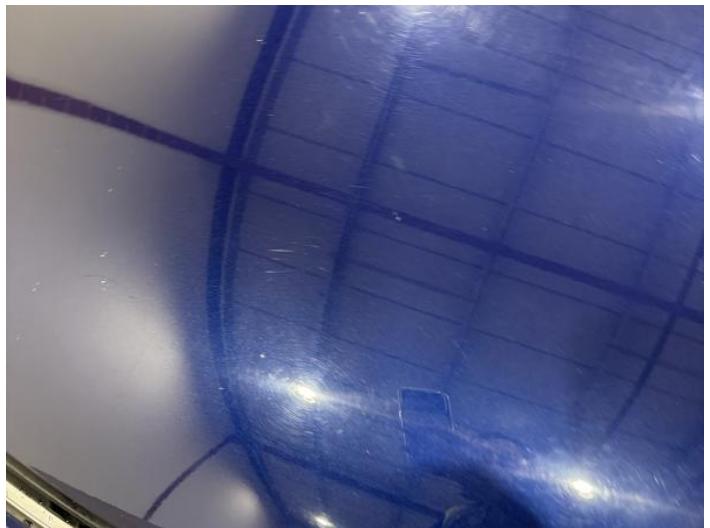
1: Bonnet
Chipped
Multiple Chips

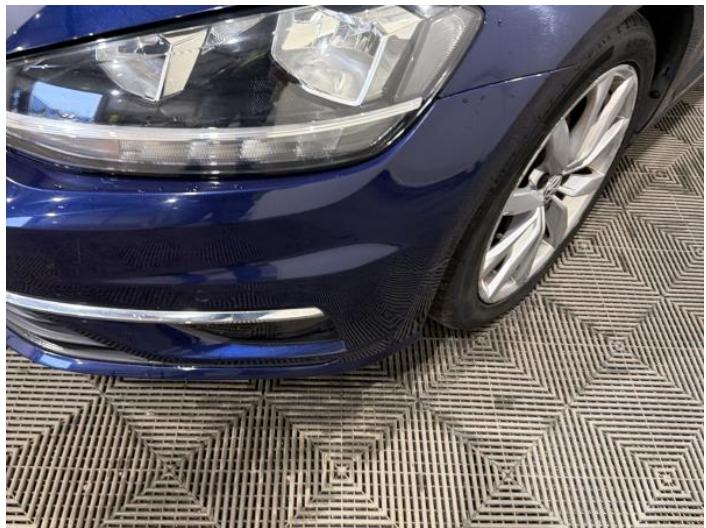
2: Bumper Front
Scratched
Over 100mm Thru Paint

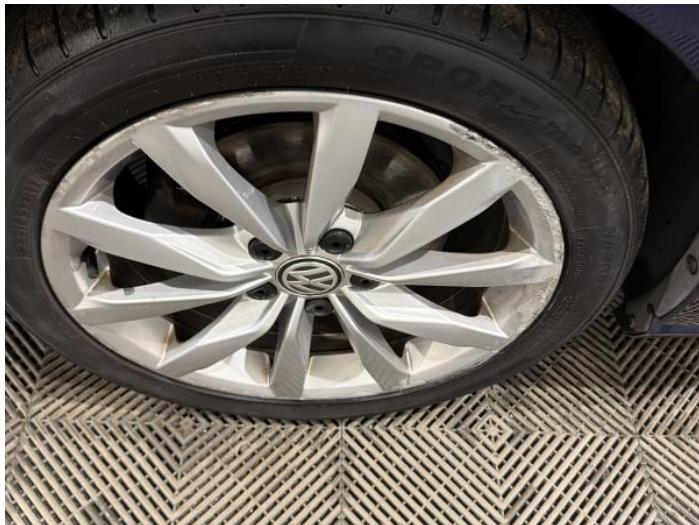
3: Wheel nsf
Scratched
Over 50mm

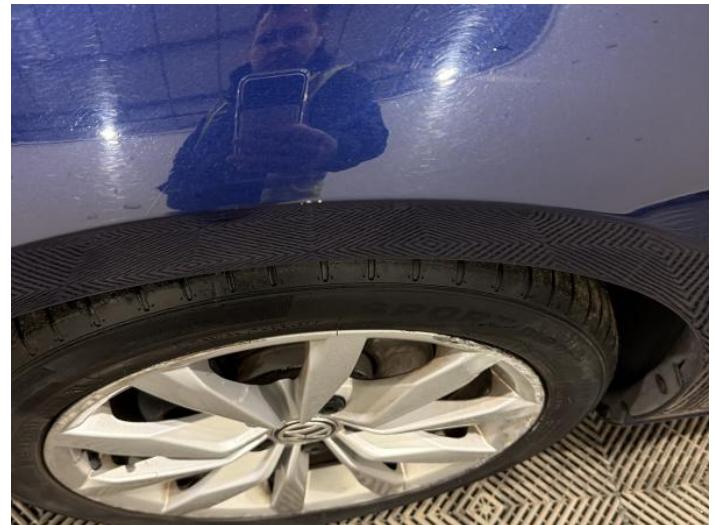
4: Wing nsf
Chipped
1 To 5

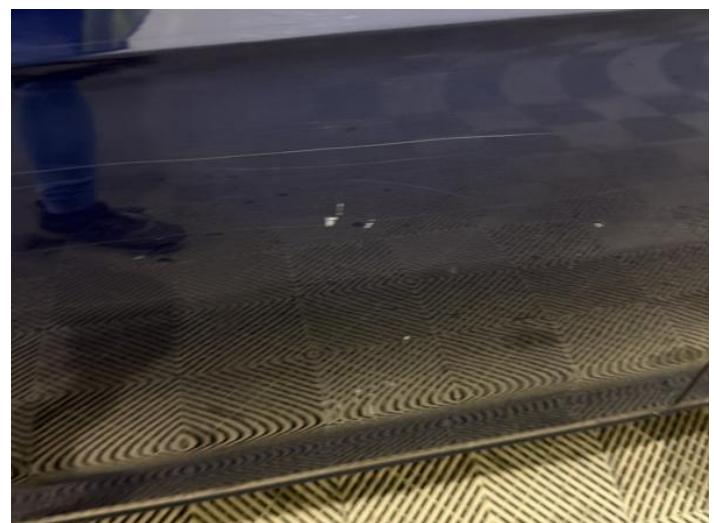
6: Door nsf
Chipped
Multiple Chips

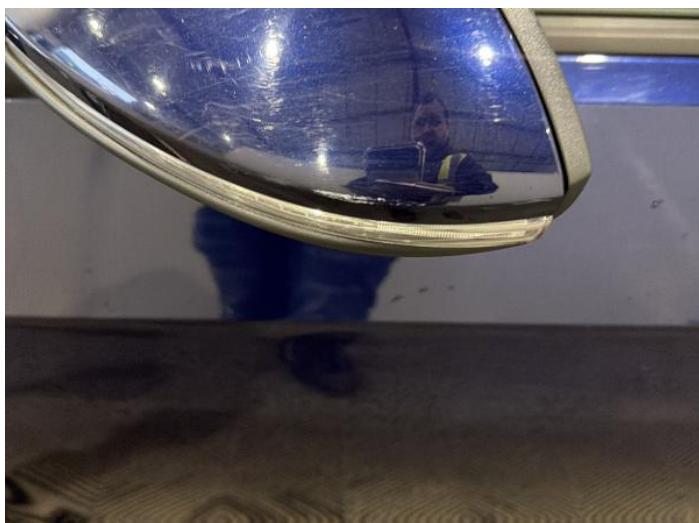
7: Door Mirror Assy nsf
Scratched (Painted)
UpTo 25mm Thru Paint

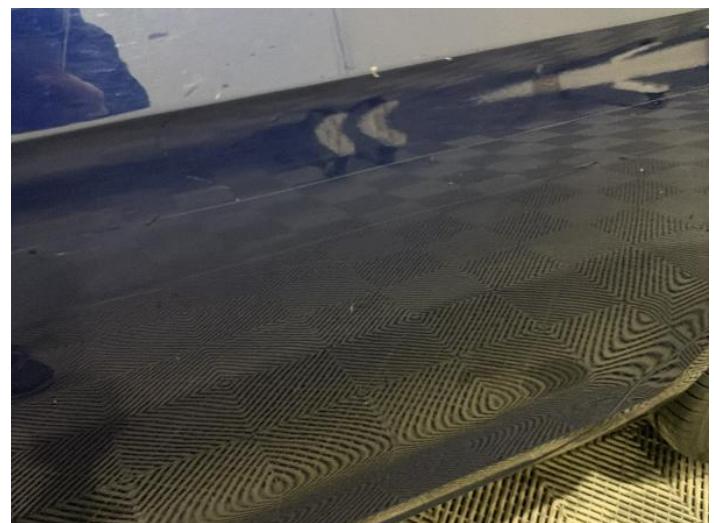
8: Door nsr
Chipped
Multiple Chips

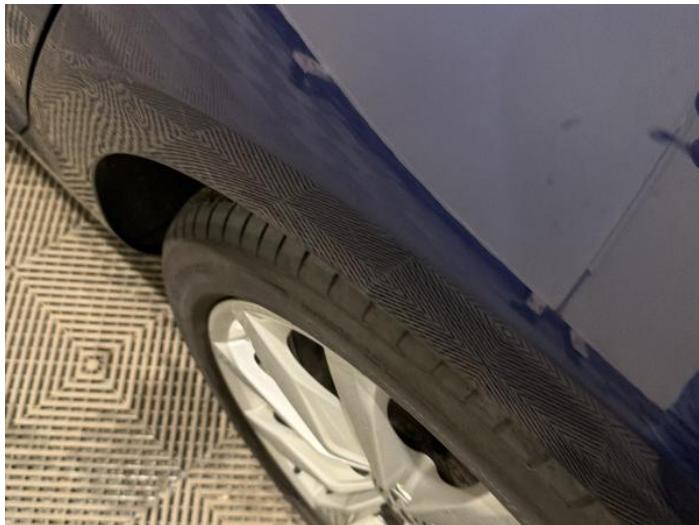
9: Qtr Panel nsr
Dented
With Paint Damage

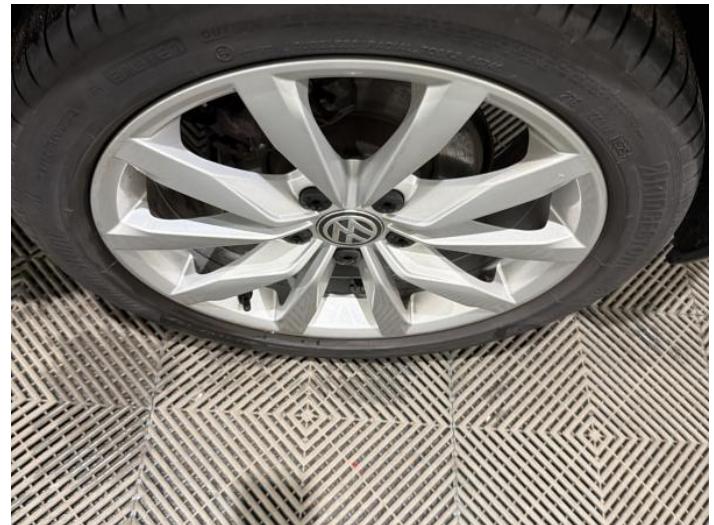
10: Wheel nsr
Scratched
Up To 50mm

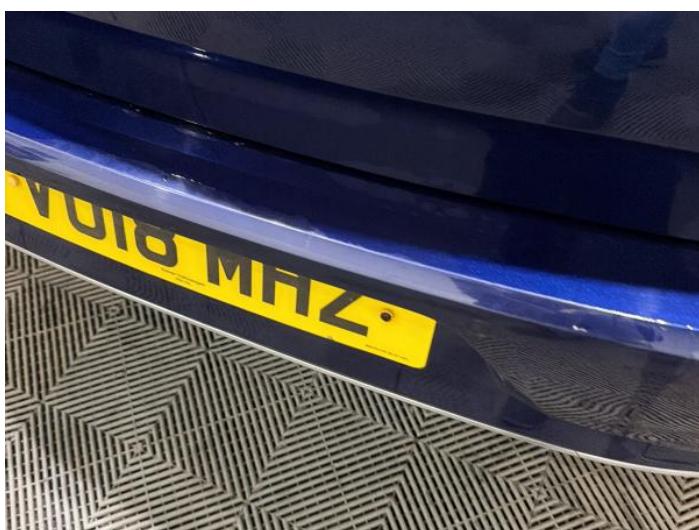
11: Bumper Rear
Scratched
25 to 100mm Thru Paint

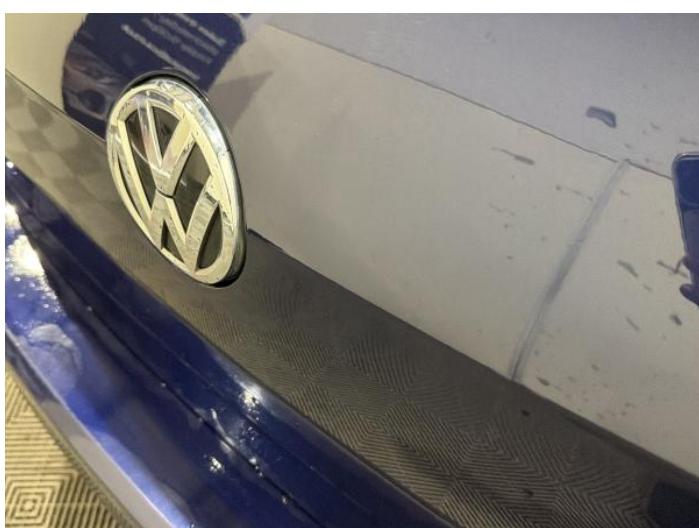
13: Boot Lid
Dented
Over 2 UpTo 10mm

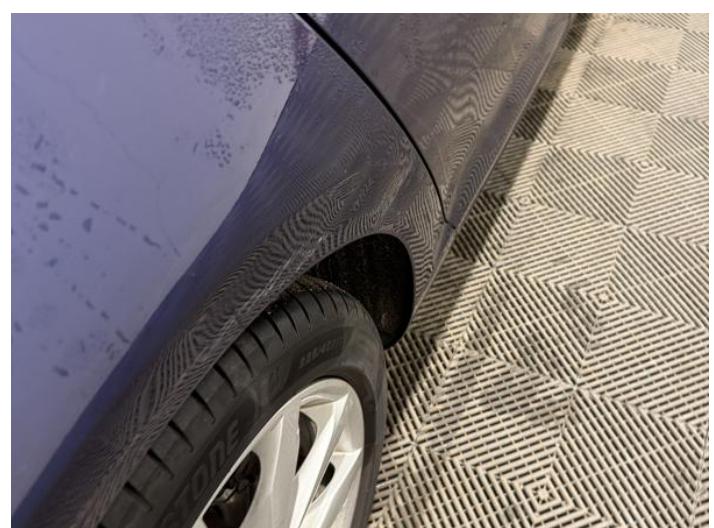
14: Qtr Panel osr
Dented
Over 30mm

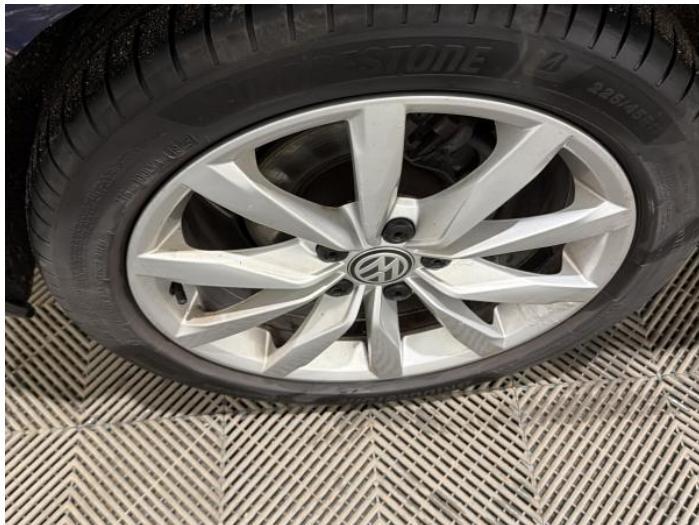
15: Wheel osr
Scratched
Up To 50mm

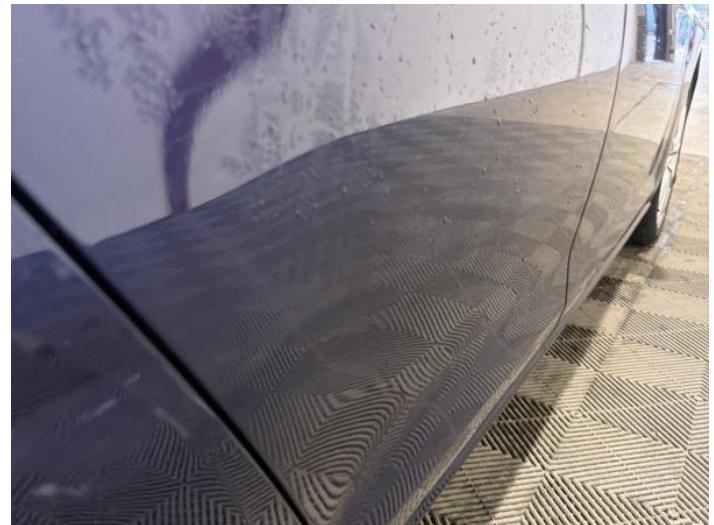
16: Door osr
Scratched
UpTo 25mm Thru Paint

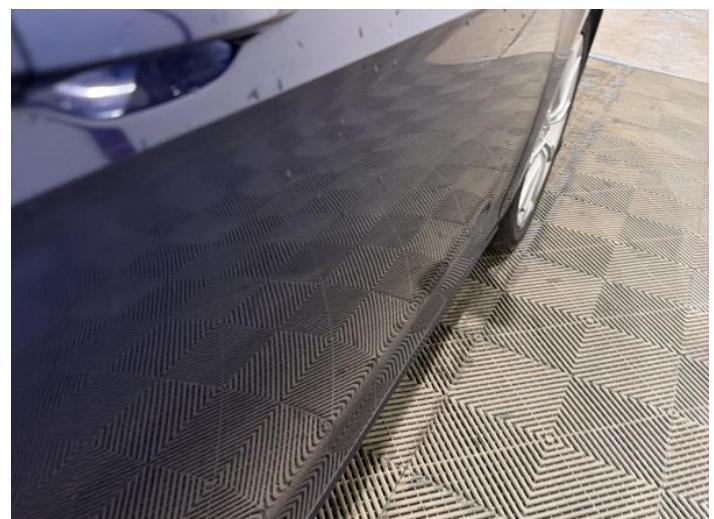
18: Door osf
Poor Previous Repair
Poor Paint

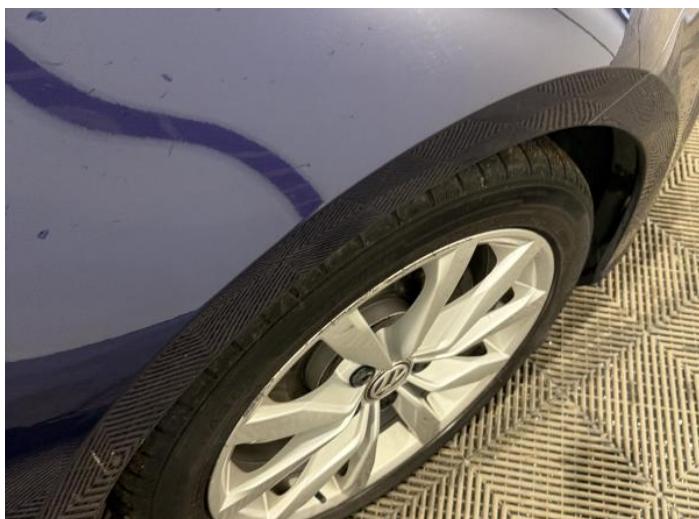
19: Wing osf
Chipped
1 To 5

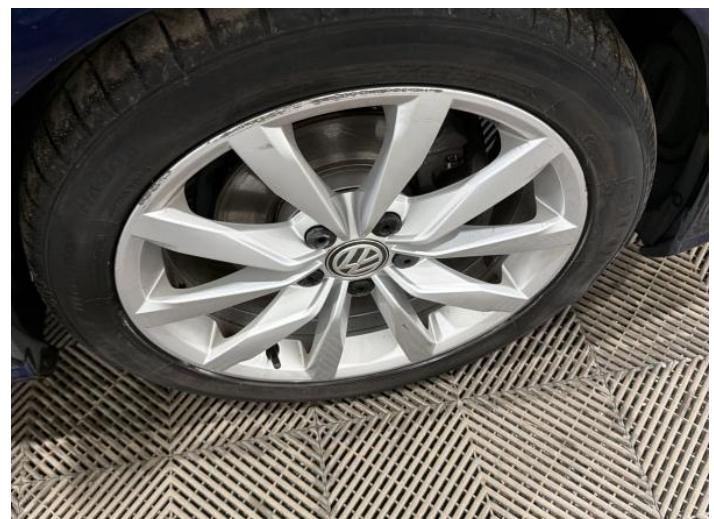
20: Wheel osf
Scratched
Over 50mm

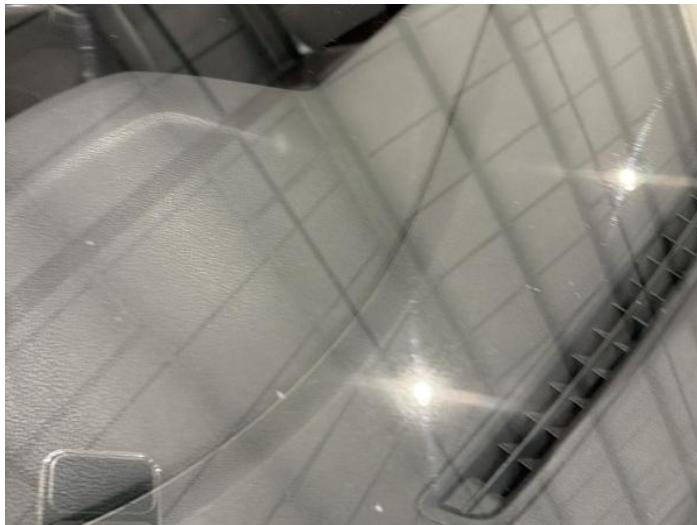
21: Screen Front
Chipped
UpTo 10mm
