## VEHICLE INSPECTION REPORT

OW17FTE

### Land Rover Discovery Sport 2.0 TD4 180 SE Tech 5dr Auto

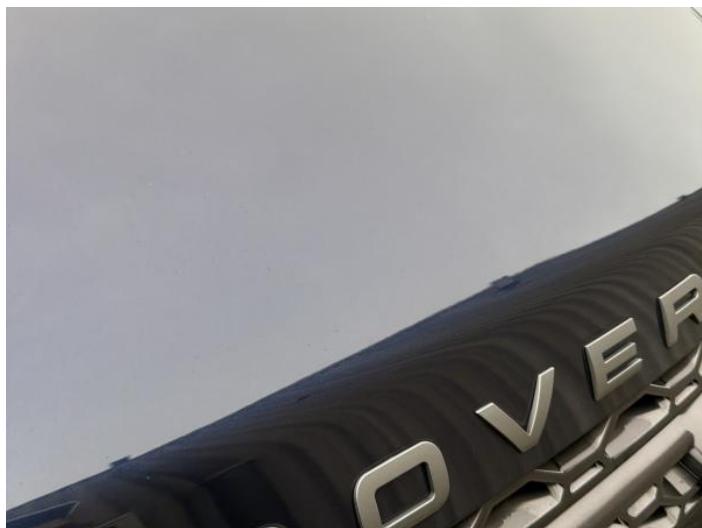
1: Bonnet  
Chipped  
1 To 5

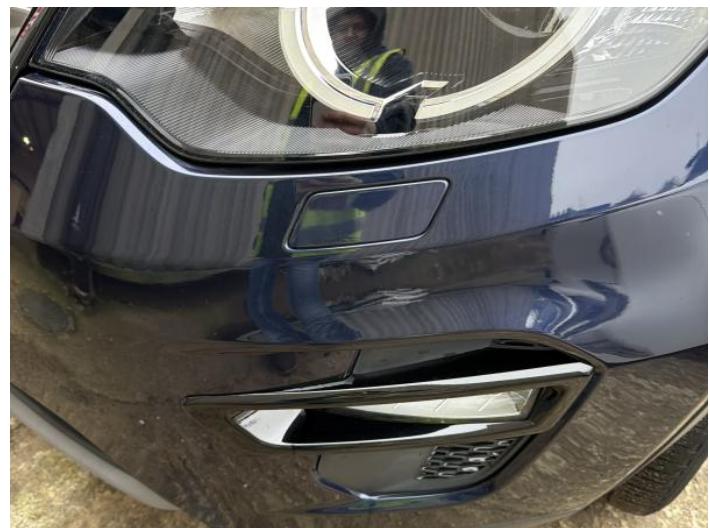
2: Bumper Front  
Chipped  
Multiple Chips

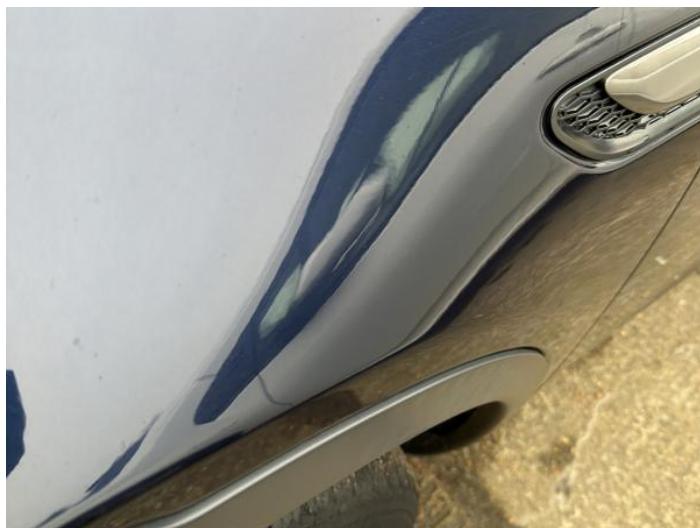
5: Wing nsf  
Chipped  
1 To 5

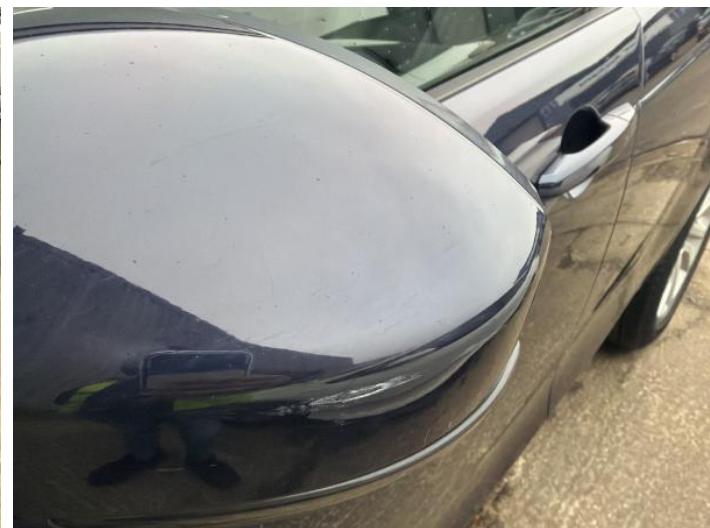
6: Door Mirror Assy nsf  
Scratched (Painted)  
UpTo 25mm Thru Paint

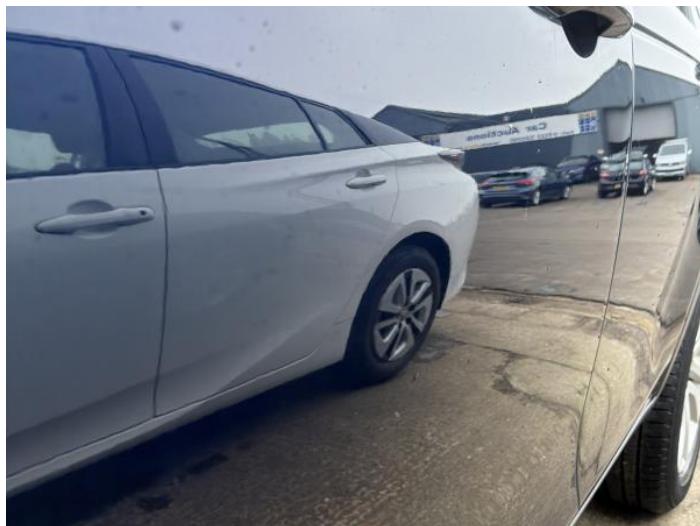
7: Door nsf  
Dented  
With Paint Damage

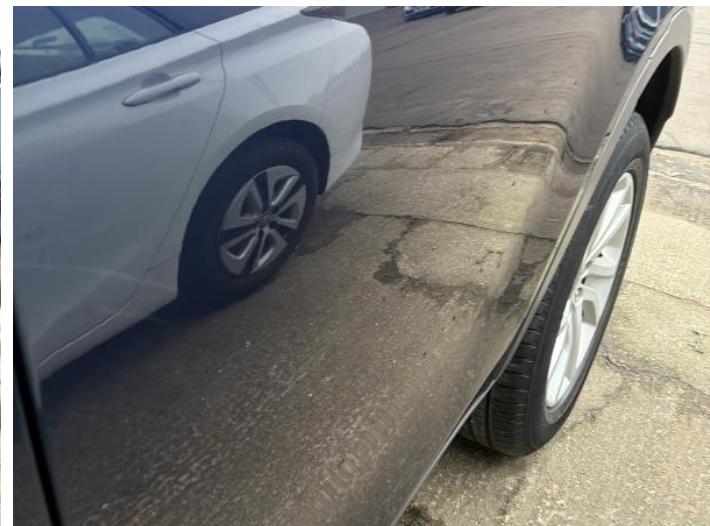
8: Door nsf  
Scratched  
Over 25mm Thru Paint

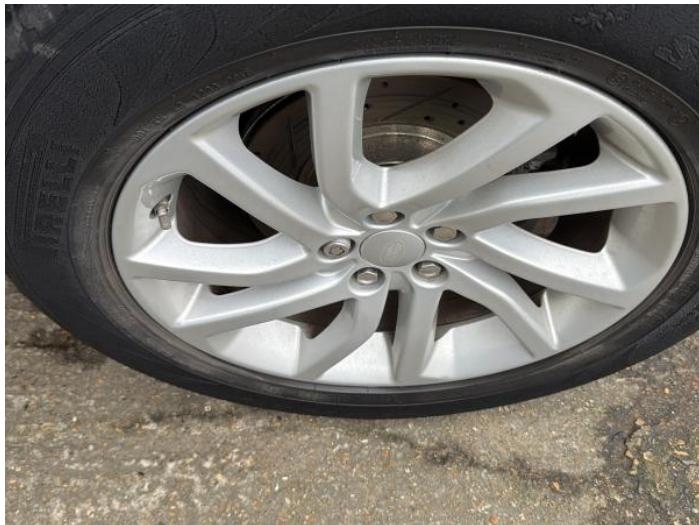
9: Wheel nsr  
Scratched  
Up To 50mm

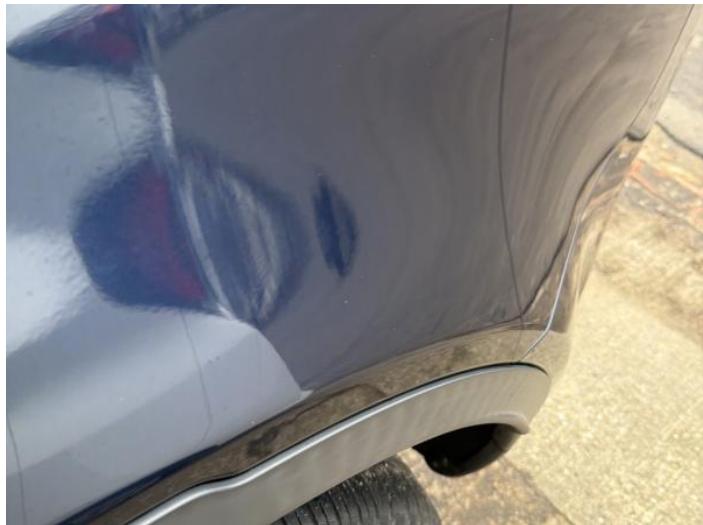
10: Qtr Panel nsr  
Chipped  
1 To 5

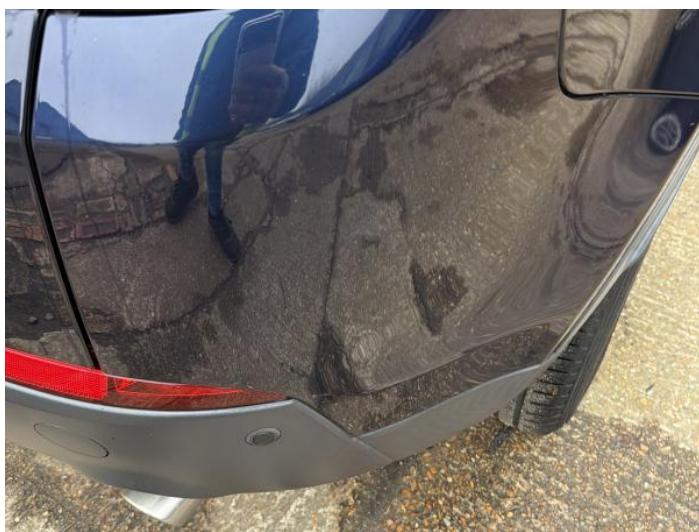
11: Bumper Rear  
Chipped  
Multiple Chips

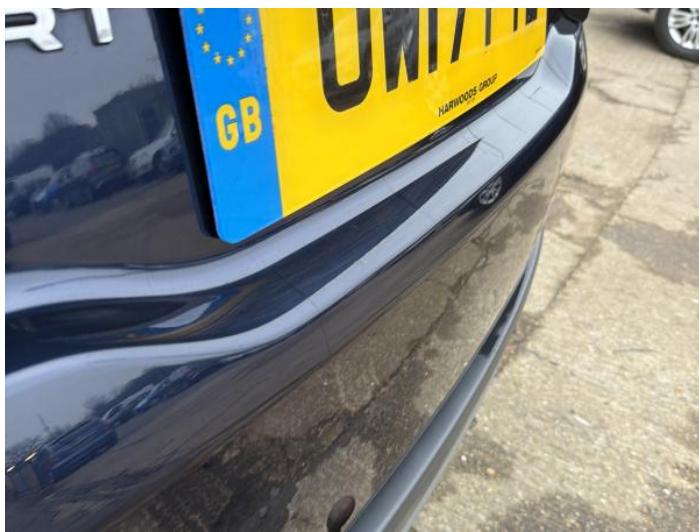
13: Boot Lid  
Dented  
Over 2 UpTo 10mm

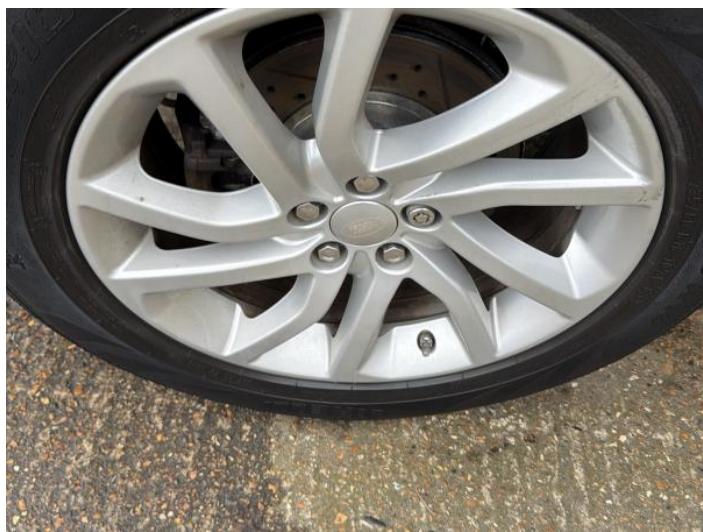
14: Wheel osr  
Scratched  
Up To 50mm

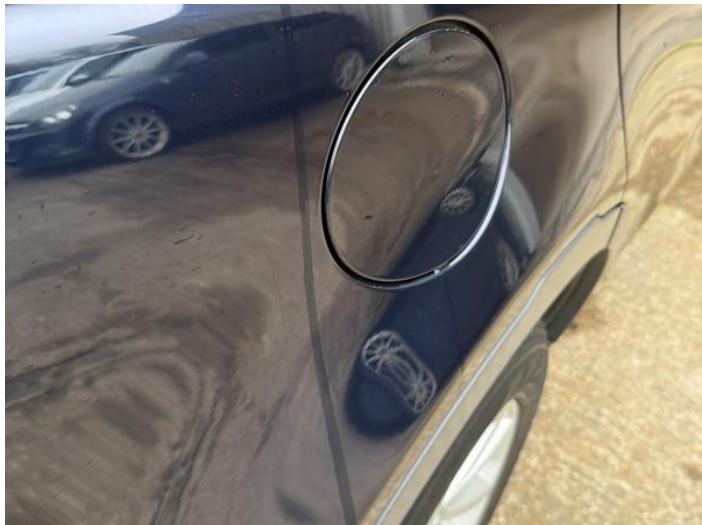
15: Qtr Panel osr  
Chipped  
1 To 5

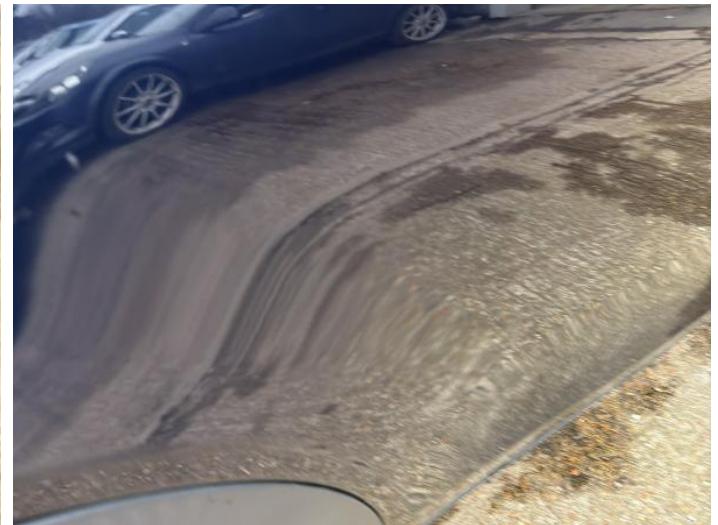
16: Door osr  
Dented  
Over 2 UpTo 10mm

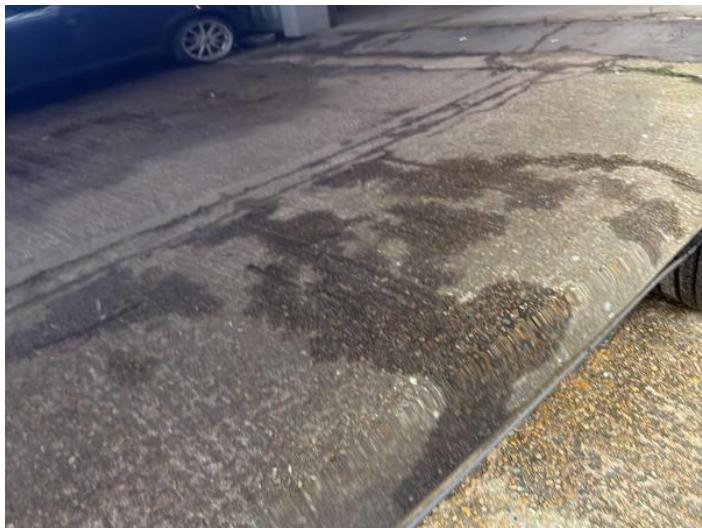
17: Door osf  
Chipped  
1 To 5

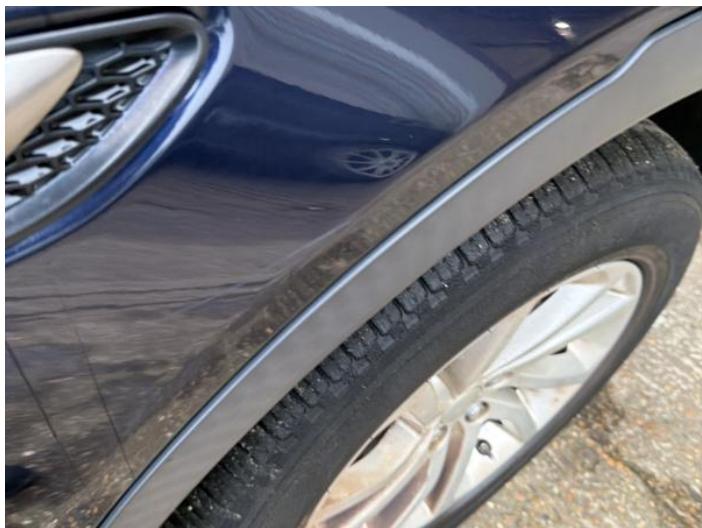
19: Wing osf  
Chipped  
1 To 5

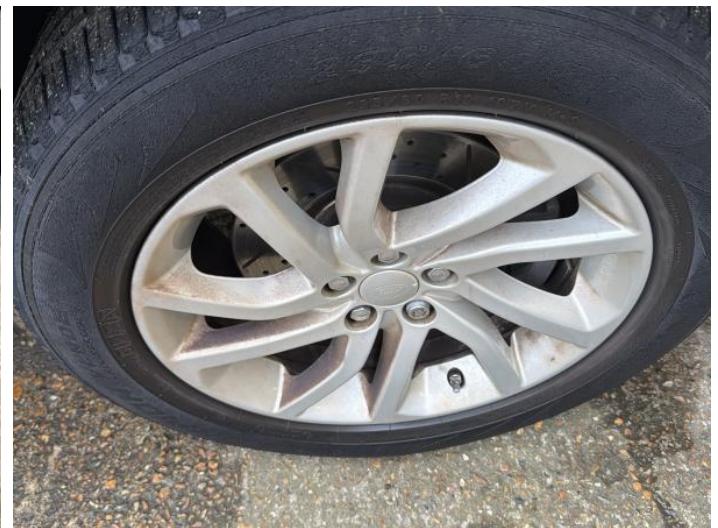
20: Wheel osf  
Scratched  
Up To 50mm
