# VEHICLE INSPECTION REPORT

GY15KPR

## Toyota Yaris 1.5 Hybrid Icon 5dr CVT

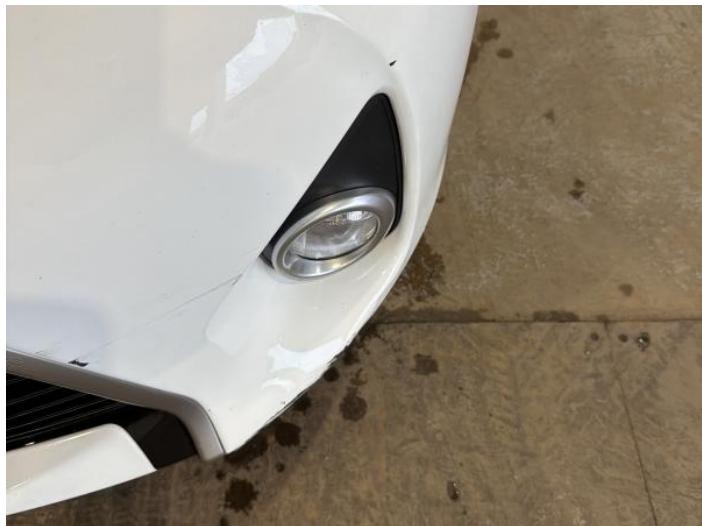
1: Bumper Front  
Scratched  
Over 100mm Thru Paint

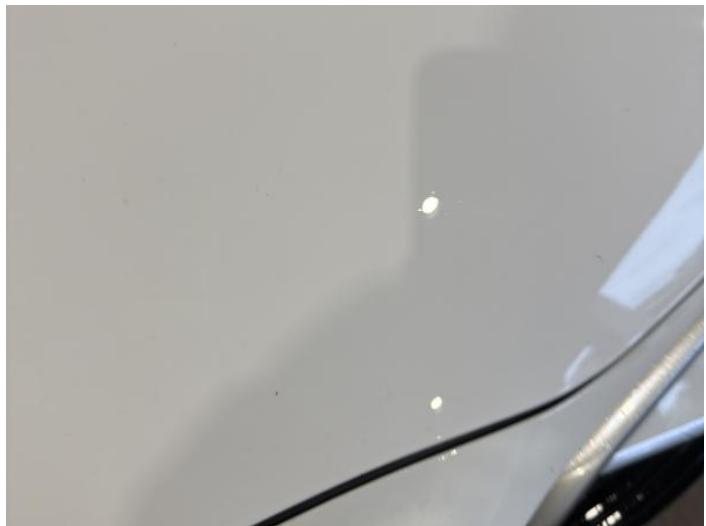
2: Bonnet  
Chipped  
1 To 5

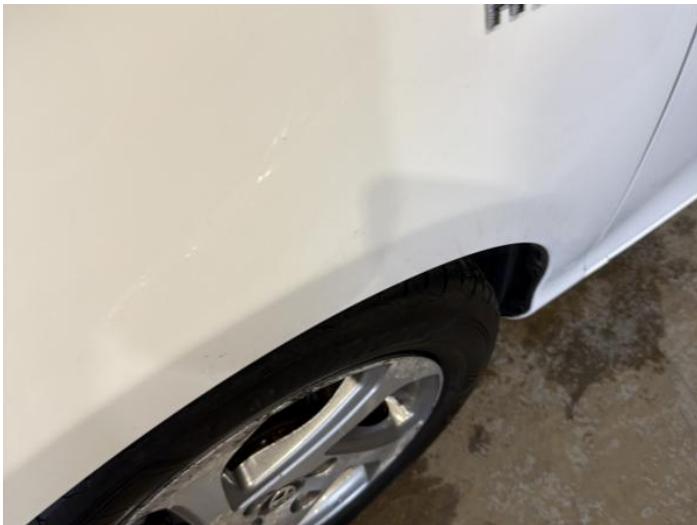
3: Wing nsf  
Chipped  
1 To 5

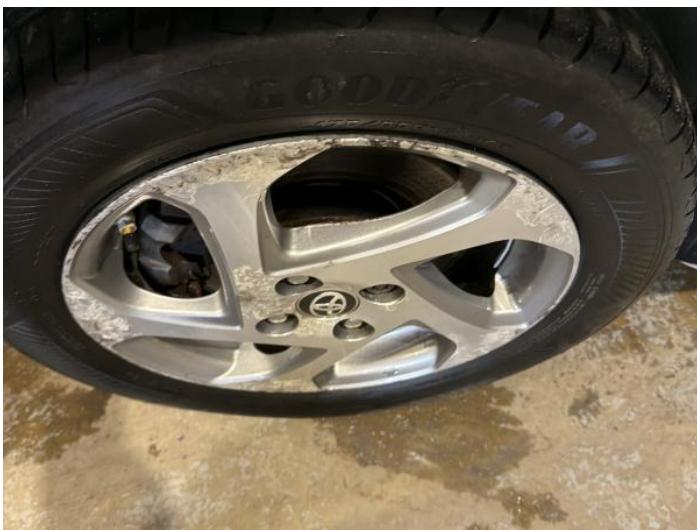
5: Wheel nsf  
Scratched  
Over 50mm

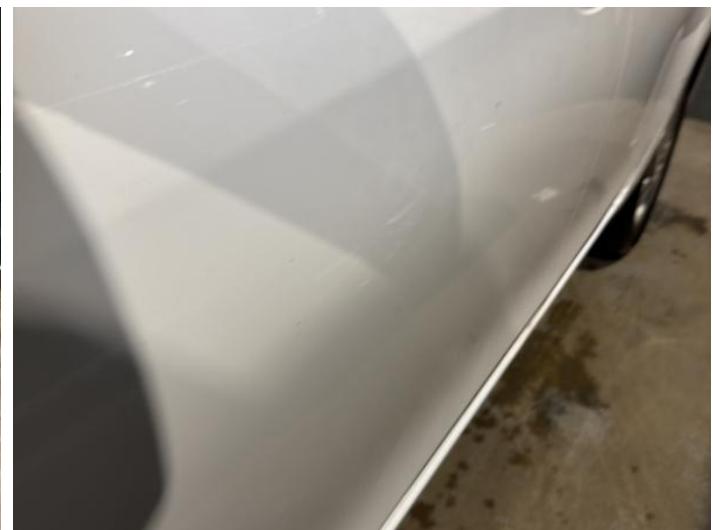
6: Door nsf  
Dented  
Over 2 UpTo 10mm

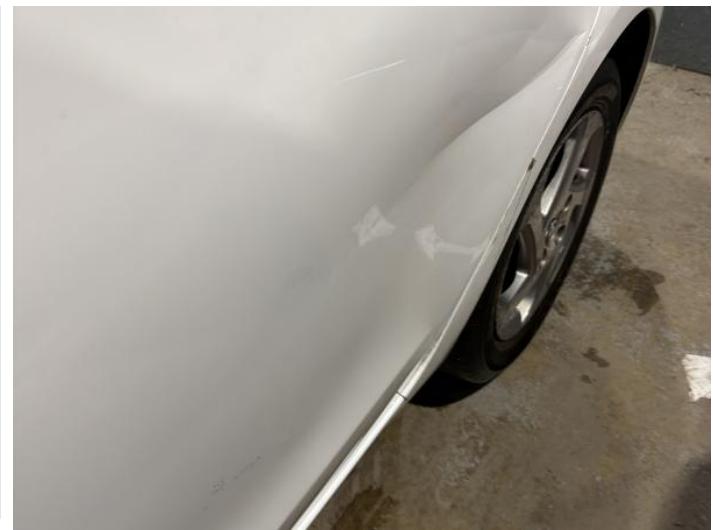
8: Door nsr  
Dented  
With Paint Damage

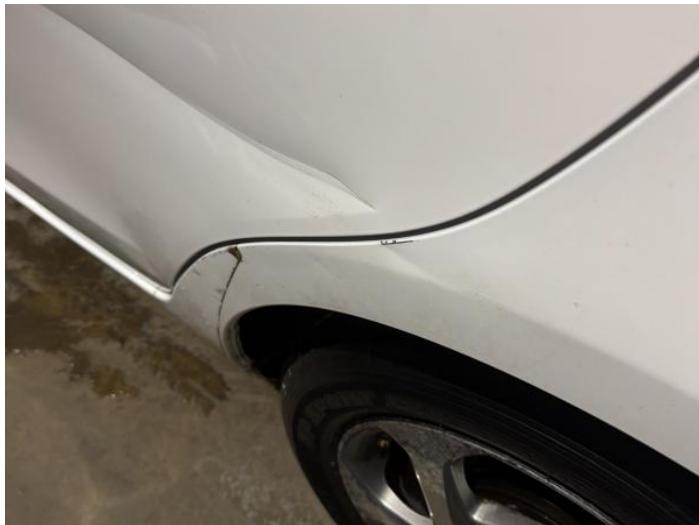
9: Qtr Panel nsr  
Dented  
With Paint Damage

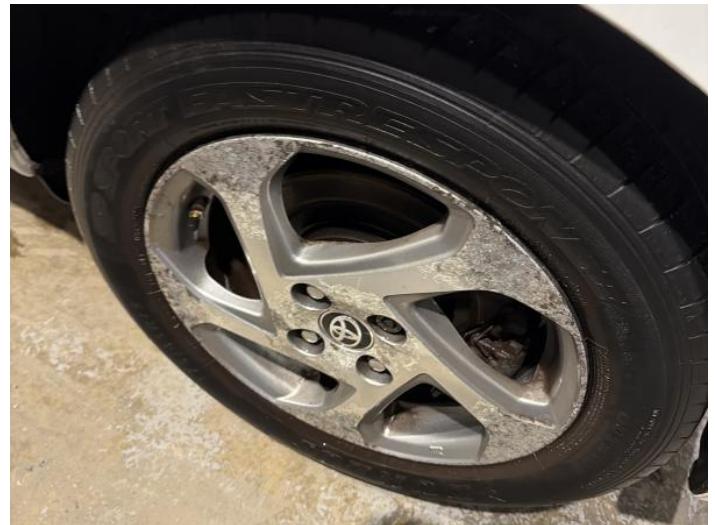
10: Wheel nsr  
Scratched  
Over 50mm

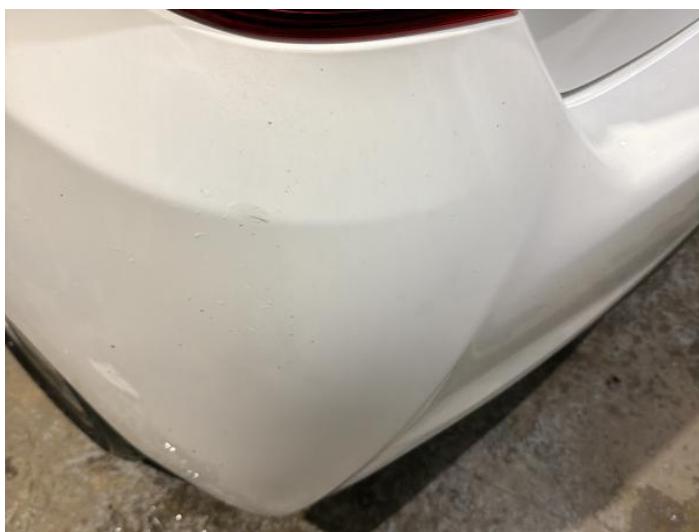
11: Bumper Rear  
Scratched  
Over 100mm Thru Paint

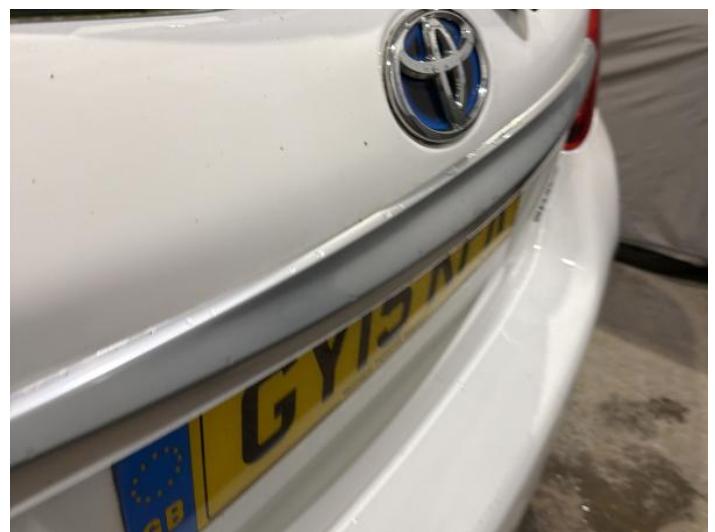
12: Boot Lid  
Chipped  
1 To 5

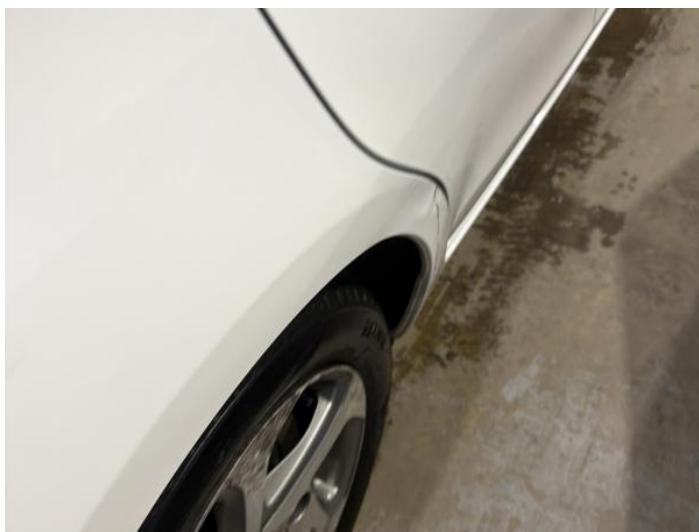
13: Qtr Panel osr  
Dented  
With Paint Damage

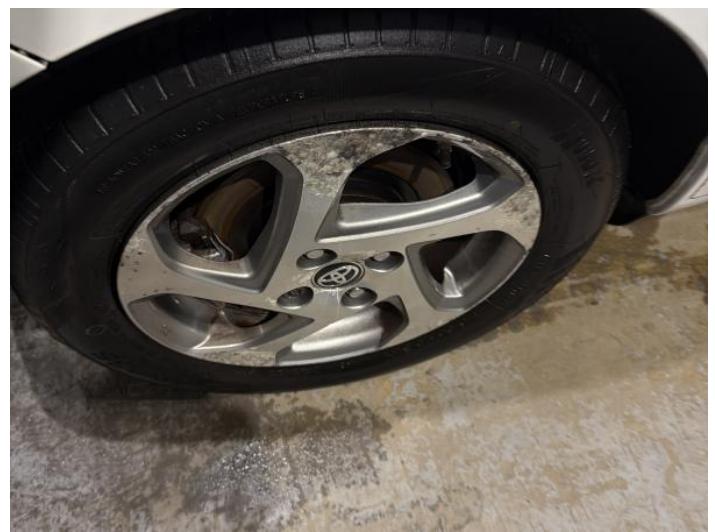
14: Wheel osr  
Scratched  
Over 50mm

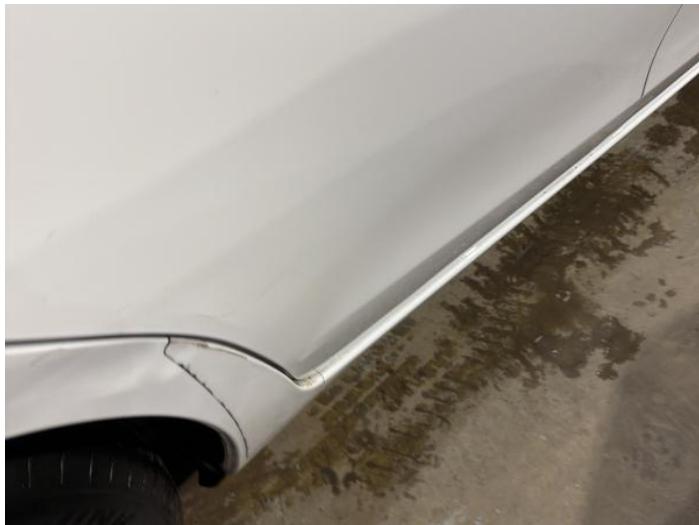
15: Door osr  
Dented  
With Paint Damage

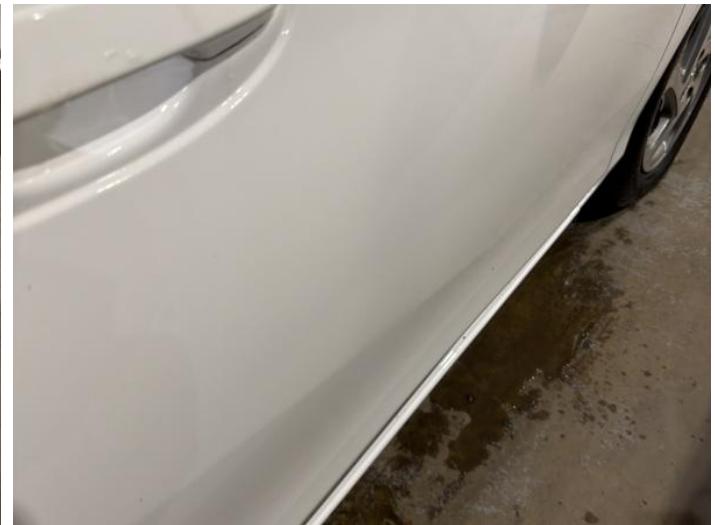
16: Door osf  
Dented  
With Paint Damage

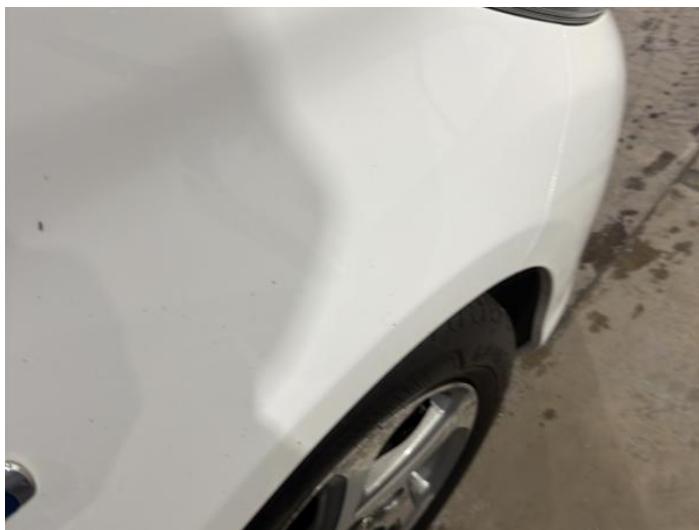
17: Wing osf  
Chipped  
1 To 5

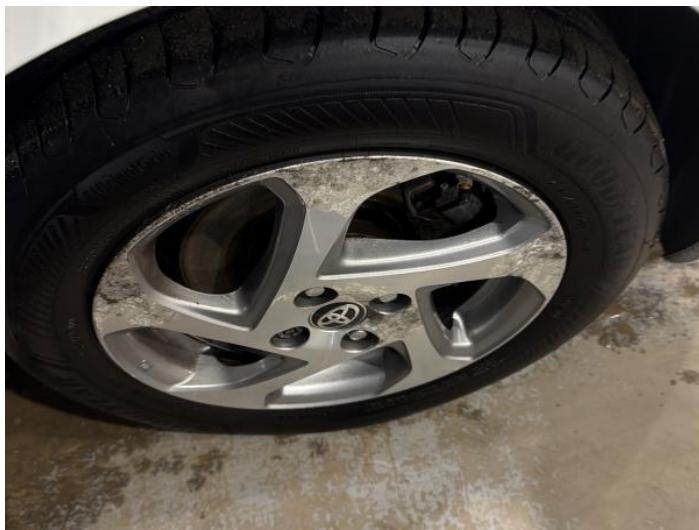
19: Wheel osf  
Scratched  
Over 50mm

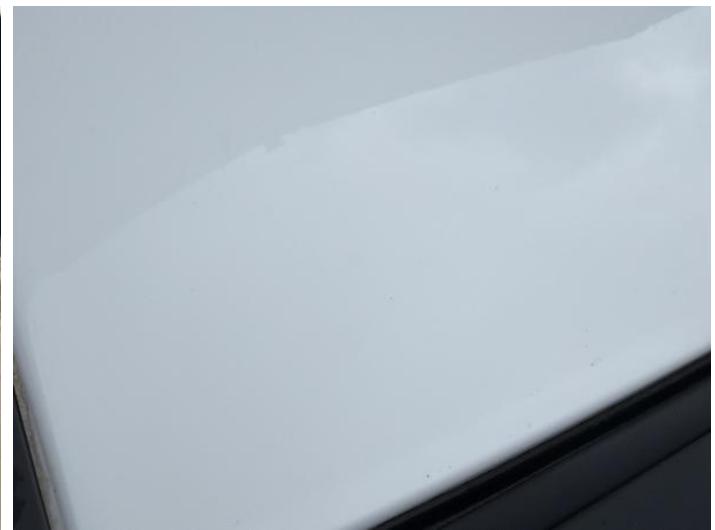
20: Roof  
Chipped  
Edge Chip
