VEHICLE INSPECTION REPORT

GX21YZK

Seat Ibiza 1.0 TSI 110 FR [EZ] 5dr

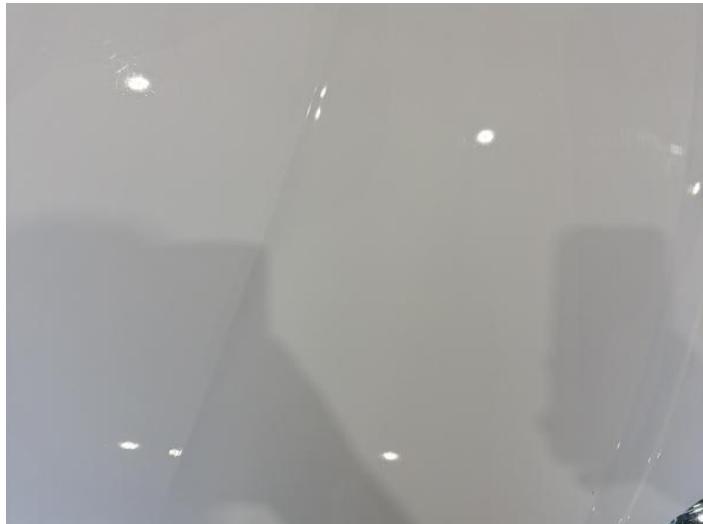
1: Bonnet
Chipped
Multiple Chips

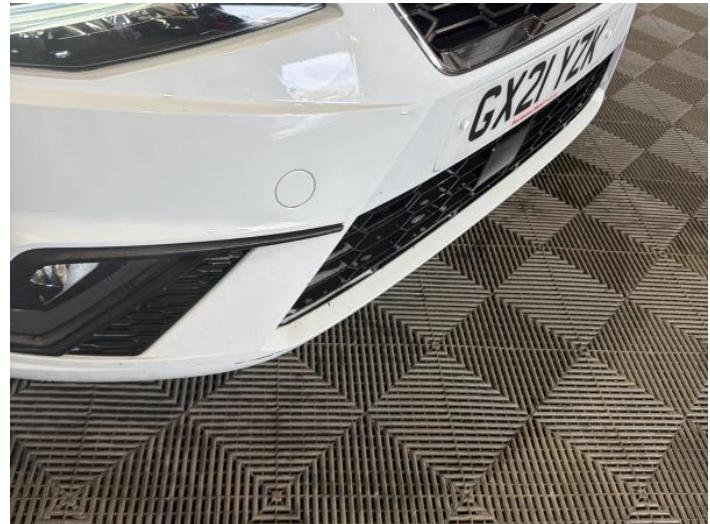
2: Bumper Front
Scratched
Over 100mm Thru Paint

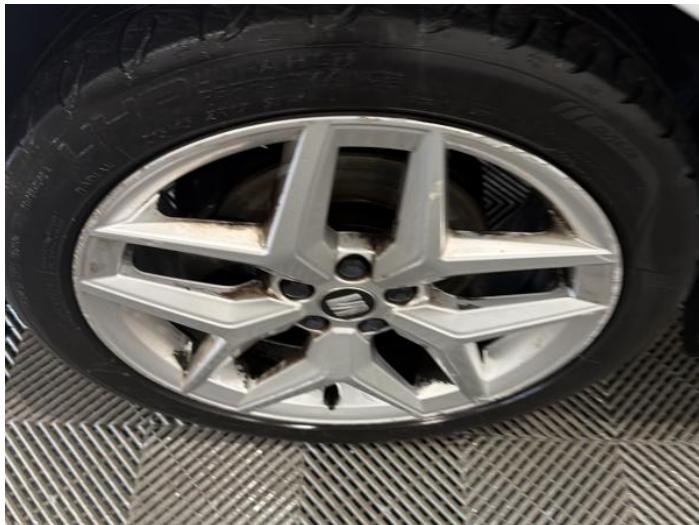
3: Wheel nsf
Scratched
Over 50mm

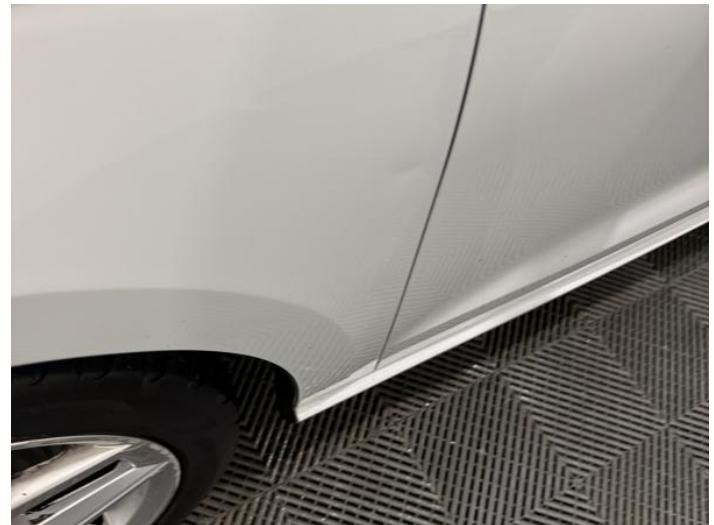
4: Wing nsf
Dented
Between 10mm + 30mm

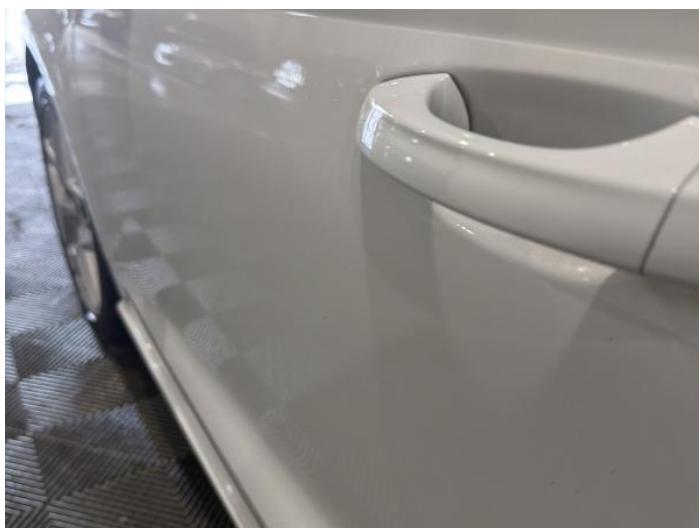
5: Door nsf
Dented
Over 2 UpTo 10mm

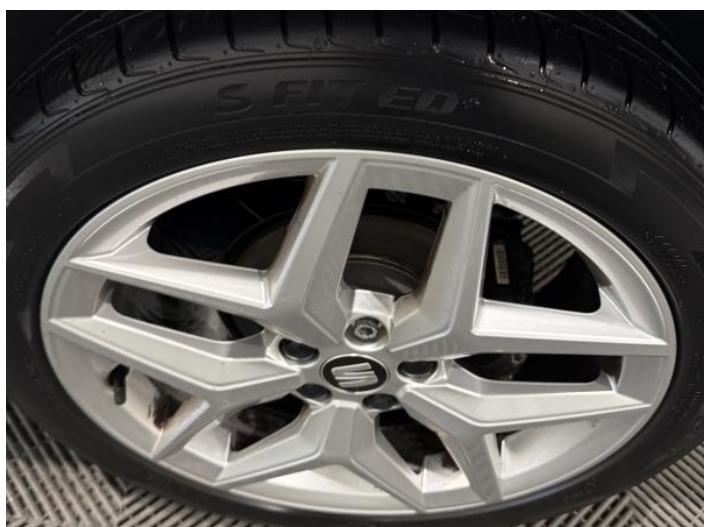
8: Wheel nsr
Scratched
Up To 50mm

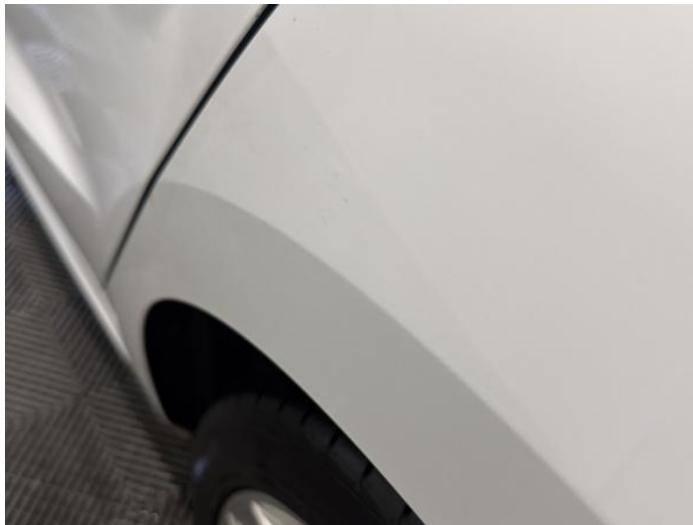
9: Qtr Panel nsr
Dented
Between 10mm + 30mm

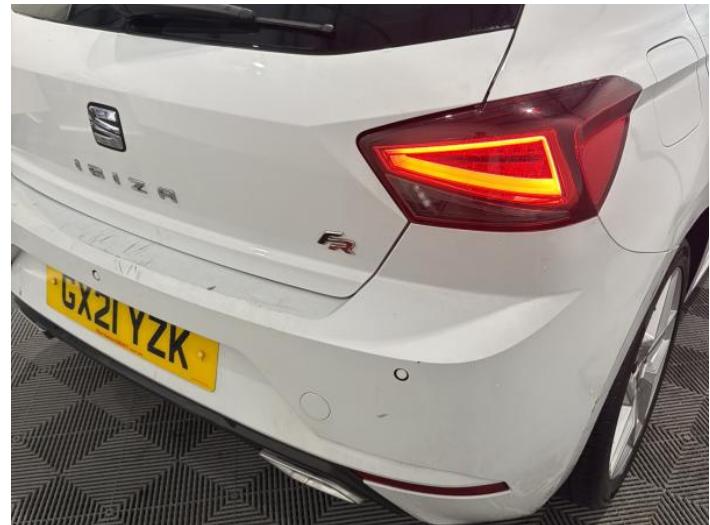
10: Bumper Rear
Scratched
Over 100mm Thru Paint

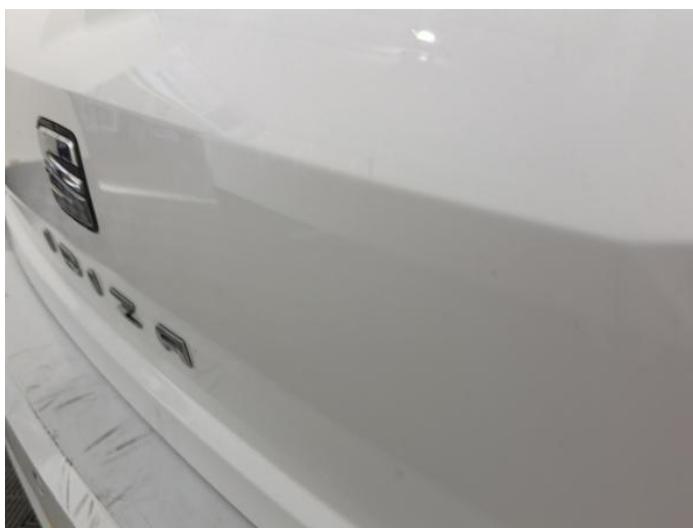
11: Boot Lid
Dented
Over 2 UpTo 10mm

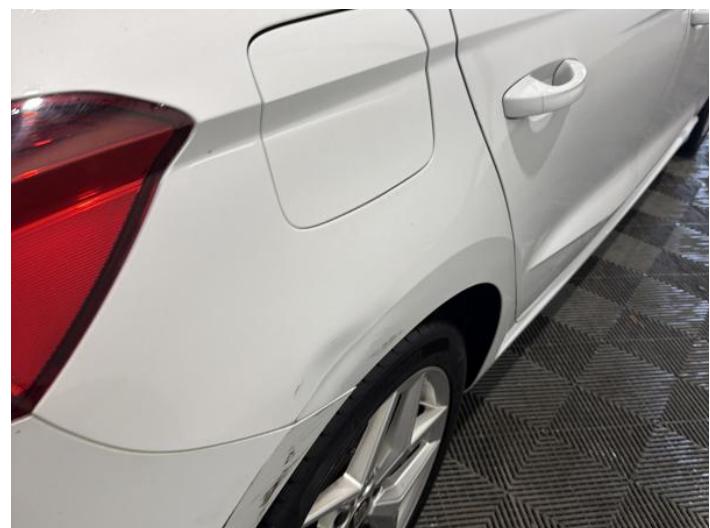
12: Qtr Panel osr
Dented
With Paint Damage

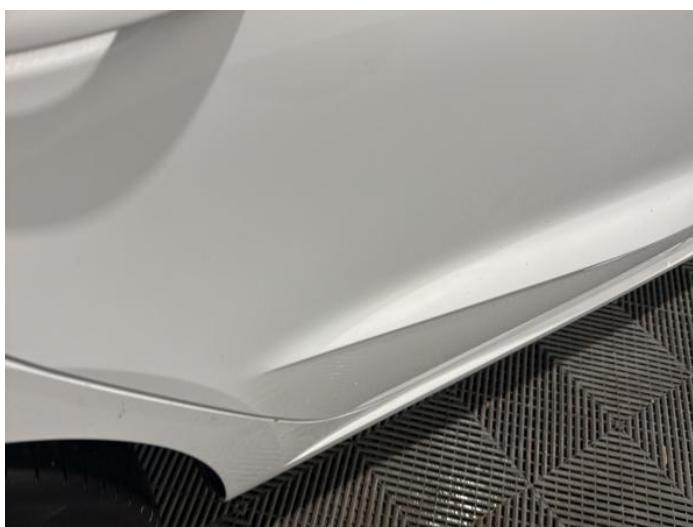
13: Qtr Panel osr
Dented
With Paint Damage

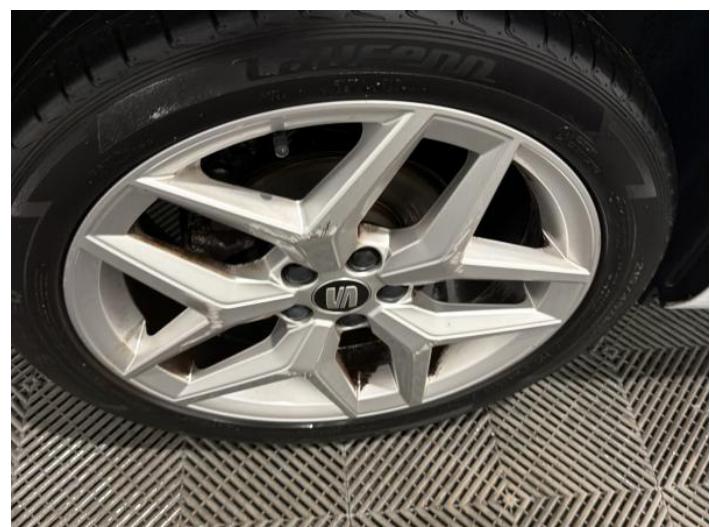
14: Wheel osr
Scratched
Over 50mm

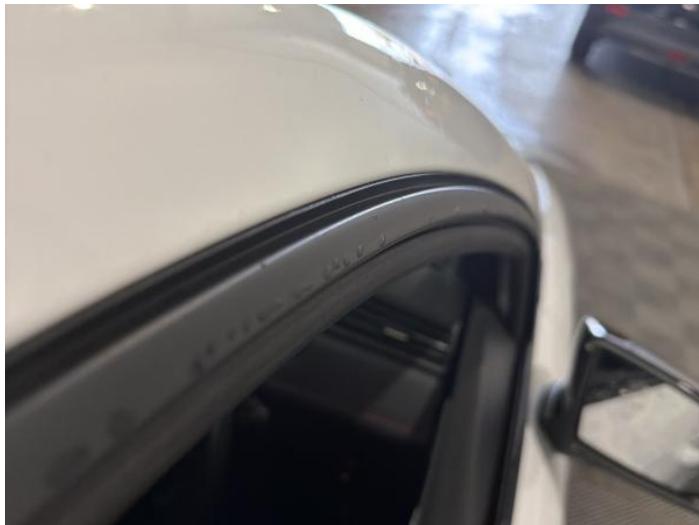
15: A Post os
Dented
Over 30mm

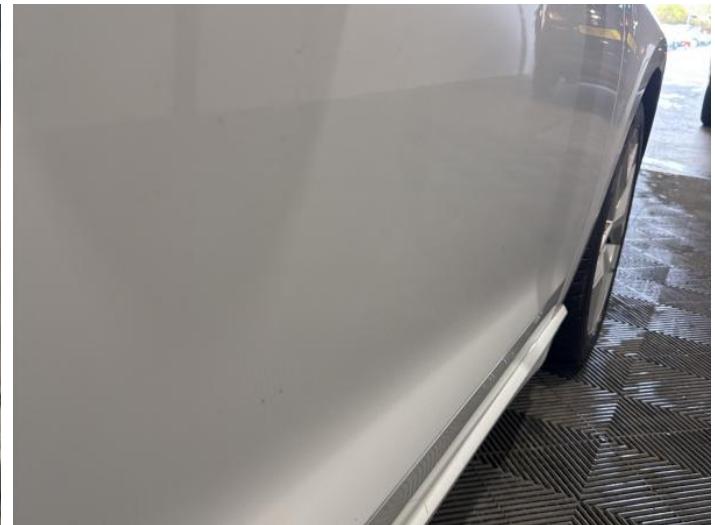
16: Door osf
Dented
Over 2 UpTo 10mm

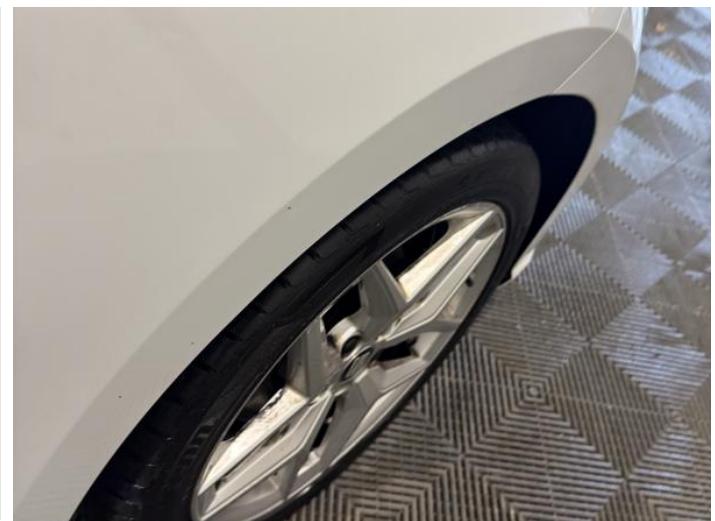
18: Wing osf
Chipped
1 To 5

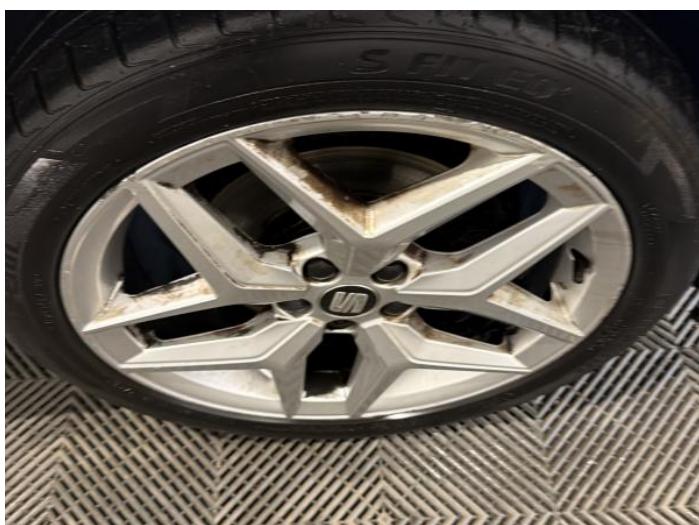
19: Wheel osf
Scratched
Over 50mm

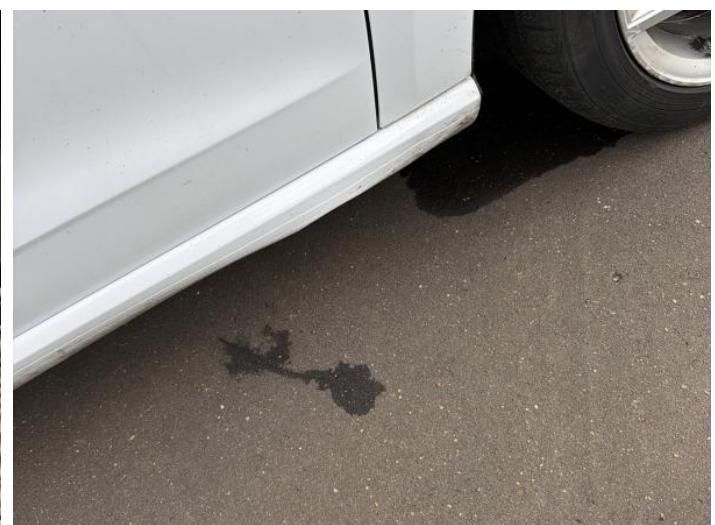
20: Sill os
Dented
Over 30mm
